# Inspection Report

## Profile building and pest inspections

**3 lando St Coombabah , Gold Coast , QLD**

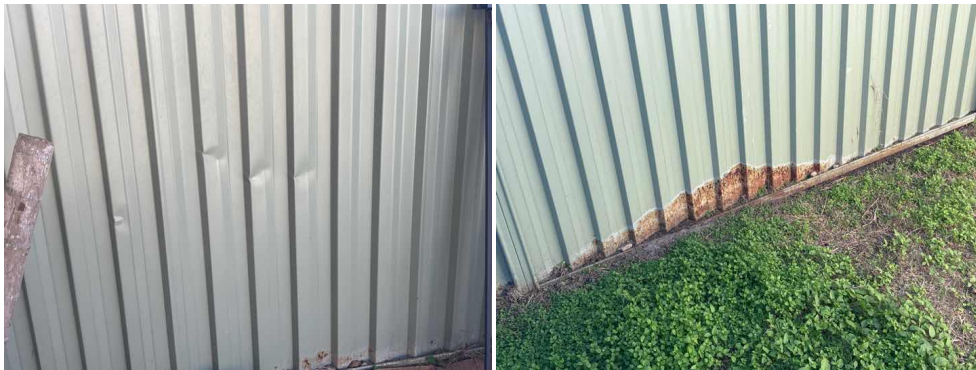
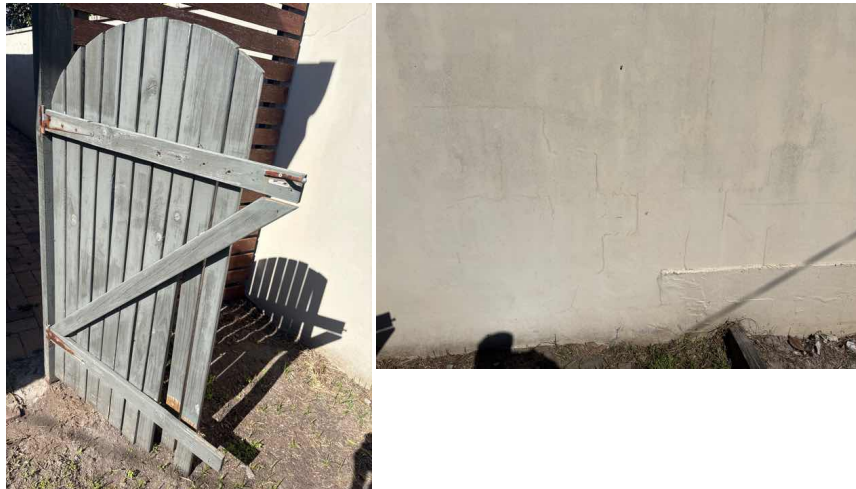
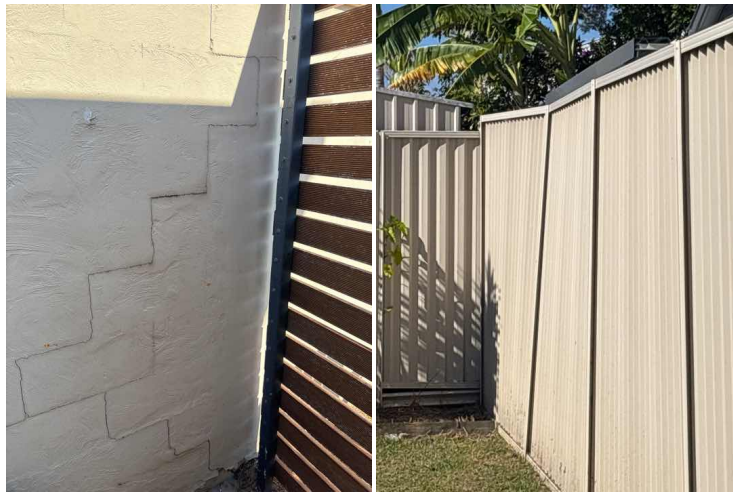
- #1. fences are leaning over slightly in some sections. Recommend to contact a licenced contractor to Repair any sections as necessary
- #2. Damage was noted to isolated sections of the metal fence. Contact a fencing contractor for repairs as necessary
- #3. Isolated Rusted sections to metal fence components. Contact a licensed contractor for Repair and replacement as necessary
- #4. General cracking to brick/block fence. Recommend to contact a licensed bricklayer for further advice and repairs
- #5. Gates are binding and/or not latching. Repairs recommended by licensed contractor

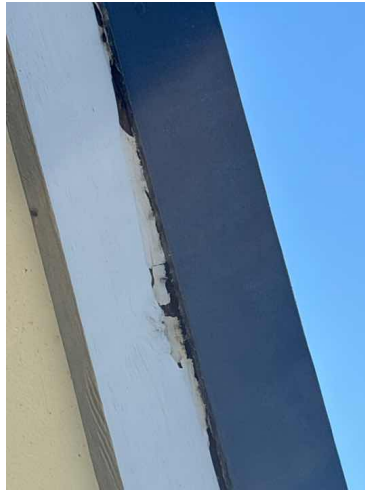
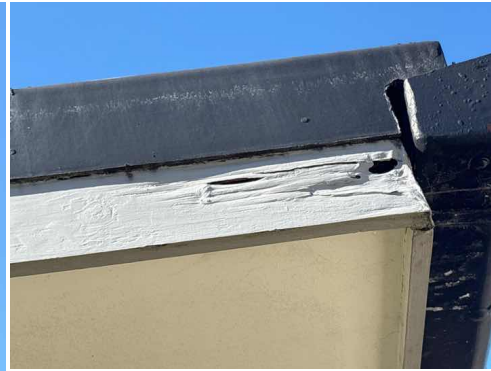
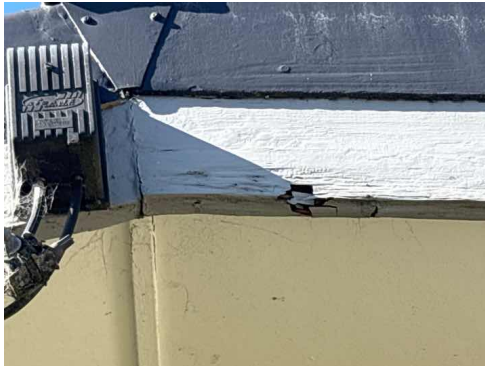
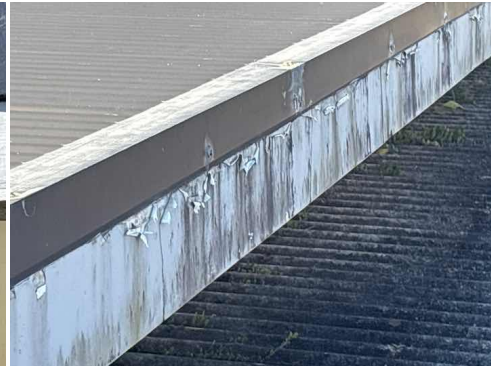
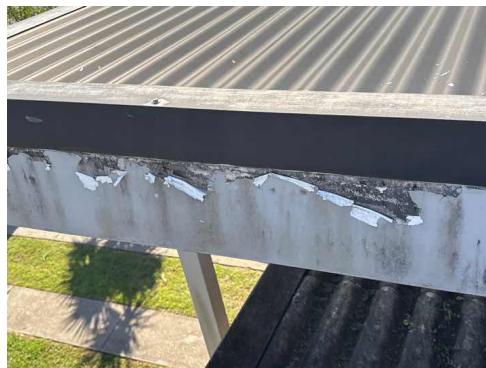
#6. Paint / finish was deteriorated in carport areas and is in need of maintenance - contact a licensed painter for further assistance and repair

#7. Sections of Timber fungal decay visible. Recommendations: A qualified carpenter should be engaged to repair/replace all affected timbers.

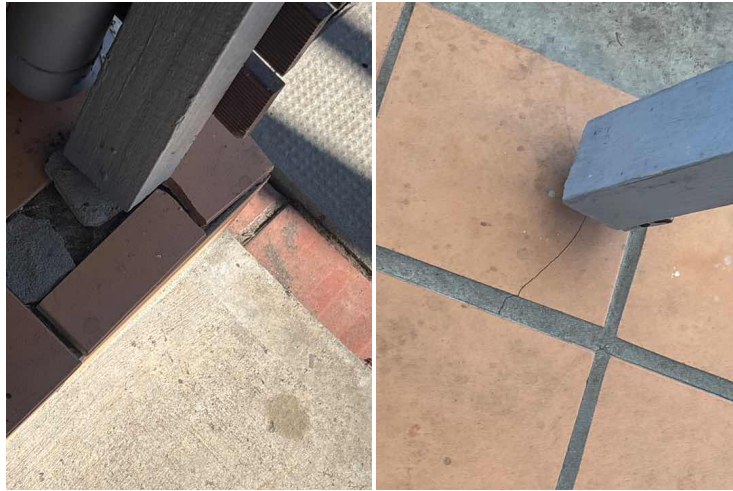
#8. Isolated Minor cracking/damage to tiles. Repair as necessary

#9. Drummy tile sections to Entry/porch. Recommend to monitor the area and proceed with repairs as required

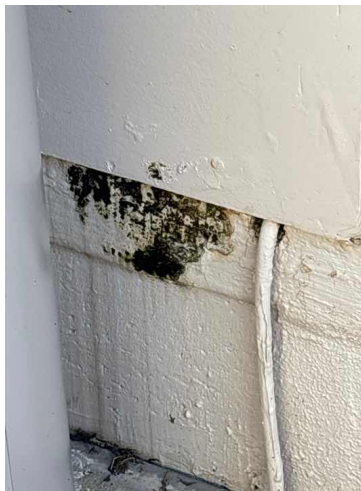
#10. Leaking detected beside hot water system from unknown source. Contact a licensed plumber for repair. Hidden damage may be present or can occur if left unattended.

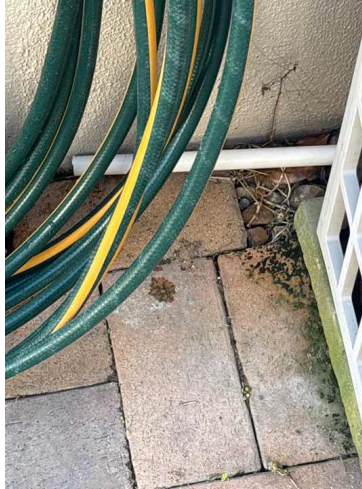
#11. The Air-Conditioning overflow requires diverting to a drain or further from the dwellings wall or footings. Excess water ponding alongside walls and into perimeter footings has the potential to cause rising damp, differential settlement and wall cracks over time. It is also conducive to termite infestation. Recommendations: Engage a plumber to rectify.

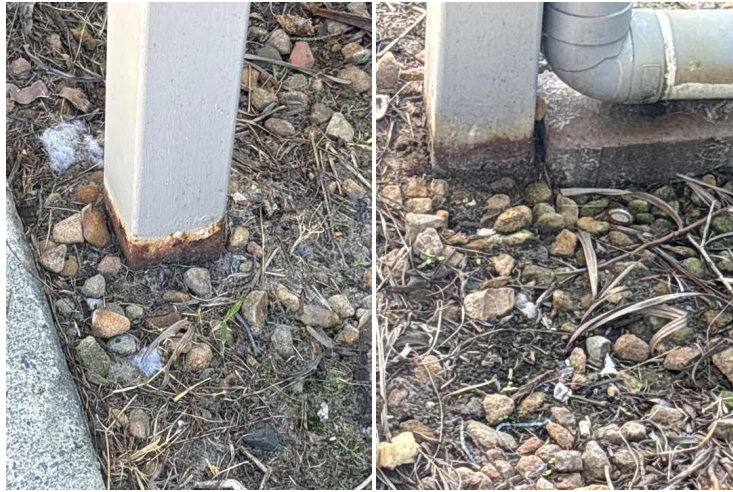
#12. Rust scale detected to the bottom of steel posts. Rust treatment/ repairs is recommended to prevent further deterioration

#13. It is recommended to clear all soil and debris from around the base of steel posts as this contributes to rust and deterioration

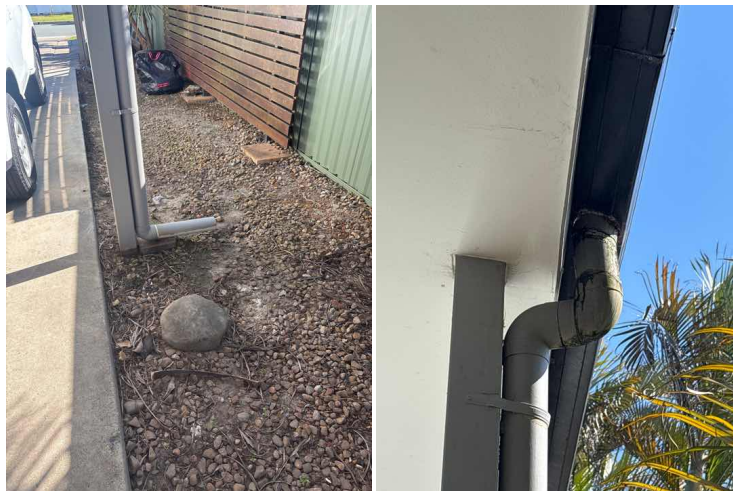
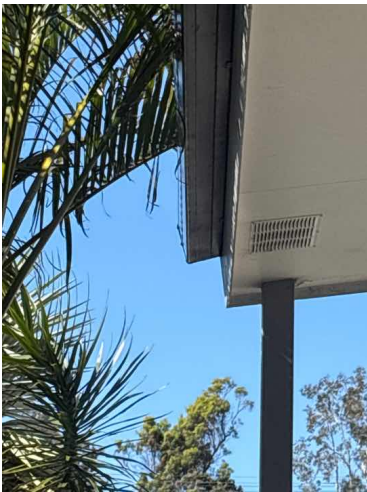
#14. Down pipe/s not connected to storm water discharge have the potential cause damage to the footings. Recommend Contacting a licensed plumber for installation

#15. Downpipe gutter junction coming apart. Contact a plumber for repairs

#16. Carport guttering is loose and/ or sagging in parts. Repairs required

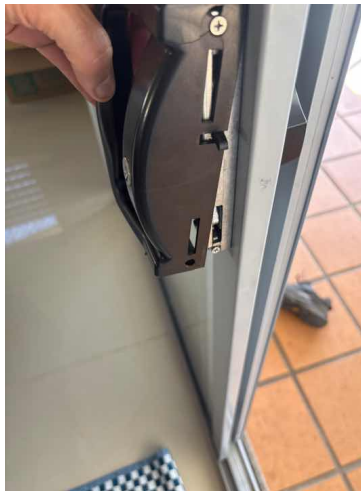
#17. Some external doors have Faulty and/or missing door latch - Repair recommended

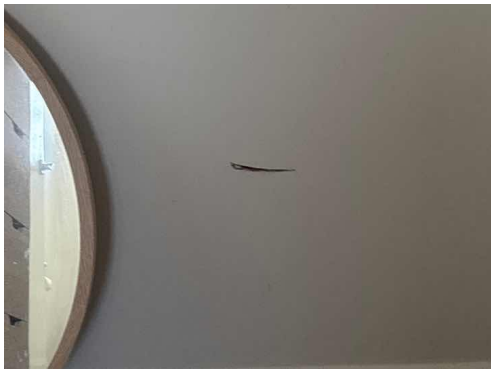
#18. Impact damage noted. Contact a licensed plasterer/ painter for repairs.

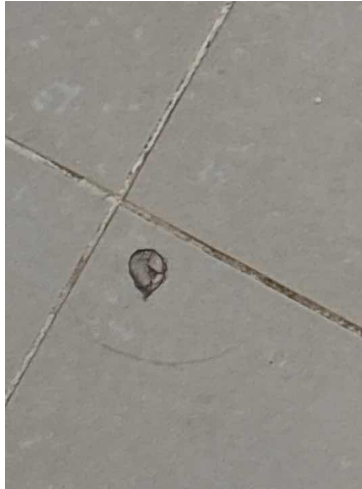
#19. Isolated chipped and damaged tiled were noted. Repairs recommended by a qualified tiler

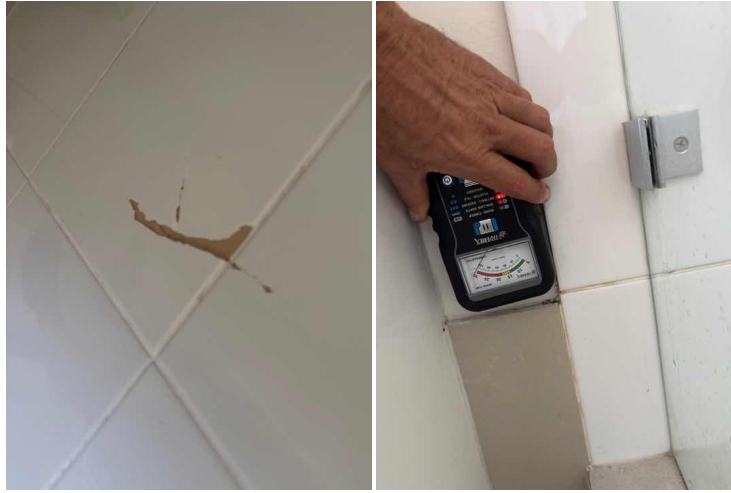
#20. High moisture readings were obtained on the wall surrounding. This may be related to the shower plumbing in wall or floor cavity leaking or failed waterproofing membrane to the area. Where high moisture has been detected, damage may have already occurred to concealed areas behind sheeting. In this case further investigation to this area is required. Recommendations: Engage a Licensed building contractor specialising in shower leaks for further assessment and advise on repair.

#21. Cracked tiles in shower enclosure. This may lead to water penetration into other areas. Immediate repairs required. Contact a licensed tiling contractor for repairs

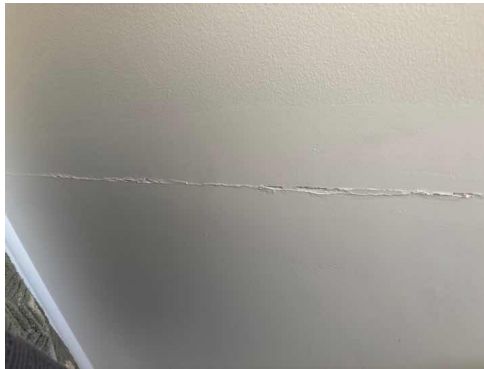
#22. Settlement Cracks Noted . These are typical and generally patch and paint will suffice,

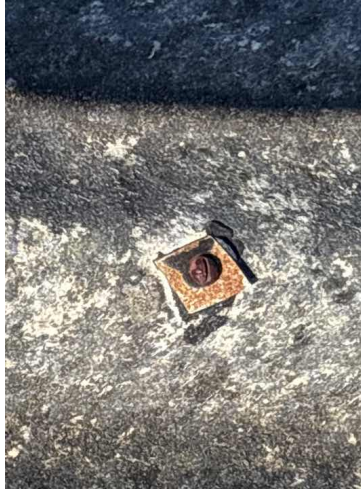
#23. Some roofing screws are rusted. Recommend rust treatment or replacement of the screws before they become too deteriorated to remove easily. Contact a licensed roofing contractor for repairs

#24. Fibro roof looked in visibly poor condition. This is possibly asbestos containing material. Recommend further assessment from a licensed roofing contractor.

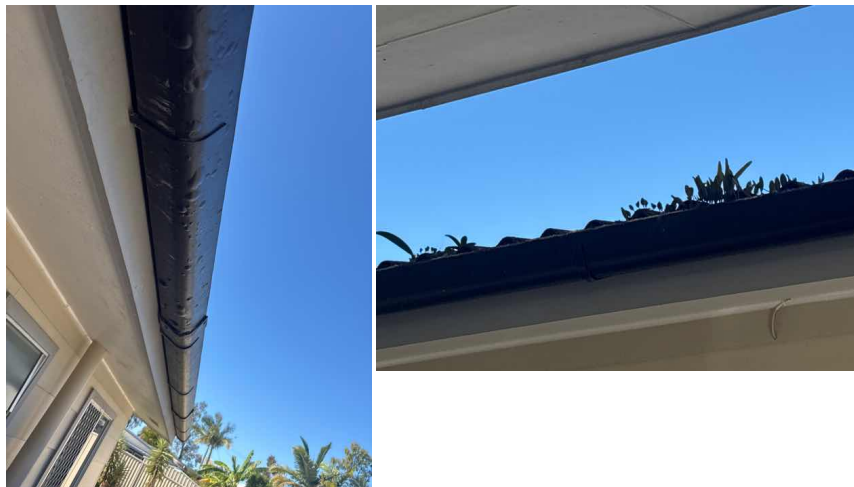
#25. There is evidence of leaking gutter joins. Silicone requires repairs. Contact a roof plumber for advice and repairs.

#26. Debris in guttering and/or valley areas- this requires cleaning out to prevent blocking of down pipes and leaking into areas below. Recommendations: Have gutters/ valleys cleaned and assessed by a plumber for adequate fall. Also regularly clean to prevent ponding. Ponding water will contribute to rust.

#27. The gutter fall appears inadequate in areas - this will allow water to pond and can lead to rust. Recommendations: A qualified roof plumber should be engaged for repairs and recommendations.

#28. Paint deteriorated/ bubbling

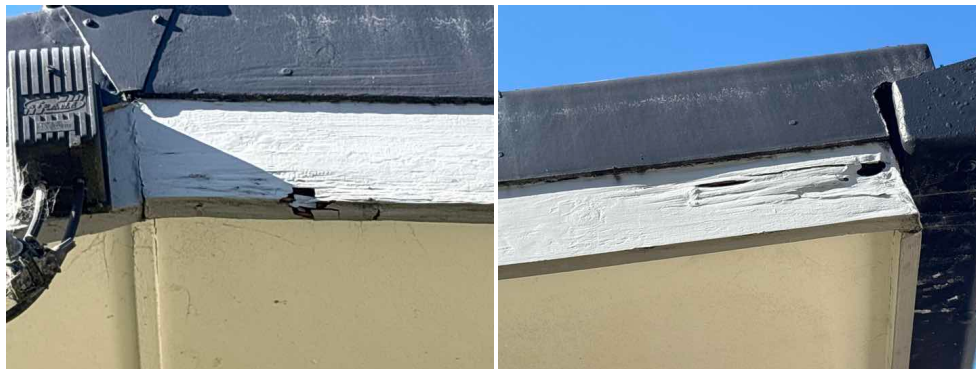
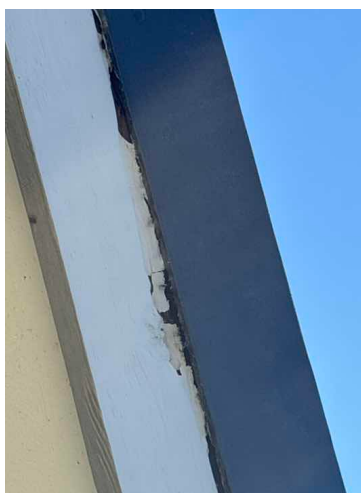
Fascia and / or Barge board

**Yes**, in the following areas ,Timber fungal decay located around the home provides conducive conditions for termite infestation. The degree of risk is high. Have all effected timber removed and replaced by a carpenter.

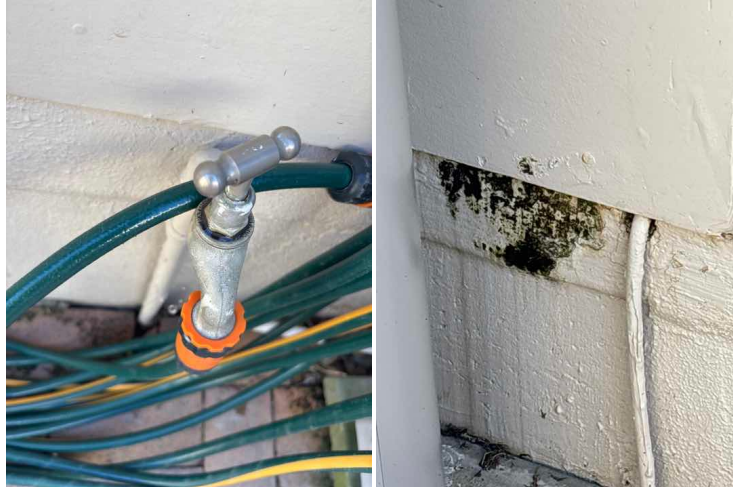
There was water leakage detected during the inspection from the tap. Liaise with a plumber to rectify same.

Leak beside hot water unit

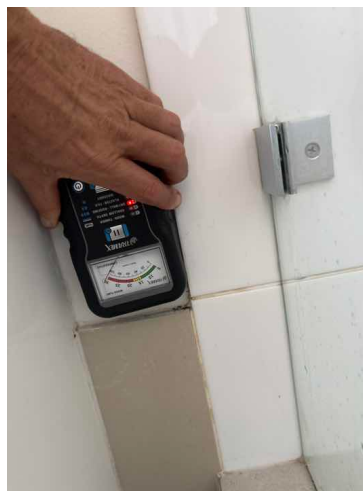
#### **Yes. To walls behind bathroom shower**

The moisture meter detected high moisture to wall beside bathroom shower.
