# Inspection Report

## Profile building and pest inspections

**4 Woodstock Ct Parkwood , Gold Coast , QLD**

### Pest And Building Inspection

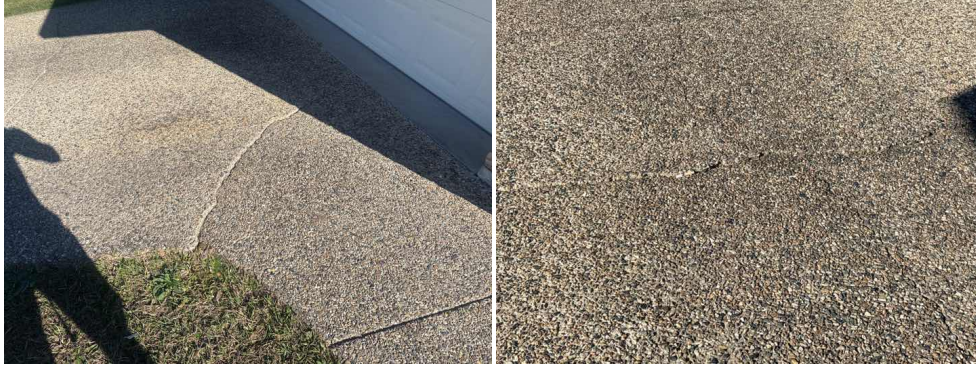
| Section | Location | Name | Comment |
|---|---|---|---|
| 2). SITE | Driveway | Driveway Condition | #1. Large cracking detected to driveway. Recommend to Contact a licensed Concretor for further advice on repairs |

#1. Large cracking detected to driveway. Recommend to Contact a licensed Concretor for further advice on repairs

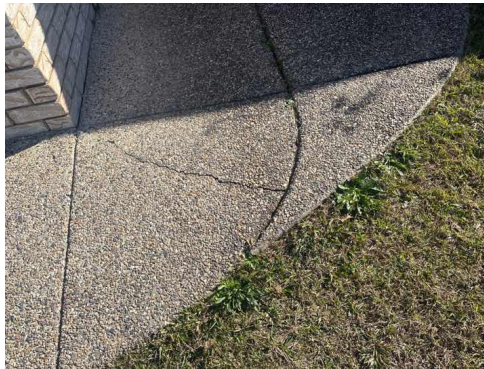
| Section | Location | Name | Comment |
|---|---|---|---|
| 2). SITE | Paths | Pathways Condition | #2. Common cracks and settlement were observed on paths. Recommend to monitor for any changes and contact a licensed concretor for repairs as needed. |

#2. Common cracks and settlement were observed on paths. Recommend to monitor for any changes and contact a licensed concretor for repairs as needed.

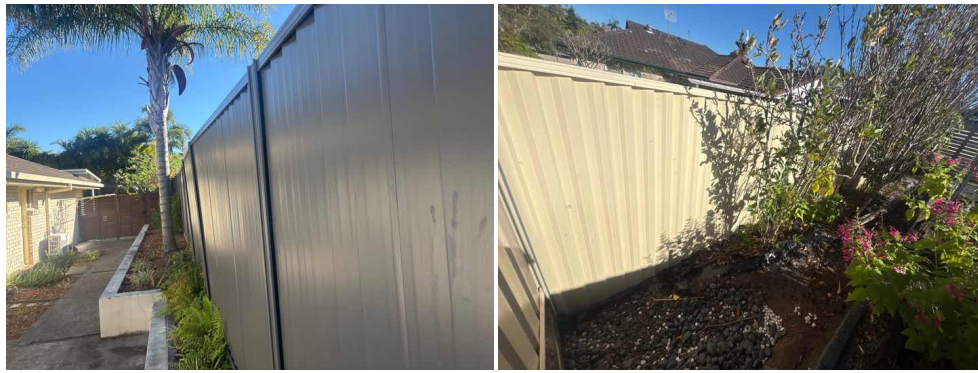
#3. Fences are leaning over moderately in some areas. Recommend to contact a licensed contractor to repair any leaning sections as necessary

#4. fences are leaning over slightly in some sections. Recommend to contact a licenced contractor to Repair any sections as necessary

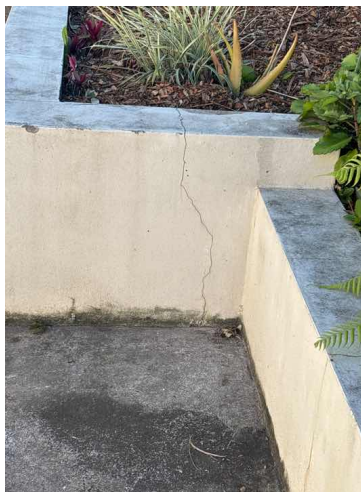
#5. Brick/block retaining walls have typical cracking to them. Recommend to monitor for any changes and to contact a licensed bricklayer for further advice and repairs as necessary

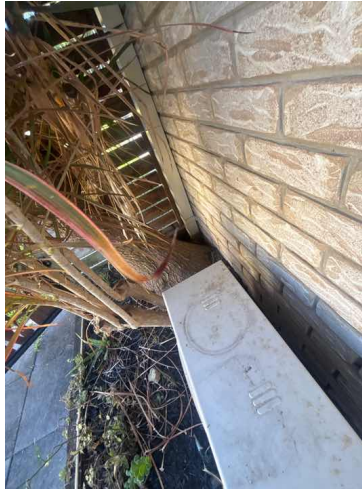
| Section | Location | Name | Comment |
|---|---|---|---|
| 2). SITE | Trees | Tree Findings | #6. Large plant base is in close proximity to the building can cause problems with the building foundations, blocking gutters and underground plumbing. Removing of trees or installing a root barrier may be required. Recommend contacting an experienced arborist for further clarification on this matter |

#6. Large plant base is in close proximity to the building can cause problems with the building foundations, blocking gutters and underground plumbing. Removing of trees or installing a root barrier may be required. Recommend contacting an experienced arborist for further clarification on this matter

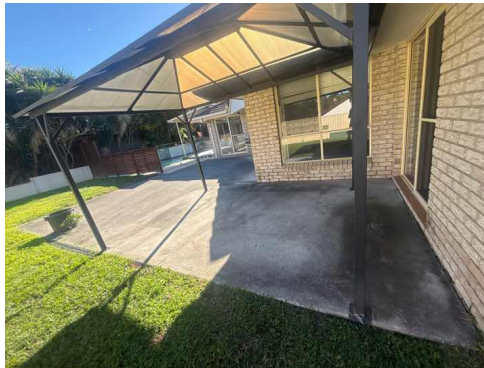
#7. Pergola is not bolted down and could blow away in strong wind

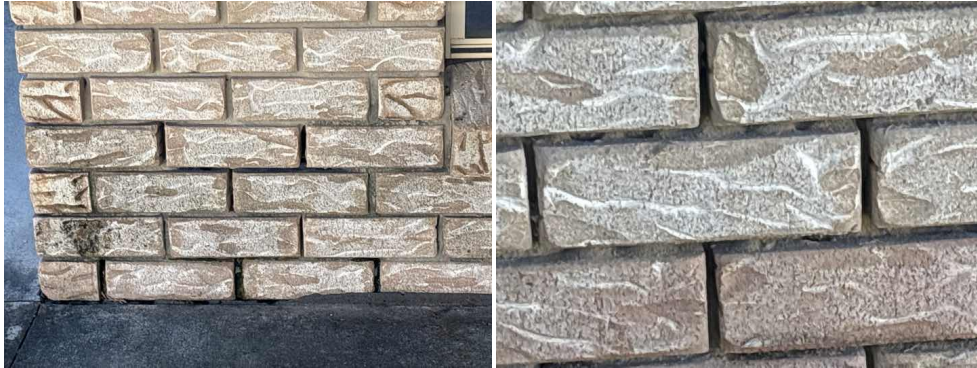
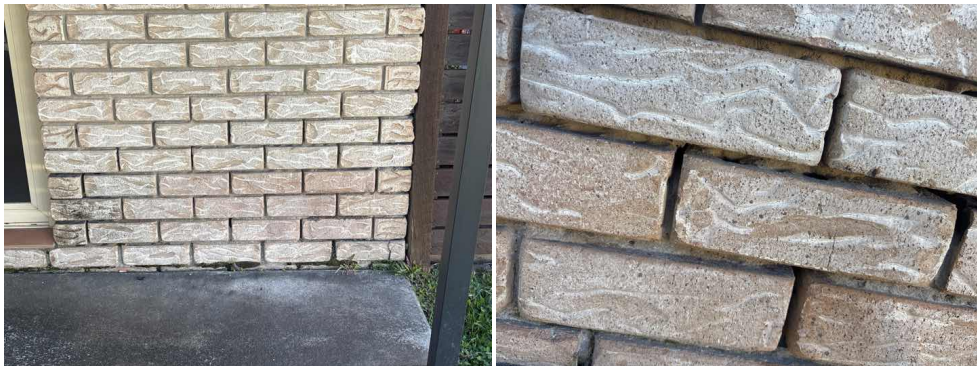
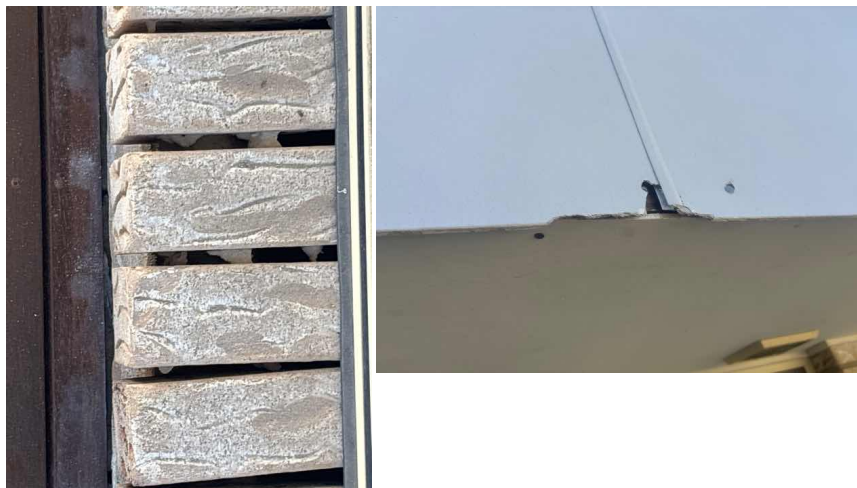
| Section | Location | Name | Comment |
|---|---|---|---|
| 3). EXTERIOR | Exterior Walls | Condition | #8. Brick mortar has deteriorated in Several areas At rear of house. Can affect the integrity of the brick wall.. Contact a licensed bricklayer for repairs. |

#8. Brick mortar has deteriorated in Several areas At rear of house. Can affect the integrity of the brick wall.. Contact a licensed bricklayer for repairs.

#9. Minor cladding damage at rear Gable

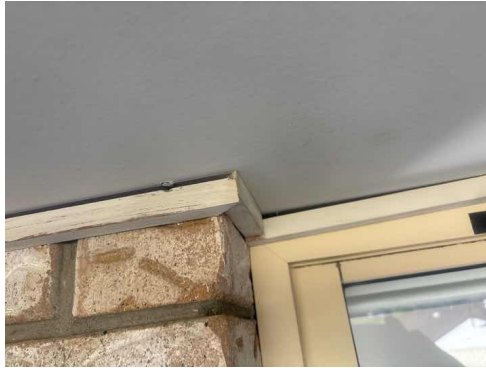
#10. Eave trim detached In a few areas. Contact a licensed carpenter for advice and repairs.

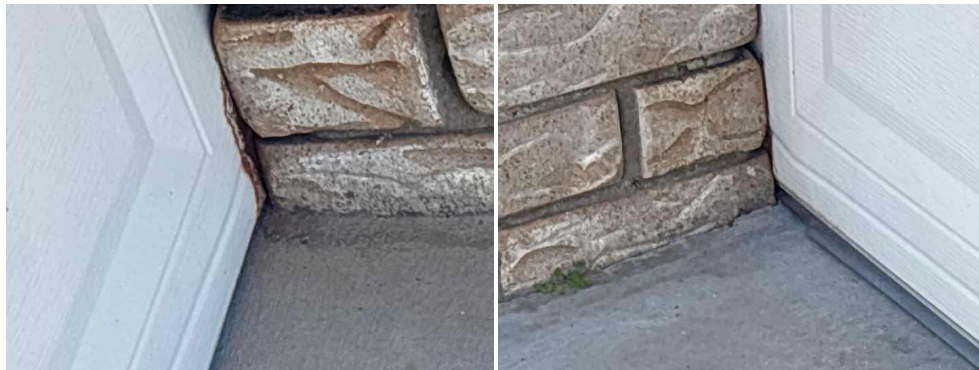
#11. Minor rust/damage to bottom corners of garage door where is rubbing against the brickwork?

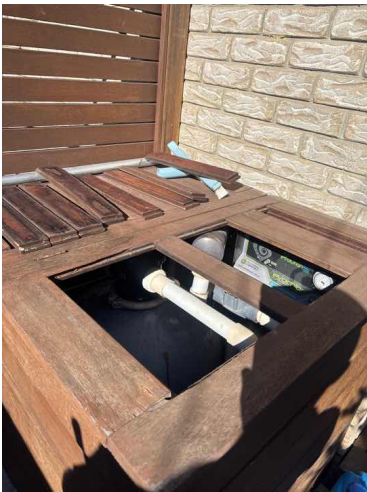
#12. Timber slats loose on pool filter cover

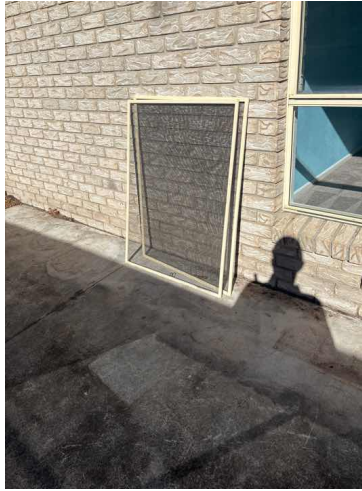
A couple of Flyscreens not installed

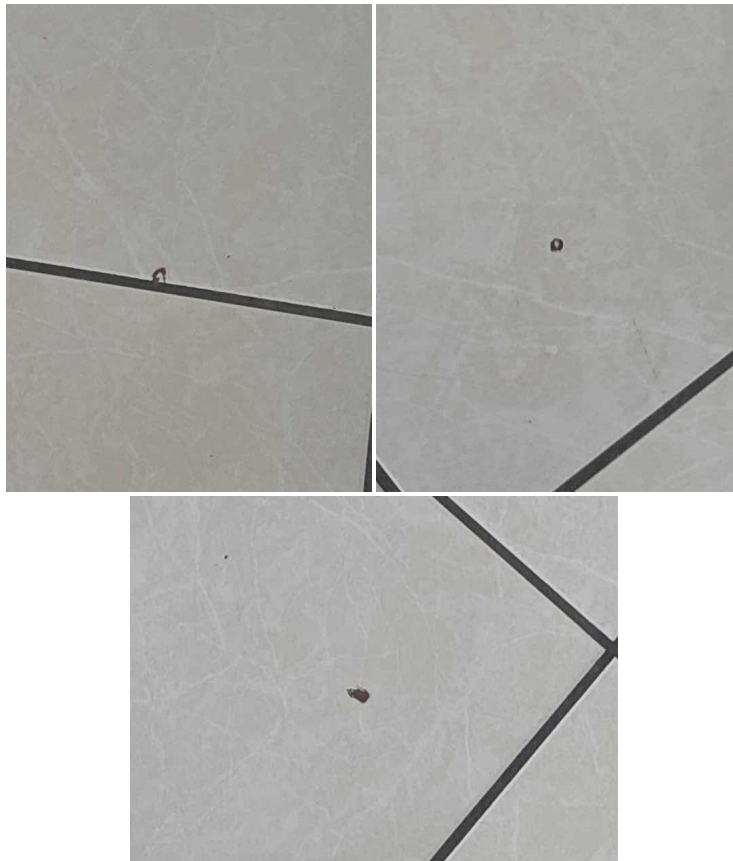
#13. Some chips to floor tiles. Cosmetic damage only. Repair as necessary

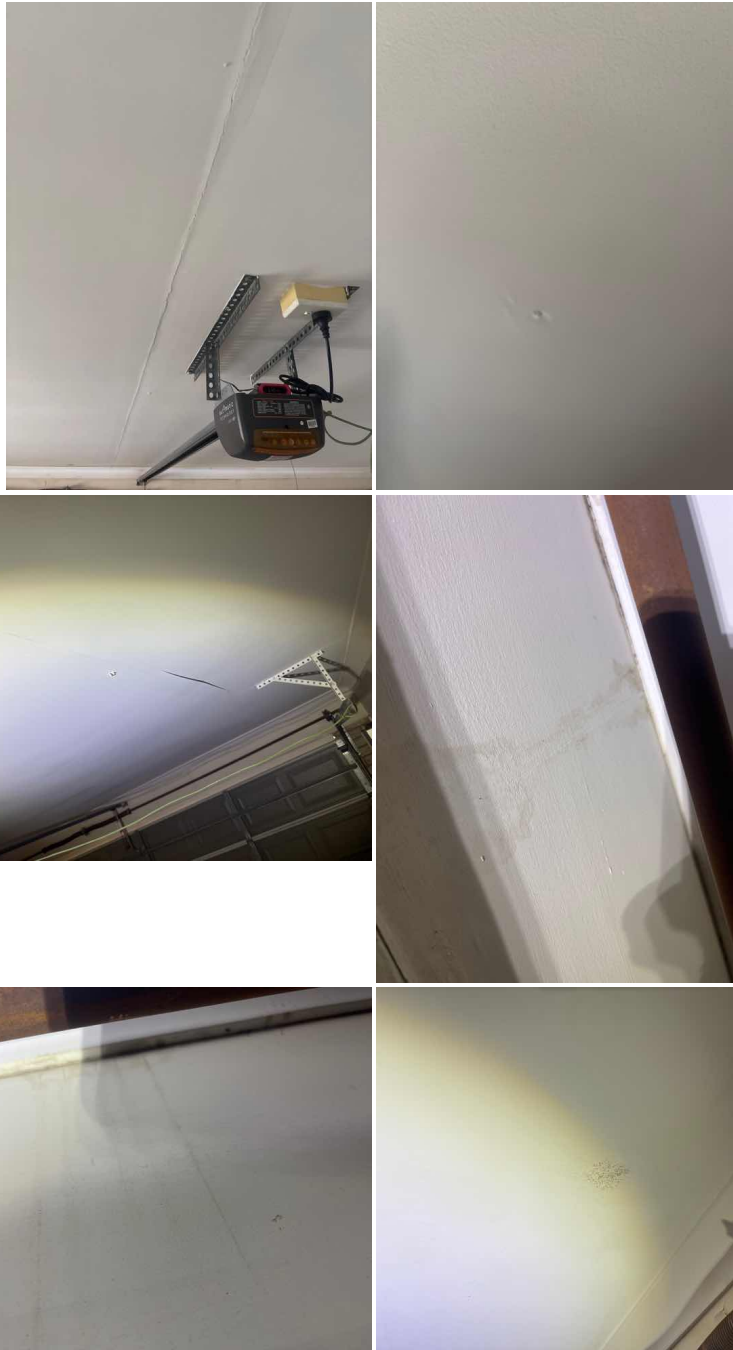
| Section | Location | Name | Comment |
|---|---|---|---|
| 7). INTERIORS. | Garage | Ceiling | #14. Ceiling and wall water stains above garage door - No moisture readings obtained. Recommendations: leaks likely to return unless repairs have been carried out -Hidden damage may be present or can occur if left unattended. Contact a licensed Roofing contractor for further evaluation and repair as necessary. Patch and paint defect as required |
| 7). INTERIORS. | Garage | Ceiling | #16. Ceiling sagging in areas - Requires repairs to prevent further collapse - Recommendations: Contact a licensed plasterer for further advice and repairs. |

#14. Ceiling and wall water stains above garage door - No moisture readings obtained. Recommendations: leaks likely to return unless repairs have been carried out -Hidden damage may be present or can occur if left unattended. Contact a licensed Roofing contractor for further evaluation and repair as necessary. Patch and paint defect as required

#15. Poor butt joint finish Visible under normal light conditions. Contact a licensed plasterer for further assistance and advise on repairs

#16. Ceiling sagging in areas - Requires repairs to prevent further collapse - Recommendations: Contact a licensed plasterer for further advice and repairs.

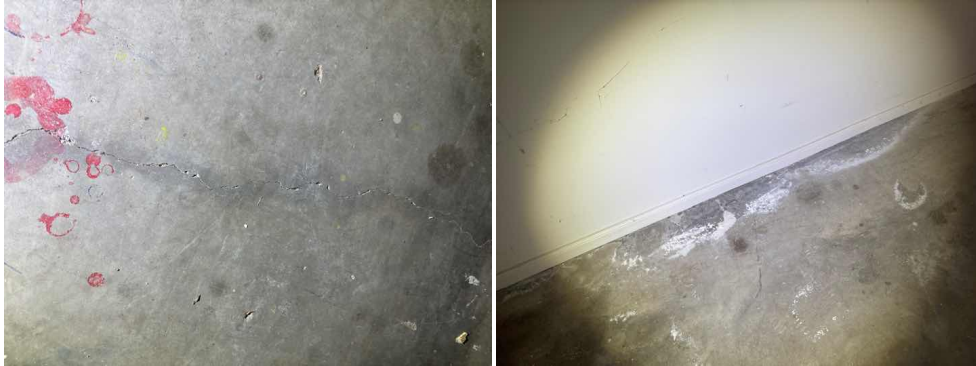
#17. Common cracking to Garage floor. This is very common of Garage floors and is generally a cosmetic defect only. Recommend to monitor for any changes and seek further assistance if necessary

#18. Salt staining entering through exterior wall. This is common of the wetting and drying of concrete. In severe cases damage to concrete can occur. Recommend to contact a licensed concreter for further assistance

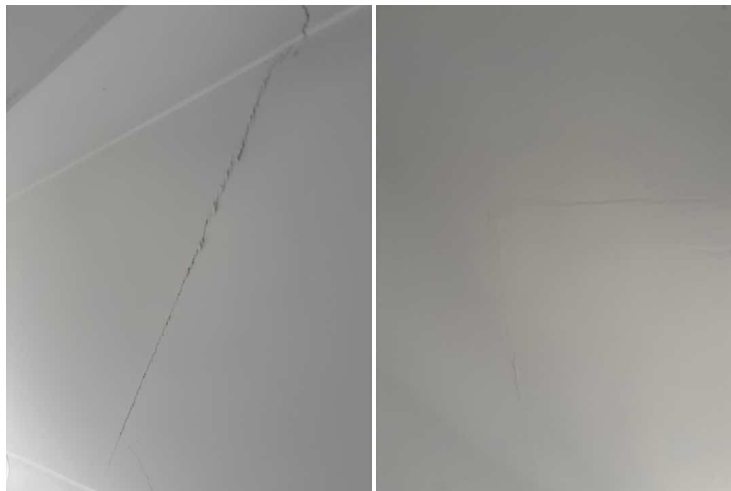
#19. Typical settlement cracking sighted. Contact a licensed plasterer for further advice and repair

#20. Cracking to ceiling hallways. Recommend the installation of an expansion joint. Contact a licensed plasterer for further advice on this matter

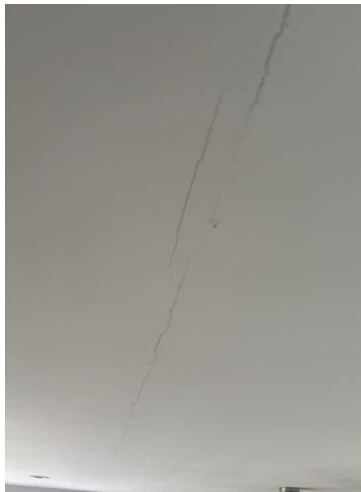
#21. Poor butt joint finish Visible under normal light conditions. Contact a licensed plasterer for further assistance and advise on repairs

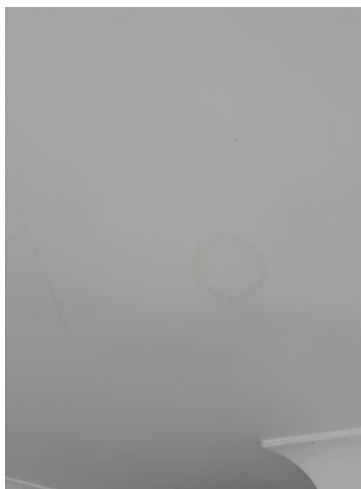
| Section | Location | Name | Comment |
|---|---|---|---|
| 7). INTERIORS. | Dining room | Ceiling | #23. Ceiling water stains - No moisture readings obtained. Recommendations: leaks likely to return unless repairs have been carried out -Hidden damage may be present or can occur if left unattended. Contact a licensed Roofing contractor for further evaluation and repair as necessary. Patch and paint defect as required |

#23. Ceiling water stains - No moisture readings obtained. Recommendations: leaks likely to return unless repairs have been carried out -Hidden damage may be present or can occur if left unattended. Contact a licensed Roofing contractor for further evaluation and repair as necessary. Patch and paint defect as required

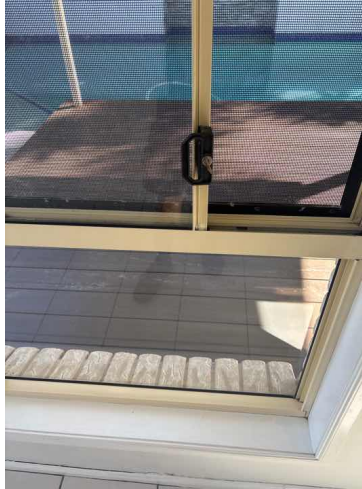
#24. Some Windows are difficult to open and close. Maintenance to rolling/ sliding mechanism required. Contact a window repair company for repairs.

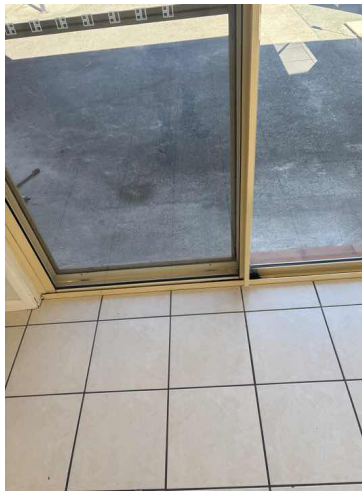
#25. Some external Sliding Doors are difficult to open and close. Maintenance to rolling/ sliding mechanism recommended

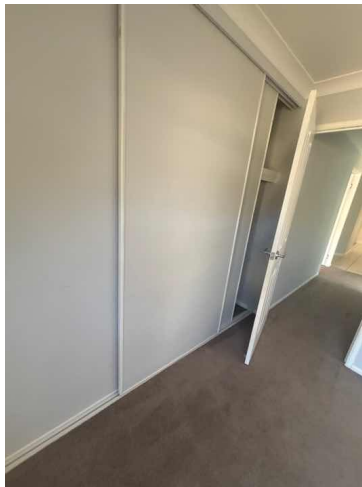
#26. Sliding doors were not operating correctly on day of inspection. Maintenance required

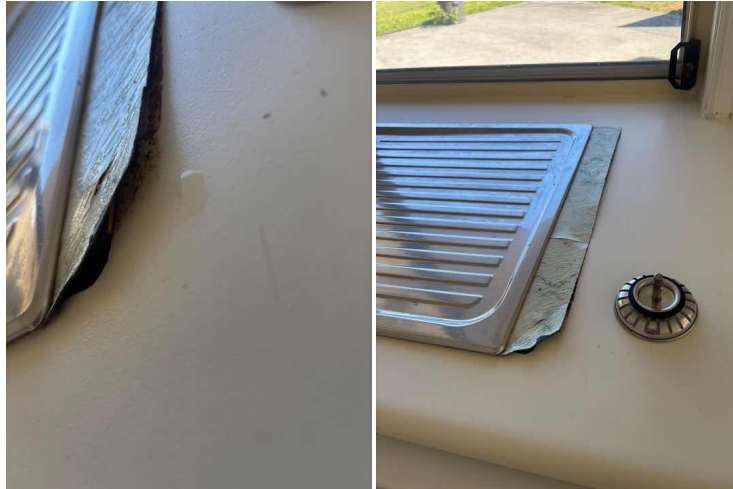
#27. Poor finish around sink where cut out was wrong size.

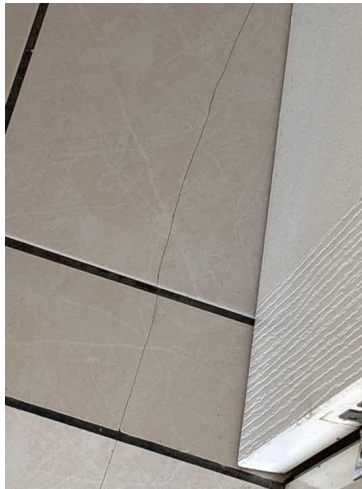
#28. Minor cracks floor tiles. A qualified tiler should be engaged for repairs.

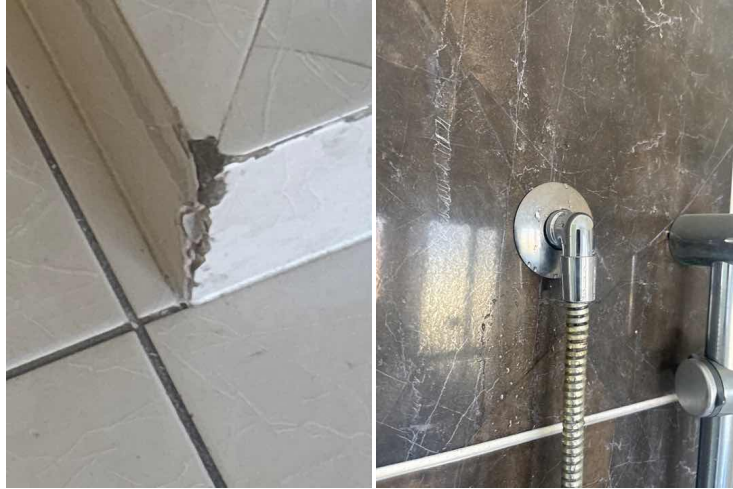
#29. Shower head is leaking. A qualified plumber should be engaged for advice and recommendations.

#30. Cracked tiles to shower hob. Contact a licensed Tiler for repairs.

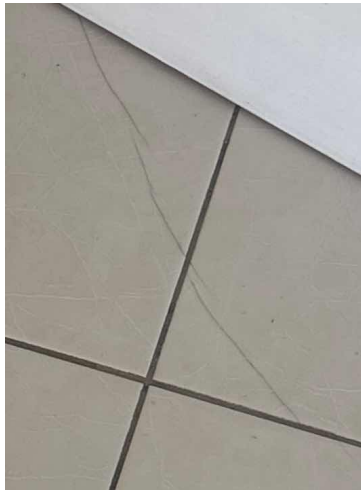
#31. Cracked floor tiles detected. Recommend contacting a licensed for Tiler for further advice on this matter

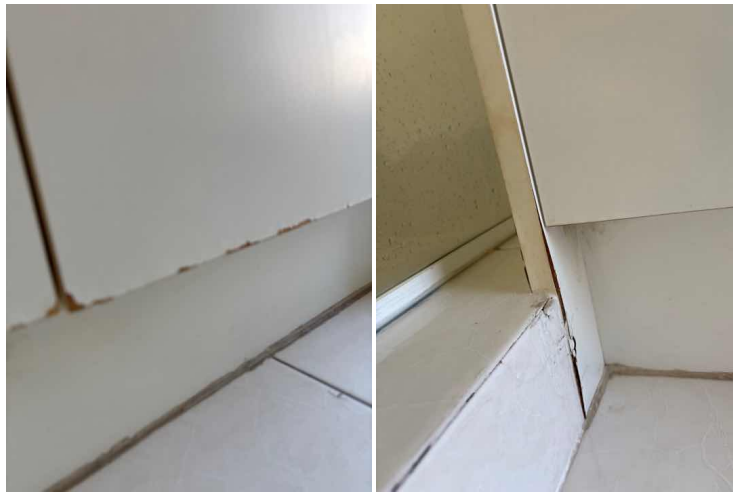
#32. Some minor cosmetic damage to sections of vanity

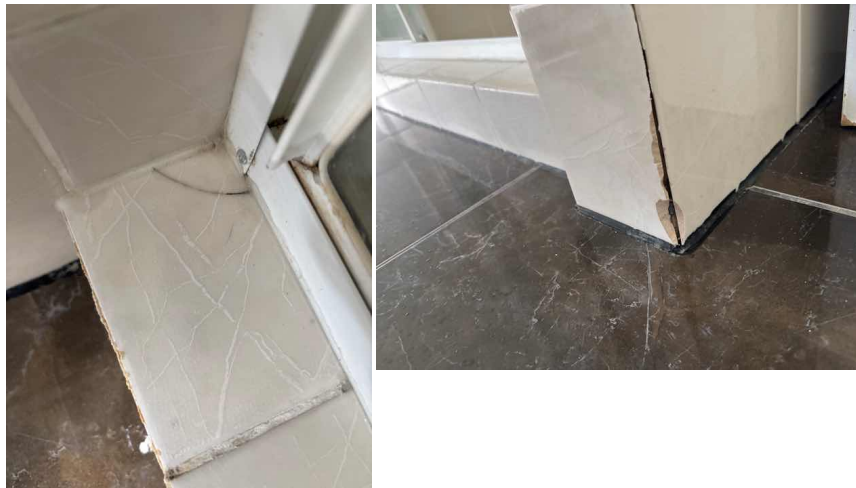
#33. Cracked tiles to shower hob. Contact a licensed Tiler for repairs.

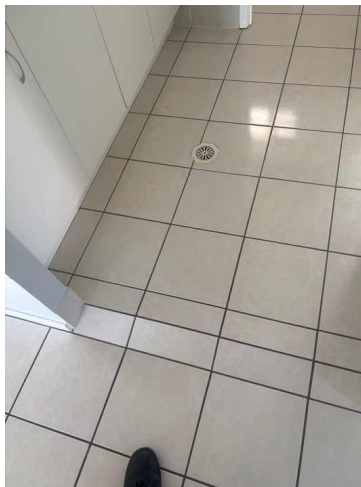
#34. Some Drummy floor tiles detected. No evidence of lifting or cracking. Recommend to monitor the area for any changes and proceed with repairs as necessary

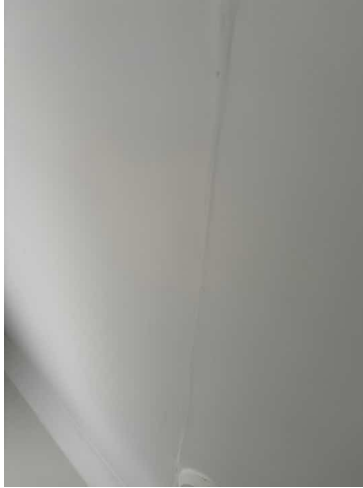
#35. Settlement Cracks Noted . These are typical and generally patch and paint will suffice,

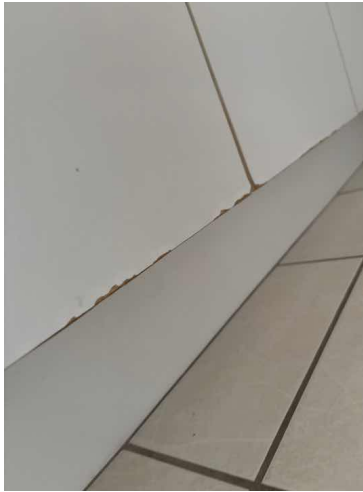
#36. Some minor cosmetic damage to sections of vanity

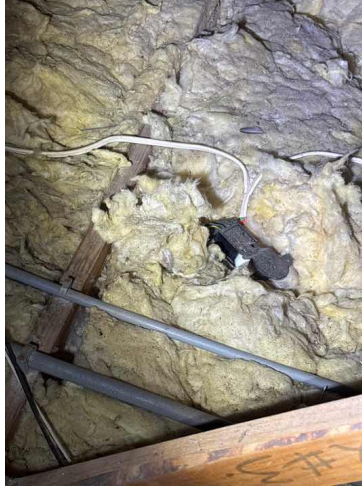
| Section | Location | Name | Comment |
|---|---|---|---|
| 11). ROOF VOID. | Insulation | Insulation | #37. Insufficient spacing between down lights to insulation and/or timbers. This poses a fire risk. Contact a licensed Electrician for repairs urgently |

#37. Insufficient spacing between down lights to insulation and/or timbers. This poses a fire risk. Contact a licensed Electrician for repairs urgently

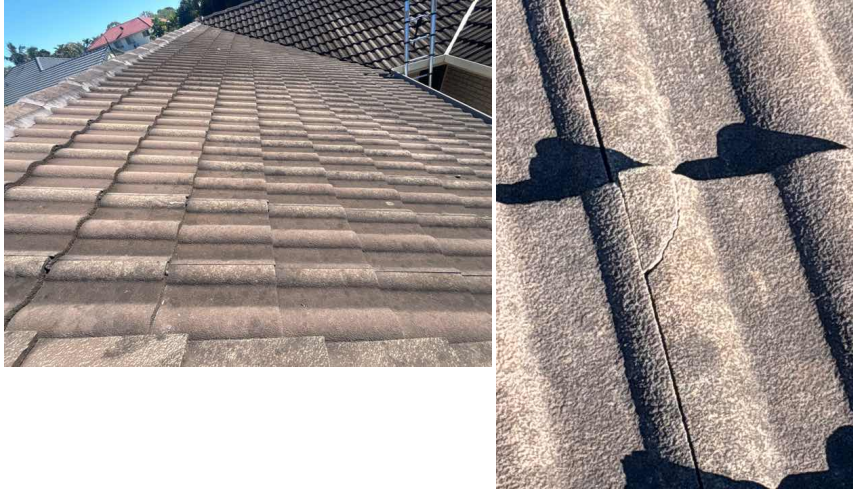
#38. Paint has deteriorated to several areas of the roof. Seek further advice from a roof restoration contractor as necessary

#39. The corners of some roof tiles have been cracked off. It is recommended to have these repaired to prevent any possible chance of leaks occurring. Contact a licensed roof tile for repairs.

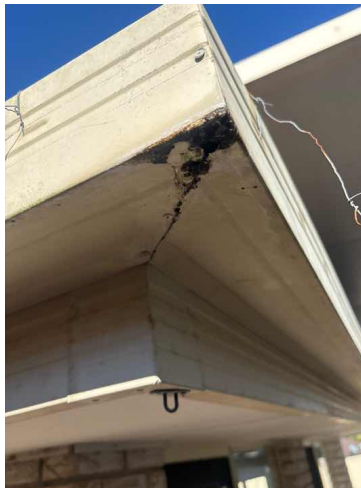
#40. There is evidence of leaking gutter joins. Silicone requires repairs. Contact a roof plumber for advice and repairs.

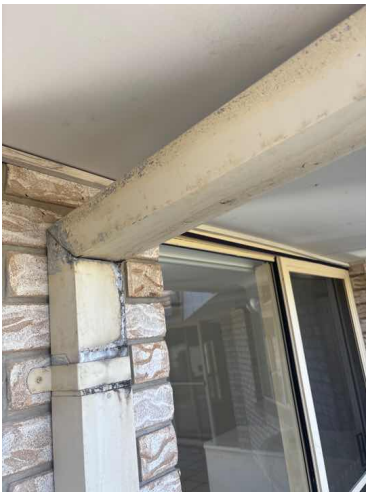
#41. Leaking down pipe joins visible. Recommendations: A qualified roof plumber should be engaged to repair.

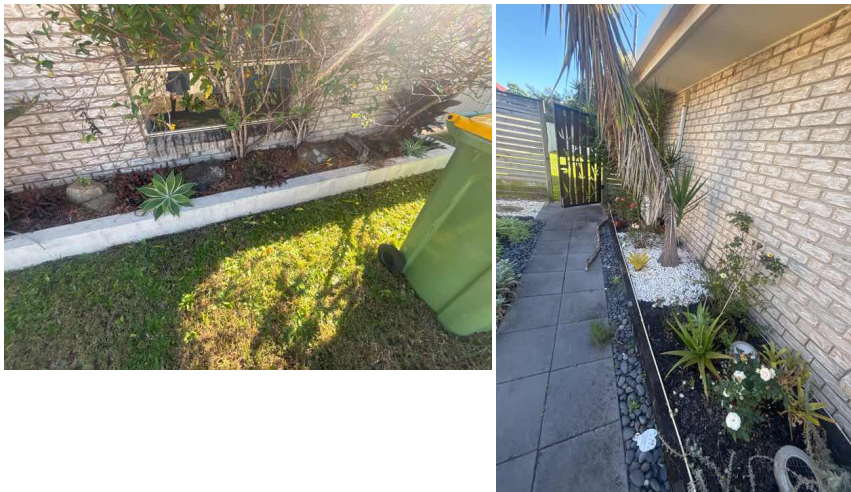
There is mulch and/ or garden beds/ plants located close to the house. These garden beds provide conducive conditions for termites to nest. These garden beds should be removed or relocated further away from the house. The degree of risk is moderate to high.

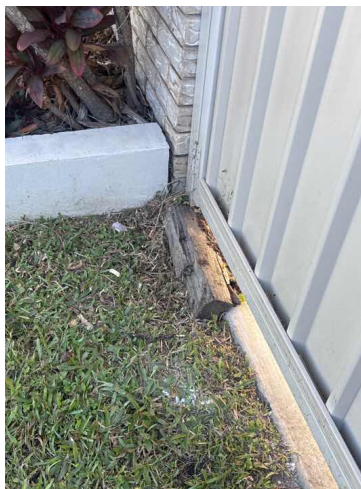
Timber or debris in contact with ground located in sub floor and/or close to external walls. This provides conducive conditions for termite infestation. The degree of risk is high. Remove all Timbers and debris.

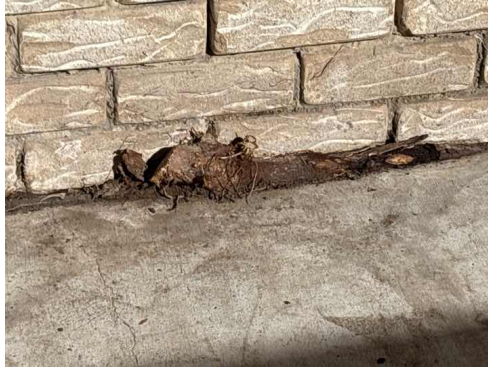
Any tree roots hard enough against the house provides conducive conditions for termite activity and should be fully removed
