# Inspection Report

## Profile building and pest inspections

**1/16 Cassia Dr Coomera , Gold Coast , QLD**

### Pest And Building Inspection

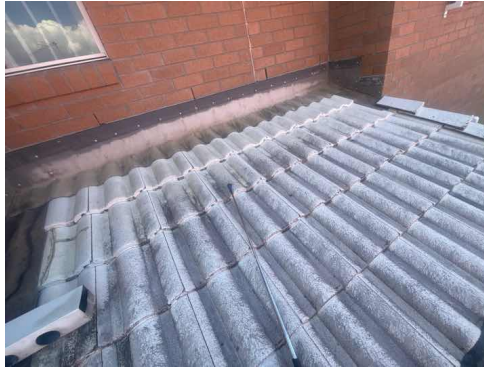
No inspection to upper roof surface due to height. Not accessible off a 3.6 meter ladder (as per Australian standard) An inspection of this area is strongly recommended once safe access has been provided

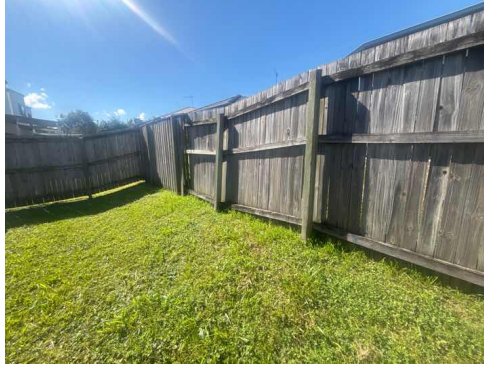
| Section | Location | Name | Comment |
|---|---|---|---|
| 2). SITE | Fences & Gates | Overall Condition | #1. Rear Fence is leaning over moderately in some areas. Recommend to contact a licensed contractor to repair any leaning sections as necessary |

#1. Rear Fence is leaning over moderately in some areas. Recommend to contact a licensed contractor to repair any leaning sections as necessary

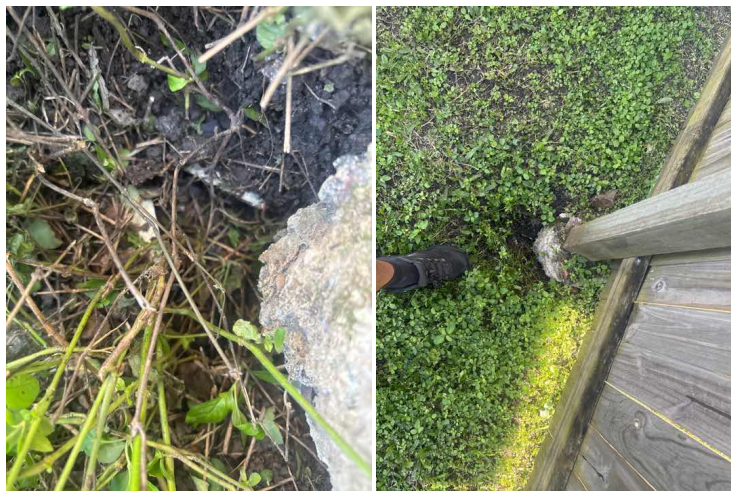
| Section | Location | Name | Comment |
|---|---|---|---|
| 2). SITE | Exterior plumbing | Broken pipe | #2. Broken plumbing pipe sighted In backyard. This can cause leaking next to the building which could lead to subside or heaving of the building. This is also conducive to termite activity. Contact a licensed plumber for immediate repairs |

#2. Broken plumbing pipe sighted In backyard. This can cause leaking next to the building which could lead to subside or heaving of the building. This is also conducive to termite activity. Contact a licensed plumber for immediate repairs

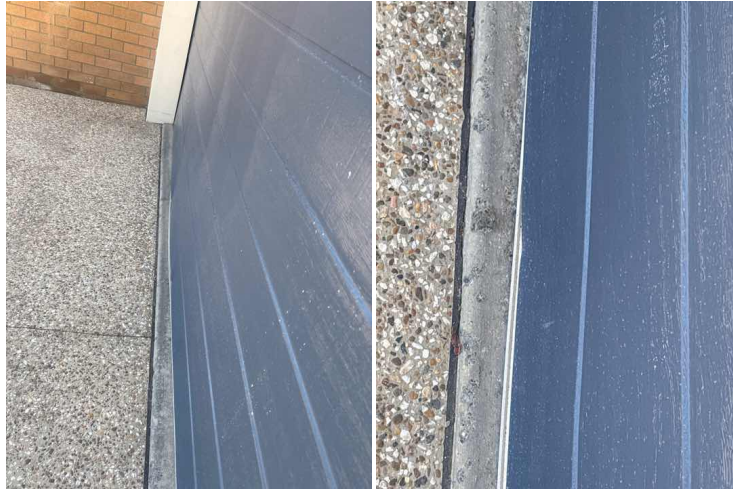
| Section | Location | Name | Comment |
|---|---|---|---|
| 3). EXTERIOR | Garage doors | Garage door | #3. Impact damage sighted to garage door or doors. Repair as necessary |

#3. Impact damage sighted to garage door or doors. Repair as necessary

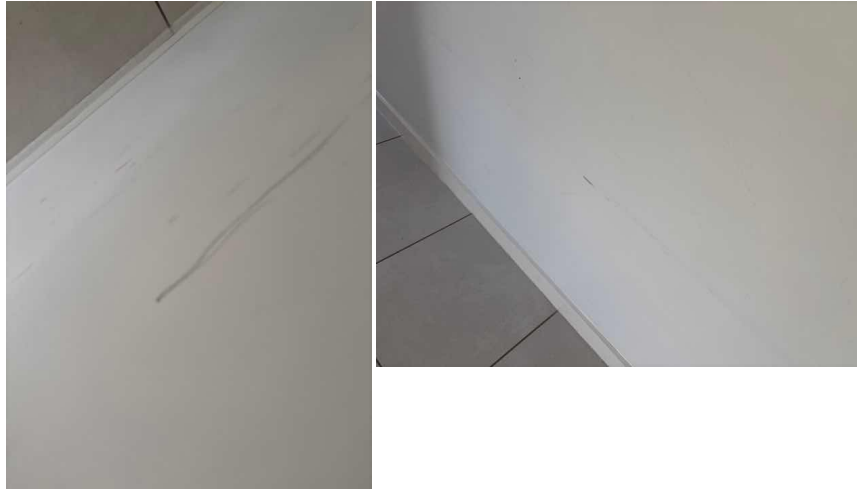
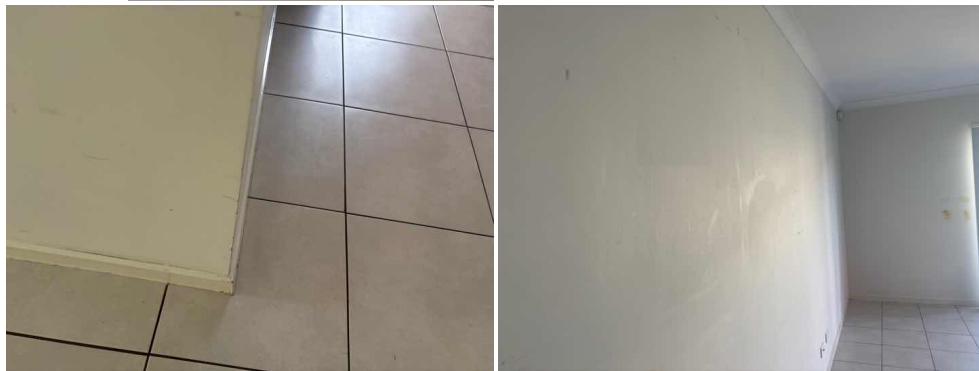
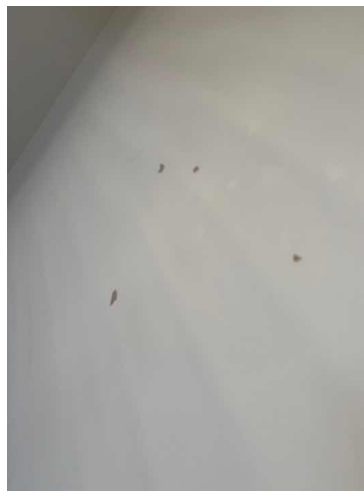
| Section | Location | Name | Comment |
|---|---|---|---|
| 7). INTERIORS. | Internal Areas | Walls | #4. Typical defects and marks to internal wall and ceiling linings for the age of the property. Patching and painting where required will improve overall appearance. Contact a licensed painter for further assistance |

#4. Typical defects and marks to internal wall and ceiling linings for the age of the property. Patching and painting where required will improve overall appearance. Contact a licensed painter for further assistance

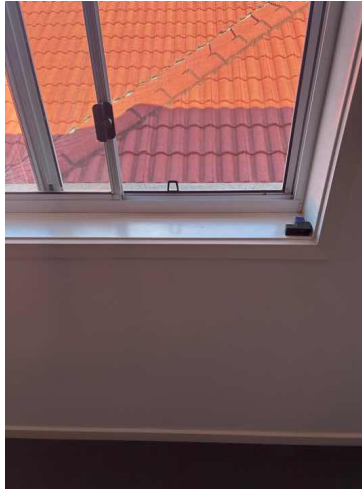
| Section | Location | Name | Comment |
|---|---|---|---|
| 7). INTERIORS. | Internal Areas | Windows | #5. Where window sills are less than 1.7 meters off floor and floor has a drop of more than 2 meters. Current building regulations require window opening to be restricted or a secure approved screen be installed to prevent falls. Although not a requirement for older houses it is strongly recommended that windows be made to comply with current regulations for safety reasons. |

#5. Where window sills are less than 1.7 meters off floor and floor has a drop of more than 2 meters. Current building regulations require window opening to be restricted or a secure approved screen be installed to prevent falls. Although not a requirement for older houses it is strongly recommended that windows be made to comply with current regulations for safety reasons.

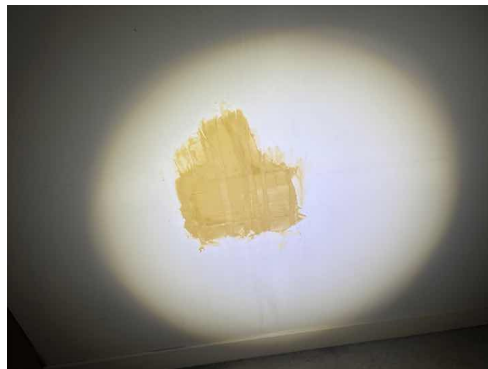
| Section | Location | Name | Comment |
|---|---|---|---|
| 7). INTERIORS. | Garage | Walls | #6. Incomplete Patch/Paint repairs noted. Call a licensed Plasterer/ painter for repairs |

#6. Incomplete Patch/Paint repairs noted. Call a licensed Plasterer/ painter for repairs

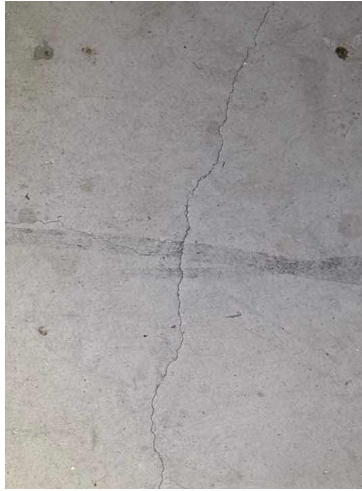
| Section | Location | Name | Comment |
|---|---|---|---|
| 7). INTERIORS. | Garage | Flooring | #7. Common cracking to Garage floor. This is very common of Garage floors and is generally a cosmetic defect only. Recommend to monitor for any changes and seek further assistance if necessary |

#7. Common cracking to Garage floor. This is very common of Garage floors and is generally a cosmetic defect only. Recommend to monitor for any changes and seek further assistance if necessary

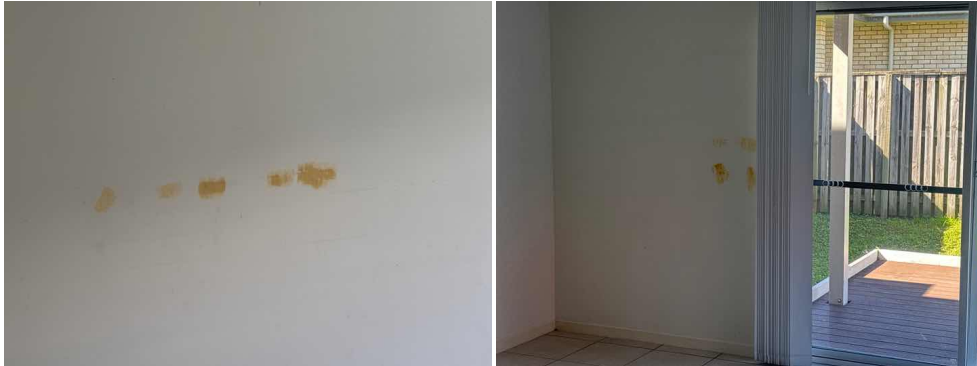
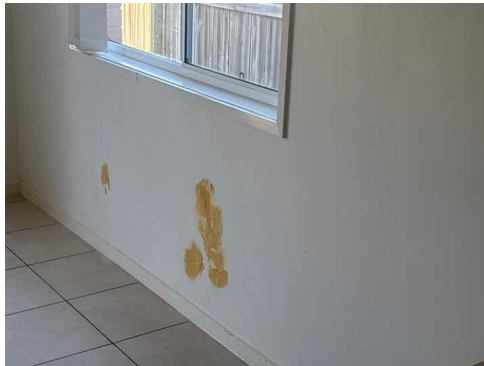
| Section | Location | Name | Comment |
|---|---|---|---|
| 7). INTERIORS. | Living room | Walls | #8. Incomplete Patch/Paint repairs noted. Call a licensed Plasterer/ painter for repairs |

#8. Incomplete Patch/Paint repairs noted. Call a licensed Plasterer/ painter for repairs

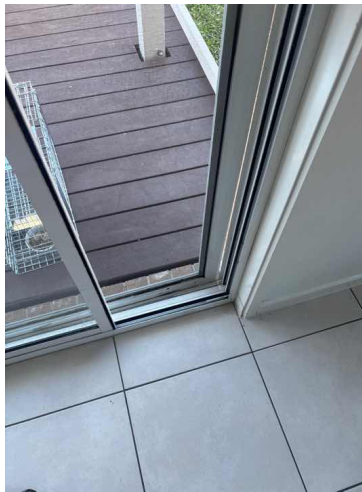
| Section | Location | Name | Comment |
|---|---|---|---|
| 7). INTERIORS. | Living room | External doors | #9. Fly screen is off its track. Maintenance Recommended. |

#9. Fly screen is off its track. Maintenance Recommended.

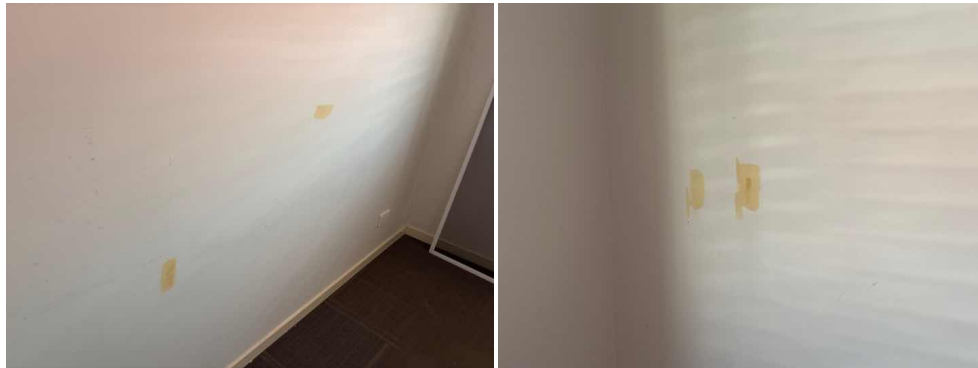
| Section | Location | Name | Comment |
|---|---|---|---|
| 7). INTERIORS. | Bedroom 3 | Walls | #10. Incomplete Patch/Paint repairs noted. Call a licensed Plasterer/ painter for repairs |

#10. Incomplete Patch/Paint repairs noted. Call a licensed Plasterer/ painter for repairs

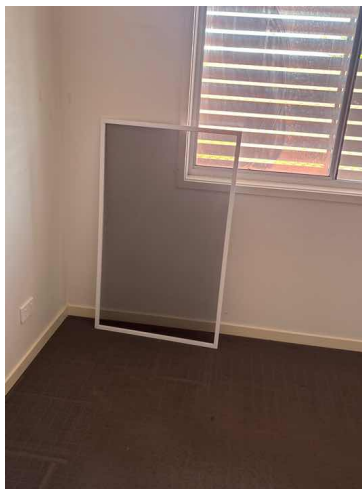
#11. Fly screen not installed

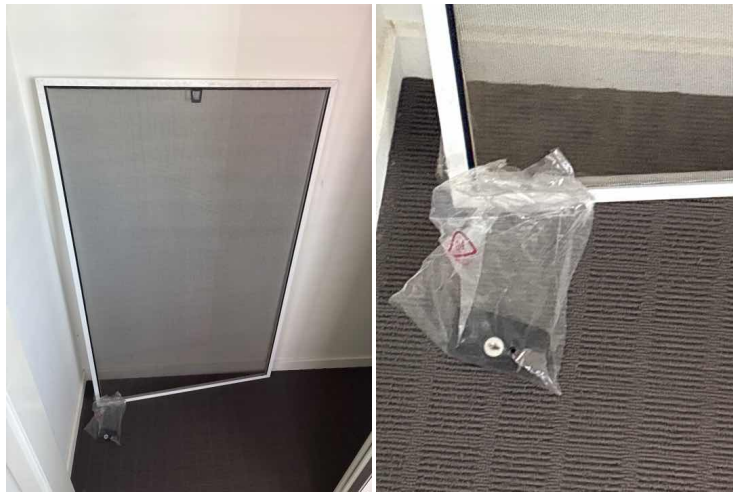
#12. Flat screen and handle Not installed

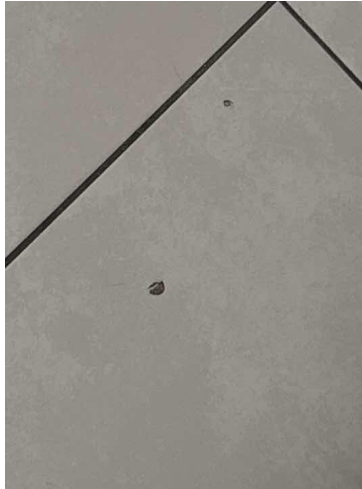
| Section | Location | Name | Comment |
|---|---|---|---|
| 8). KITCHEN & LAUNDRY. | Kitchen | Floor | #13. Some chipped and damaged tiled were noted. Repairs recommended by a qualified tiler |

#13. Some chipped and damaged tiled were noted. Repairs recommended by a qualified tiler

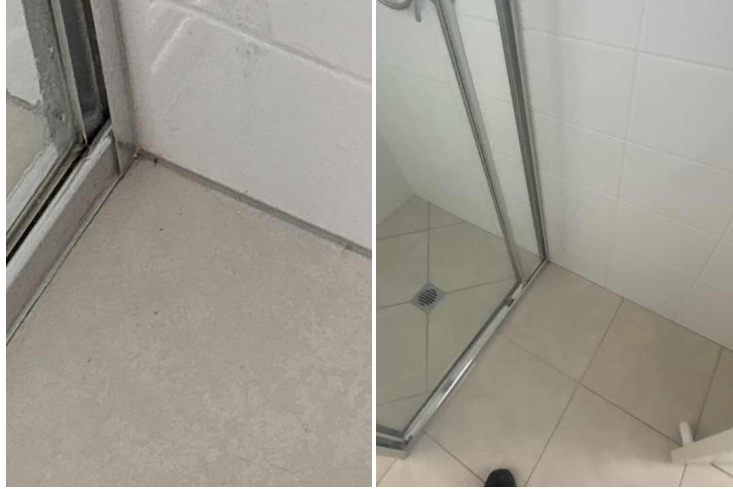
| Section | Location | Name | Comment |
|---|---|---|---|
| 9). BATHROOM(S). | Main Ensuite | Shower | #14. Water is leaking from shower screen. This can cause damage to surrounding Timbers and joinery. Recommend contracting a shower screen contractor for repairs |

#14. Water is leaking from shower screen. This can cause damage to surrounding Timbers and joinery. Recommend contracting a shower screen contractor for repairs

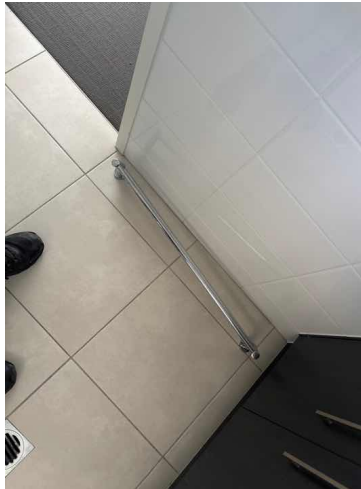
| Section | Location | Name | Comment |
|---|---|---|---|
| 9). BATHROOM(S). | Main Ensuite | Walls | #15. Towel rail loose or damaged. Repairs recommended |

#15. Towel rail loose or damaged. Repairs recommended

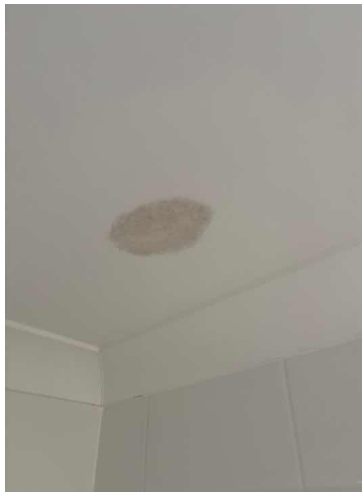
| Section | Location | Name | Comment |
|---|---|---|---|
| 9). BATHROOM(S). | Main Ensuite | Ceiling | #16. Ceiling water stains - No moisture readings obtained. Recommendations: leaks likely to return unless repairs have been carried out -Hidden damage may be present or can occur if left unattended. Contact a licensed Roofing contractor for further evaluation and repair as necessary. Patch and paint defect as required |

#16. Ceiling water stains - No moisture readings obtained. Recommendations: leaks likely to return unless repairs have been carried out -Hidden damage may be present or can occur if left unattended. Contact a licensed Roofing contractor for further evaluation and repair as necessary. Patch and paint defect as required

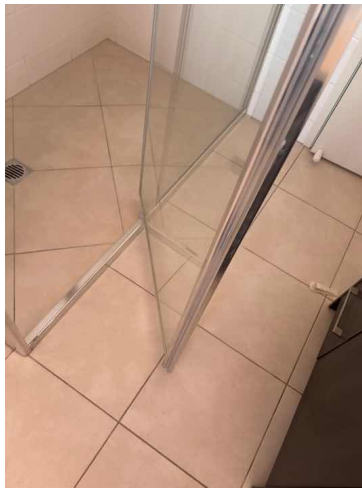
| Section | Location | Name | Comment |
|---|---|---|---|
| 9). BATHROOM(S). | Bathroom upstairs | Shower | #17. The shower screen door requires adjustment, maintenance or repair to operate properly. |

#17. The shower screen door requires adjustment, maintenance or repair to operate properly.

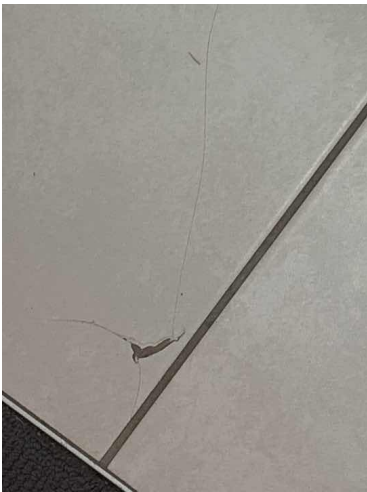
| Section | Location | Name | Comment |
|---|---|---|---|
| 9). BATHROOM(S). | Toilet upstairs | Flooring | #18. Cracked floor tiles detected. Recommend contacting a licensed for Tiler for further advice on this matter |

#18. Cracked floor tiles detected. Recommend contacting a licensed for Tiler for further advice on this matter

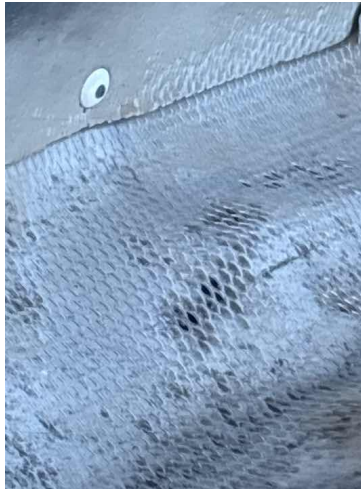
| Section | Location | Name | Comment |
|---|---|---|---|
| 13). ROOF, GUTTER AND DOWNPIPES | Roof Covering | Roof Condition (tile) | #19. Deterioration to lower rear roof flashings. This may lead to Leaks into the area below.. Contact a licensed roofing contractor for immediate repairs |

#19. Deterioration to lower rear roof flashings. This may lead to Leaks into the area below.. Contact a licensed roofing contractor for immediate repairs

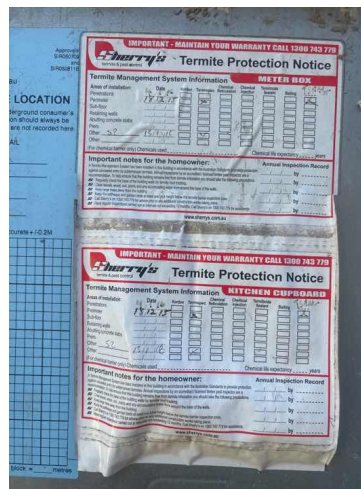
Termite notice for a physical termite barrier installed to the property. Please note that a physical barrier does not prevent termite entry into the building. It is used as a visual inspection point to detect for termite entry. Physical barriers require a clearance of 75 mm above external ground level as per Australian standard (check with manufacturers warranty). If the barrier is less than 75 mm above ground level, is damaged or is covered over, it is deemed inadequate and a chemical termite management system would be required.

Strongly recommend to obtain all documentation regarding this termite management system

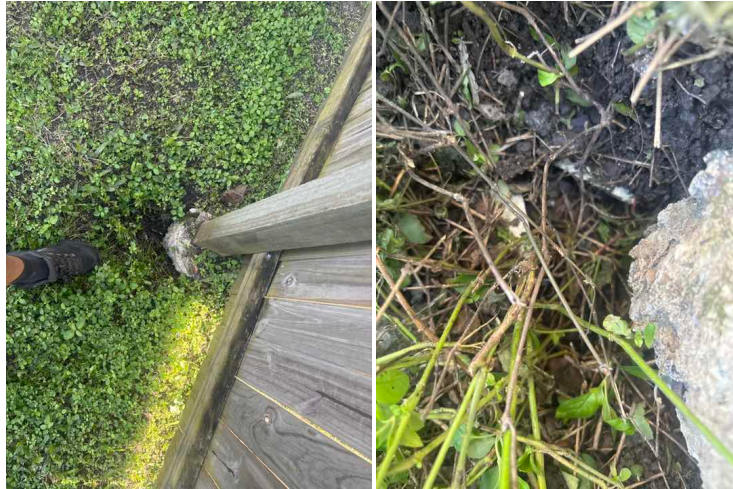
Broken pipe in back yard
