# Inspection Report

## Profile building and pest inspections

**2/16 Cassia Dr Coomera , Gold Coast , QLD**

### Pest And Building Inspection

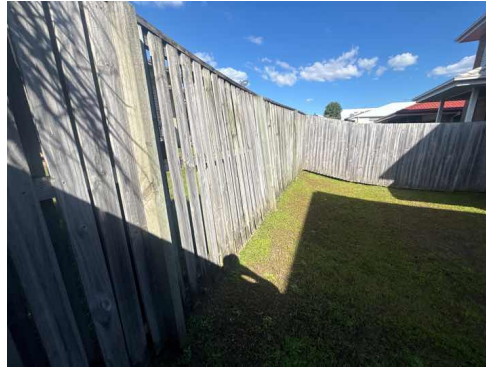
#1. Rear Fence leaning badly in sections- Recommendations: Repairs are recommended by fencing contractor to avoid unsafe conditions

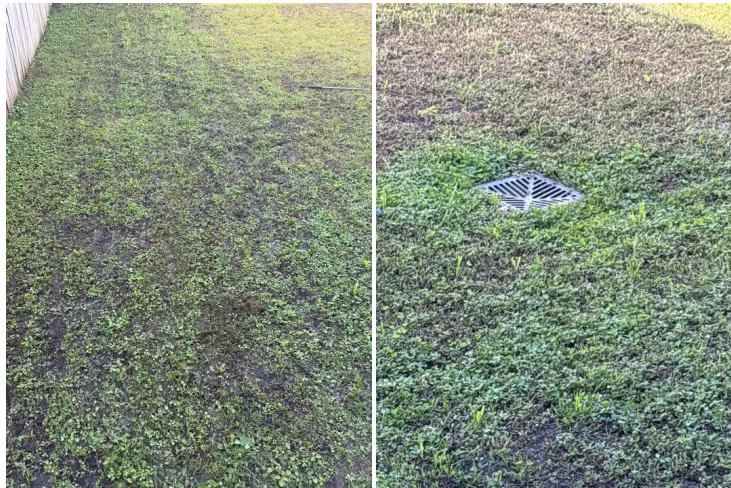
#2. There is evidence at the rear of the home that water ponding would occur. This appears due to drainage pit in wrong position. This can cause subsidence or heaving to the building. Recommendations: A qualified landscaping contractor or a plumber should be engaged for advice and recommendations as necessary

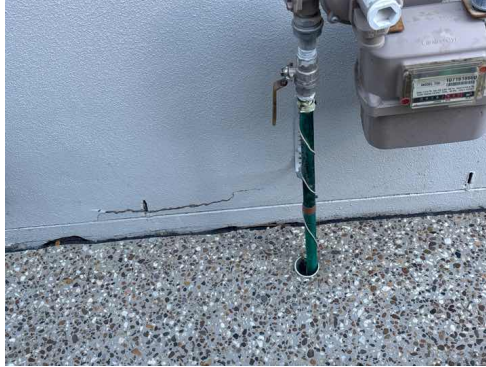
#3. Isolated Damaged sections of external wall render. Contact a licensed rendering contractor for repairs

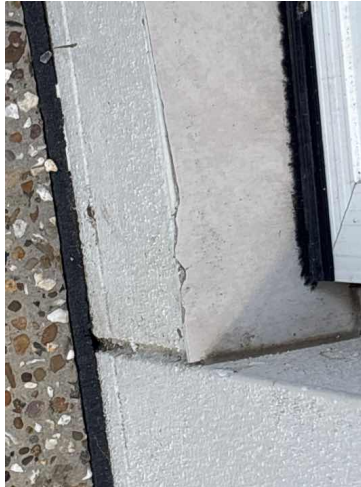
#4. Cracked front door sill tiles detected. Repairs recommended

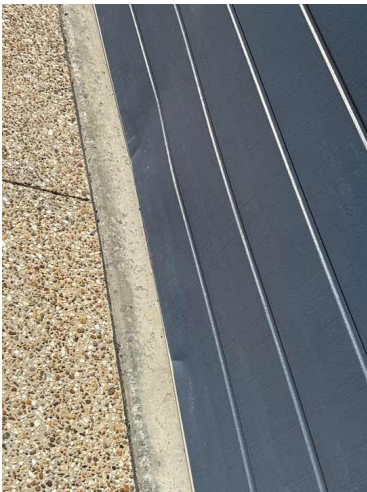
#5. Impact damage sighted to garage door or doors. Repair as necessary

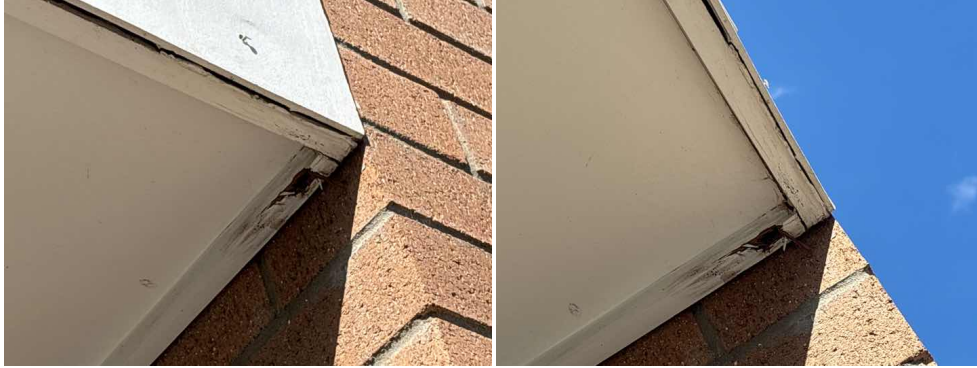
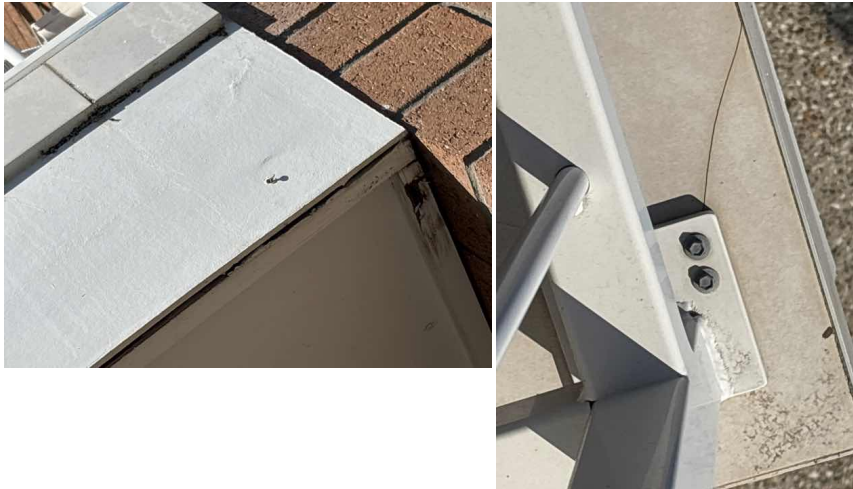
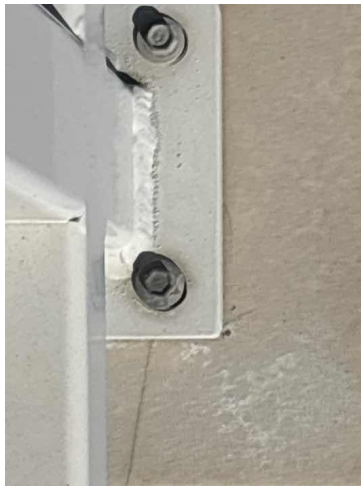
#6. isolated Cracked tiles to deck area. Repairs recommended

#7. There is evidence of leaks below tiled deck at front of house. The sheets are popped off and there is decay to the trims. hidden damage may be present or can occur if left unattended. Further investigation into the cause and Repairs recommended. Contact a licensed Tiler/ Waterproofer for further assistance.

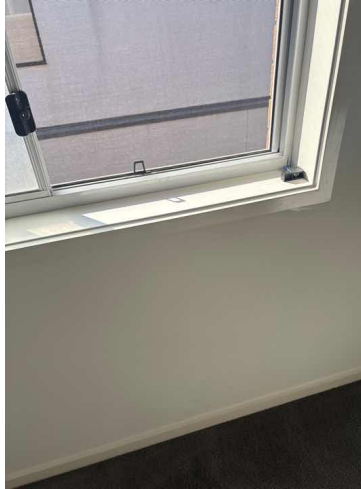
#8. Where window sills are less than 1.7 meters off floor and floor has a drop of more than 2 meters. Current building regulations require window opening to be restricted or a secure approved screen be installed to prevent falls. Although not a requirement for older houses it is strongly recommended that windows be made to comply with current regulations for safety reasons.

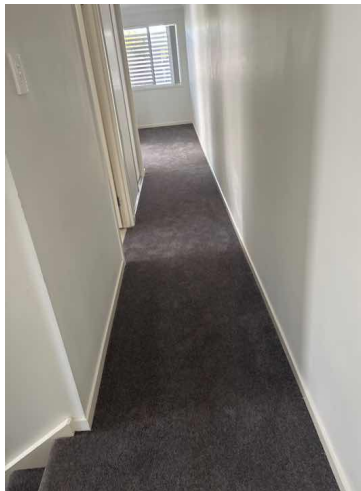
#9. The floor is squeaky in areas. Re fixing may help the issue. Contact a licenced carpenter for further advice and repairs

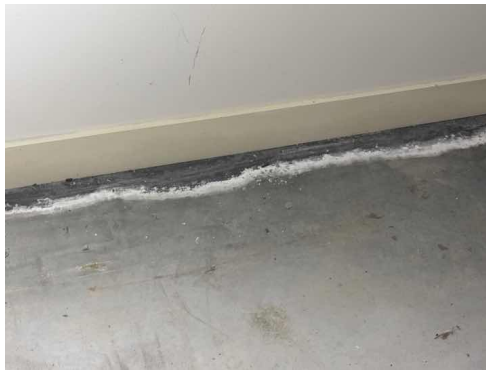
#10. Salt staining entering through exterior wall. This is common of the wetting and drying of concrete. In severe cases damage to concrete can occur. Recommend to contact a licensed concreter for further assistance

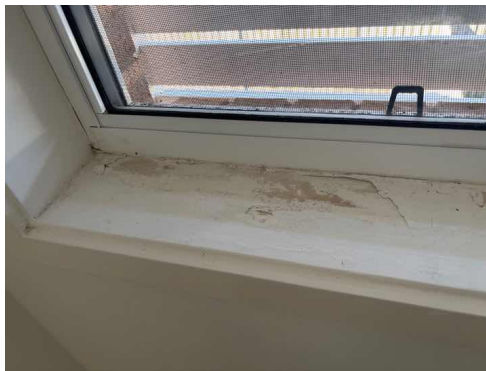
#11. Evidence of leaks to windows. Unless repairs have been carried, leaks are likely to re-occur. Contact a licenced window contractor for further testing and repairs as required.

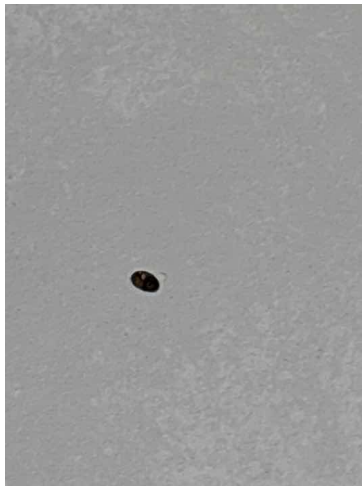
#12. Isolated chips to floor tiles. Cosmetic damage only. Repair as necessary

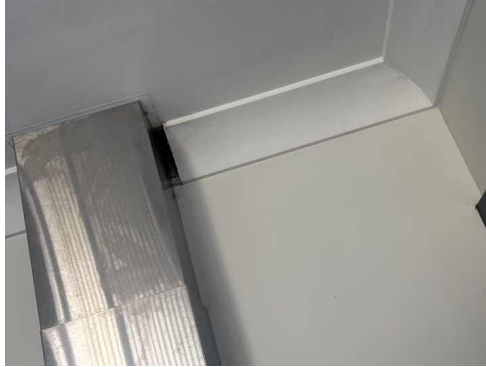
#13. Cornice has been cut back too far for Rangehood and there is now a large gap

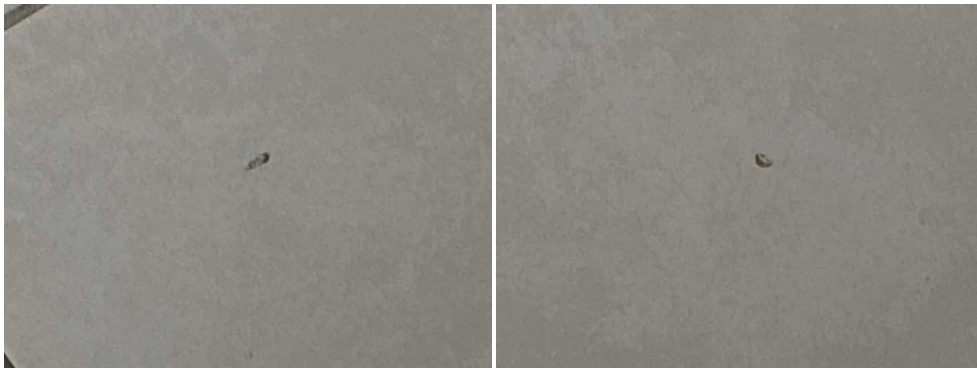
#14. Some chipped and damaged tiled were noted. Repairs recommended by a qualified tiler

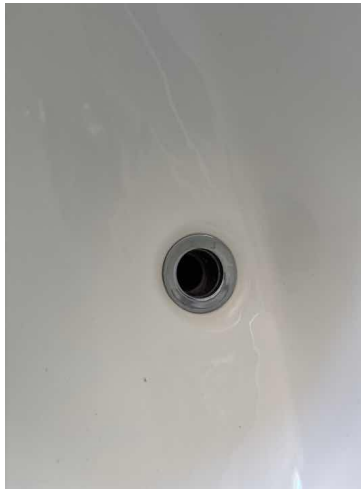
#16. Missing or faulty basin plug. Maintenance recommended

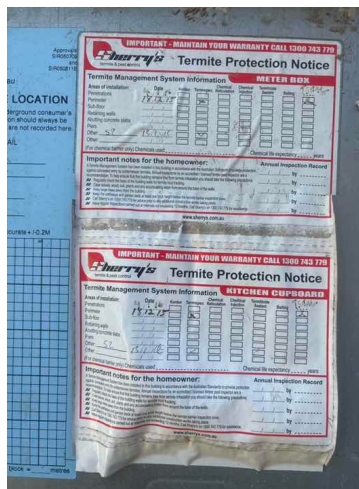
Termite notice for a physical termite barrier installed to the property. Please note that a physical barrier does not prevent termite entry into the building. It is used as a visual inspection point to detect for termite entry. Physical barriers require a clearance of 75 mm above external ground level as per Australian standard (check with manufacturers warranty). If the barrier is less than 75 mm above ground level, is damaged or is covered over, it is deemed inadequate and a chemical termite management system would be required.

Strongly recommend to obtain all documentation regarding this termite management system

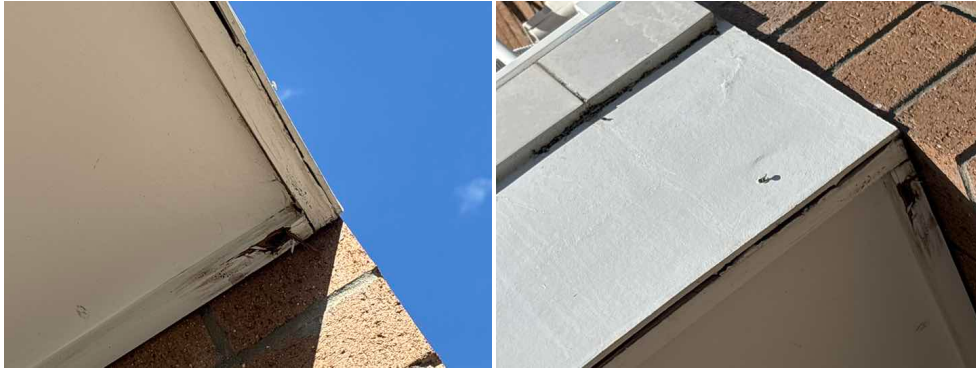
Evidence of leaks below tiled deck

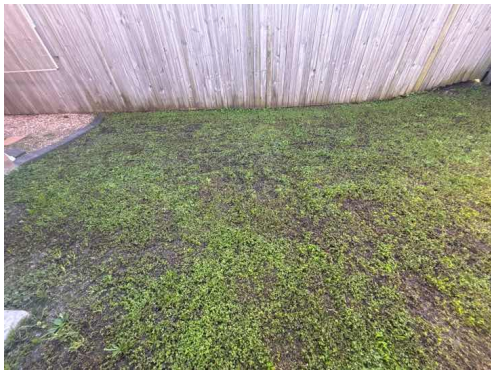
Evidence of Rear site Surface water ponding: Surface water drainage needs assessing and rectifying by a qualified plumber. This excessive moisture can cause conducive conditions for termites. The degree of risk is moderate to high.
