# Property Inspection Report

19 Colthorpe Street,  
Boondall

Inspection Prepared For:  
Gavin Ram

Date of Inspection: 11/8/2026 | Time: 4:15 PM

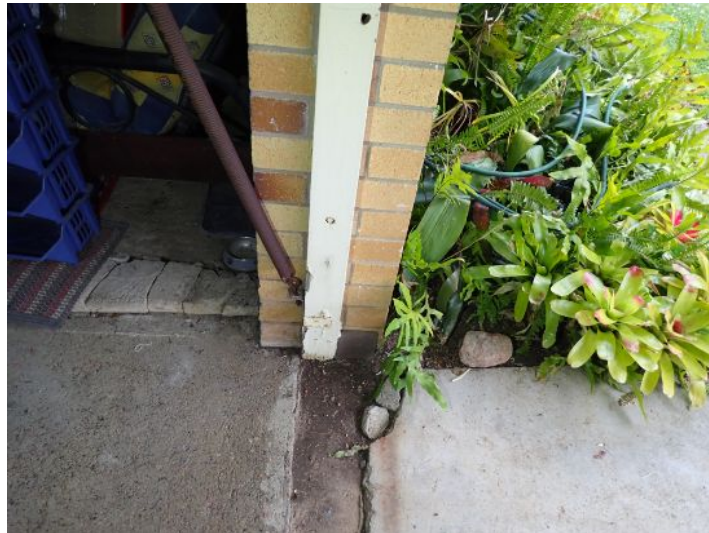
- Visible sections of the concrete slab appeared satisfactory.
- Most areas of the concrete slab not visible due to floor coverings.
- All concrete floor slabs experience some degree of cracking due to shrinkage in the drying process. In most instances floor coverings prevent recognition of cracks or settlement in all but the most severe cases. Where carpeting and other floor coverings are installed, the materials and condition of the flooring underneath cannot be determined.

- There is an infill slab to the home, this slab may or may not be an integral part of the foundation. Joins along these slabs may be vulnerable to entry by moisture and or timber pests such as termites.

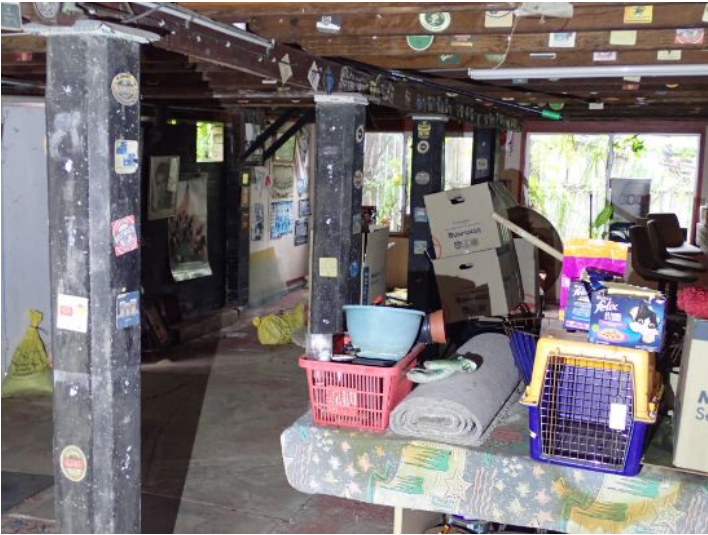
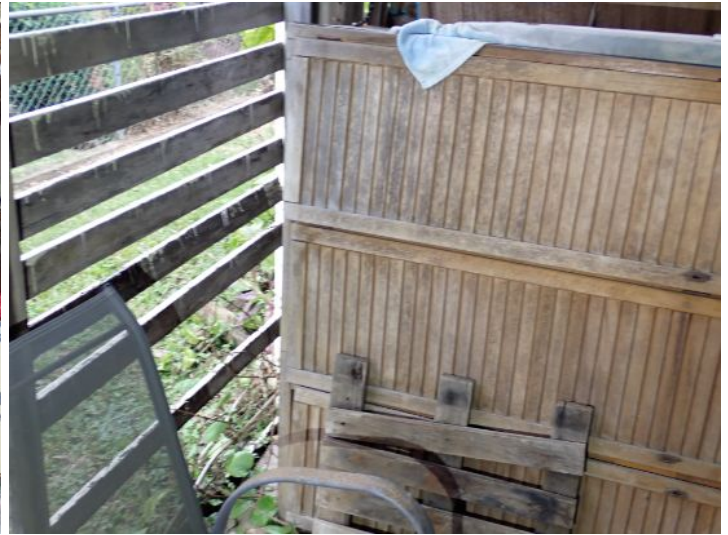
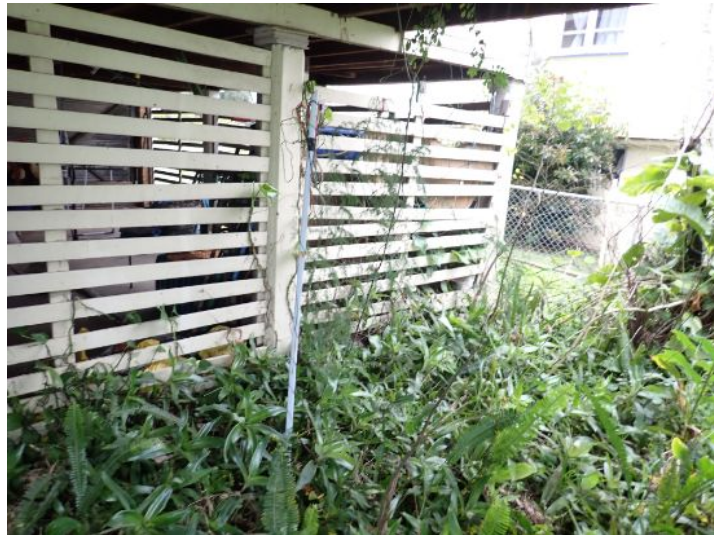
- ### Posts and Girders:
- Concrete piers
  - Timber Beams noted.
- ### Observations:
- The foundations appear to be performing satisfactorily.

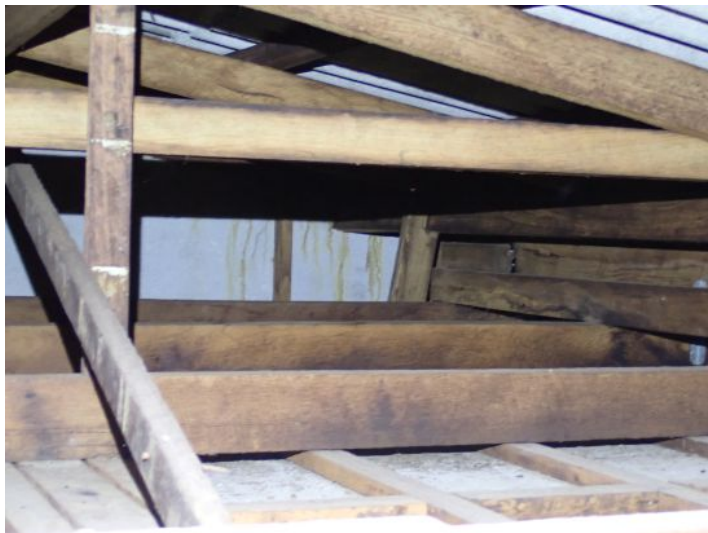
- There is no insulation on the ceiling in the roof space. Expect higher heating and cooling energy costs. It is recommended that insulation be added to improve the thermal efficiency of the home.

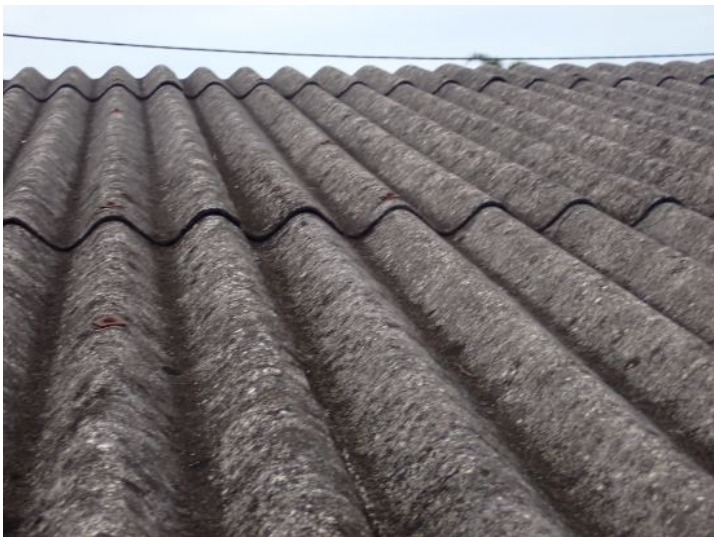
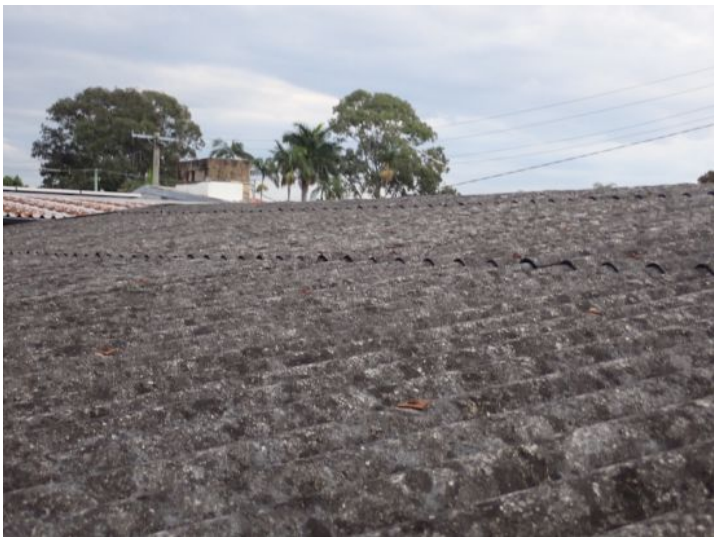
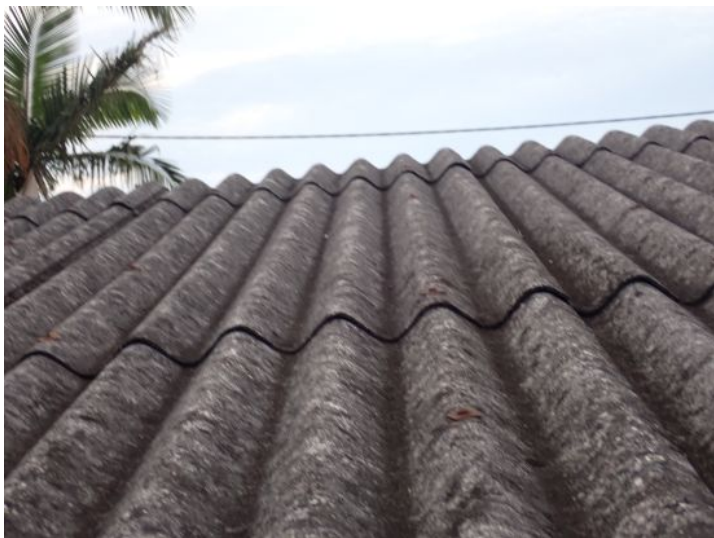
- The asbestos roofing material appears to be in satisfactory condition relative to its age.

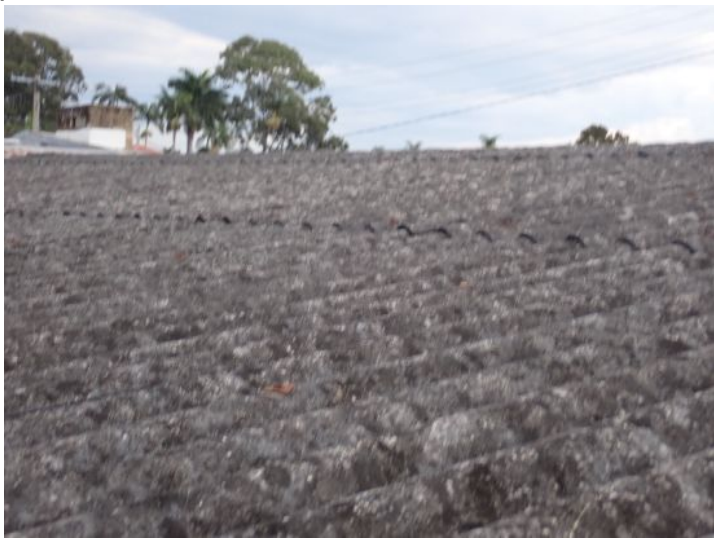
- Some of the fixings located on the roof sheeting are rusty and should be replaced in due course.

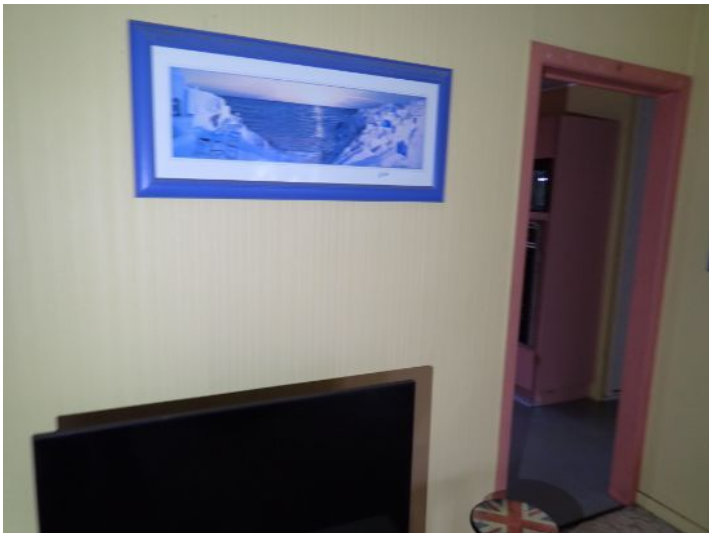
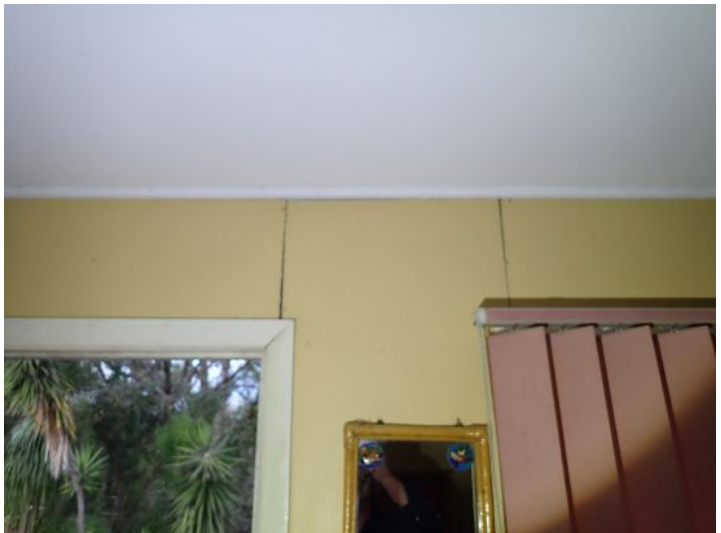
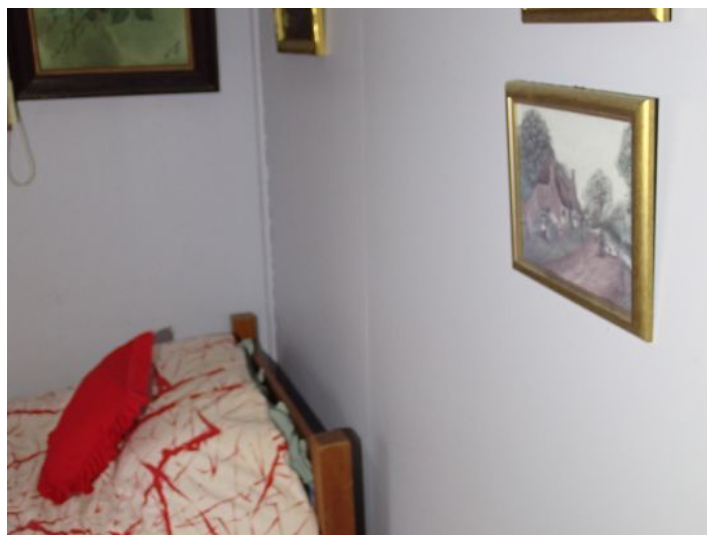
- Due to normal minor differential movement within the property or foundations, small cracks have appeared at various locations within the home. These cracks do not appear to have affected the overall structural integrity of the property and can be patched normally.
- There are marks and imperfections to the interior walls at various locations. These can be repaired normally.

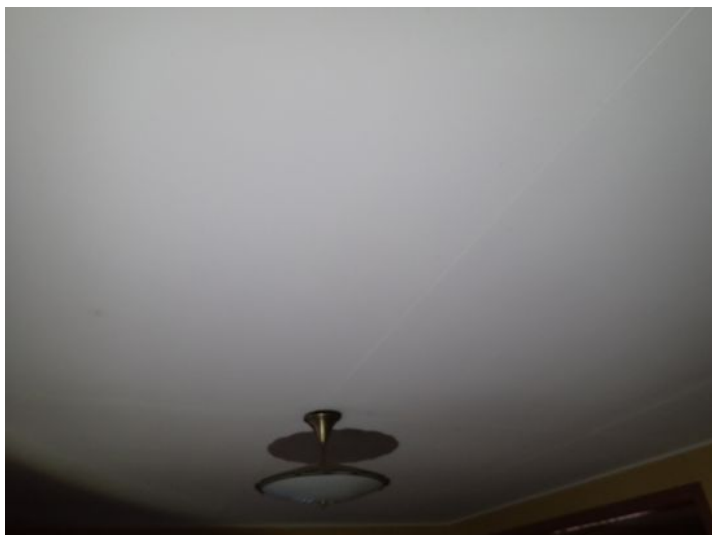
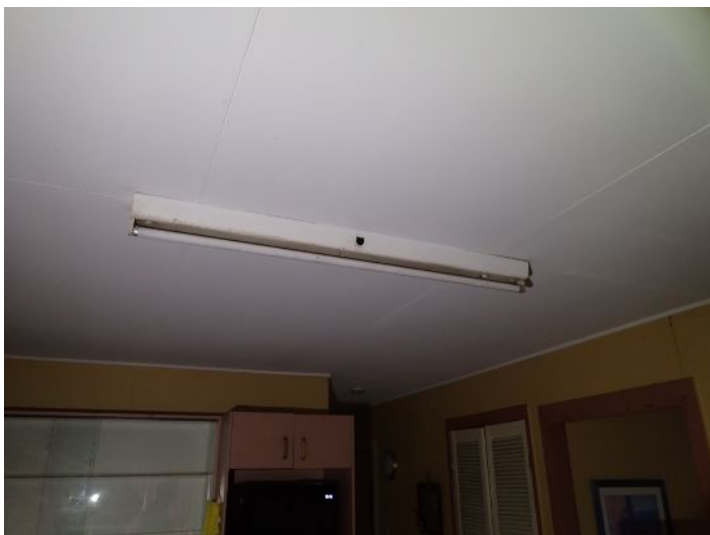
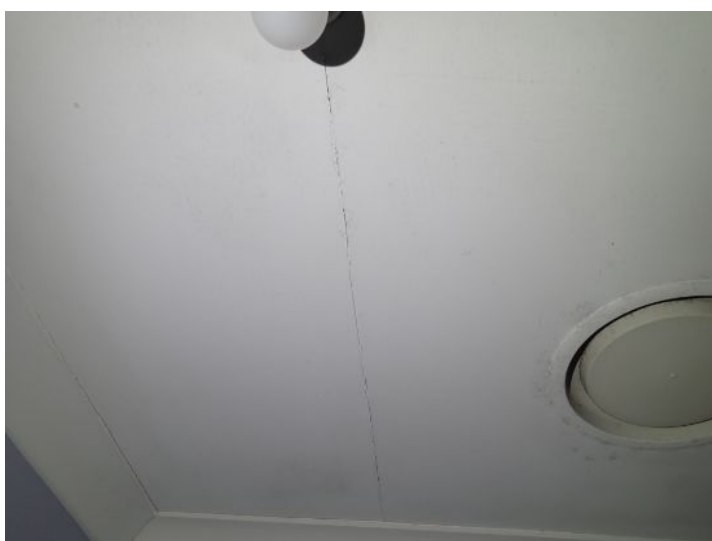
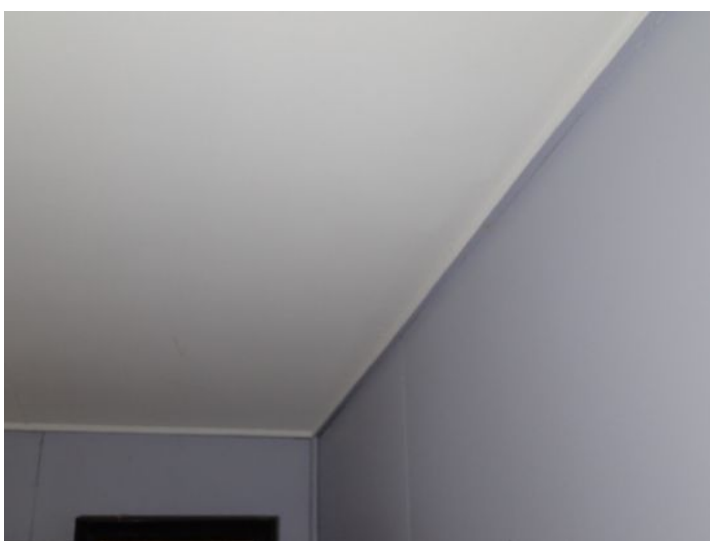
- There is what appears to be Asbestos clad ceilings noted that appear to be functional.

- There are marks and imperfections to the interior ceilings at various locations. These can be repaired normally.

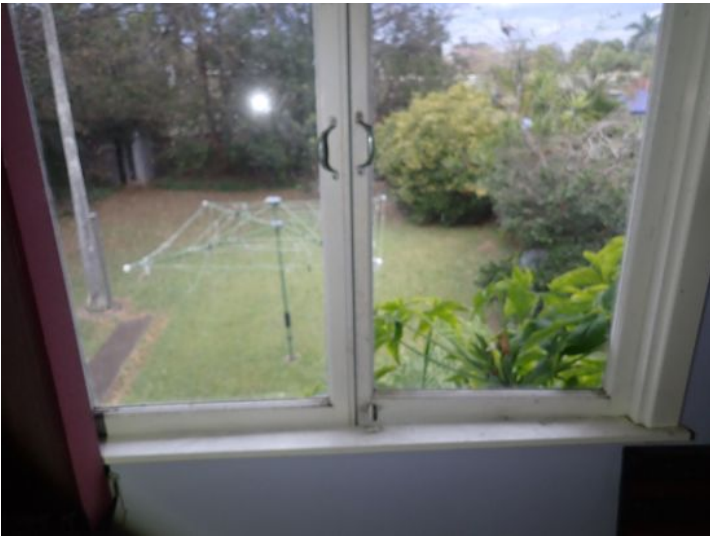
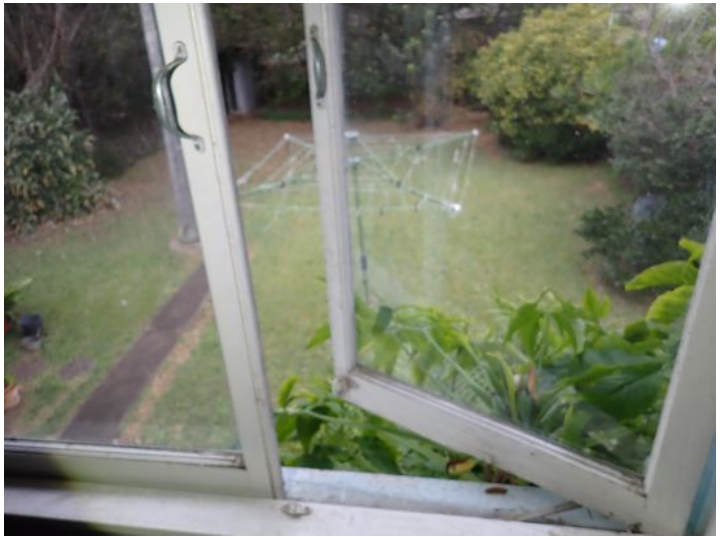
- Windows operated during the inspection appeared functional.
- Peeling paint observed, recommend scraping and painting as necessary.

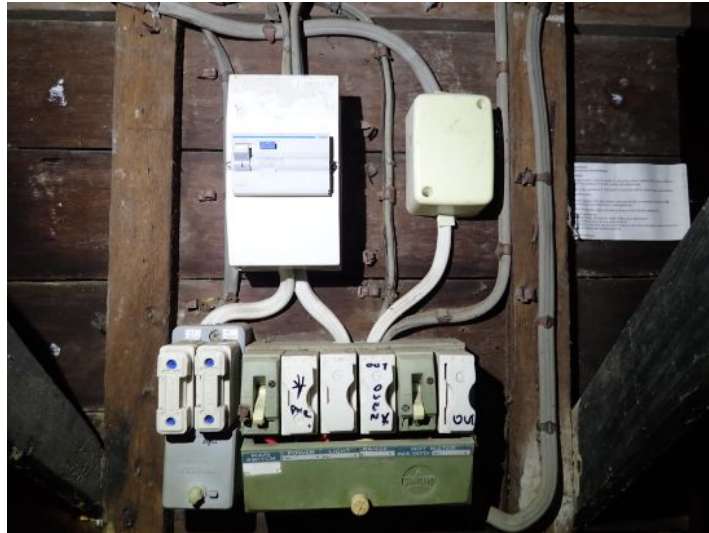
Observations: At least one RCD (Safety Switch) has been installed. It does appear that the lighting circuit is not protected by a RCD. To increase the electrical safety you may wish to consider having the lighting circuit protected by a RCD.

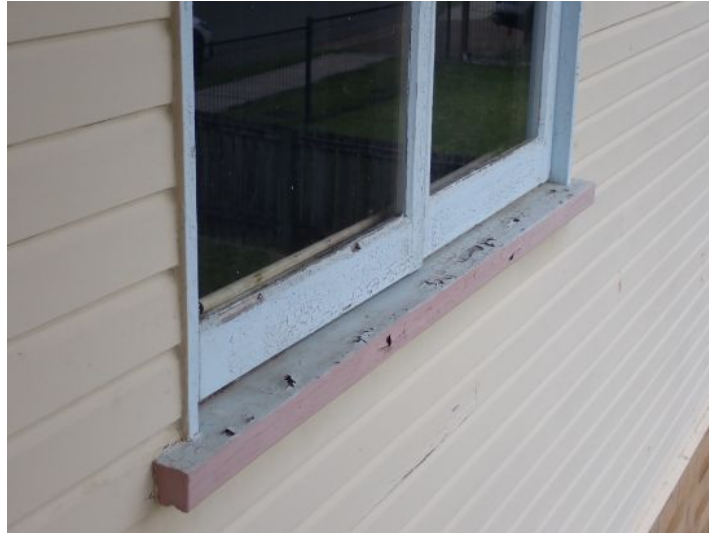
- Components appeared in satisfactory condition at the time of inspection unless noted
- Peeling paint observed, recommend scraping and painting as necessary.

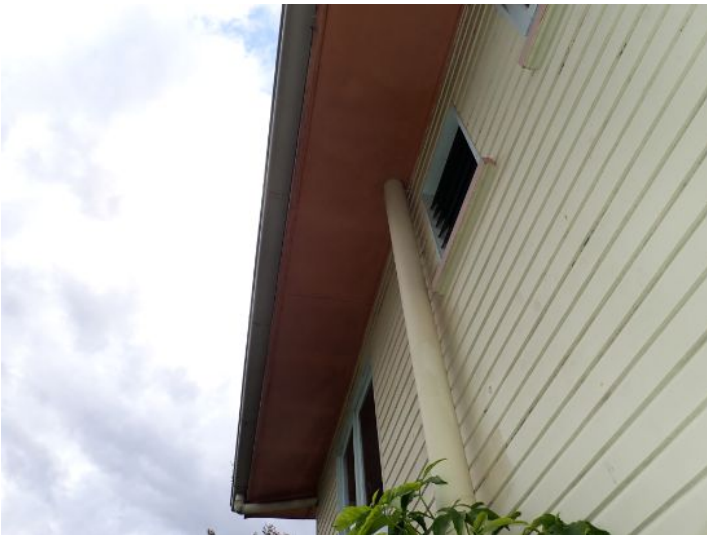
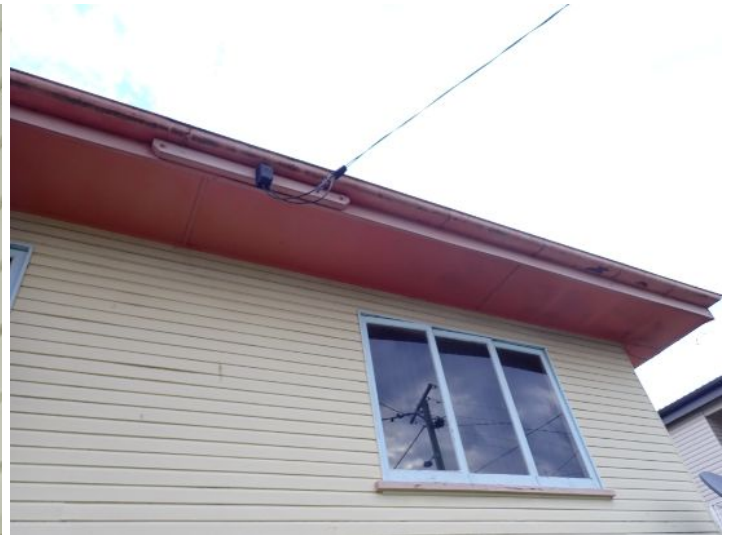
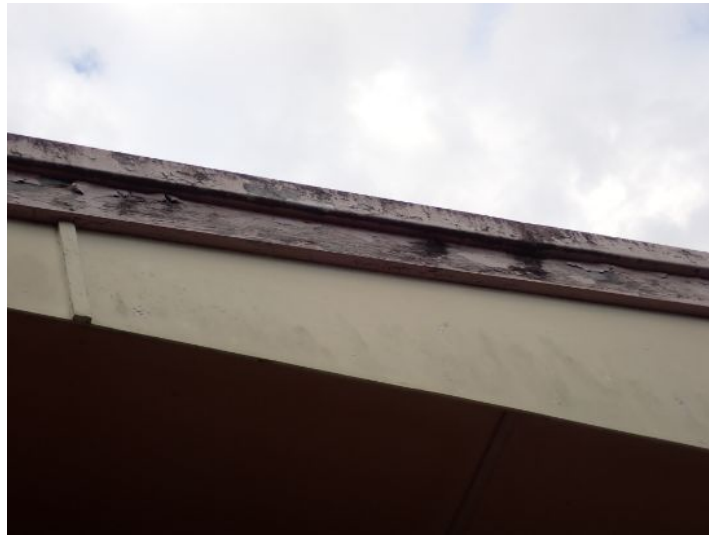
- The eaves are in satisfactory condition.
- Some weathered timber noted to the west fascia board.. Recommend review for maintenance as required.

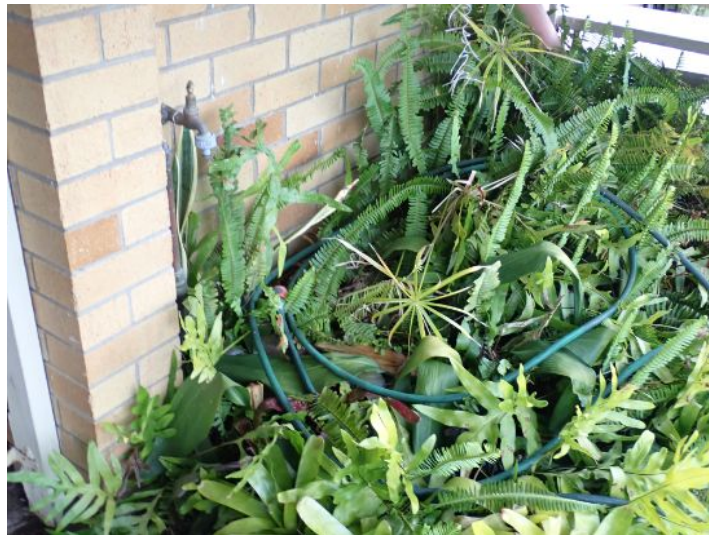
- There are a number of garden beds which are adjacent to the external walls. This can result in water moisture affecting the structure over time. It is recommended that either the beds be removed or a water barrier be placed between the garden bed and the external walls. If these beds are retained it is important that any watering is directed away from the building and kept to an absolute minimum and is controlled.

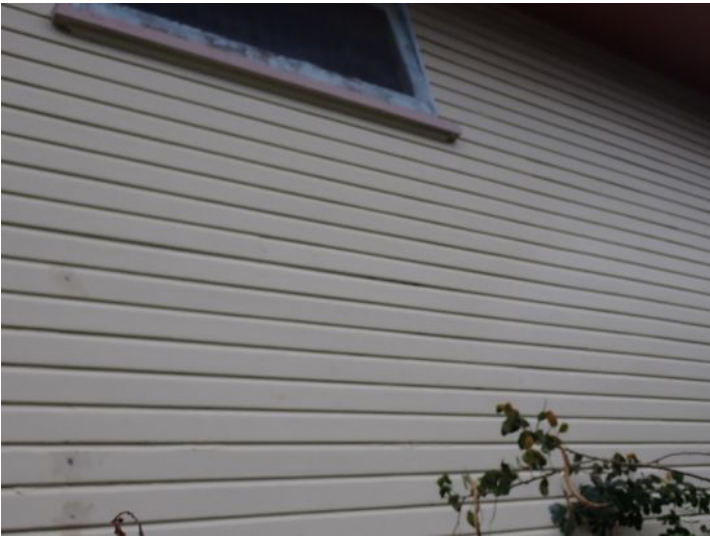
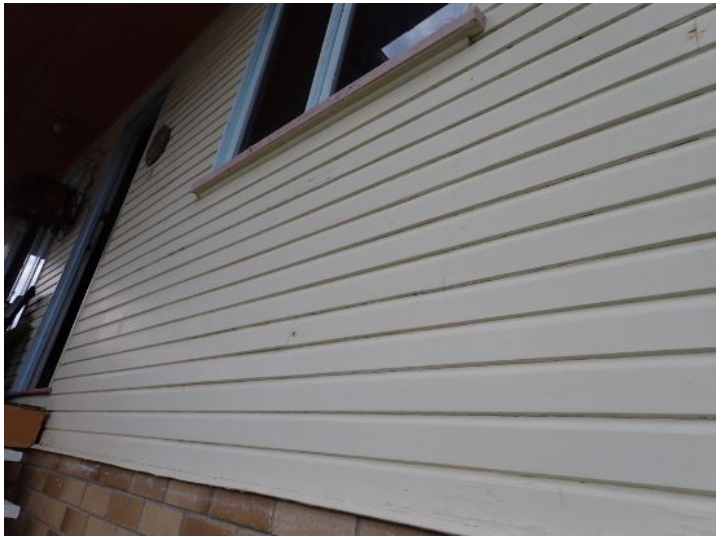
- External cladding appears to be in satisfactory condition relative to its age.
- Some areas need prep, priming and repainting. Ensure that composition siding is kept sealed and painted, including the bottom edges. Keeping the siding well sealed will extend the life of the siding.

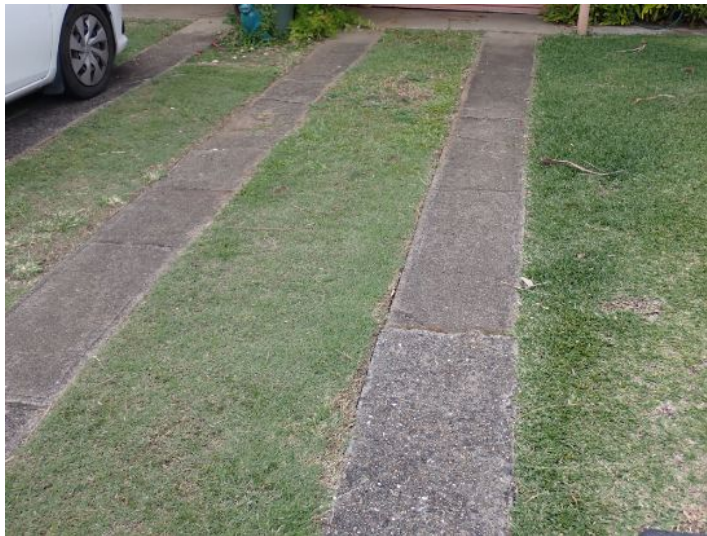
- Some areas of settlement and uplift were noted on the driveway. These areas do not appear to have affected the structural integrity of the home or the function of the driveway in any way and can be repaired/levelled normally.

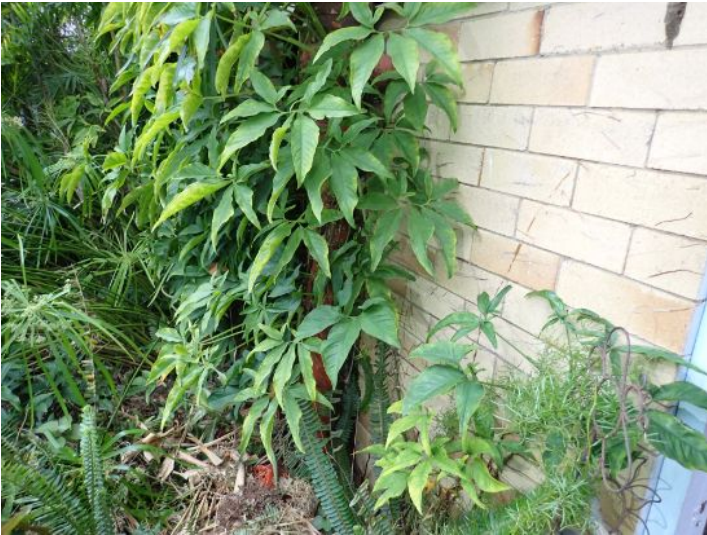
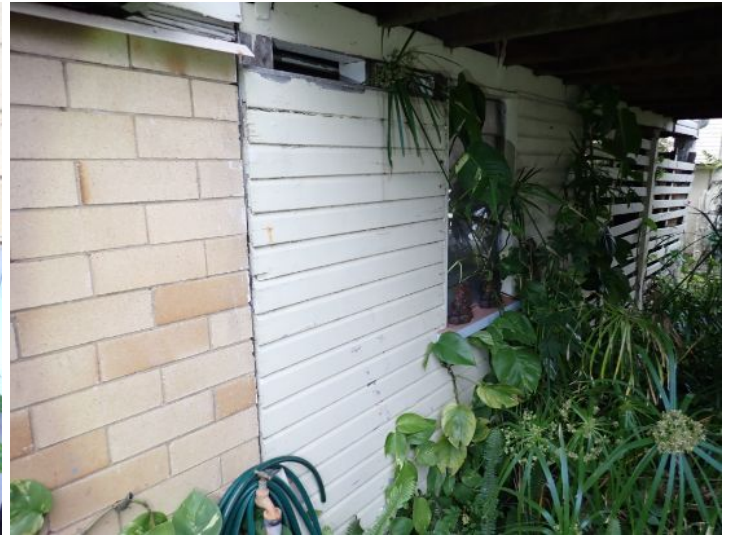
- Prune or remove any plants that are in contact or proximity to home to eliminate pathways of wood destroying insects.

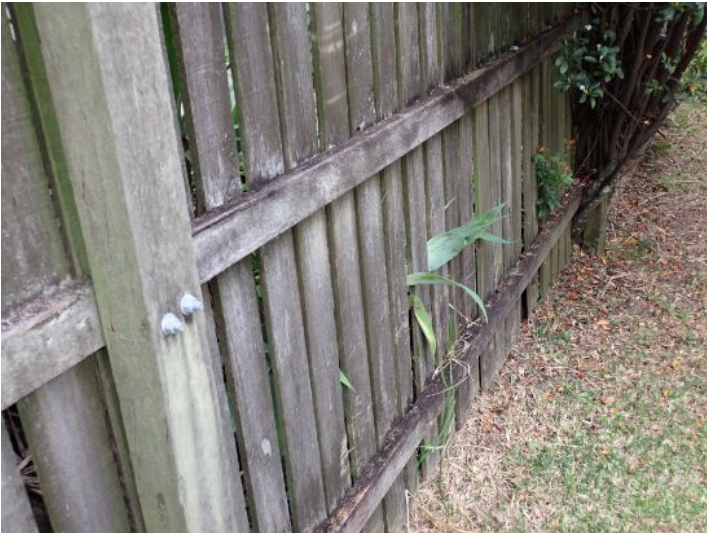
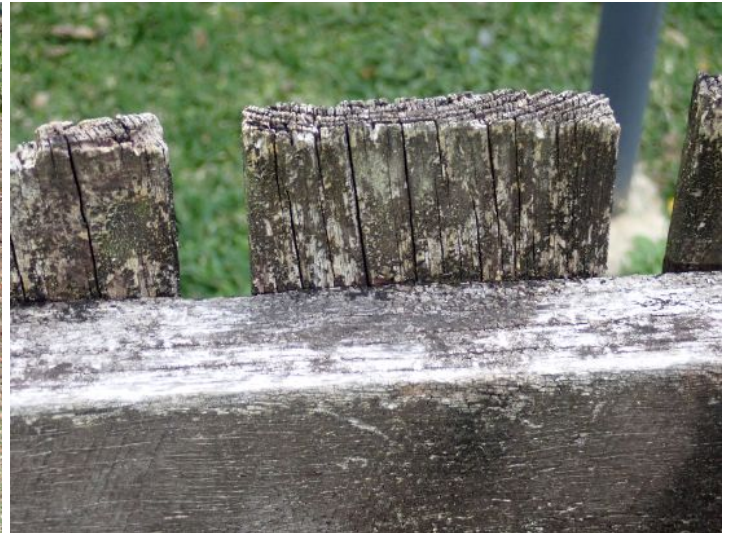
- Wood deterioration observed. Wood decay noted. Recommend repairs/replacement as needed.

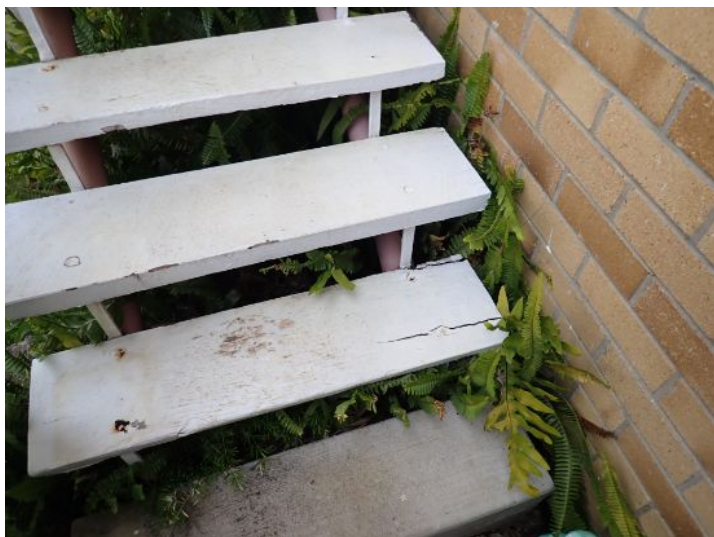
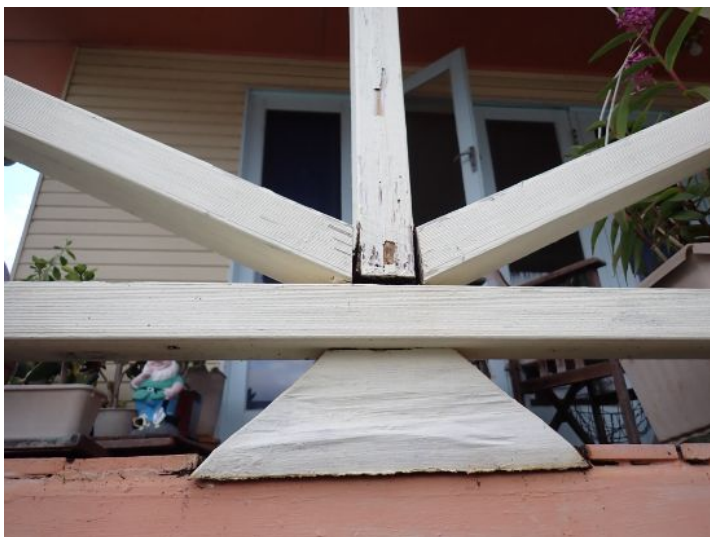
- Inspected steps were in good condition at the time of the inspection unless noted
- Some of the treads have some wood decay noted, replace as required
- The balustrade around the front deck has wood decay and will need some maintenance to repair

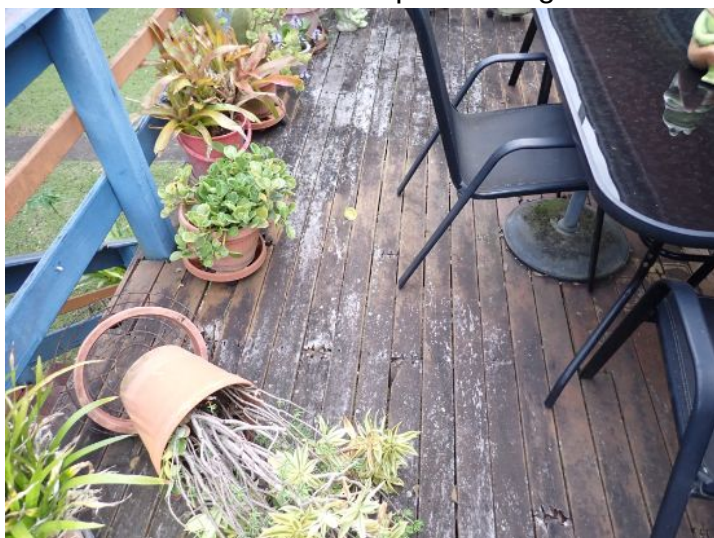
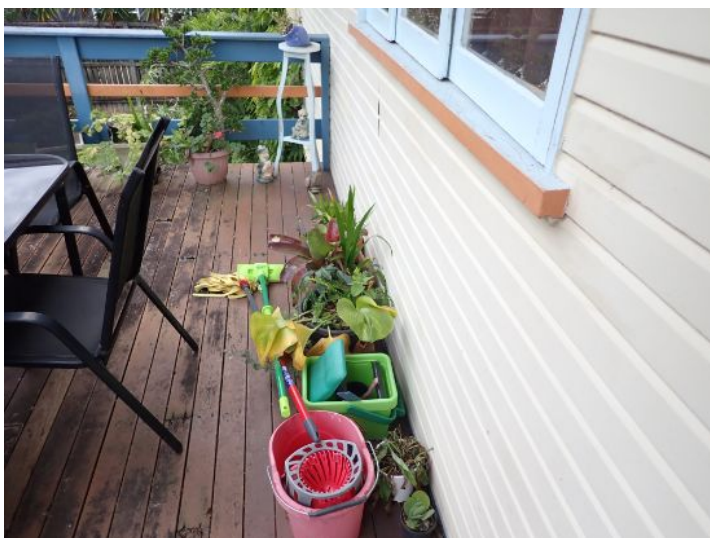
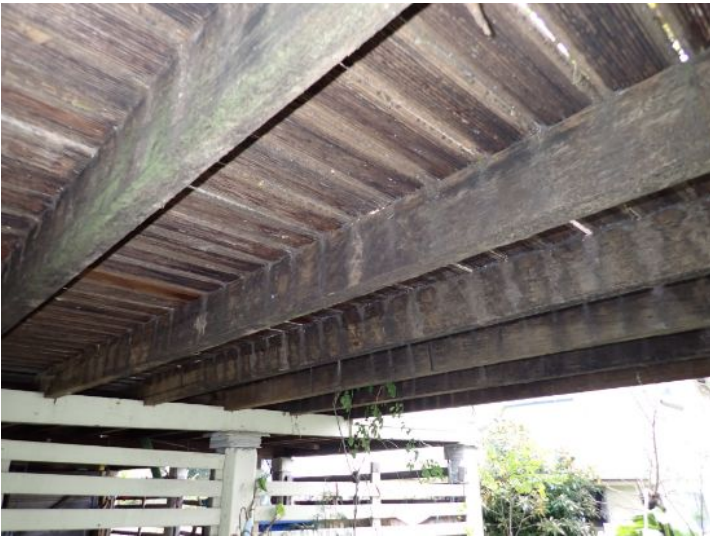
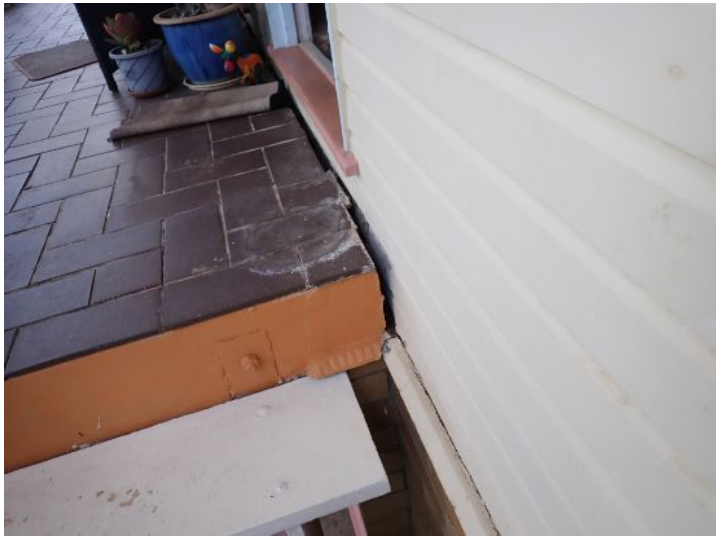
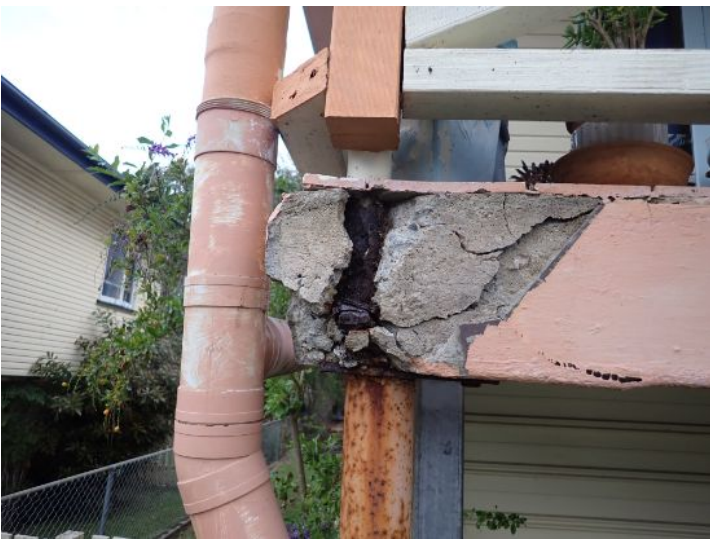
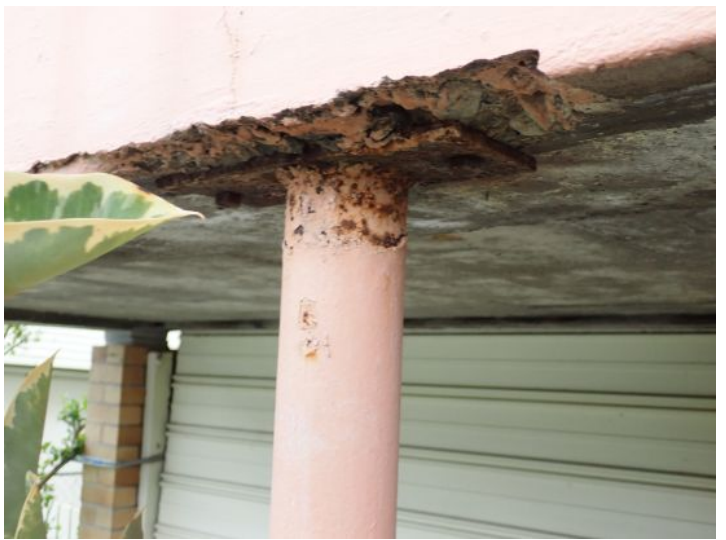
- Repairs and monitoring required for both balconies
- Wood decay noted on the rear balcony structure. This does not appear to have affected the overall structural integrity of the balcony but should be maintained to prevent further degradation of the timber. The deck boards should be replaced in due course
- Settlement of balcony footing and slab identified. This structure does not seem to be part of the main structure and there is no evidence of impact to the main structure. It also appears that this settlement is not new. We recommend monitoring to ensure no further movement occurs to the front slab balcony.
- Area of the front slab balcony has broken away from the main slab, due to the rust noted to the support posts and reinforcement. Maintenance required to repair damaged areas

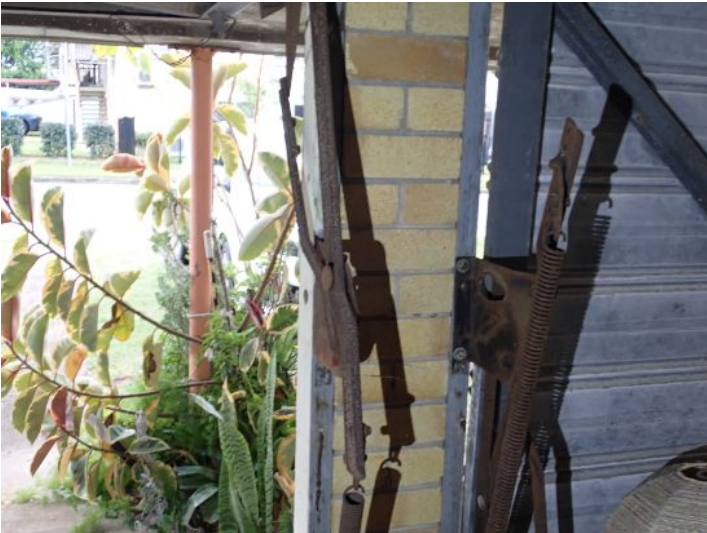
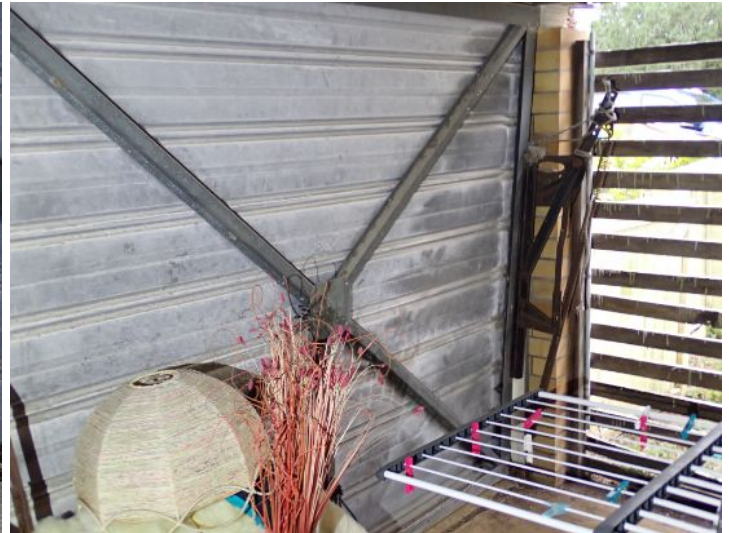
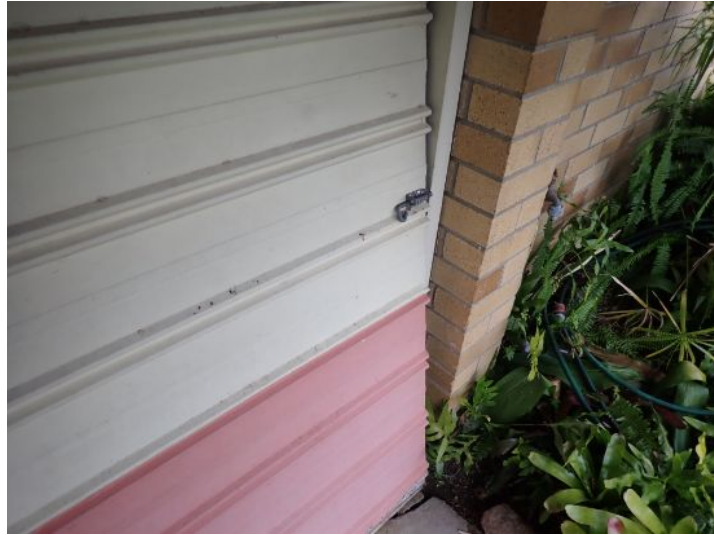
- Did not fully close. This requires some maintenance.
- Door is difficult to open. Some maintenance is required.
