# Timber Pest Inspection Report

**19 Colthorpe Street,  
Boondall**

**Inspection Prepared For:**  
**Gavin Ram**

**Date of Inspection: 12/8/2026 | Time: 4:15 PM**

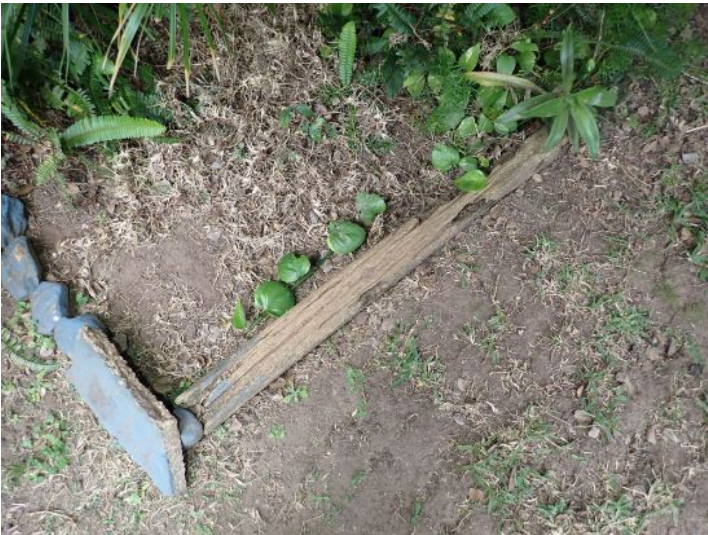
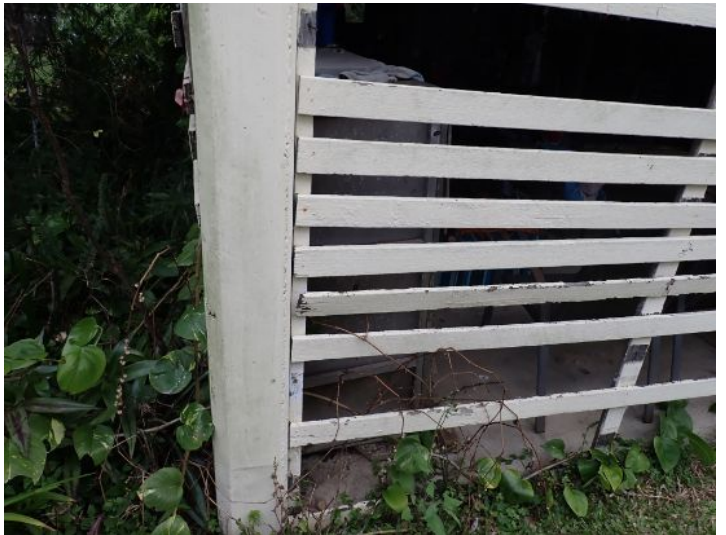
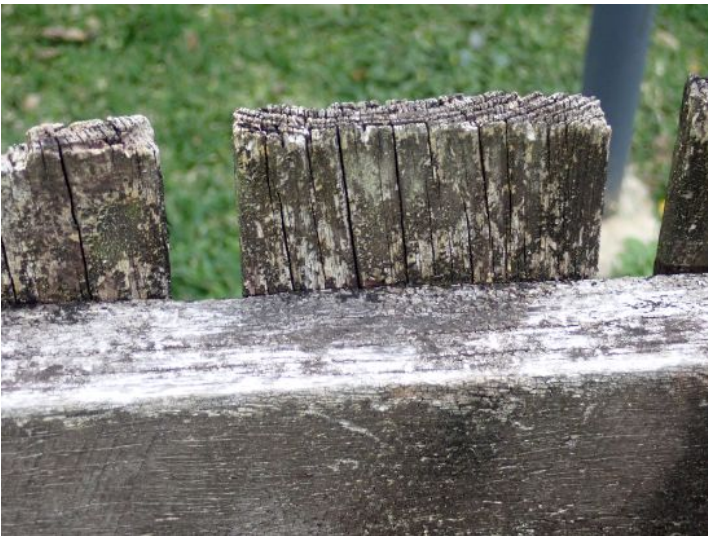
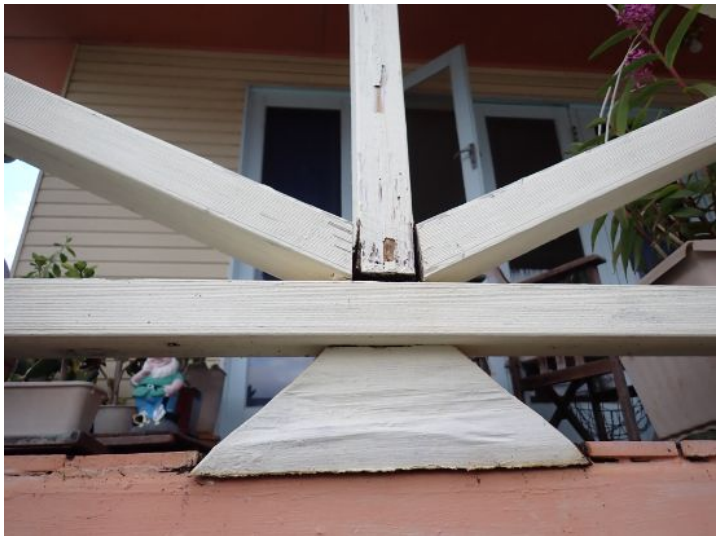
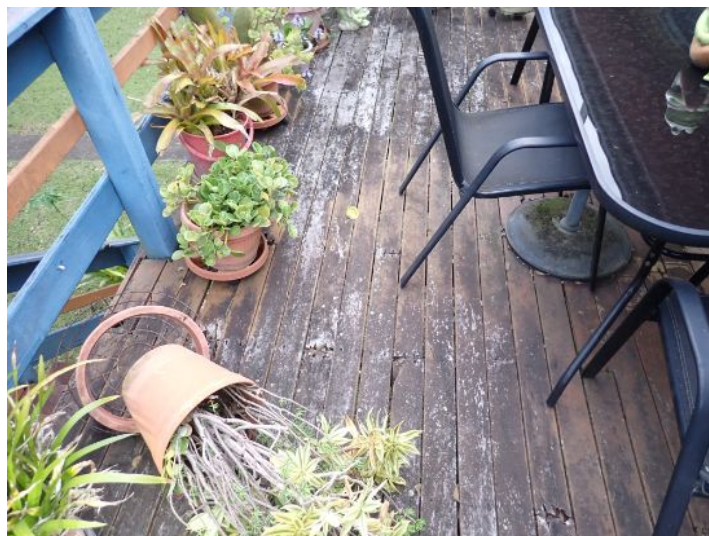
- Timber condition is decaying.
- Wood decay/fungus was detected in landscaping timber, tree stumps, subfloor cladding, fence pailings balustrading and rear balcony

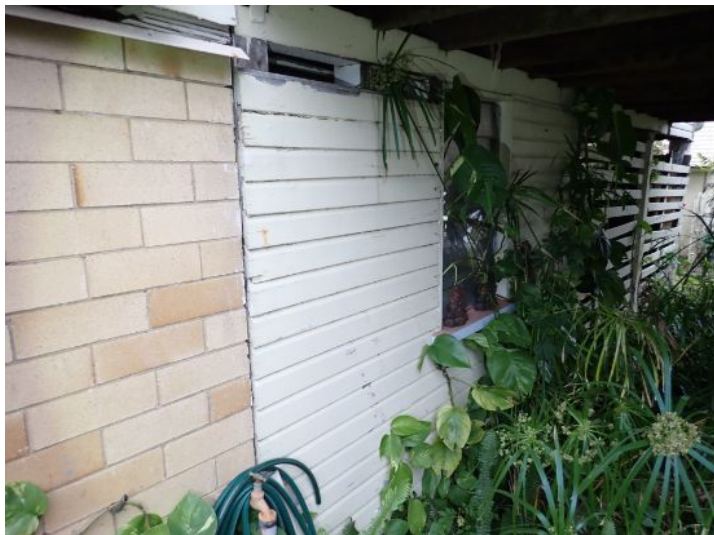
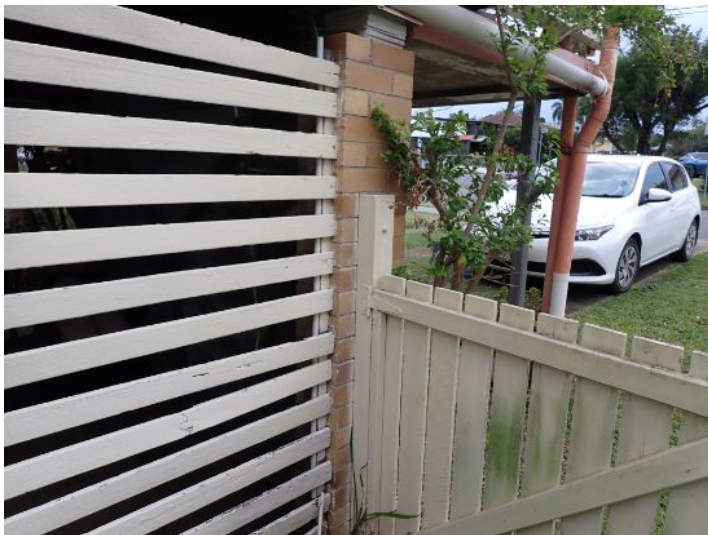
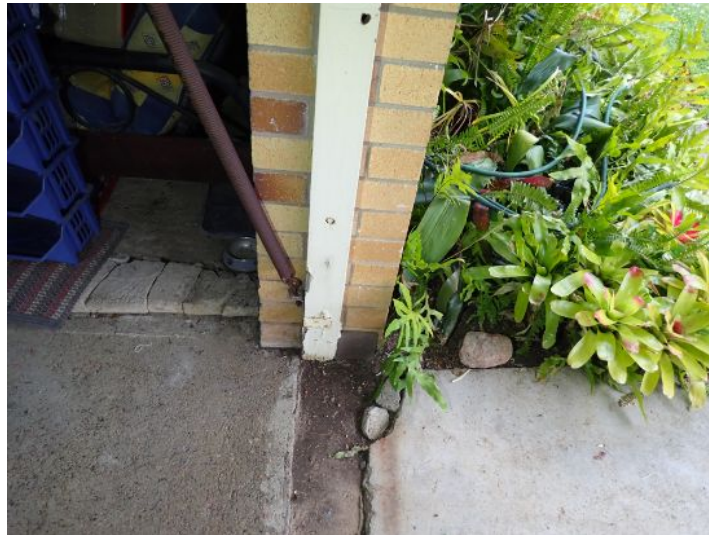
The fence posts are attached to the external wall of the home and could provide concealed access for timber pest, the post should be trimmed to allow at least 75mm clearance with the finished ground surface.

The garage door guide posts are against the exterior wall, which may allow termites to breach any barrier and gain concealed access to the property structure.

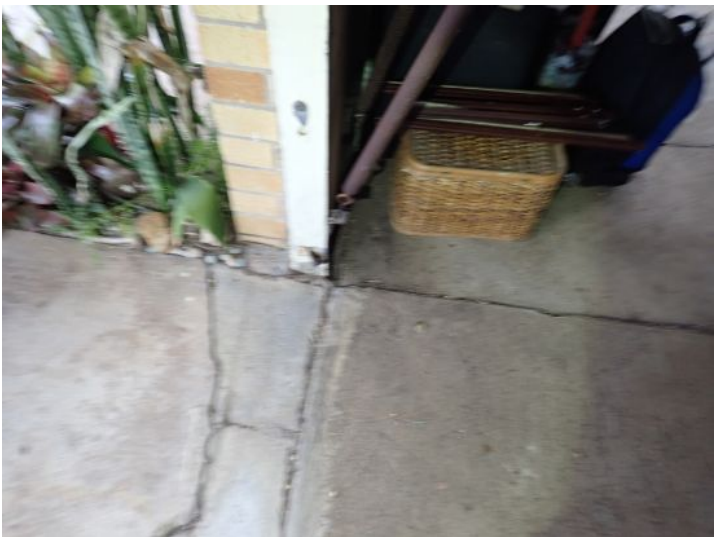
- Slab edges are covered by soil and concrete.

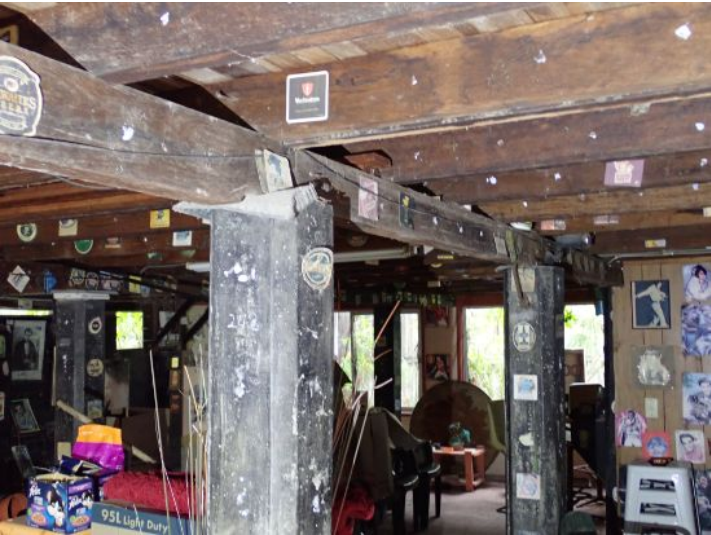
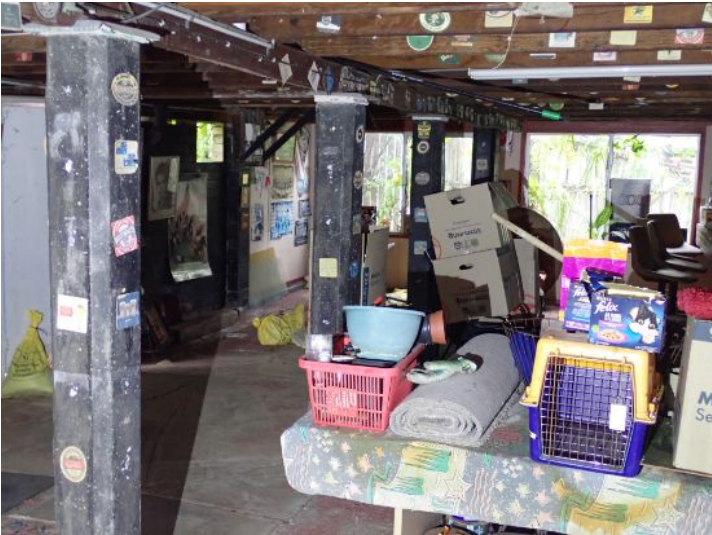
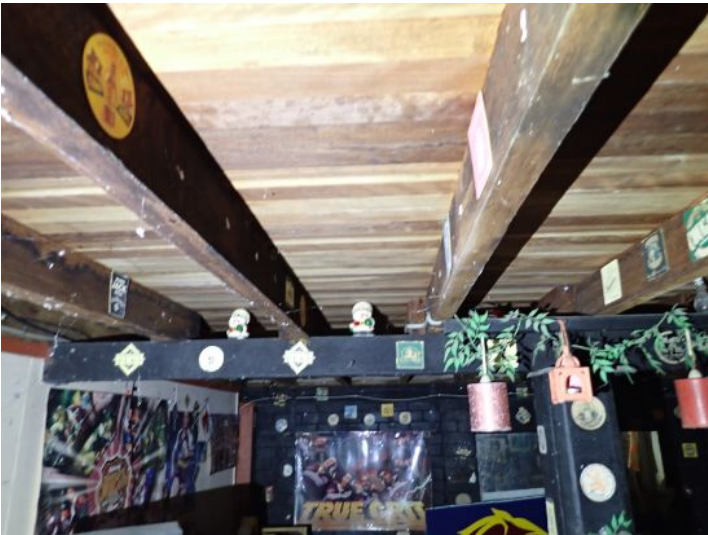
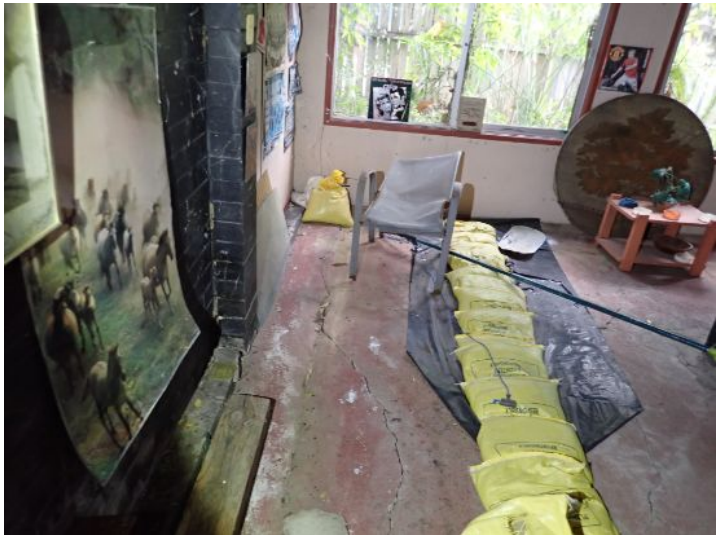
- The additional walls and sheeting installed to the raised foundations after the home was built, bridge the termite barrier (termite caps) in numerous places rendering them ineffective in protecting the home. In this situation regular timber pest inspections are required.

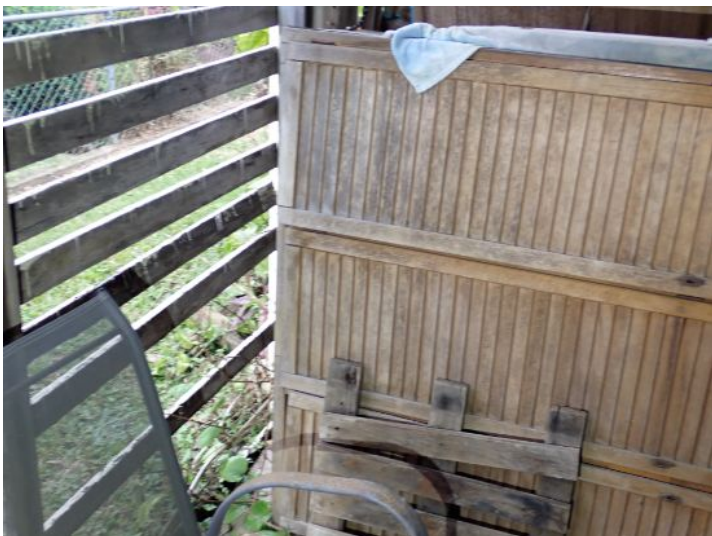
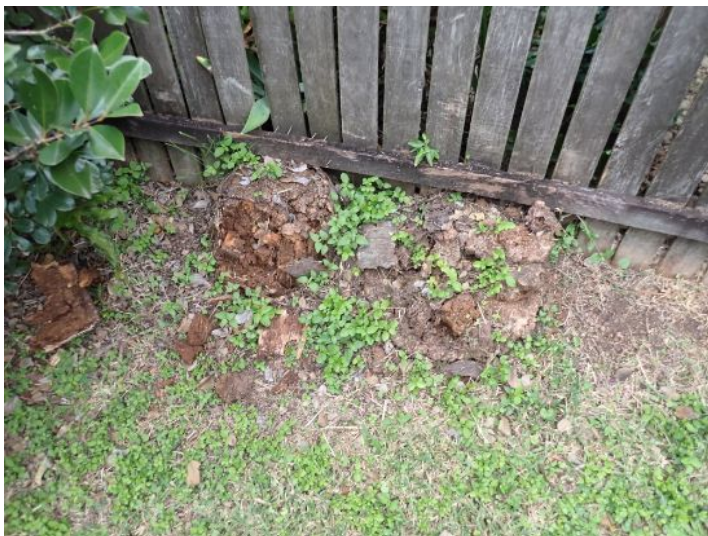
- There is landscaping/stored timber, or old tree stumps in contact with the ground that provides possible breeding grounds for subterranean termites. These should be removed.

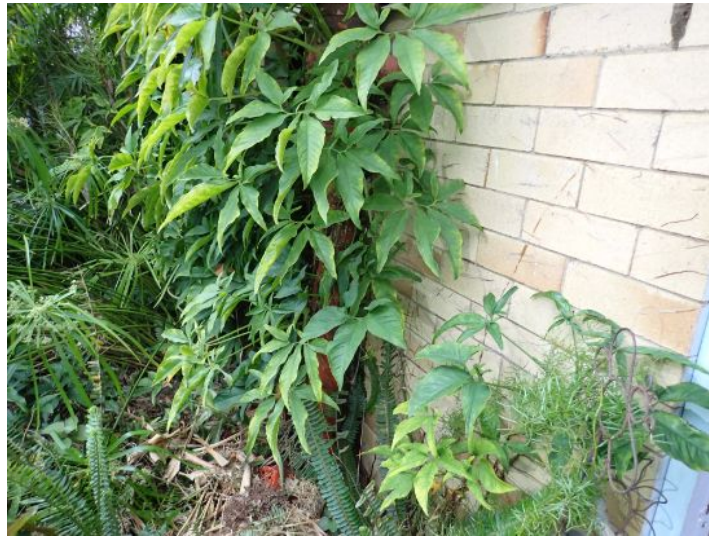
- Prune or remove any plants that are in contact or proximity to home to eliminate pathways of wood destroying insects.
- Remove any garden beds abutting the home to eliminate excessive moisture.

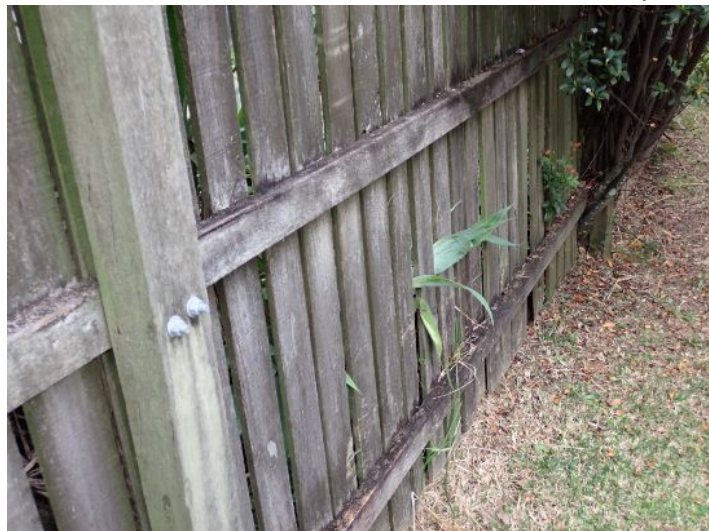
- Wood Decay damage noted in the fence.
- Wood deterioration observed. Recommend repairs/replacement as needed.

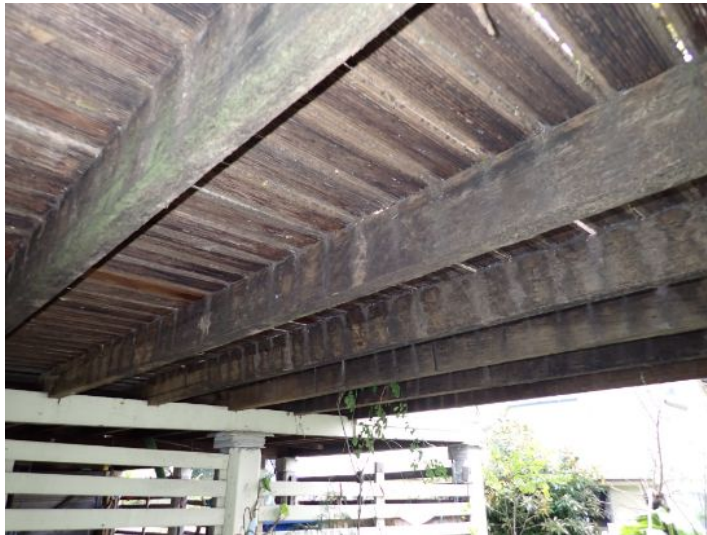
- Wood Decay damage noted in the deck.
- Inspected deck can cause a bridge over any termite installed barriers. It is recommended that the deck should be isolated from attaching to the property, or the soil under and next to the deck should be treated.
- There is timber decking or form work in contact with the ground which may allow termite bridging over any existing termite barrier.
- Rotten floor boards noted. Recommend review for repair as required.

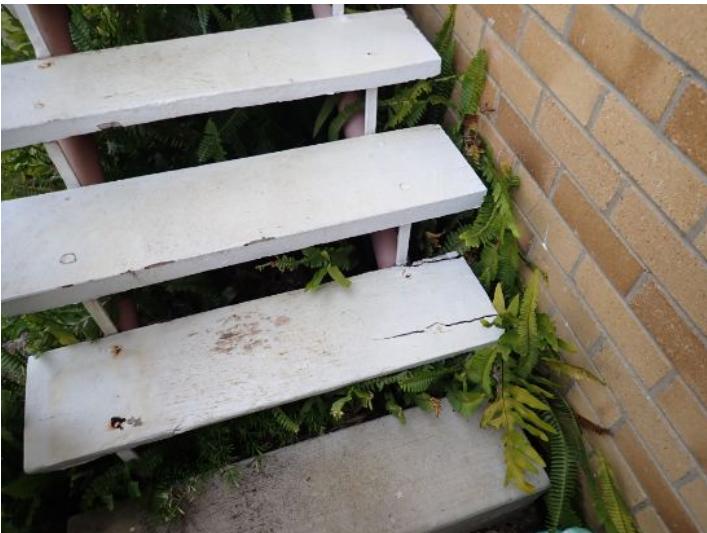
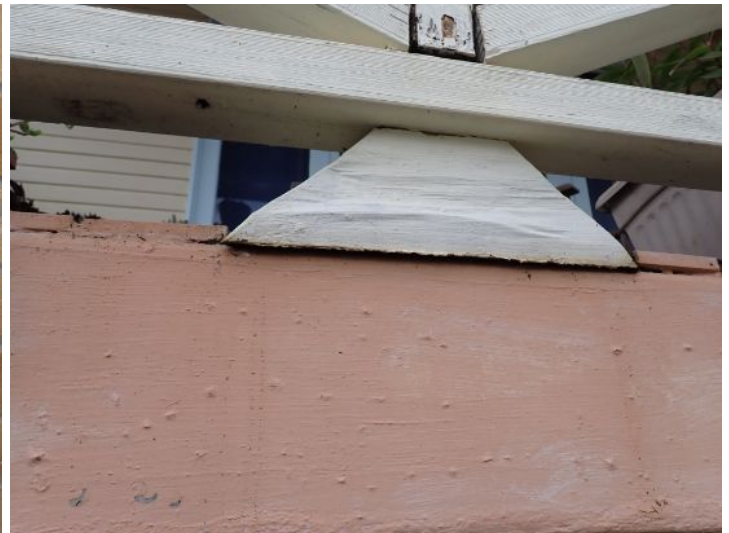
- Inspected steps were in good condition at the time of the inspection unless noted
- Wood Decay damage noted in stairs.
- Wood Decay damage noted in balustrade

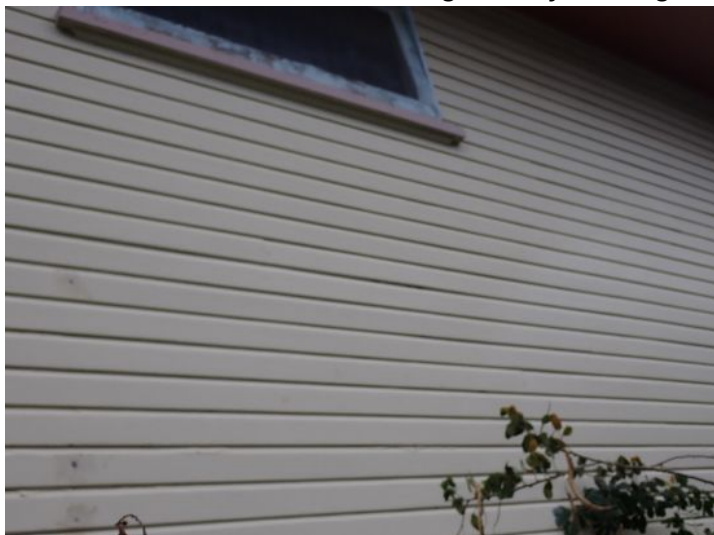
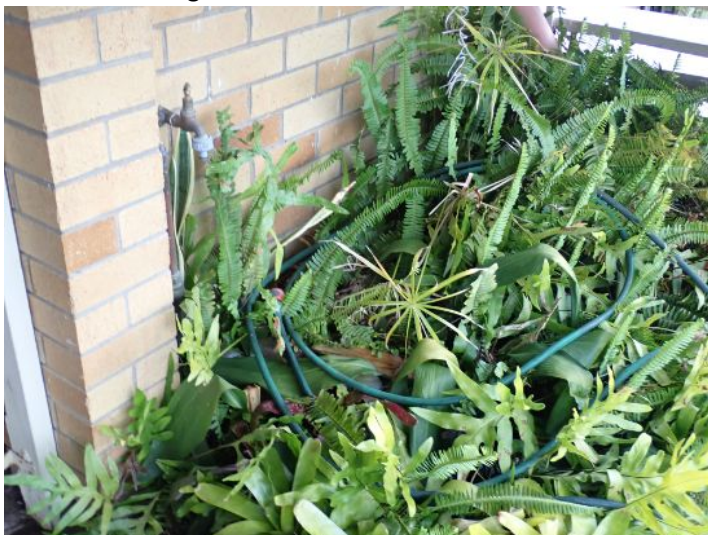
- There are garden beds which are abutting external walls. This can result in water moisture affecting the structure over time. It is recommended that either the beds be removed or a water barrier be place between the garden bed and the external walls. If these beds are retained it is important that any watering is directed away from the building and kept to an absolute minimum and is controlled. These are a risk area for termite activity.
- Weathered wood surfaces observed. Wood deterioration and rot can occur. Prep, prime and paint wood trim as needed.
- Cladding-Soil contact or proximity. This may provide entrance of moisture or insects to siding. Recommend grading soil so there is at least 150mm of space (where practical) between the cladding and the soil below and checking for any damaged trim and siding materials.

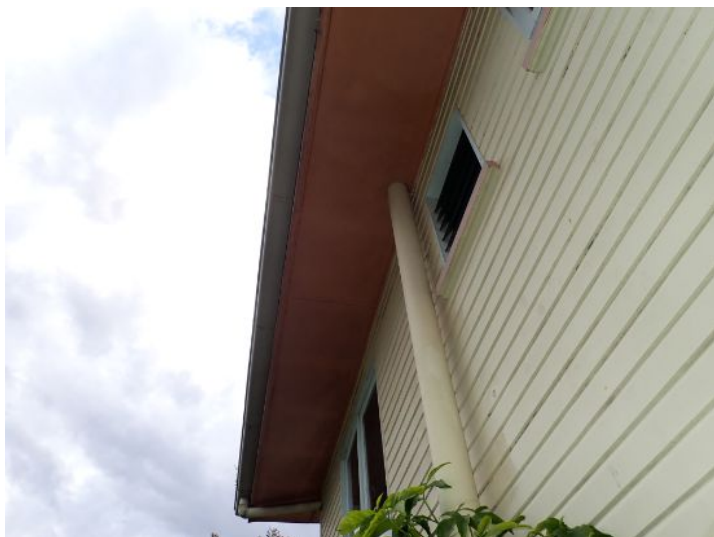
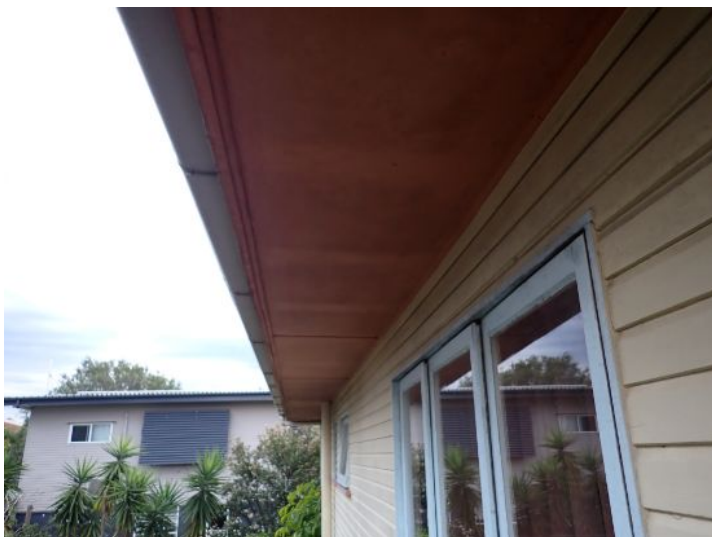
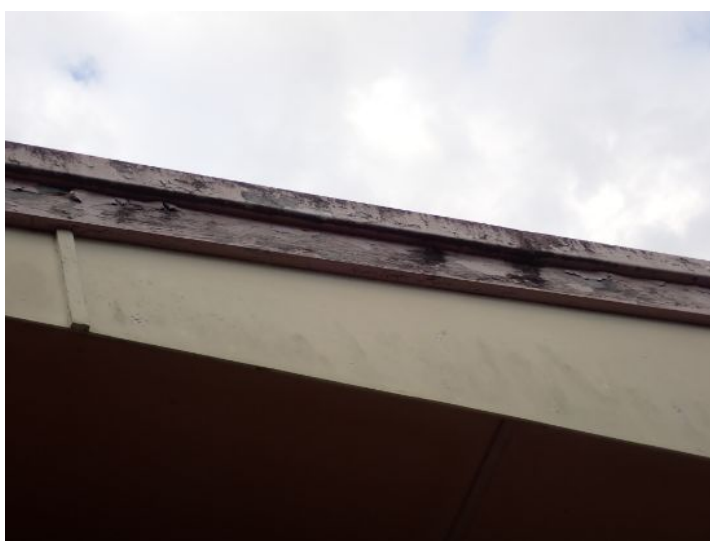
- Moisture damage, wood rot, observed. Recommend review for repair as necessary.

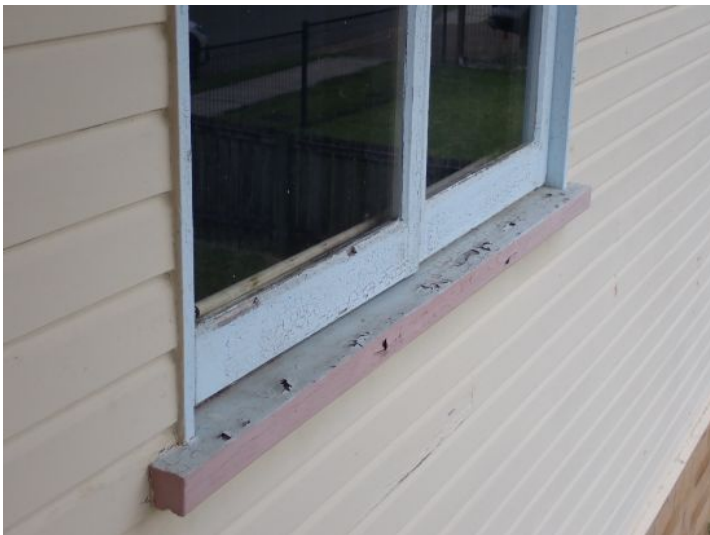
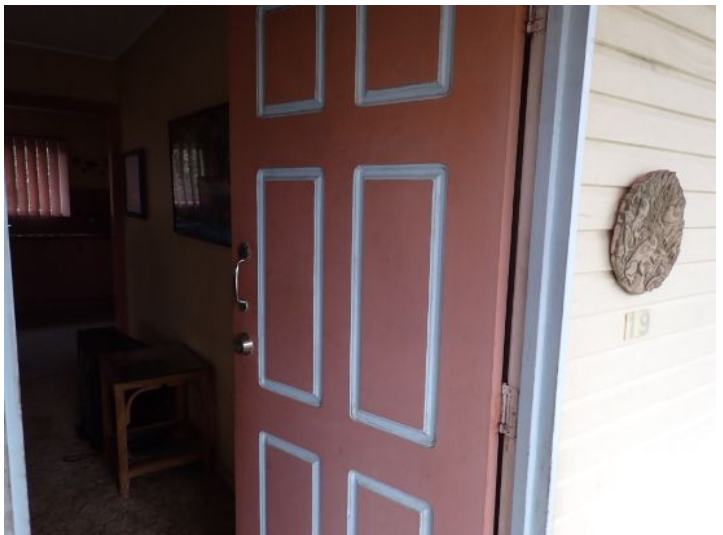
- Windows are weathered, paint is chipping and peeling away. Any exterior wood must be protected from the elements as best as possible.
