Inspection Report

BPP Inspections

559 Robinson Rd West, Aspley, QLD

Pest And Building Inspection

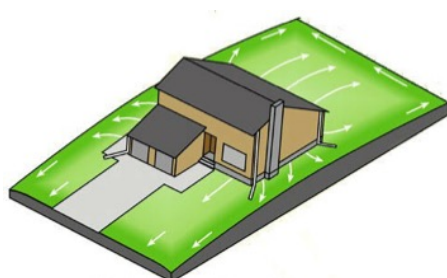
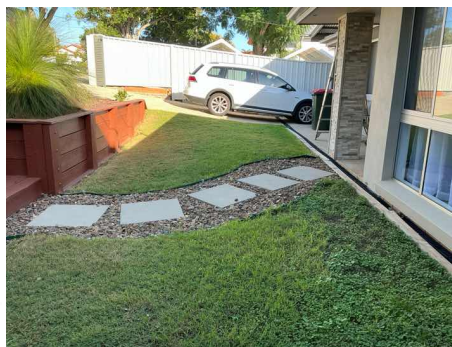
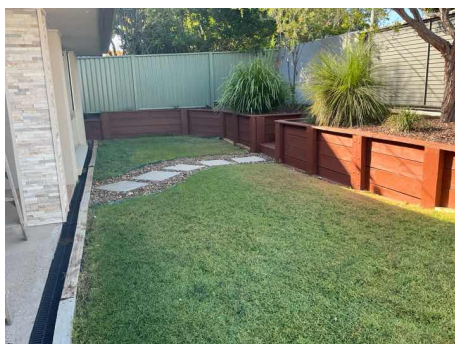
#1. The ground levels along the perimeter walls at the front of the home did not appear to fall away from the property walls sufficiently due to the natural landscape and contour. Recommendations: This will need to be assessed during a period of rainfall and if surface water appears to be entering the sub floor if applicable or ponding against the perimeter walls, engage a plumber or landscaper to assess and rectify as required. All drains should be regularly checked by a plumber and kept clean of debris to allow surface water to be carried away from the dwelling.

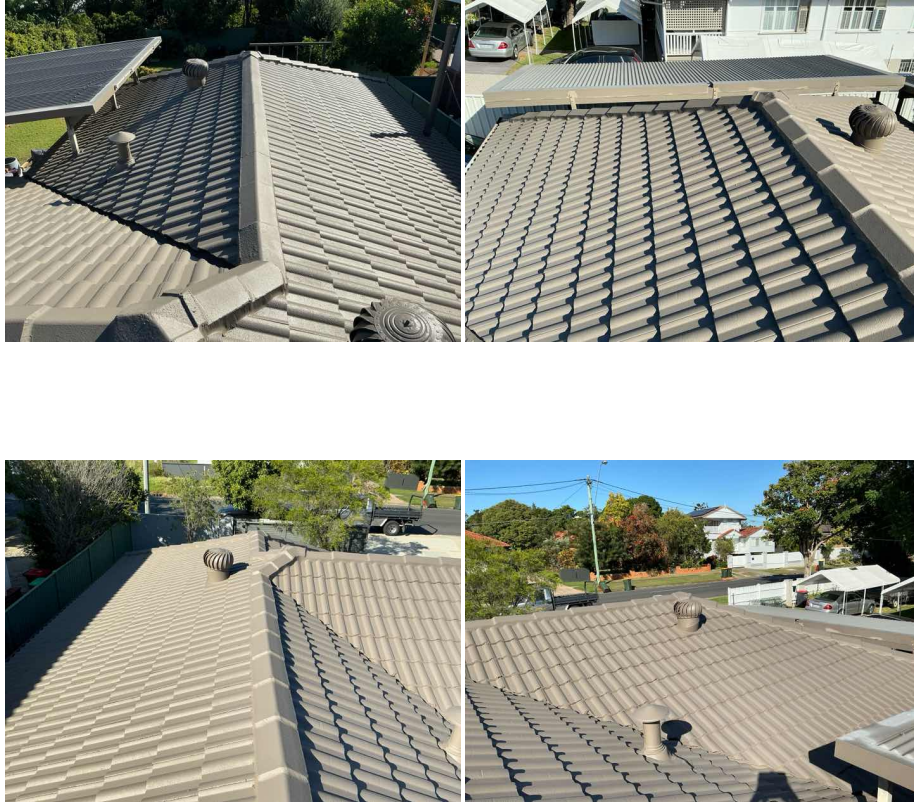
Roof Covering Type

Of the visible areas, the general condition of the roof is in serviceable condition for the age.

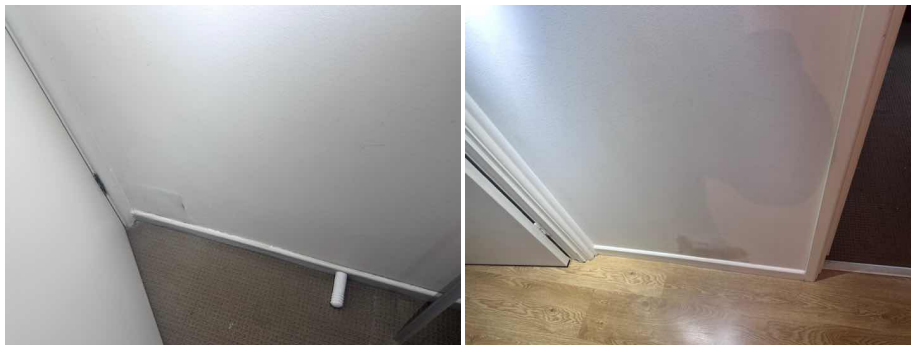
#2. The wall in the room directly behind the shower recess shows recent inspection hole repairs. High moisture readings were measured, with no mould or visible damage. Whilst this appears minor at the time of the inspection, this has the potential to deteriorate further over time if no maintenance repairs are carried out. Contact a lic bathroom sealer company for further advice and recommendations.

High moisture readings were measured.

General maintenance required.

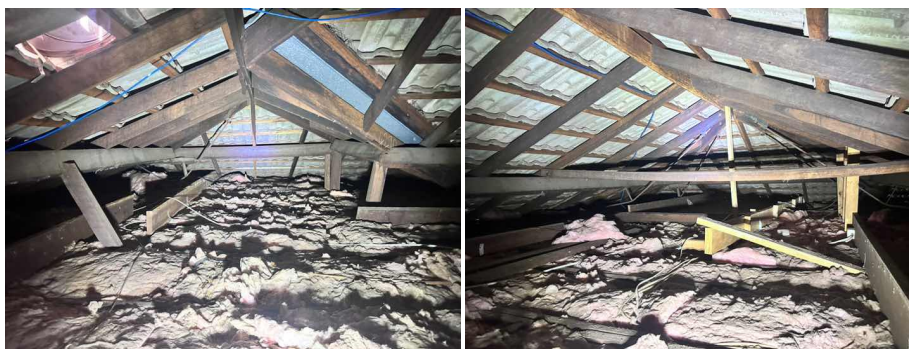
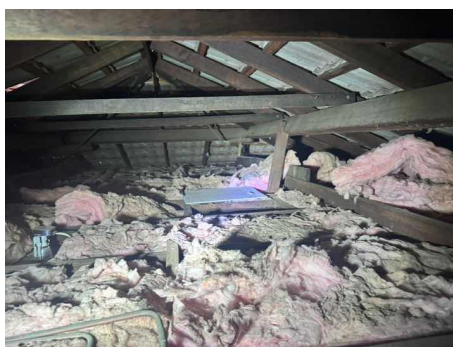
Roof Frame Type

Visible sections of the roof void is in a serviceable condition for age of this dwelling.

#5. Termite damage was visible to components of the building. This would require further invasive inspection to determine the extent of damage. Ensure termite management chemical is kept within its active lifespan. Contact a lic Builder to assess and repair as required.

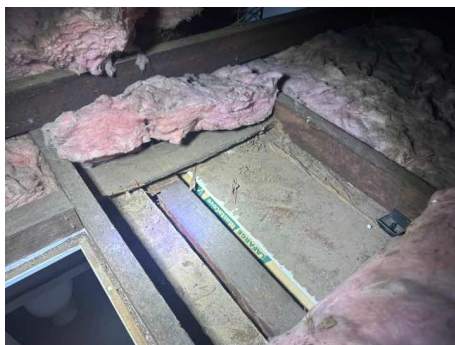
Roof frame timber

Yes, termite damage was found in the following

No

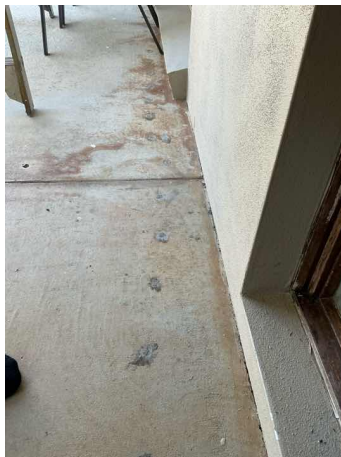
5. Ant Capping and Termite Shields

This building has no cavity protection from concealed termite entry. The perimeter chemical soil treatment is the only method to protect the building against termite attack. Ensure that the termite chemical treatment is kept within its expiry date and regular inspections are carried out.

Do not garden or dig around the direct building perimeter without consulting a lic pest control technician.

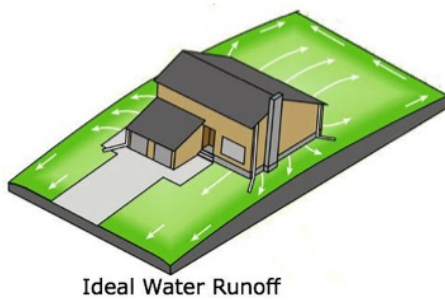
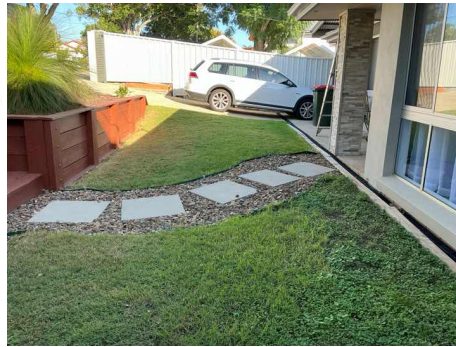
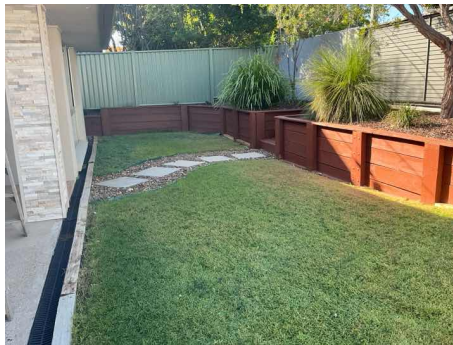
#1. The ground levels along the perimeter walls at the front of the home did not appear to fall away from the property walls sufficiently due to the natural landscape and contour. Recommendations: This will need to be assessed during a period of rainfall and if surface water appears to be entering the sub floor if applicable or ponding against the perimeter walls, engage a plumber or landscaper to assess and rectify as required. All drains should be regularly checked by a plumber and kept clean of debris to allow surface water to be carried away from the dwelling.

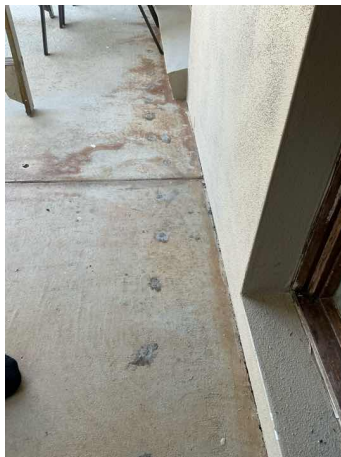
5. Ant Capping and Termite Shields

The Termite Shields Appear To Be

Do not garden or dig around the direct building perimeter without consulting a lic pest control technician.
