Inspection Report

BPP Inspections

3/13 Turrbal Place, Aspley, QLD

Pest And Building InsP-ection

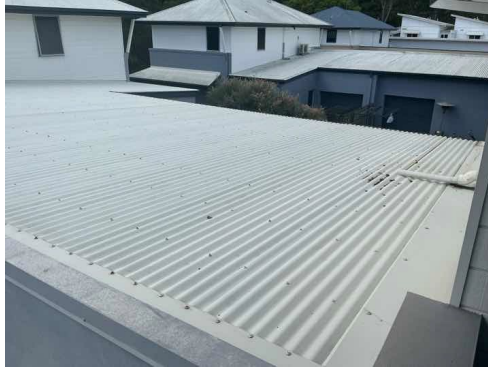
Metal roof cladding

Of the visible areas, the general condition of the roof is in serviceable condition for the age.

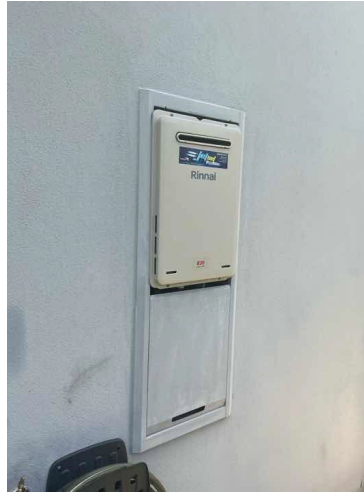
The hot water system appears to be in a serviceable condition. No specific tests other than running the hot water from a tap was carried out. No determination has been made as to the suitability or adequacy of the hot water system in relation to capacity or otherwise.

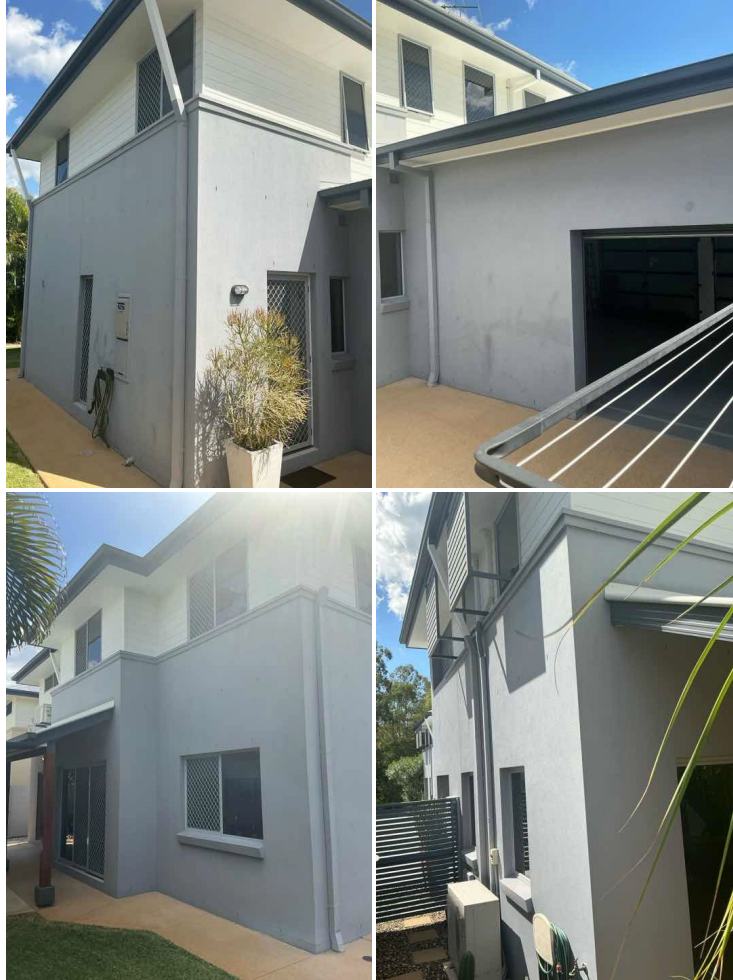
The building is a brick veneer base lower storey with lightweight cladding to the upstairs.

On visual inspection, the general condition of the exterior walls is serviceable for the age.

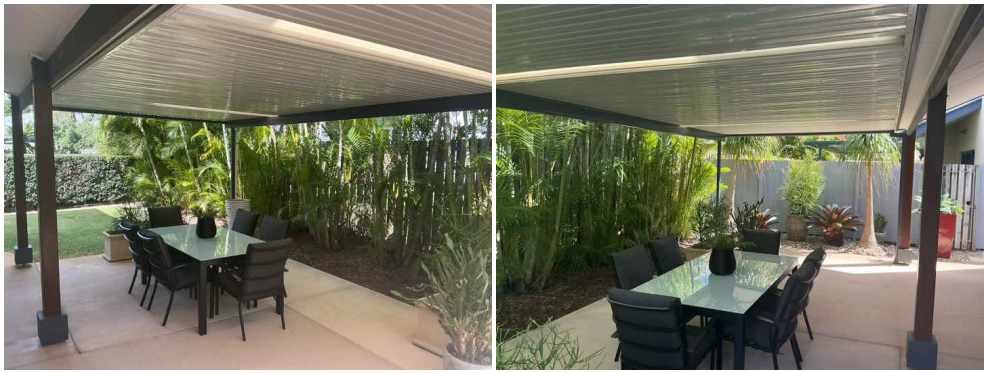
Visible sections of the Alfresco area are serviceable or in reasonable or condition for the age of this dwelling.

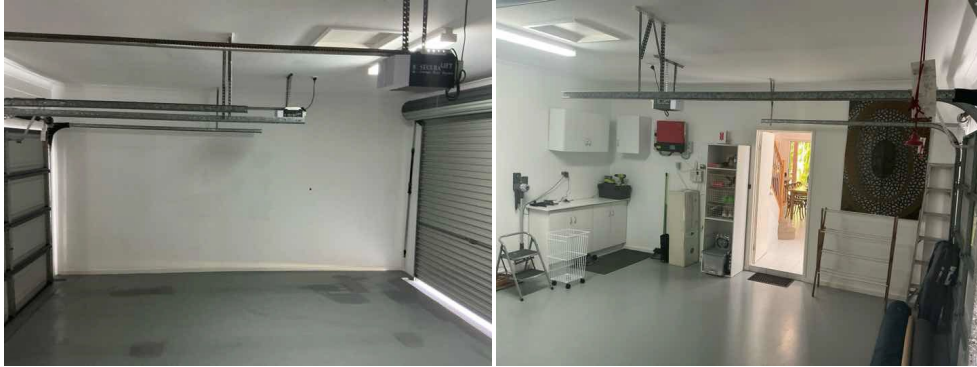
Of accessible and visible areas, the garaging is considered to be in a serviceable condition.

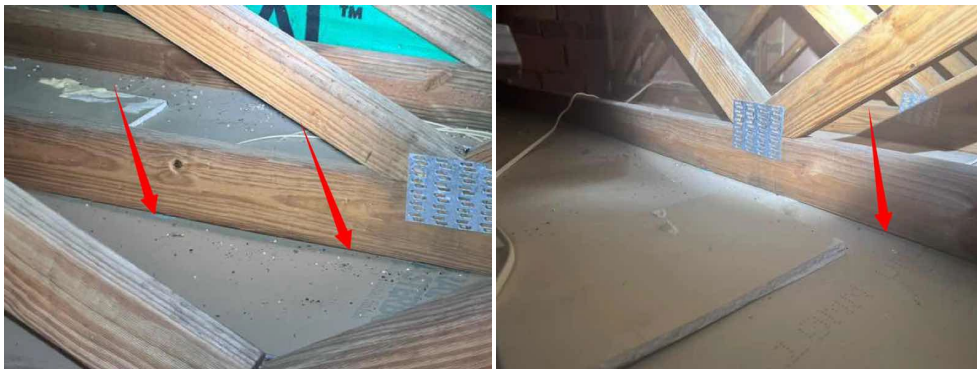
#1. The plasterboard ceiling glue has released from its contact points leaving the sheeting supported mainly by its screw fixings. The ceiling requires an assessment by a lic plasterer to determine the process involved with repair. Sagging ceilings have potential for collapse as the areas detached expand.

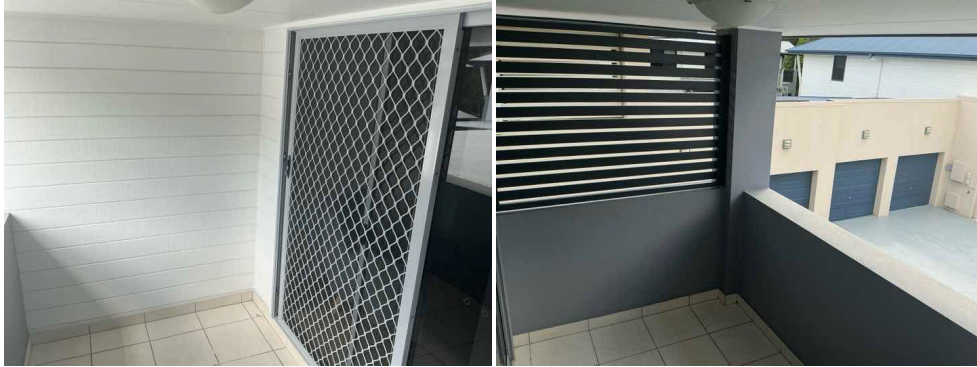
Though we are not structural engineers the balcony/s appear to be in a serviceable condition.

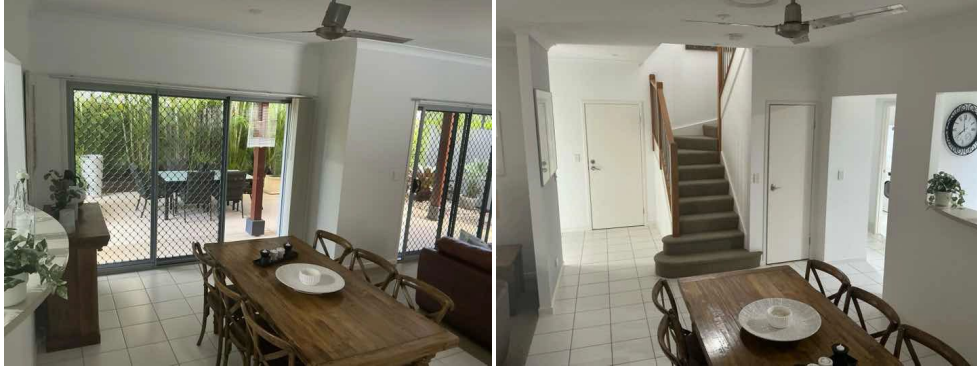
The dining room is in serviceable condition with no notable structural defects sighted.

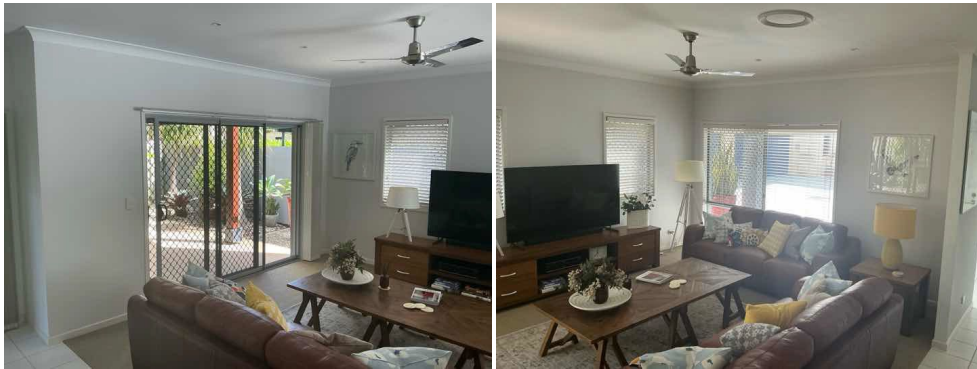
The family room is in serviceable condition with no notable structural defects sighted.

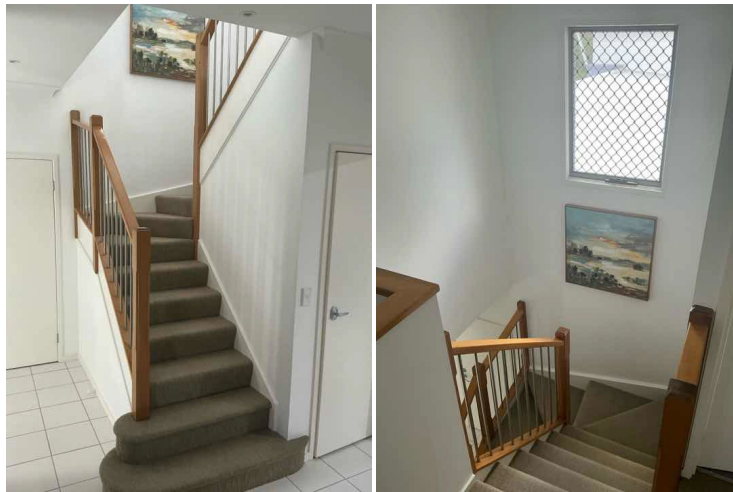
The interior stairs are in a serviceable condition with no notable defects sighted.

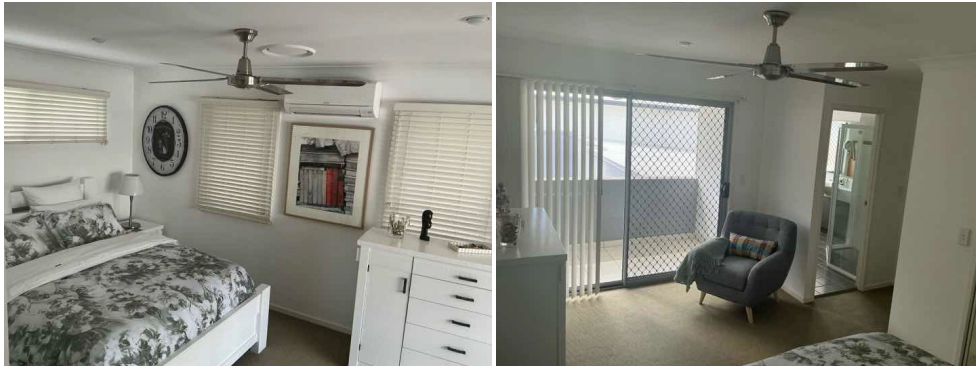
Bedroom 1

This bedroom is in serviceable condition with no notable structural defects sighted.

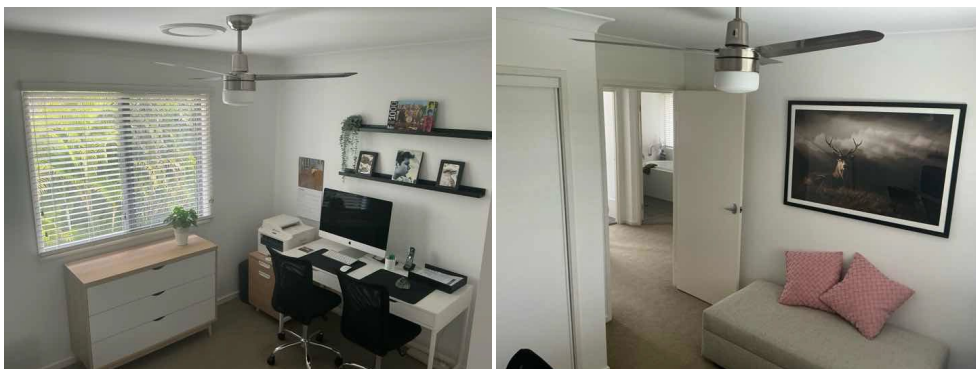
Bedroom 2

This bedroom is in serviceable condition with no notable structural defects sighted.

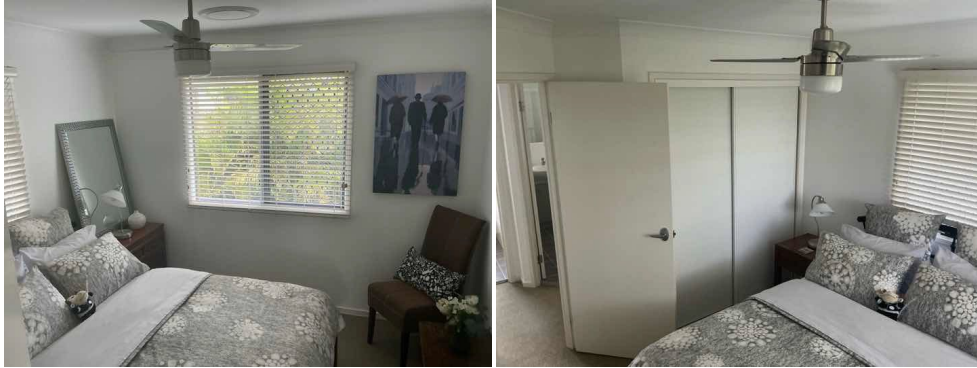
Bedroom 3

This bedroom is in serviceable condition with no notable structural defects sighted.

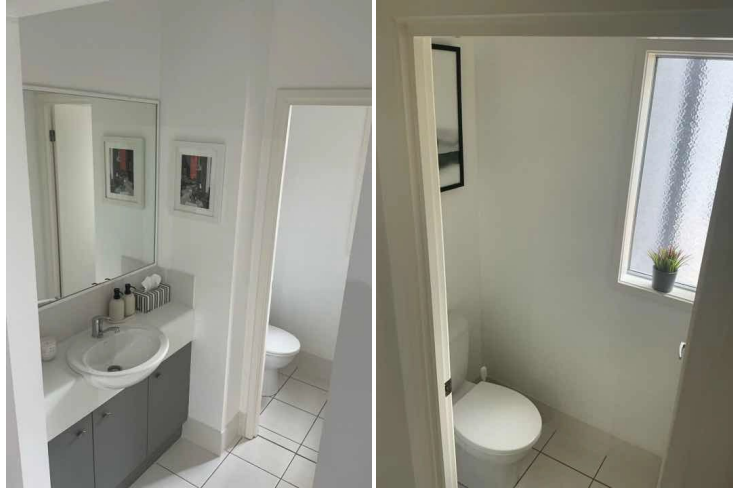
Downstairs

Of the visible areas, the general condition of this bathroom is serviceable or in reasonable condition for age of dwelling.

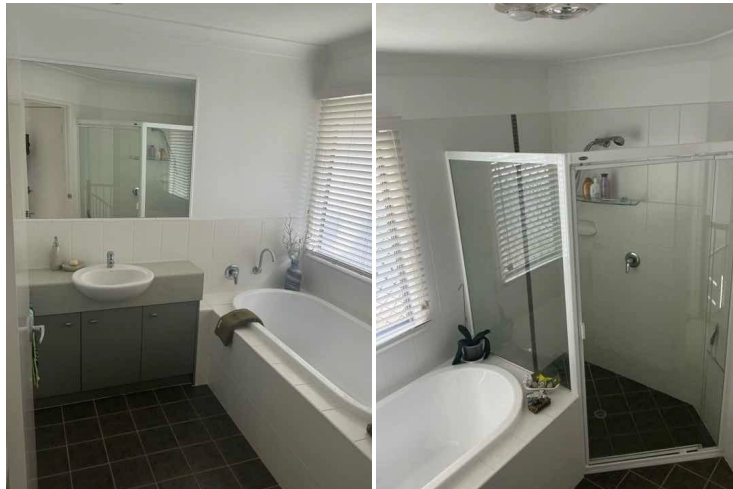
Upstairs

Of the visible areas, the general condition of this bathroom is serviceable or in reasonable condition for age of dwelling.

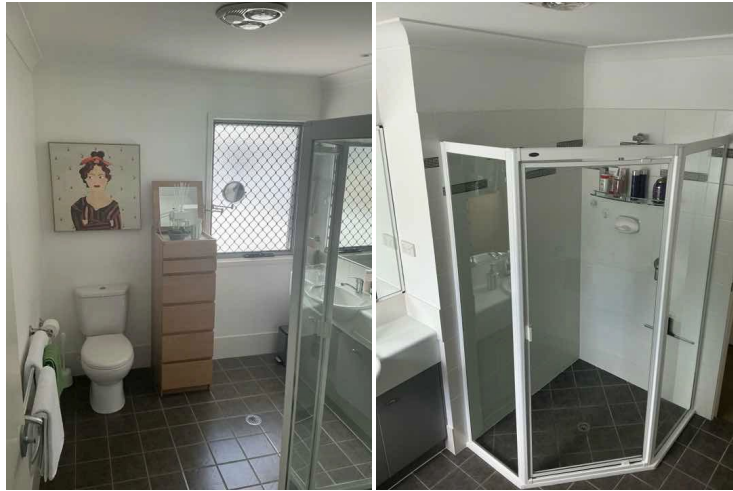
Master bedroom

Of the visible areas, the general condition of this bathroom is serviceable or in reasonable condition for age of dwelling.

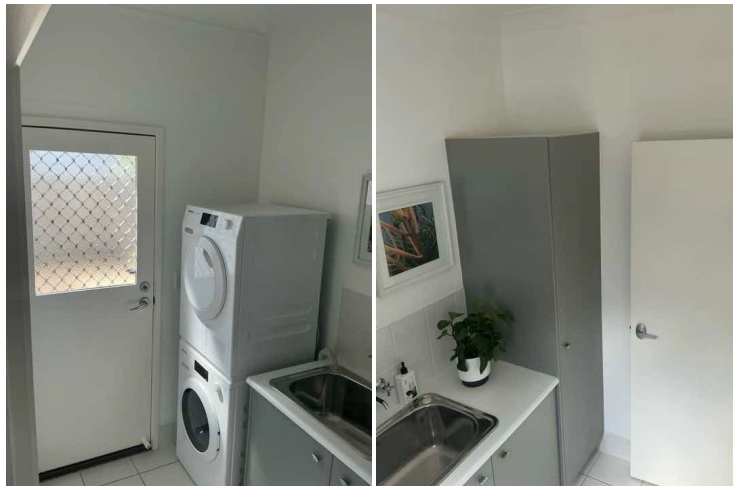
Of the visible areas, the general condition of the laundry is serviceable.

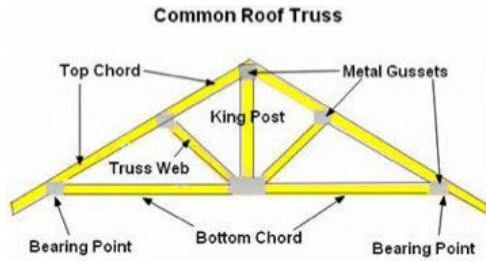
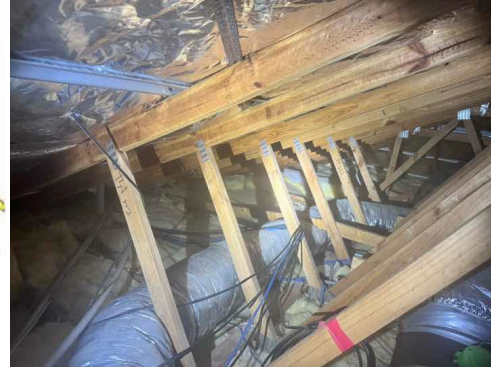
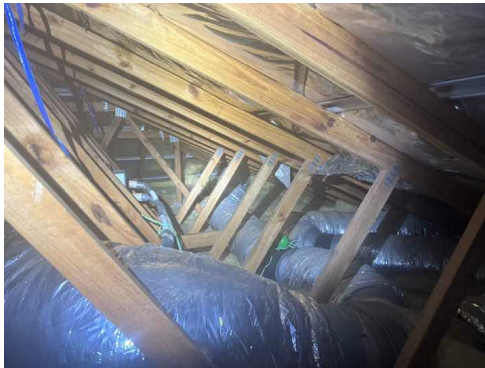
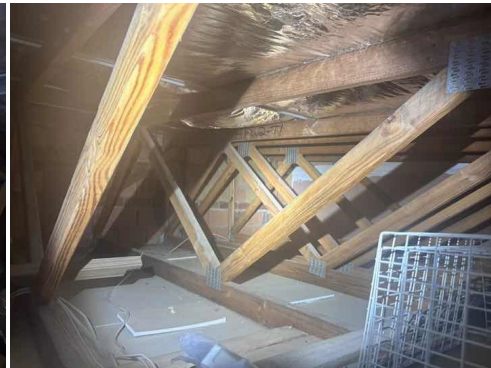
The roof frame is a truss timber frame.

Visible sections of the roof void is in a serviceable condition for age of this dwelling.

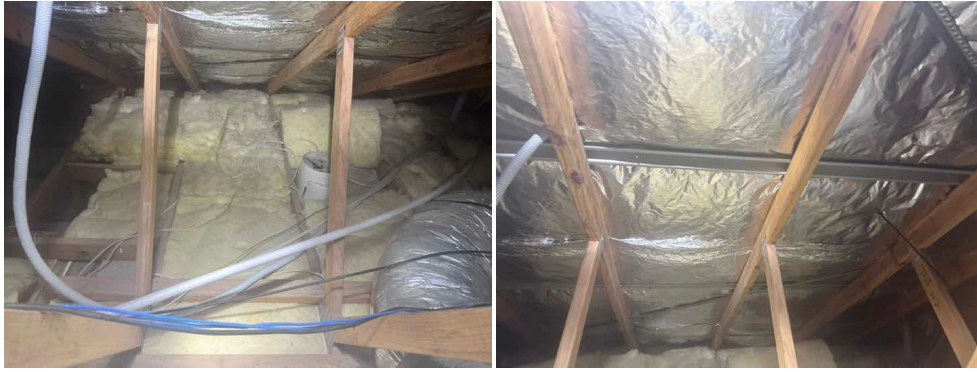
The roof space is insulated with reflective fibreglass batts under the roof cladding.

Where visible and accessible, the insulation appears to be in a serviceable condition.

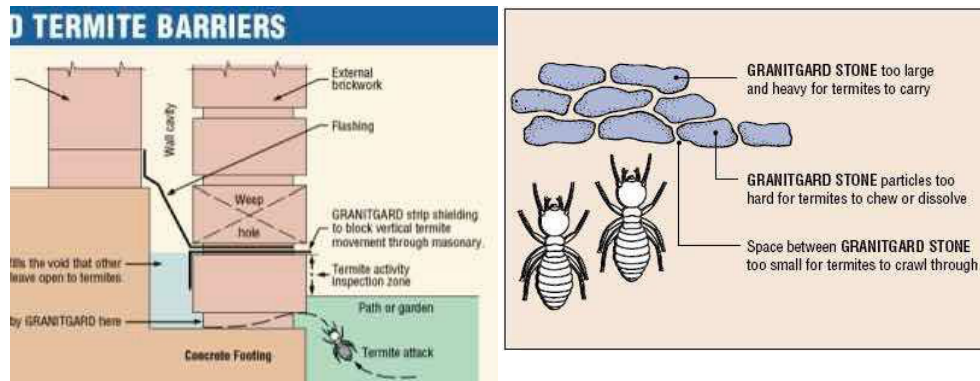
Granitgard is a fine graded stone product placed in the base of the brick cavity during the construction stage. It is designed as a long term solution if installed correctly. We are physically unable to inspect the integrity of the Granitgard as it's location is behind the bricks. We can only inspect the exterior perimeter edge of the plastic pvc dampproof course. As we cannot inspect the integrity of the barrier we recommend the installation of a chemical barrier by a lic pest control technician.
