Inspection Report

BPP Inspections

2 Sugargum Close, Bracken Ridge, QLD

Pest And Building Inspection

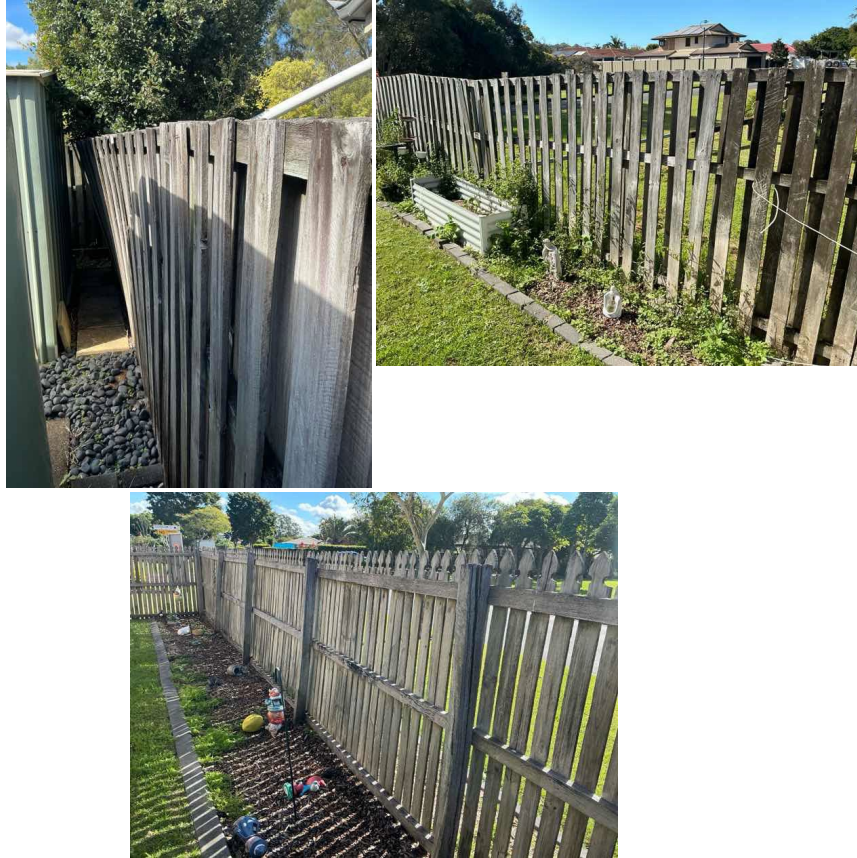
#1. General age to fence components - Recommendations: General upkeep and maintenance. A qualified fencing contractor should be engaged for repairs

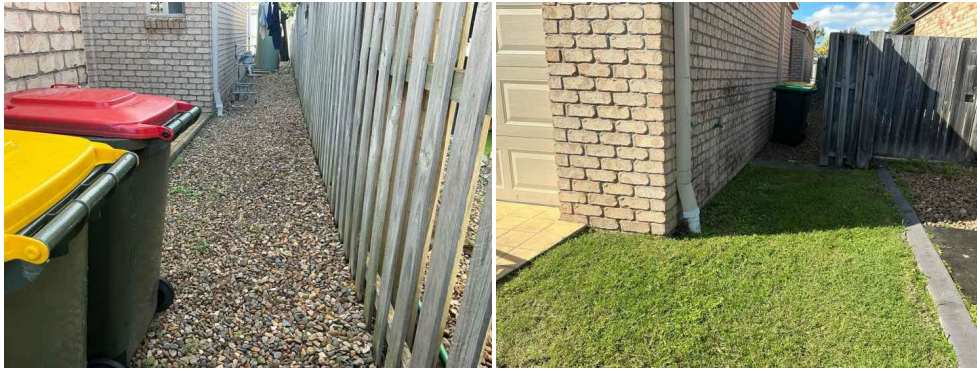
#2. The ground levels along the perimeter walls at the side of the home did not appear to fall away from the property walls sufficiently due to the natural landscape and contour. Recommendations: This will need to be assessed during a period of rainfall and if surface water appears to be entering the sub floor if applicable or ponding against the perimeter walls, engage a plumber or landscaper to assess and rectify as required. All drains should be regularly checked by a plumber and kept clean of debris to allow surface water to be carried away from the dwelling.

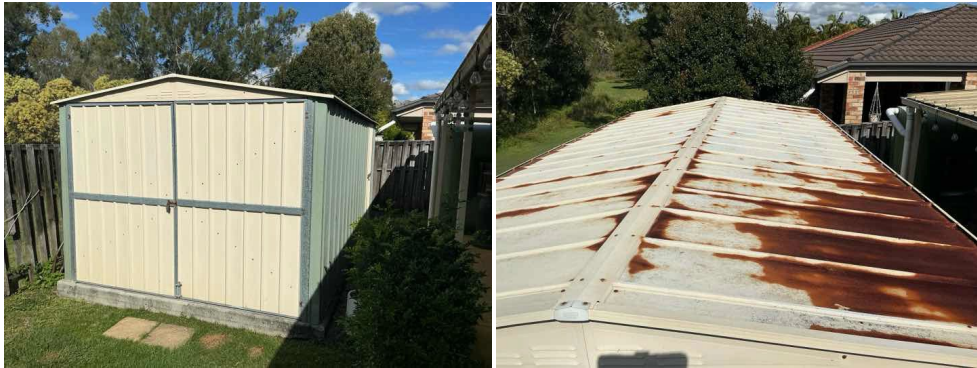
The shed is in fair usable condition.

#3. Rust developing on cladding noted. Repairs to restrict rust required.

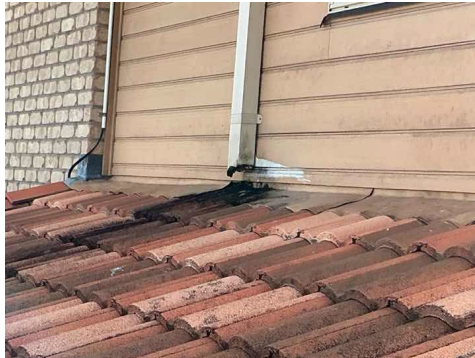
#4. Missing downpipe spreader base. This is a T piece on the base of the downpipe that is designed to spread the flow of the storm water across an area. At present this water is concentrated in one point and can lead to backflow of the gutter into building components causing damage. Recommendations: A qualified roof plumber should be engaged to repair.

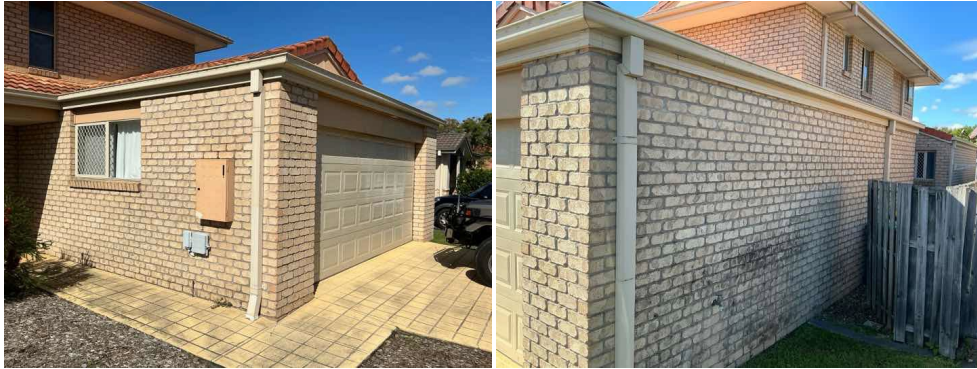
#5. General age visible to the exterior paint surfaces. Cleaning of exterior required to assess paint condition. Mouldy areas to be treated accordingly. Sealants and fillers showing signs weather exposure.

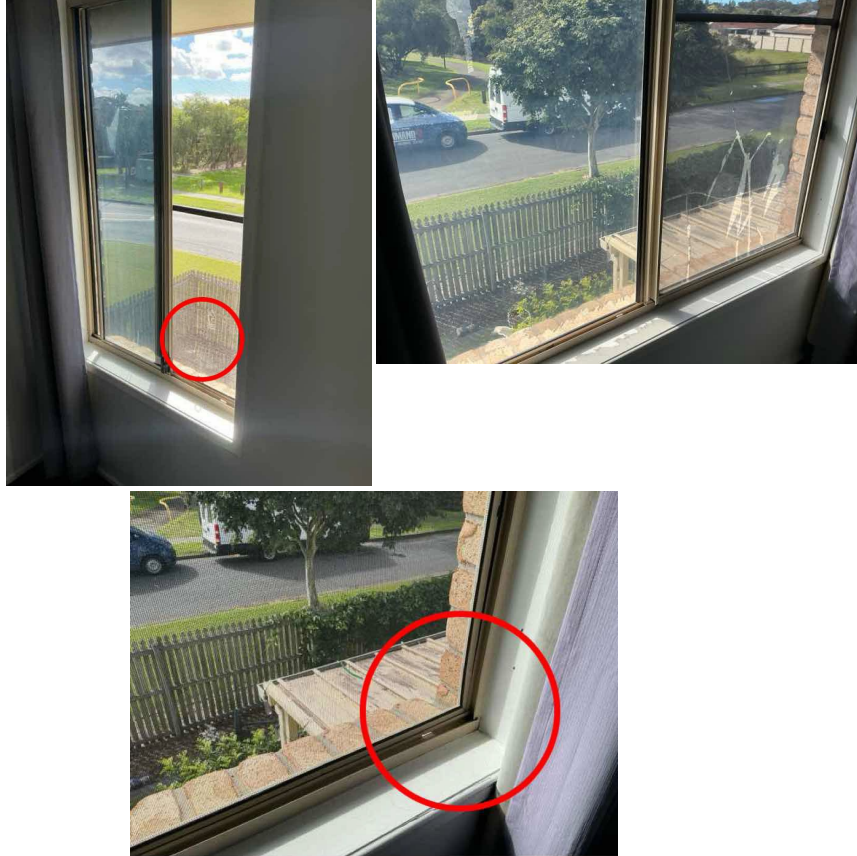
#8. Aluminium frame of the window is compressed and damaged. The window still operates correctly. Assess further if this is damage during construction or if settlement of the building has applied weight to the aluminium frame of the window.

Contact a lic Builder to assess and advise.

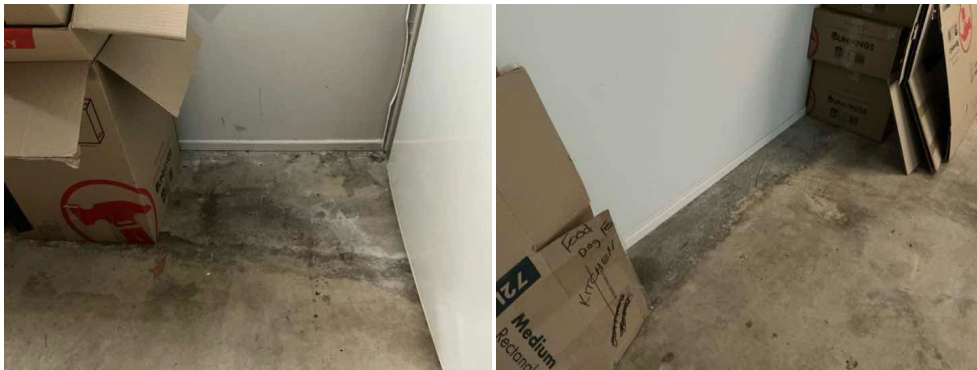
#9. Efflorescence caused by high underslab moisture and poor preparation during construction. Early stages, enquire with a specialist in efflorescence treatment/ concrete waterproofing. This should be monitored for change once treated and sealed.

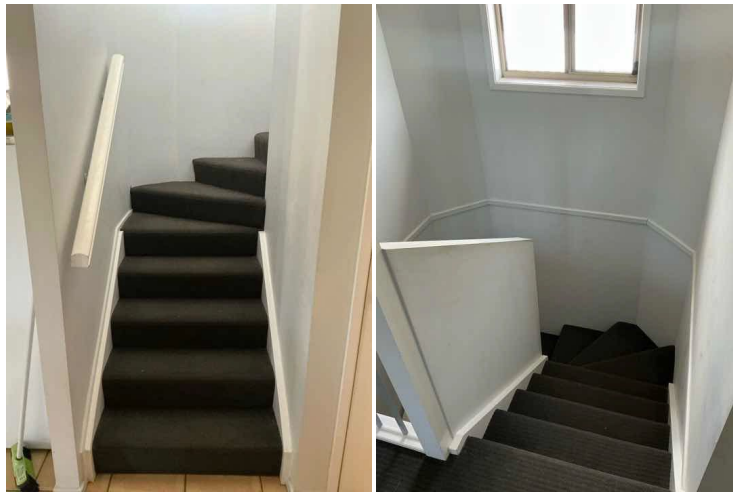
#10. No hand rail installed to the staircase. This is a building requirement and a presents a safety risk. Contact a licensed builder at the earliest.

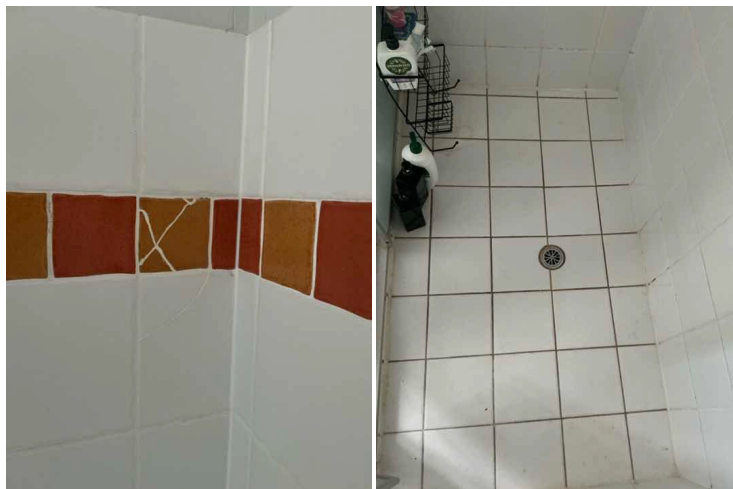
Cracked tiles visible to shower wall, assess and repair as required.

General maintenance required.

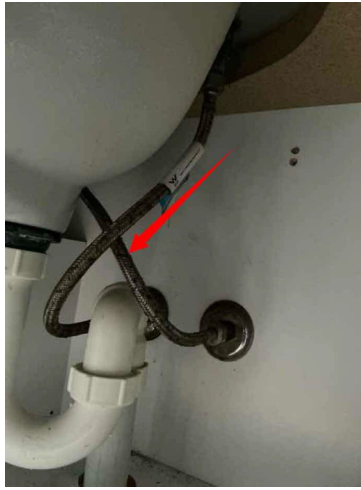
#12. There are flexible water pipes underneath the vanity cabinet. These flexible pipes have reached the end of their serviceable lifespan. These pipes have the potential to burst resulting in major water leak issue. Contact a lic plumber for advice and recommendations.

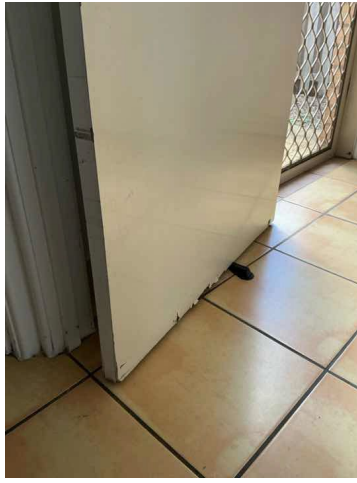
#13. The laundry door is aged and weathered. Assess and repair/ replace as required.

Contact a lic carpenter.

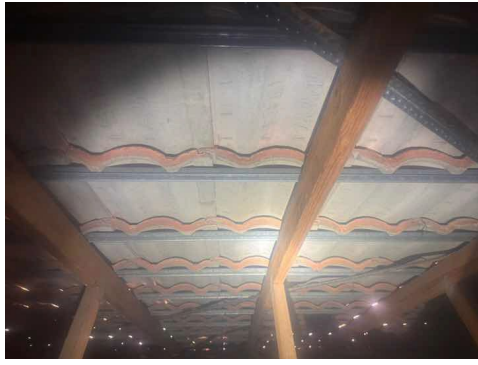
#15. The insulation in general is serviceable. However it's efficiency would be improved if certain areas were tidied up and laid neatly. Seek further advice and assessment from a licensed insulation installer.

There is no sarking installed. Sarking is the layer of reflective film material installed during construction underneath the roofing material. It provides a moisture barrier and minimal insulation. The installation of sarking is not a building requirement.

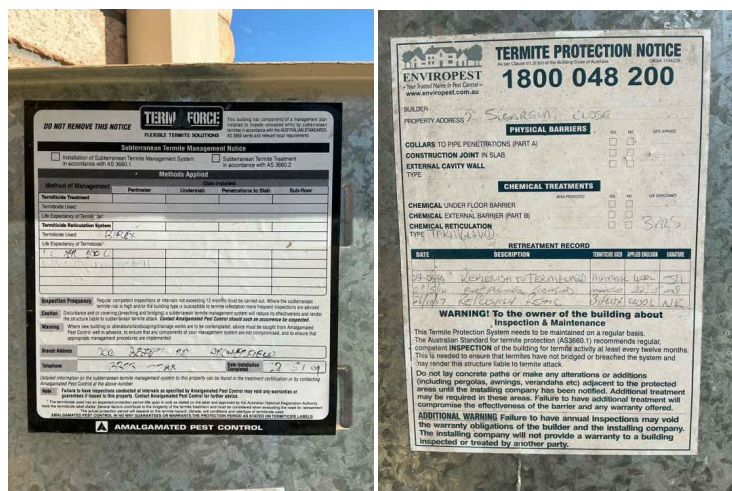
The durable notice of a building is a permanent sticker stating the method of long term termite treatment or barrier in place. This building has an expired chemical listed on the durable notice. It is then clearly reported by us, that there is no effective termite barrier in place, leaving the building susceptible to hidden termite entry.

In this case we strongly recommend that you engage the services of a licensed pest control technician to access and undertake an assessment of the property, to determine the procedure and costs involved with the installation of the recommended method of barrier installation, and termite control method.

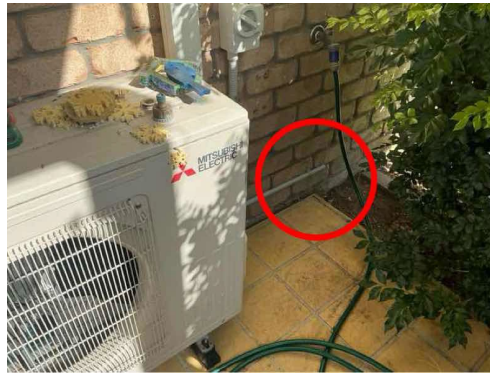
#18. The air conditioning drain was draining onto the building perimeter ground surface. This adds constant excessive ground moisture providing conducive conditions for termites.

Divert drain and connect to stormwater discharge points where possible.

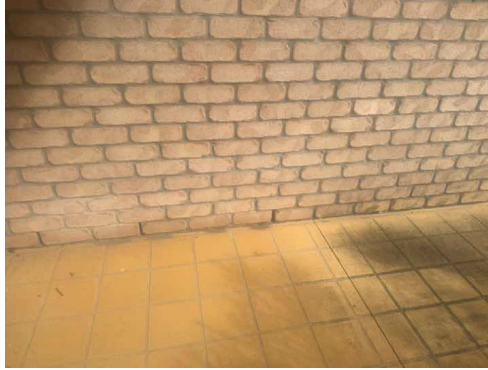
The weep holes along the garage walls did not provide the required 75 mm clearance from ground level to carry out effective inspections. Constant monitoring will be required in this area and along wall perimeter kept clean.

Perimeter chemical application will remove this risk.

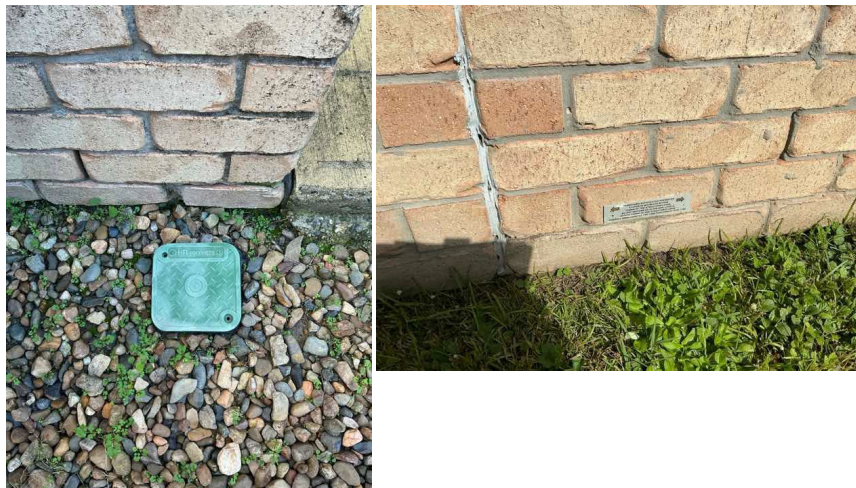
#19. The building has a chemical reticulation system installed. This system if installed and maintained correctly is designed to to protect and manage concealed termite risk. The system has not been maintained and the protection chemicals active expiry date was 2020. This has left the building exposed to concealed activity and damage for the past 6 years and current.
