Inspection Report

8 Bushland St , Boondall, QLD

Pest And Building InsP-ection

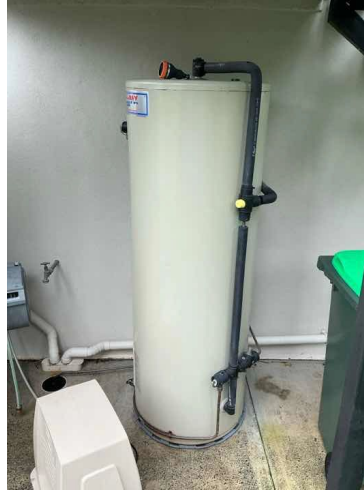
The hot water system appears to be in a serviceable condition. No specific tests other than running the hot water from a tap was carried out. No determination has been made as to the suitability or adequacy of the hot water system in relation to capacity or otherwise.

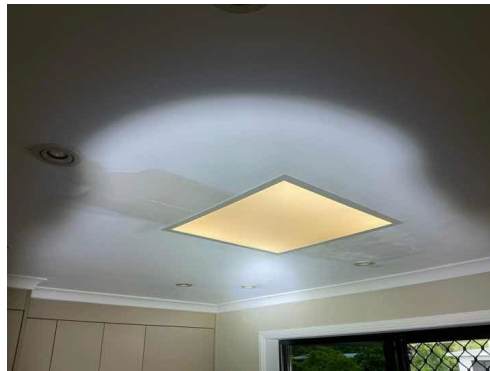
#1. Ceiling stains - No moisture readings obtained from same. Recommendations: These may have been repaired, however, you will need to monitor after a prolonged period of rainfall - If leaking persists, a qualified plumber should be engaged for advice and recommendations. Essentially, it is preferable to have all water damaged plaster replaced by a qualified plasterer due to potential detachment or collapse.

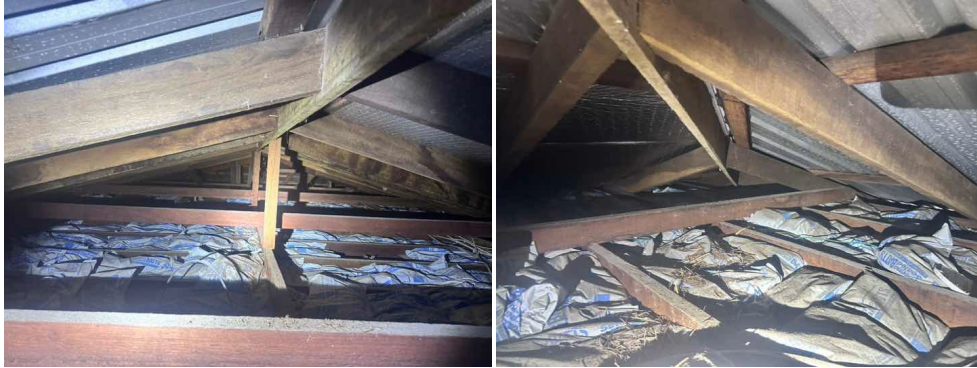
The roof frame is a conventional timber frame.

#2. The ceiling void was too confined to physically access. This was inspected from the manhole access point only. From this point the area appeared serviceable. Certain areas were unable or difficult to inspect, and as such are not included in this inspection. Invasive inspection, (areas of roof lifted) would be required to inspect these areas.

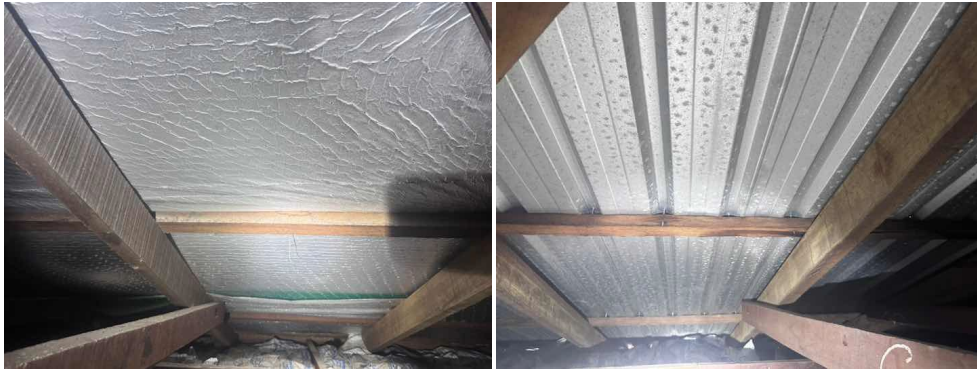
There is not complete sarking installed. Sarking is the layer of reflective film material installed during construction underneath the roofing material. It provides a moisture barrier and minimal insulation. The installation of sarking is not a building requirement.

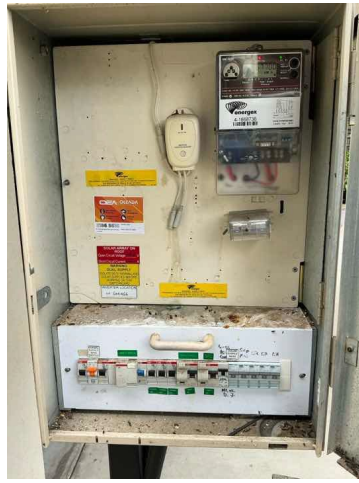
Electricity to the dwelling was connected. Note: We do not carry out electrical inspections for wiring or safety. This must be carried out by a licensed electrician and I recommend you have all electrical wiring and components assessed by a licensed electrician.

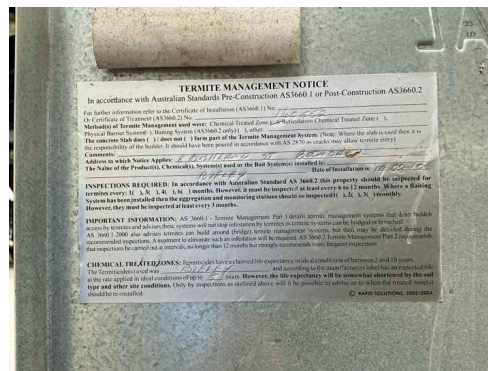
The durable notice of a building is a permanent sticker stating the method of long term termite treatment or barrier in place. This building has an expired chemical listed on the durable notice. It is then clearly reported by us, that there is no effective termite barrier in place, leaving the building susceptible to hidden termite entry.

In this case we strongly recommend that you engage the services of a licensed pest control technician to access and undertake an assessment of the property, to determine the procedure and costs involved with the installation of the recommended method of barrier installation, and termite control method.

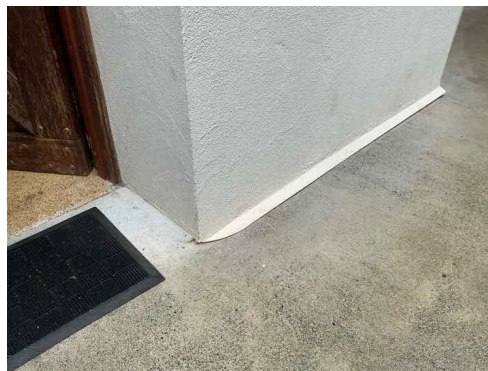
The termite shields (ant caps) are inadequate, this offers concealed entry potential for termites. A chemical soil treat will be required to protect the building against termite attack.

#5. Areas where the ant capping is breached by covering and enclosing. This provides a concealed entry point for termites in an area that is unable to be visually inspected. Activity or damage may exist in concealed areas such as the downstairs perimeter of slab, and any slab joins and pipe penetrations.

This is the area that the chemical treatment is required.
