# Inspection Report

## BPP Inspections

**207 Newman Rd, Geebung, QLD**

### Pest And Building InsP-ection

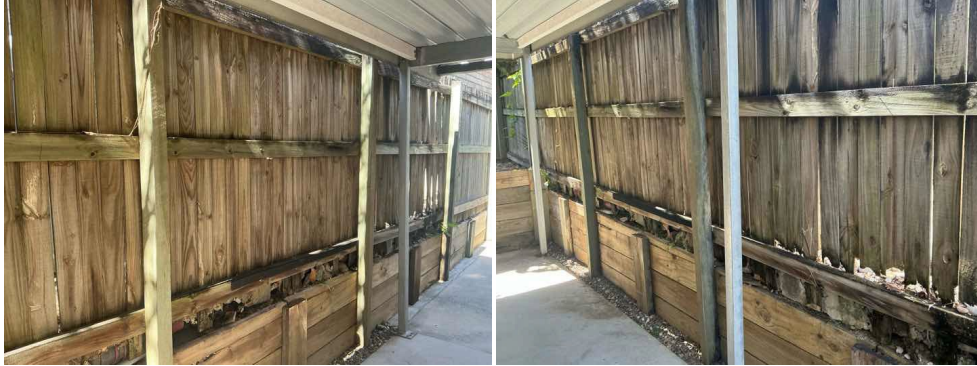
#1. General age to fence components and retaining wall Timbers supporting the neighbouring yard.

Recommendations: General upkeep and maintenance. A qualified fencing contractor should be engaged for repairs

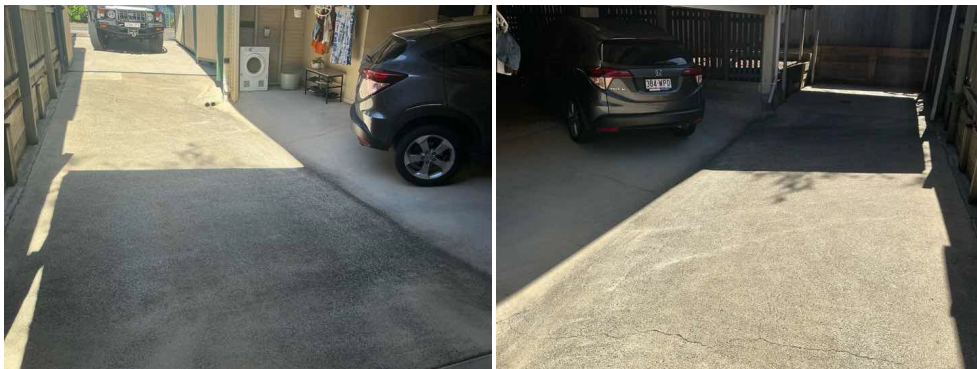
#2. The ground levels along the perimeter walls of the home did not appear to fall away from the property walls sufficiently due to the natural landscape and contour. Recommendations: This will need to be assessed during a period of rainfall and if surface water appears to be entering the sub floor if applicable or ponding against the perimeter walls, engage a plumber or landscaper to assess and rectify as required. All drains should be regularly checked by a plumber and kept clean of debris to allow surface water to be carried away from the dwelling.

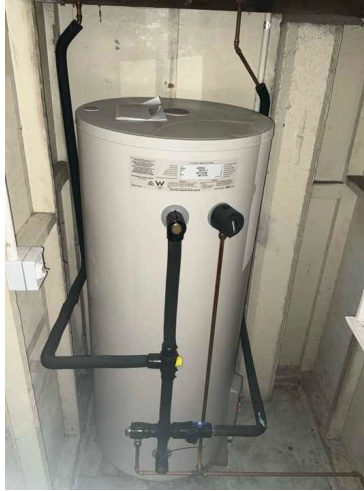
The hot water system appears to be in a serviceable condition. No specific tests other than running the hot water from a tap was carried out. No determination has been made as to the suitability or adequacy of the hot water system in relation to capacity or otherwise.

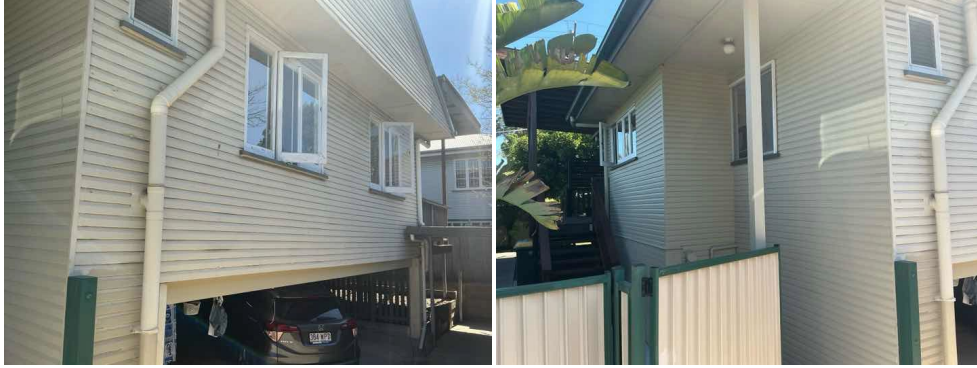
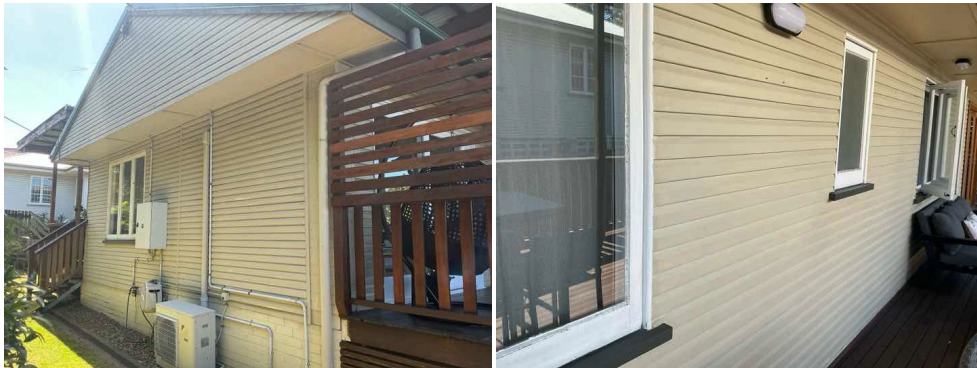
On visual inspection, the general condition of the exterior walls is serviceable for the age.

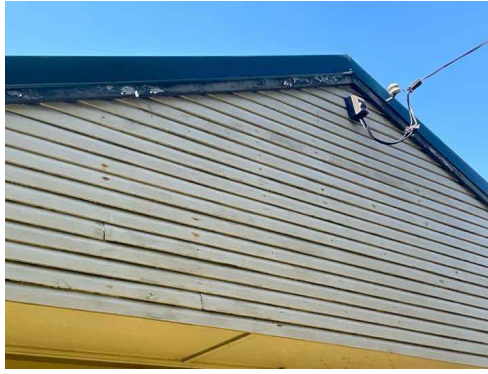
#3. General age visible to the exterior paint surfaces. Cleaning of exterior required to assess paint condition. Mouldy areas to be treated accordingly. Sealants and fillers showing signs weather exposure.

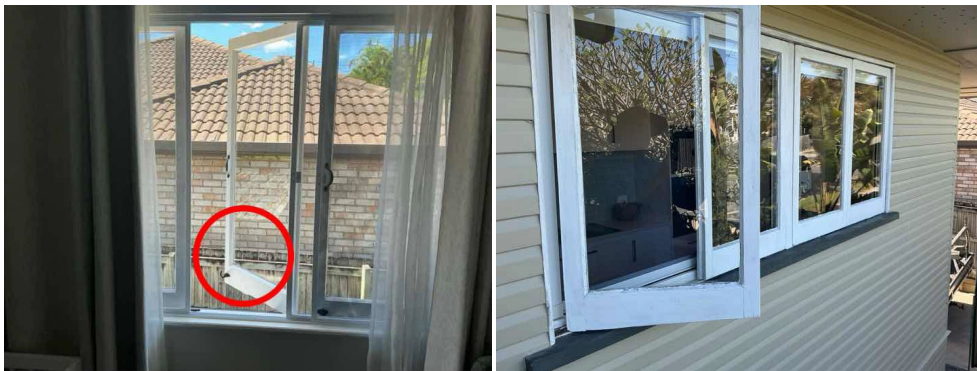
Age observed to window components. Maintenance required. Assess each window and improve sealants and lubricants to mechanical components.

#4. Selected upstairs windows are able to be fully opened. This was compliant at the time of construction and technically no requirement to rectify. Current building code has identified a fall risk and requires a limited opening of 125 mm or secure screening to be in place.

Contact a lic Builder, Glazier to assess and rectify.

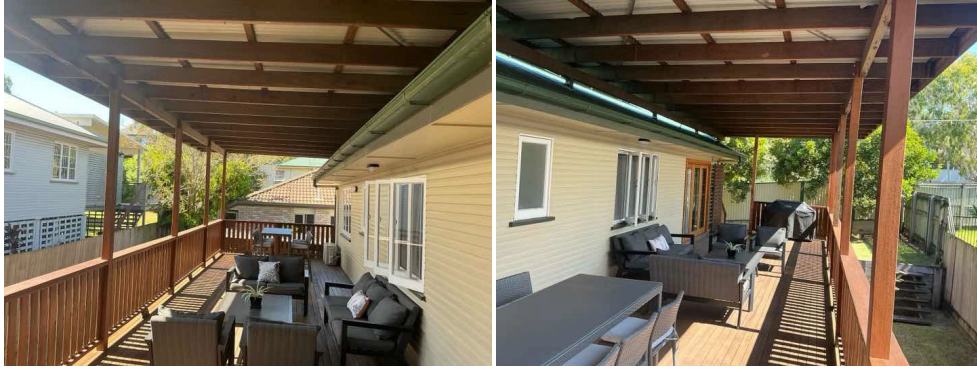
Of areas visible, the decking appears to be in a serviceable condition.

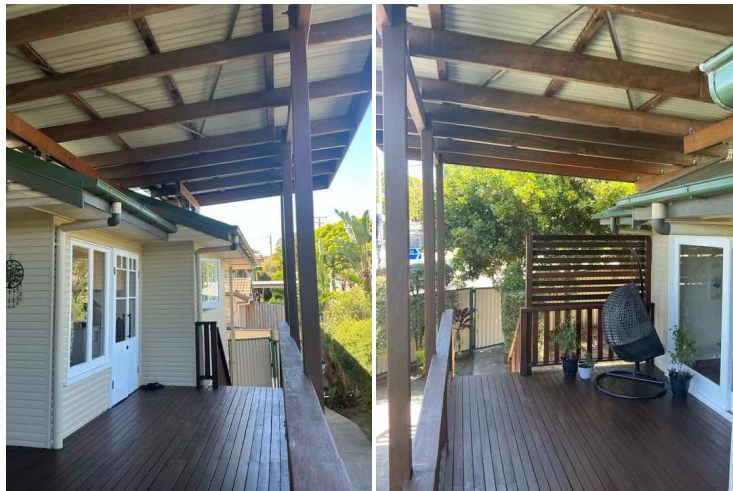
Though we are not structural engineers the balcony/s appear to be in a serviceable condition.

Minor maintenance required to stair handrail post as required.

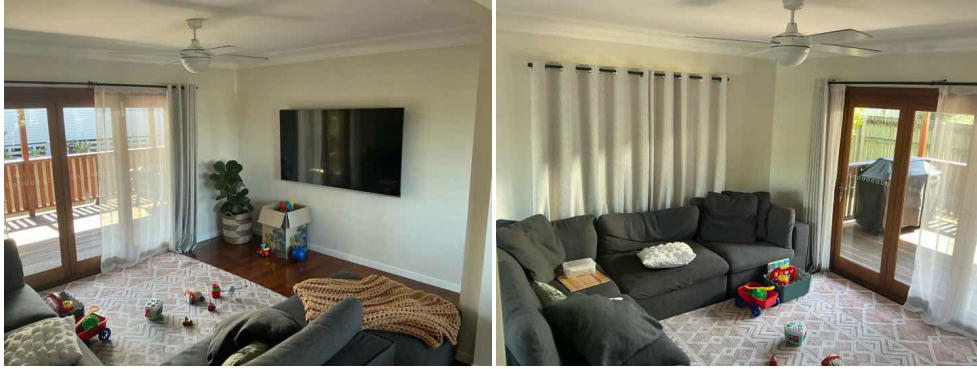
The lounge room is in serviceable condition with no notable structural defects sighted.

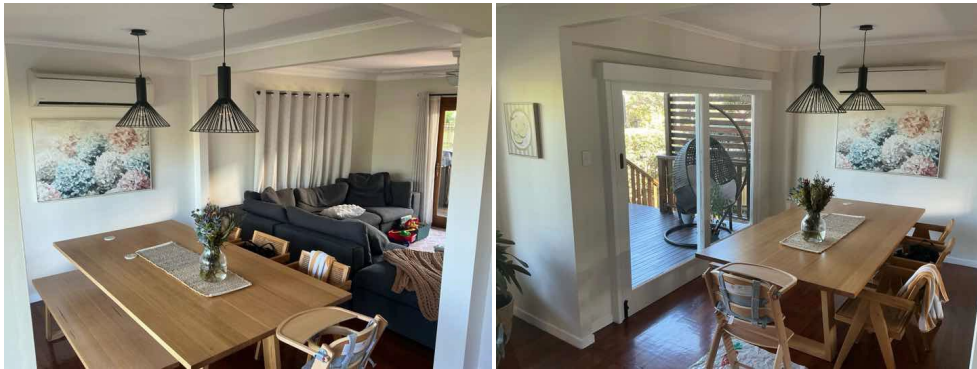
The dining room is in serviceable condition with no notable structural defects sighted.

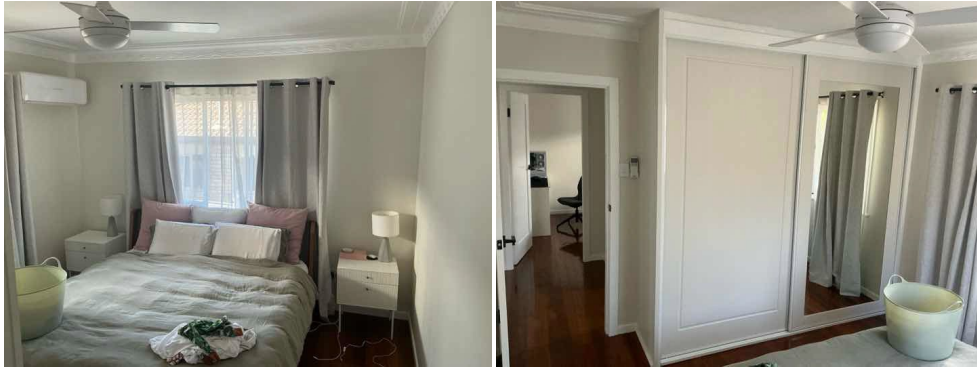
This bedroom is in serviceable condition with no notable structural defects sighted.

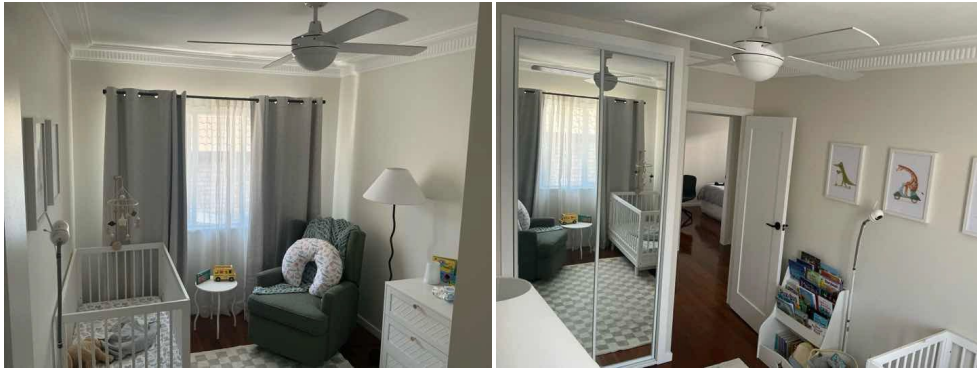
This bedroom is in serviceable condition with no notable structural defects sighted.

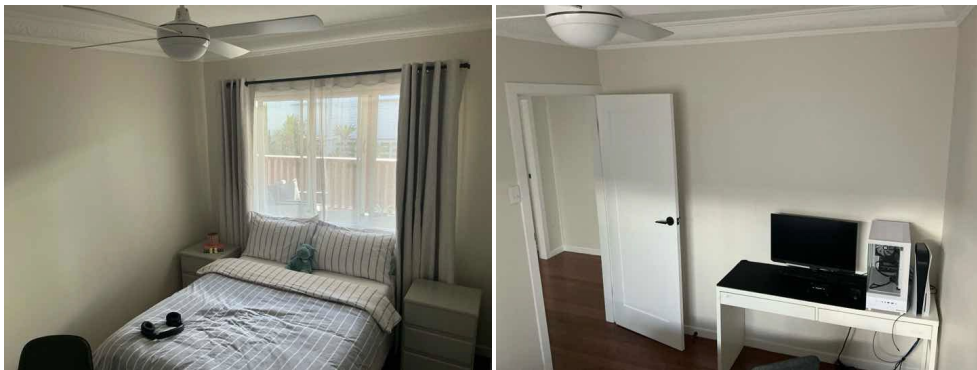
This bedroom is in serviceable condition with no notable structural defects sighted.

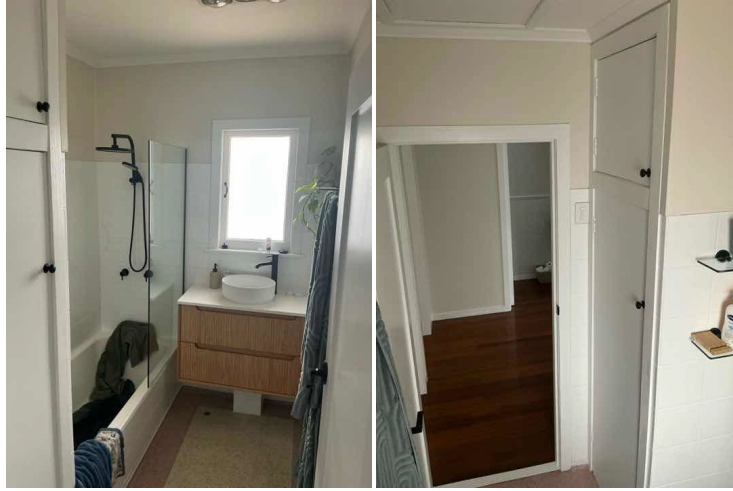
Hall

Of the visible areas, the general condition of this bathroom is serviceable or in reasonable condition for age of dwelling.

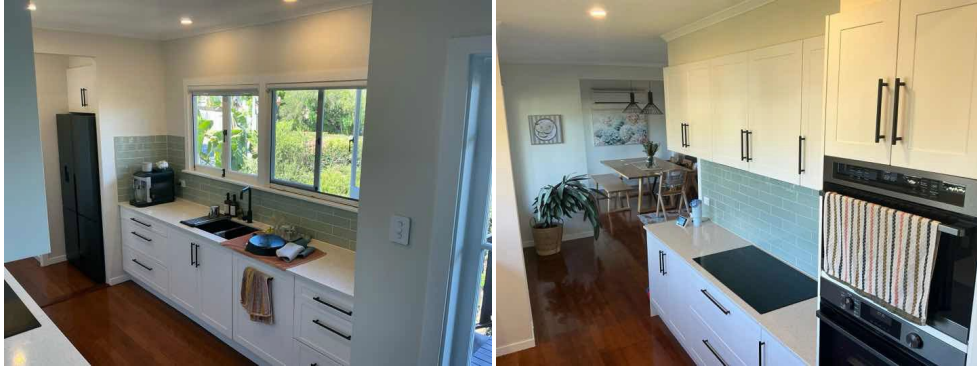
Of the visible areas, the general condition is serviceable or in reasonable condition for age of dwelling.

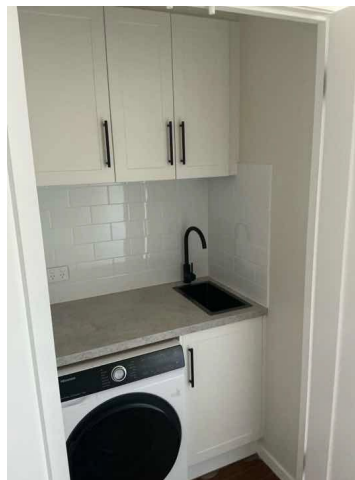
Of the visible areas, the general condition of the laundry is serviceable.

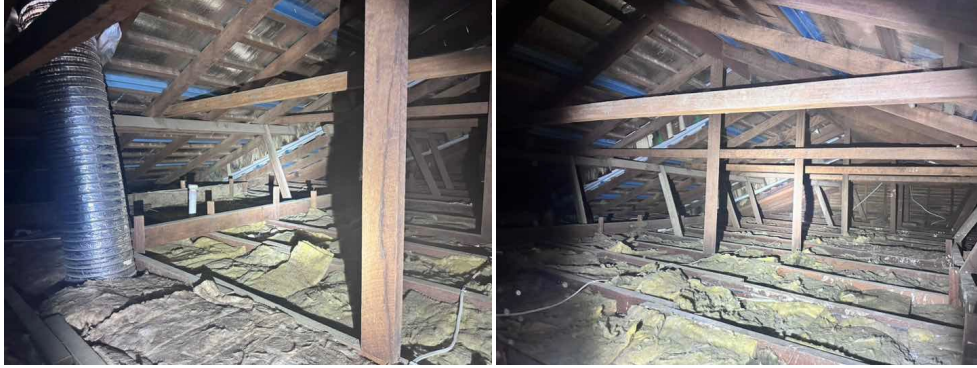
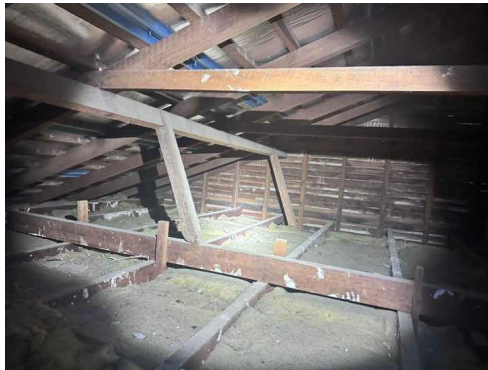
The roof frame is a conventional timber frame.

Visible sections of the roof void is in a serviceable condition for age of this dwelling.

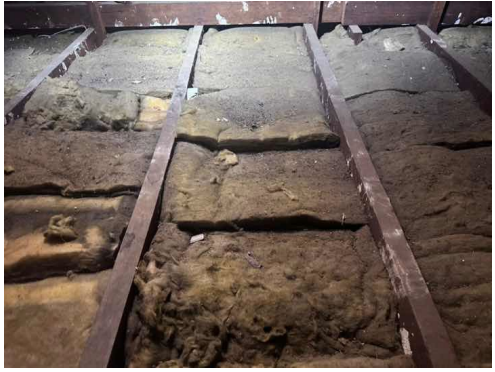
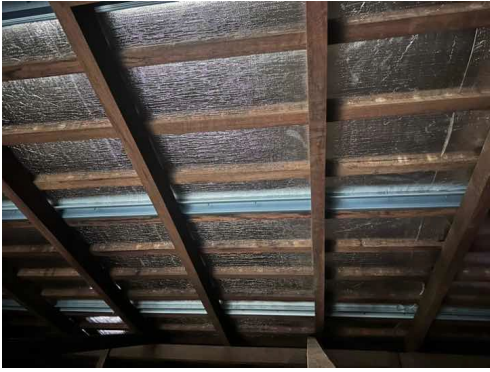
Where visible and accessible, the insulation appears to be in a serviceable condition.

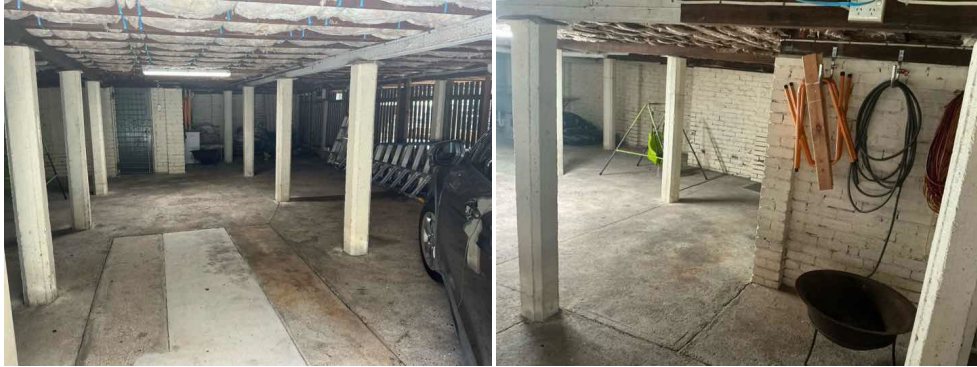
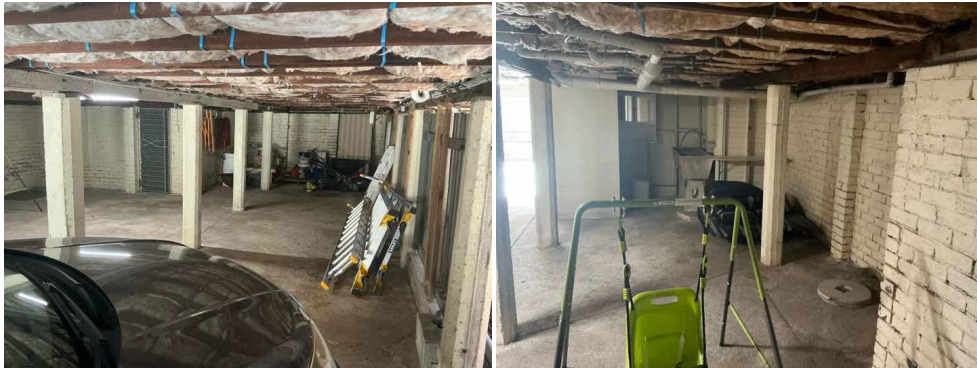
Of areas accessible and visible, the subfloor and components appeared to be in a serviceable condition.
