# Property Inspection Report

58 Northumbria Road,  
Boondall

Date of Inspection: 16/7/2026 | Time: 4:00 PM

- Basic - Structural Condition Report

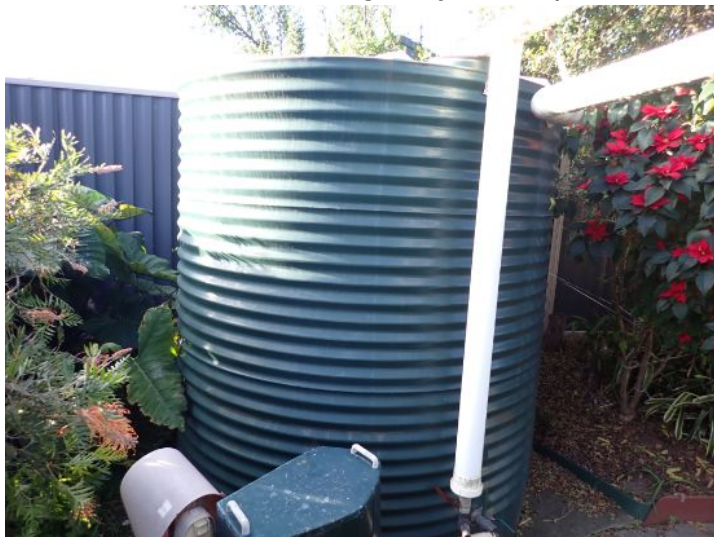
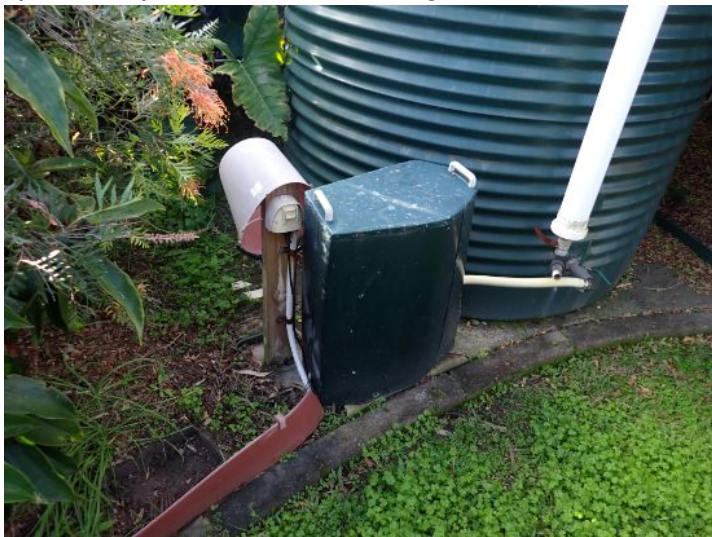
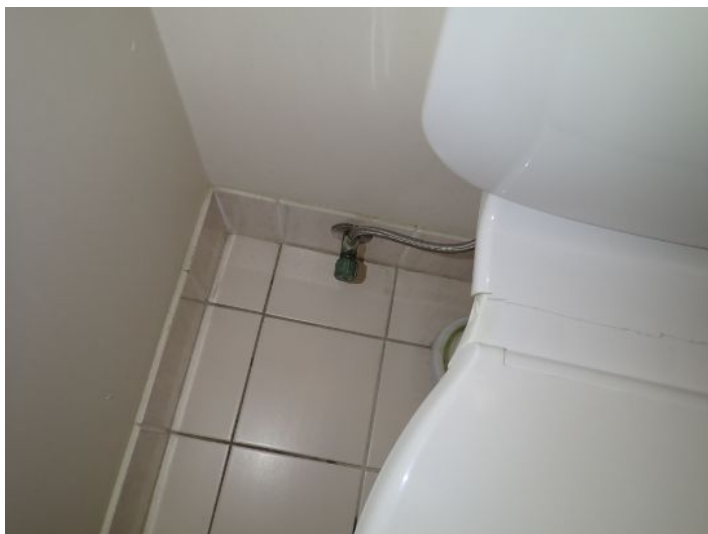
- A water pump and water tank storage were located at the north side of the property. The function of the water pump and associated systems have not been tested as part of the inspection process and should be checked at the final settlement inspection.
- We recommend all braided flexible water hoses in the property be checked regularly and replaced as required to prevent water damage.

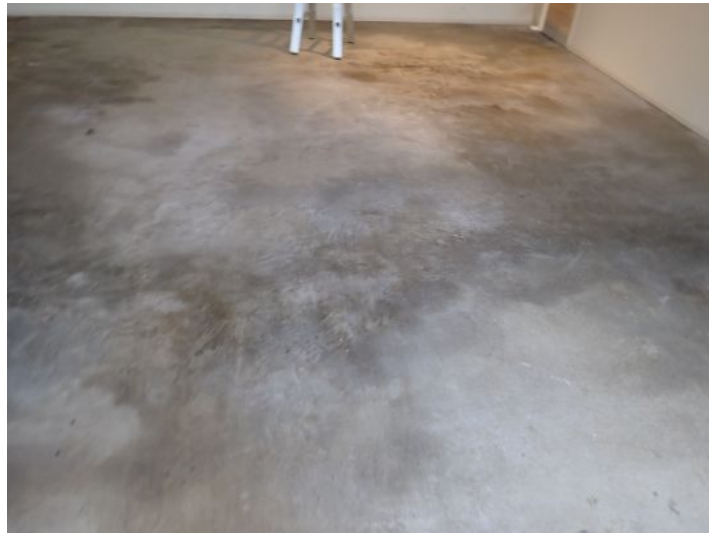
- Visible sections of the concrete slab appeared satisfactory.
- Most areas of the concrete slab not visible due to floor coverings.
- All concrete floor slabs experience some degree of cracking due to shrinkage in the drying process. In most instances floor coverings prevent recognition of cracks or settlement in all but the most severe cases. Where carpeting and other floor coverings are installed, the materials and condition of the flooring underneath cannot be determined.

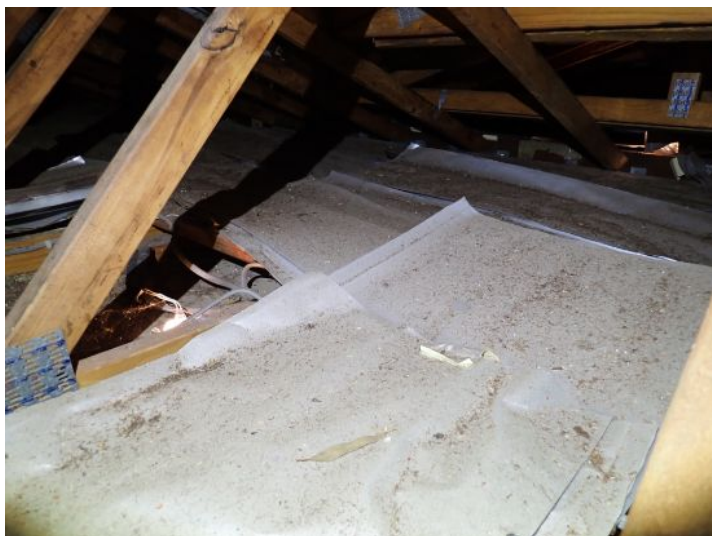
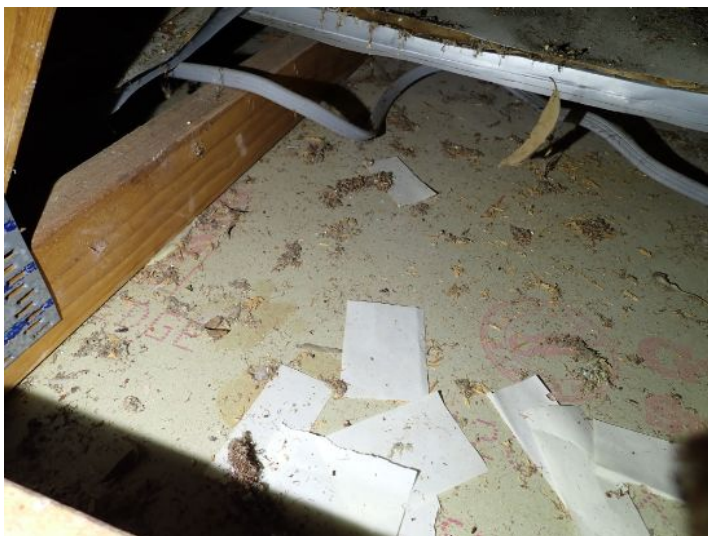
- The ceiling structure appeared functional.
- Due to the placement of insulation on the top of the ceilings it is not possible to fully inspect the condition of the ceiling structure and supports. Inspection was limited and based on what was visually accessible at the time of the inspection.

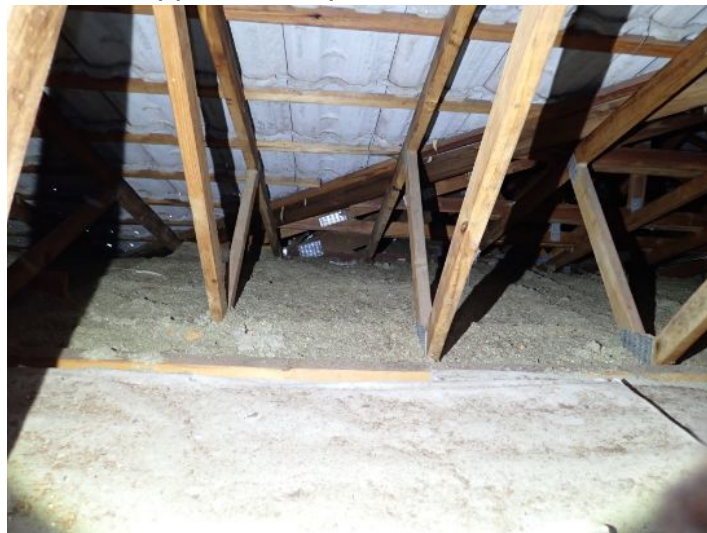
- Insulation averages about 75mm to 100mm in depth.
- Insulation appears adequate.

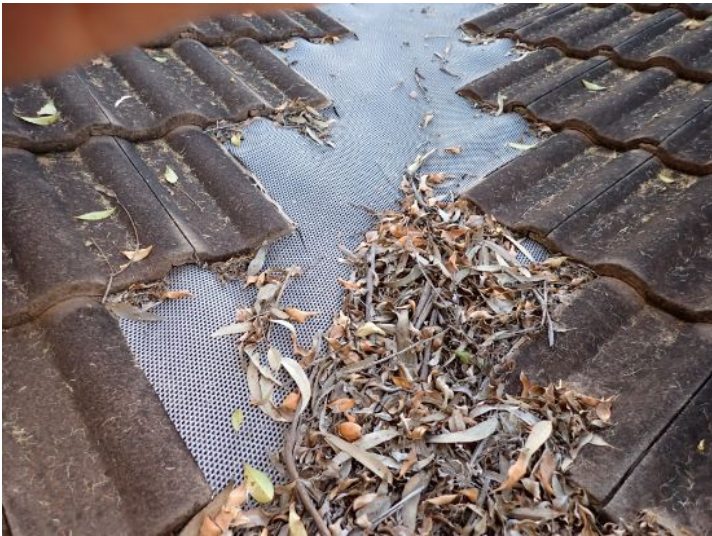
- Clean roof areas: Significant amounts of organic debris evident.

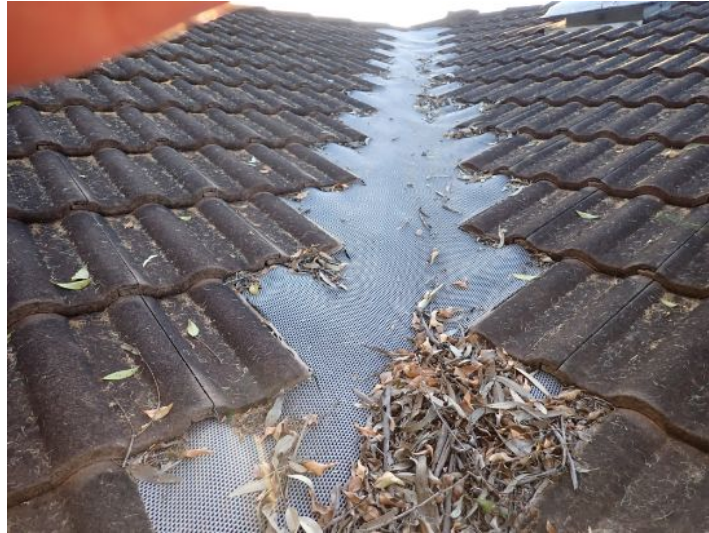
- Flashing is an impervious material (usually galvanized sheet metal) that comes in a variety of shapes and sizes and is used to cover, waterproof, and direct water away from roof penetrations and from valleys and intersections between the roof covering and other materials.
- Some of the valley flashings have some leaf debris which should be cleared out.

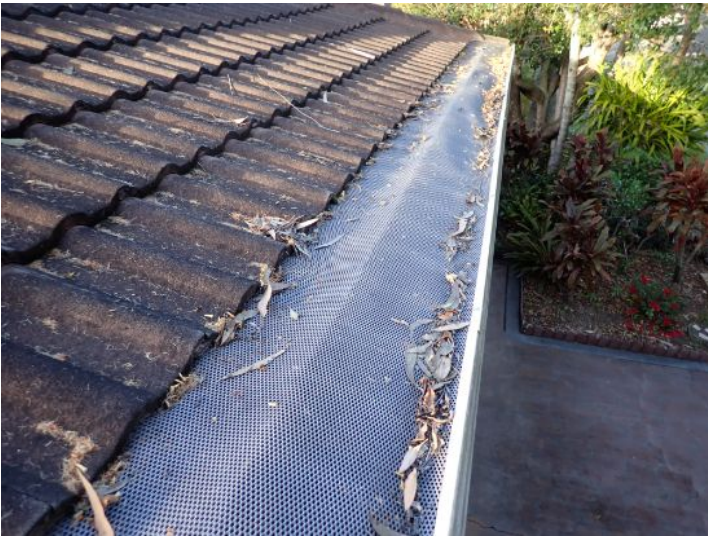
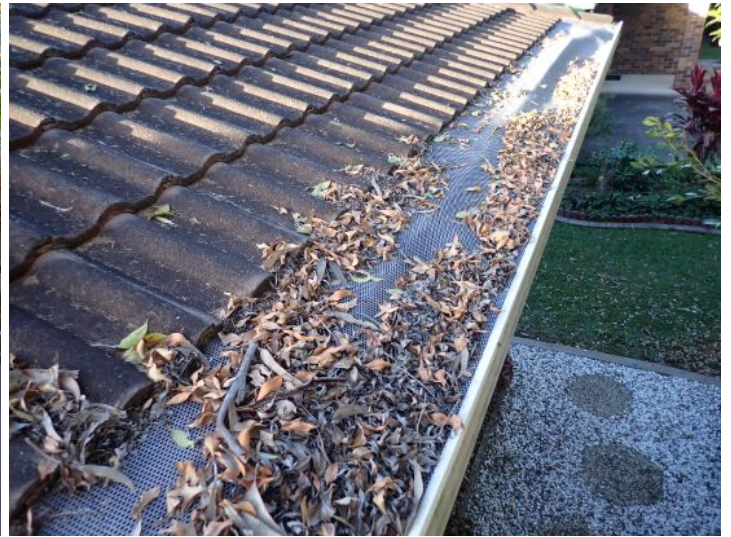
- No major function concerns noted at the time of inspection.
- The gutters should be regularly cleared of debris to ensure the proper flow of water from the roof.

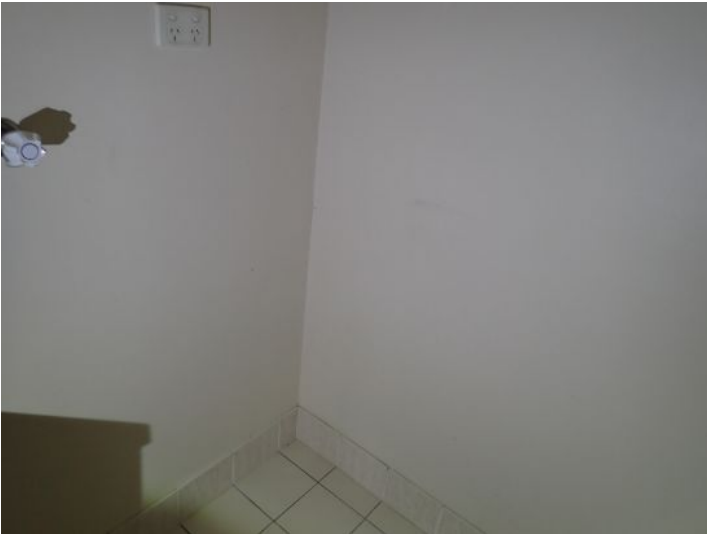
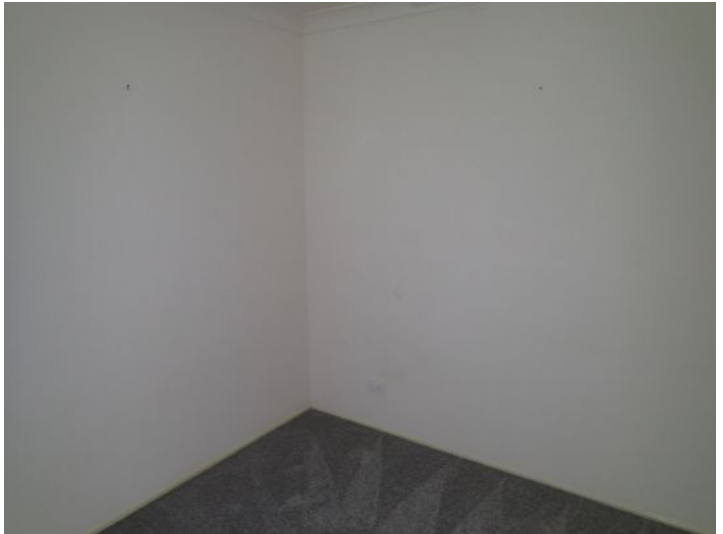
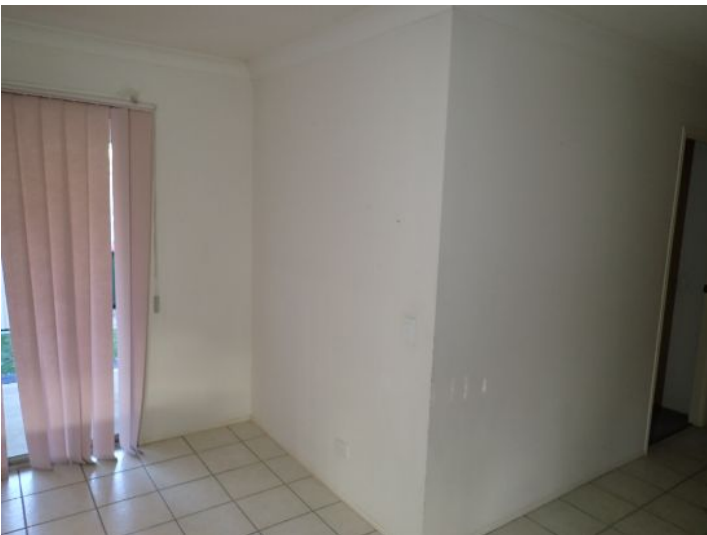
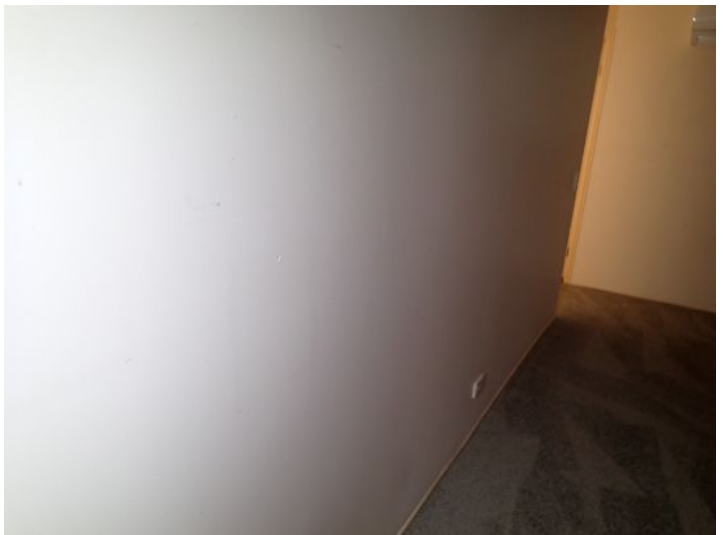
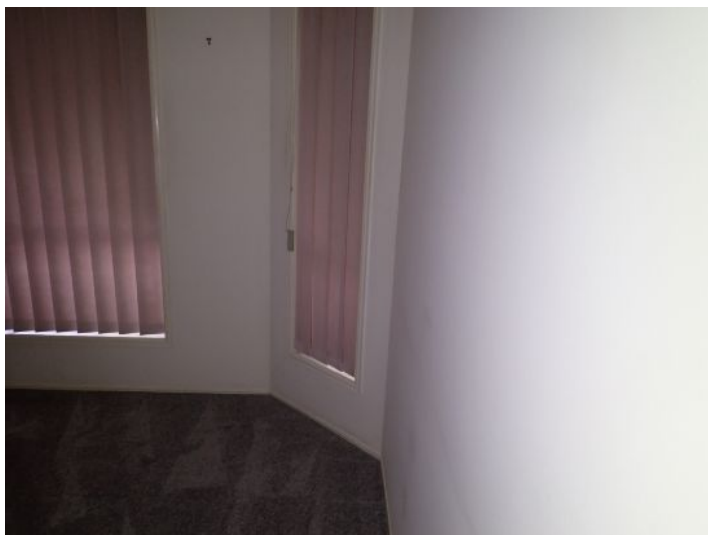
- There are marks and imperfections to the interior walls at various locations. These can be repaired normally.

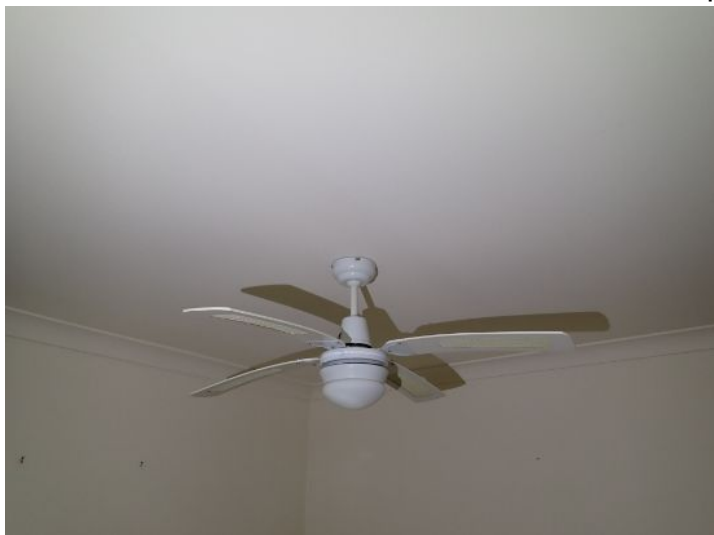
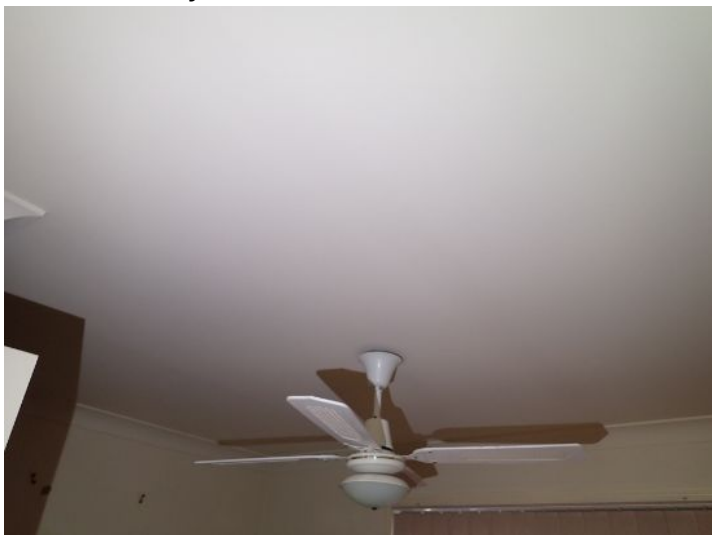
- There are marks and imperfections to the interior ceilings at various locations. These can be repaired normally.

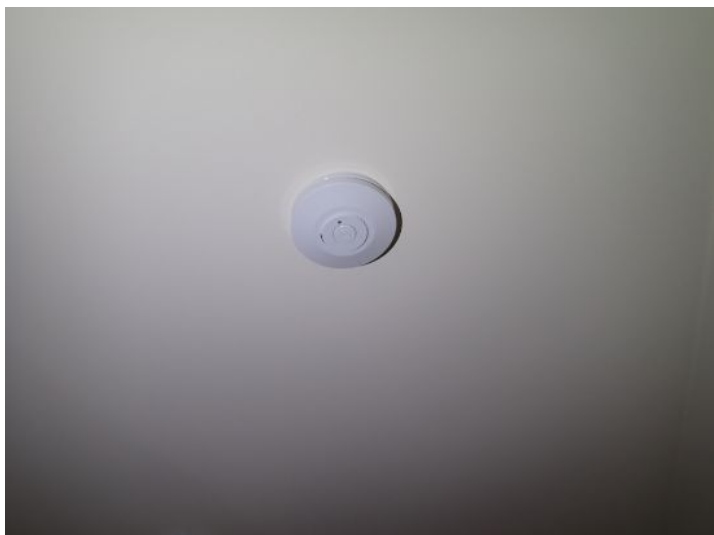
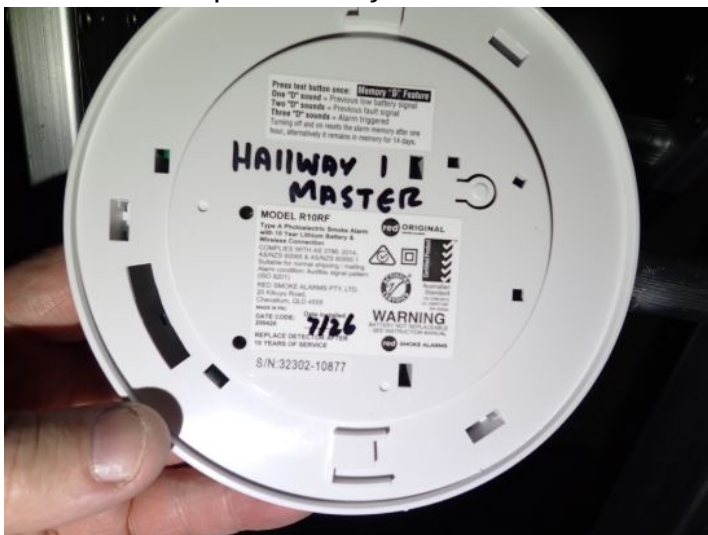
- Testing of smoke alarms is not included in this inspection. Pushing the "Test" button only verifies that there is power at the alarm--either a battery or hardwired to the house power--and not the operational workings of the alarm. The operational check is done by filling the sensor with smoke and is beyond the scope of this inspection. Battery operated smoke alarms should be checked routinely and the batteries changed frequently.
- From 1 January 2022, all dwellings being sold in Queensland require hardwired and or non-removable 10-year battery interconnected, photoelectric, smoke alarms installed in every bedroom, in hallways which connect bedrooms and the rest of the dwelling, and on each storey.
- There appears to be interconnected smoke alarms installed in the hallways and bedrooms of the home. The service replacement year is noted as 2036

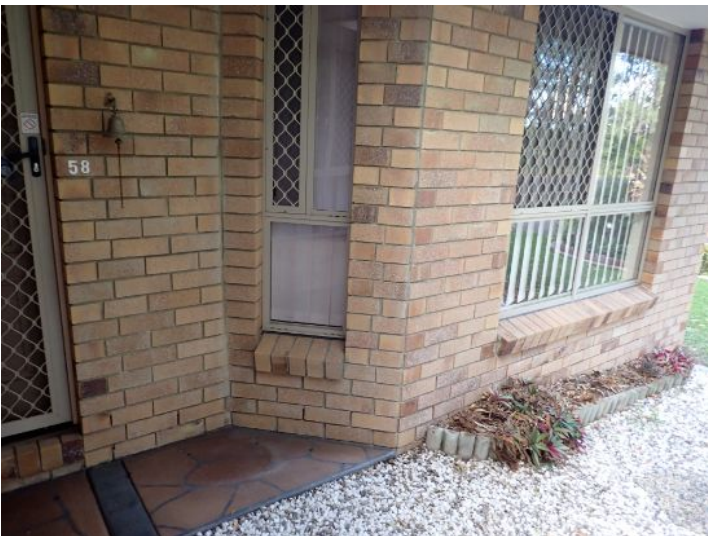
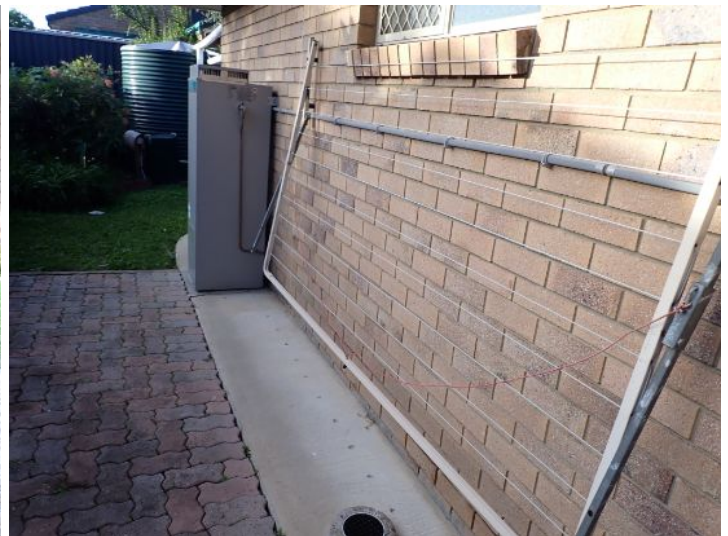
- There are a number of garden beds which are adjacent to the external walls. This can result in water moisture affecting the structure over time. It is recommended that either the beds be removed or a water barrier be placed between the garden bed and the external walls. If these beds are retained it is important that any watering is directed away from the building and kept to an absolute minimum and is controlled.

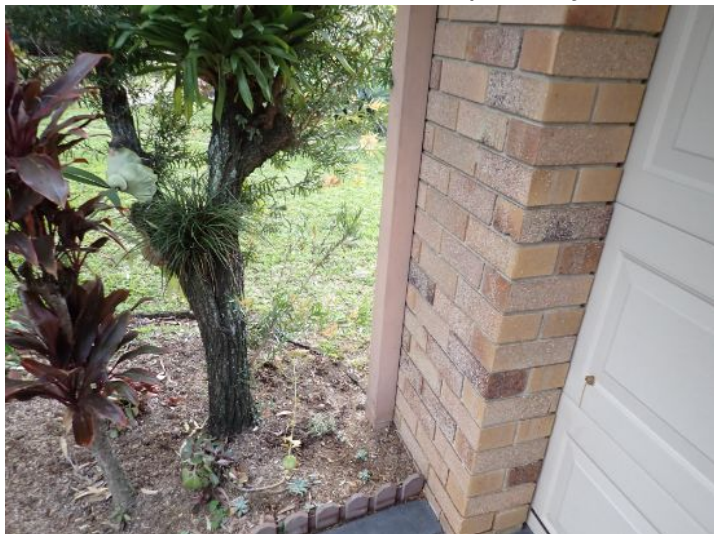
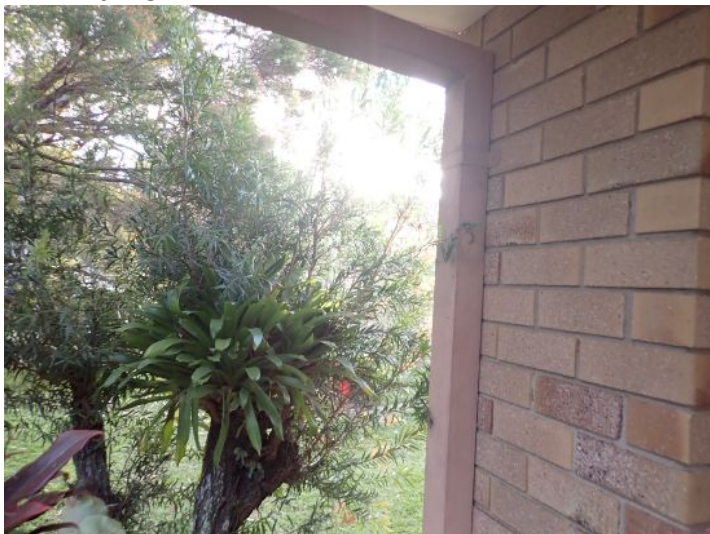
- Trees that begin to grow too close to or overhang property should be trimmed back; this will help reduce the frequency of having to clean out the gutters which should be done on a regular basis.
- Prune or remove any plants that are in contact or proximity to home to eliminate pathways of wood destroying insects.

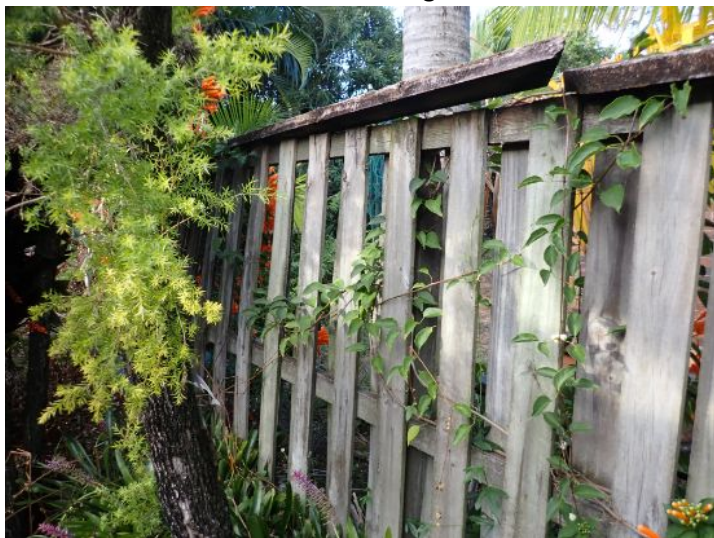
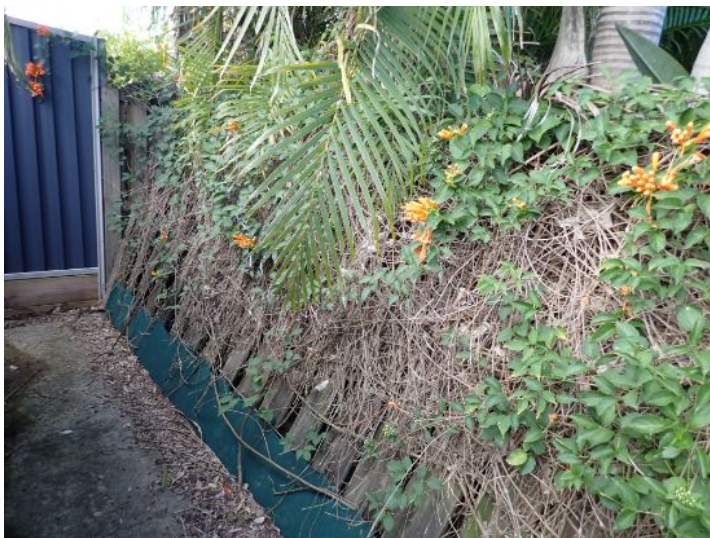
- The boundary fence is leaning in areas. Some maintenance will be required to bring the fence back to the vertical.
