# Timber Pest Inspection Report

**58 Northumbria Road,  
boondall**

**Date of Inspection: 16/7/2026 | Time: 4:00 PM**

- Timber Pest Inspection in accordance with AS4349.3-2010

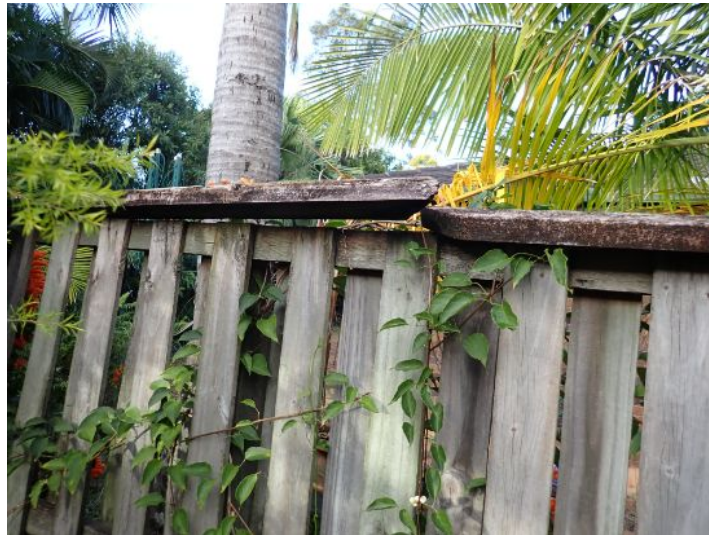
- Wood decay/fungus was detected in the fence
- Timber condition is decaying.

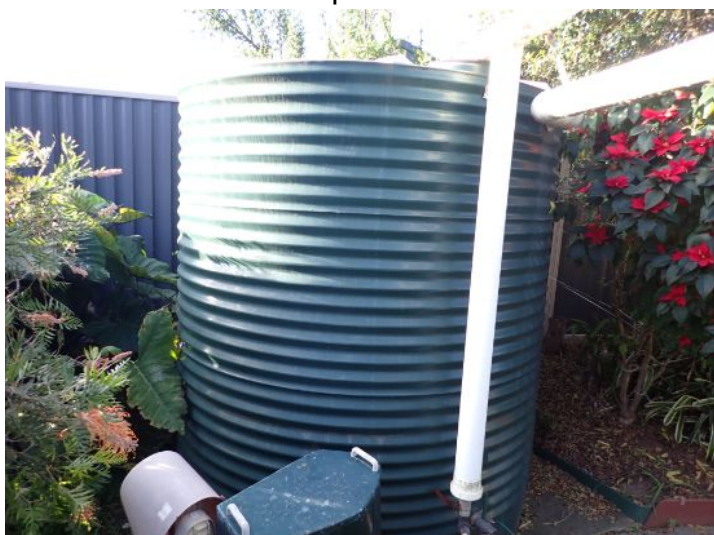
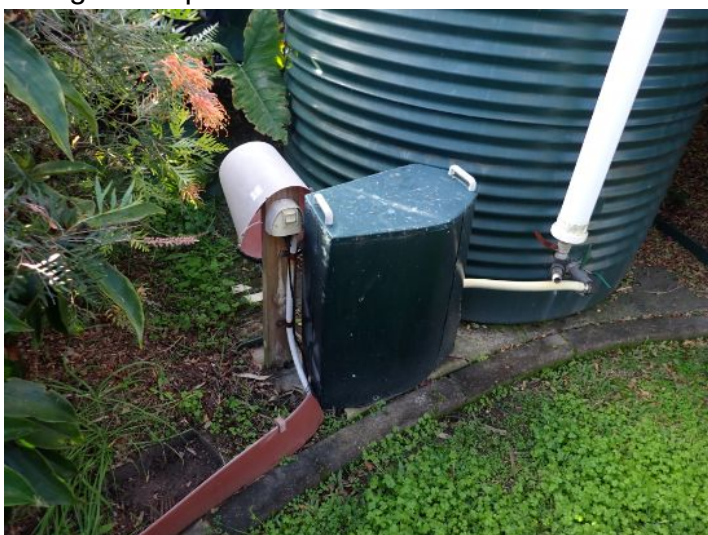
Observations: There did not appear to be any evidence of excessive moisture.

Condensation and dampness beneath poly water tanks is common. This condition causes excessive moisture conditions and should be monitored as part of an effective termite management plan.

Ensure water tanks and pumps are free of leaks as this condition will create excessive moisture.

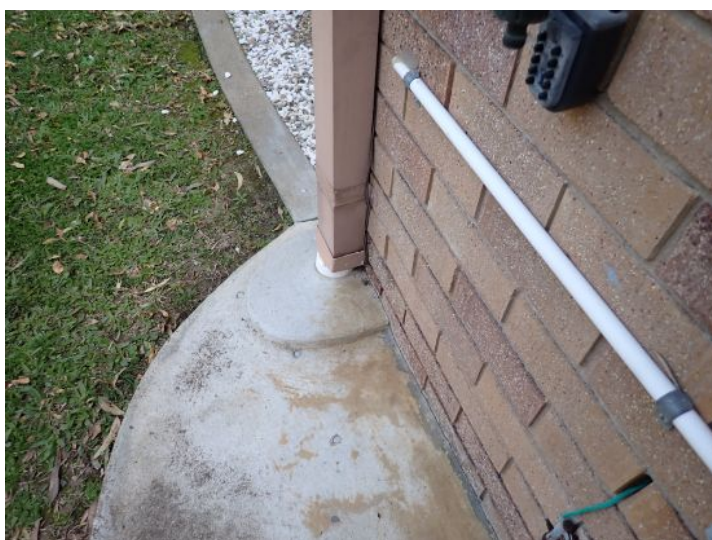
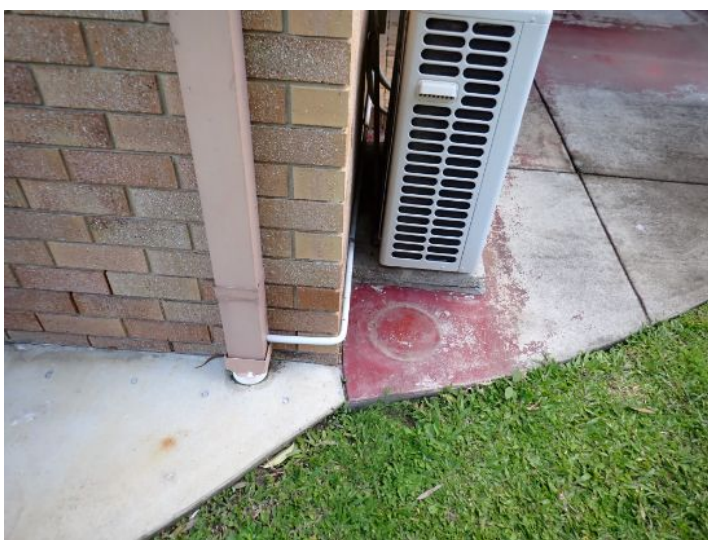
- Slab edges are clear and in good condition, unless noted.
- Slab edges are covered by soil and concrete. This may allow concealed termite entry into the wall frame. Slab edges should be cleared of soil and concrete.

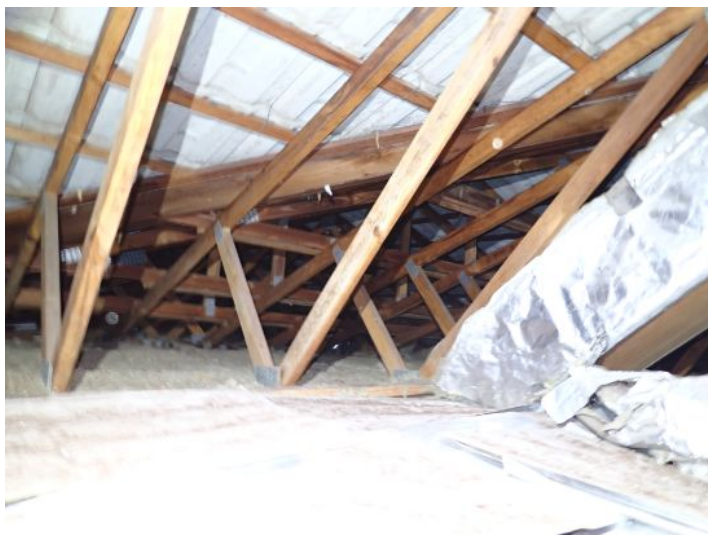
- Access was available through a manhole in the garage.
- Limited visibility and access due to insulation and pitch.

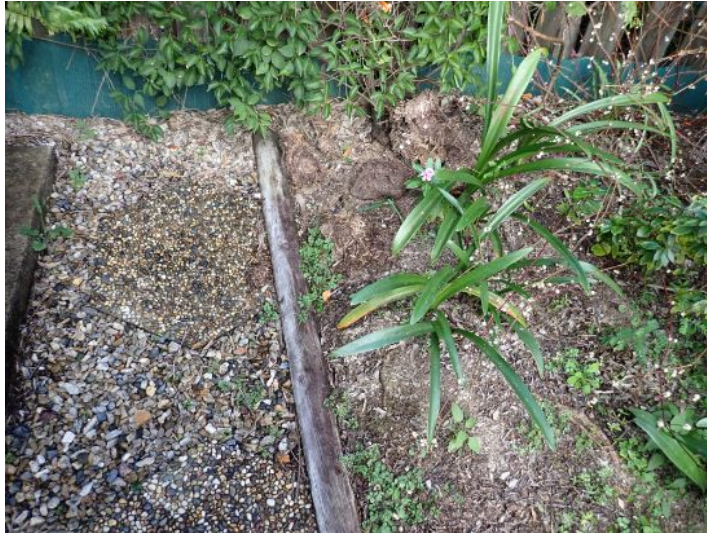
- There is timber landscaping materials used on the property or against the edge of the home, which could attract termites or provide possible entry points for termites into the home. These should be removed or replaced with a material less susceptible to termite attack.

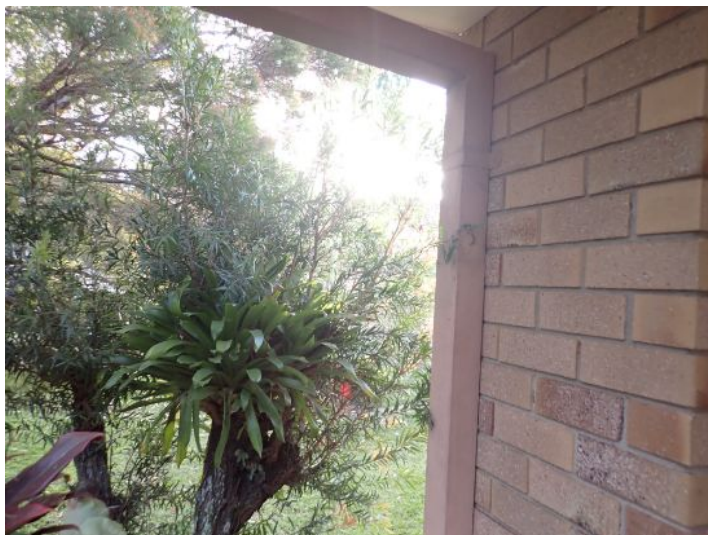
- There are tree branches touching the house structure, which can provide possible entry points/bridging for termites into the home. These should be pruned or removed.
- Prune or remove any plants that are in contact or proximity to home to eliminate pathways of wood destroying insects.
- Remove any garden beds abutting the home to eliminate excessive moisture.

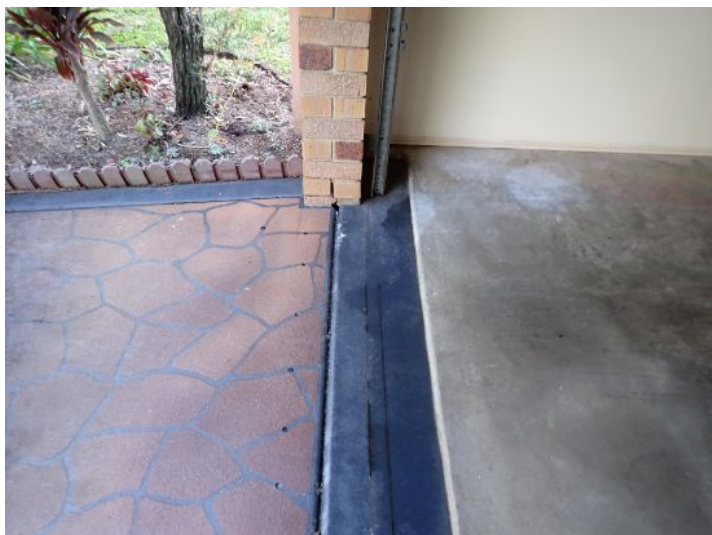
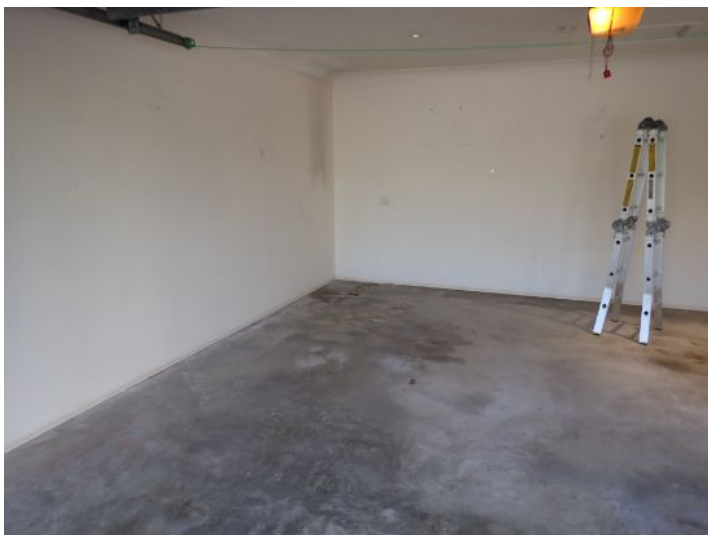
- Often the gap between the slab in the garage and the slab for the home can be a susceptible area for attack. Monitor this area for termite activity in the future.

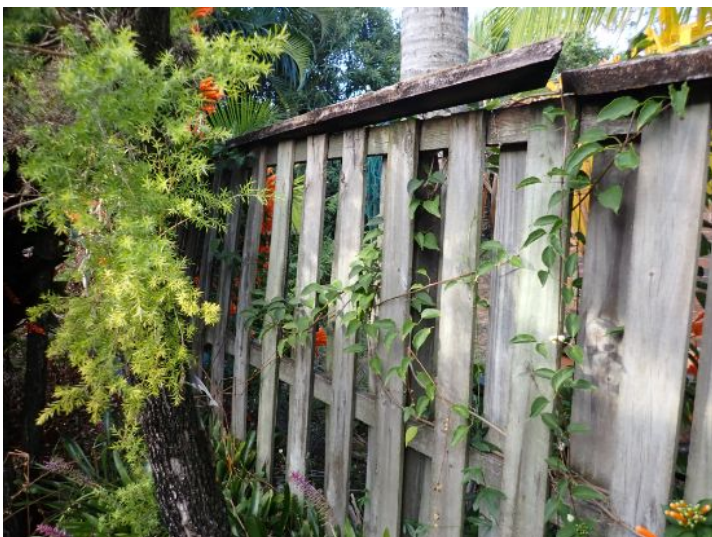
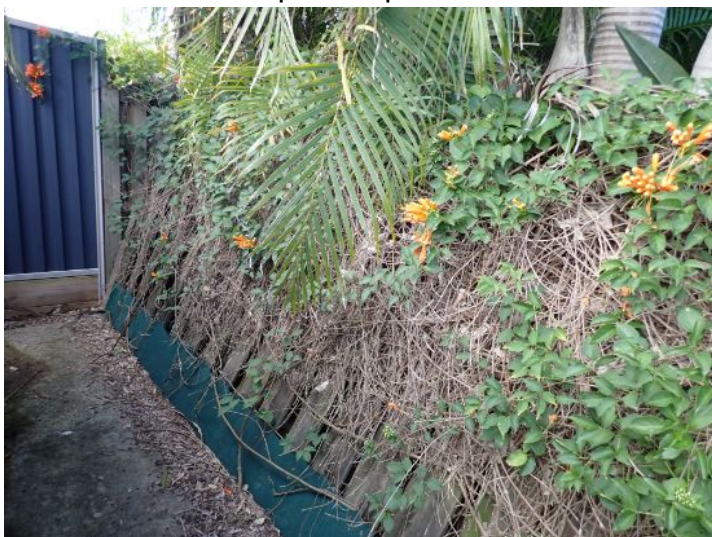
- Timber fences are in good condition unless noted
- Wood Decay damage noted in the fence.
- Wood deterioration observed. Recommend repairs/replacement as needed.

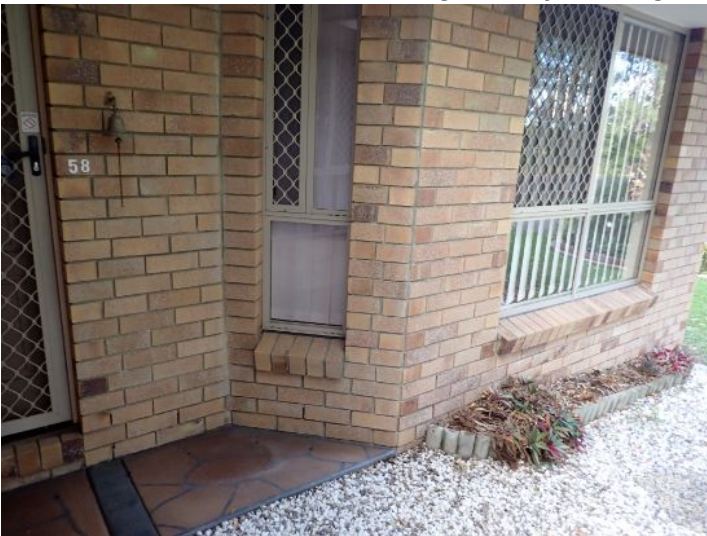
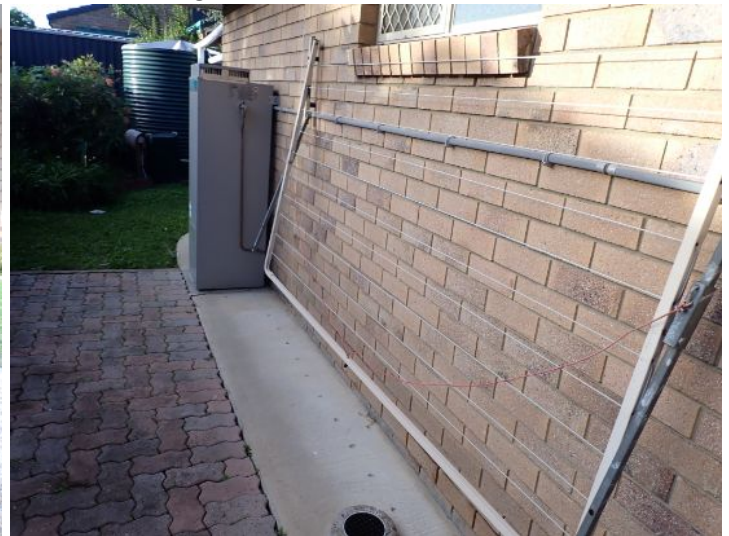
- There are garden beds which are abutting external walls. This can result in water moisture affecting the structure over time. It is recommended that either the beds be removed or a water barrier be place between the garden bed and the external walls. If these beds are retained it is important that any watering is directed away from the building and kept to an absolute minimum and is controlled. These are a risk area for termite activity.
- Cladding-Soil contact or proximity. This may provide entrance of moisture or insects to siding. Recommend grading soil so there is at least 150mm of space (where practical) between the cladding and the soil below and checking for any damaged trim and siding materials.
