Inspection Report

BPP Inspections

10 Furley St, Aspley, QLD

Pest And Building Inspection

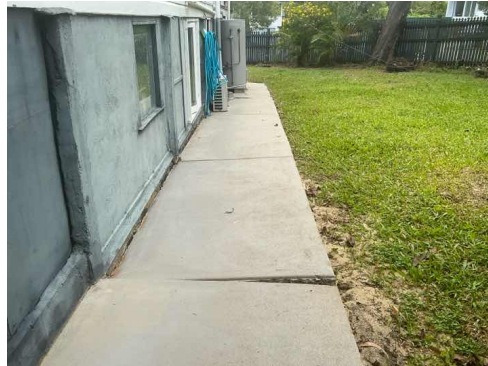
Pathways Condition

#1. There is visible subsidence in the footpath. Further assessment required and rectification may be necessary. Contact a lic Builder or Concretor.

This footpath subsidence allows water to drain towards the building and into the foundation.

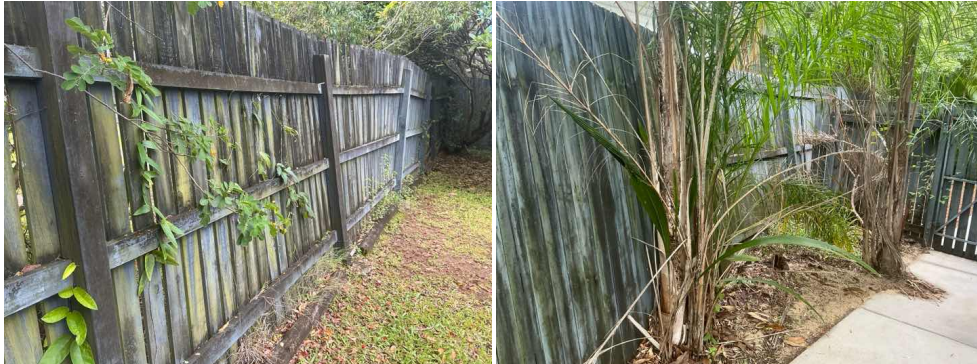
Overall Condition

#2. General age to fence components - Recommendations: General upkeep and maintenance. A qualified fencing contractor should be engaged for repairs

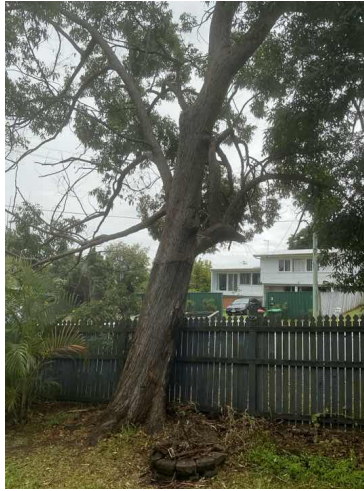
Tree Findings

#3. Large native tree with visible termite damage. Contact a lic arborist to assess tree and trim or remove as required.

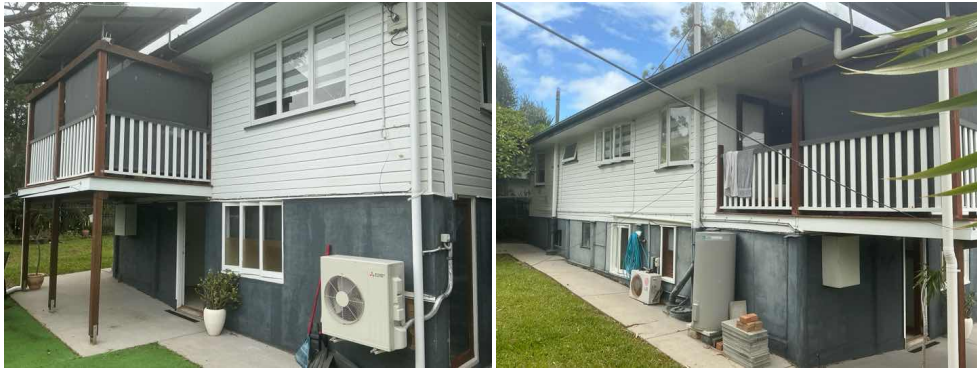
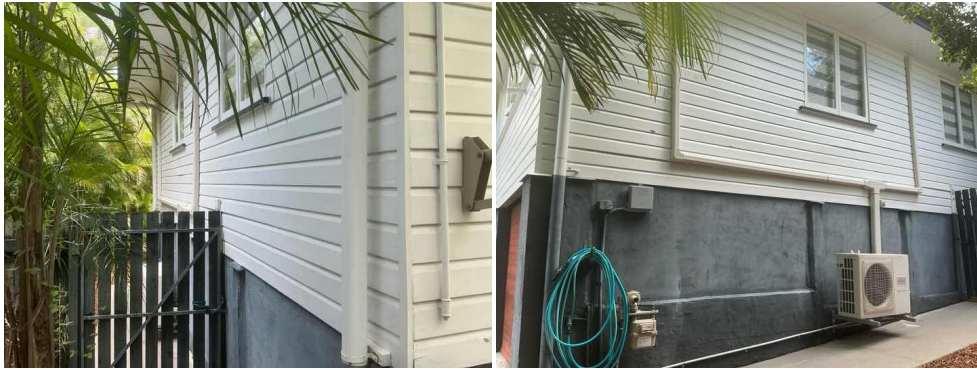
On visual inspection, the general condition of the exterior walls is serviceable for the age.

#4. General age visible to the exterior paint surfaces. Cleaning of exterior required to assess paint condition. Mouldy areas to be treated accordingly. Sealants and fillers showing signs weather exposure.

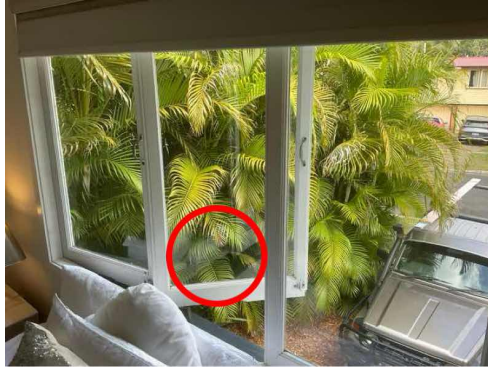
Overall Condition

#5. Selected upstairs windows are able to be fully opened. This was compliant at the time of construction and technically no requirement to rectify. Current building code has identified a fall risk and requires a limited opening of 125 mm or secure screening to be in place.

Contact a lic Builder, Glazier to assess and rectify.

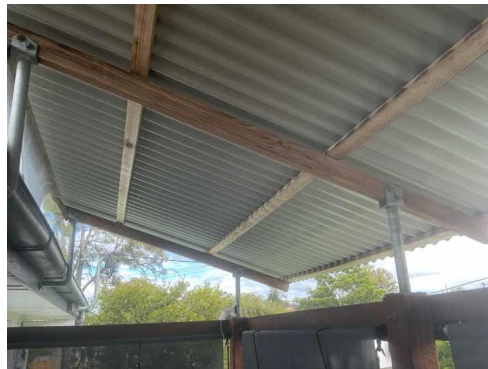
Deck Framework

#6. Lightweight roof frame, no council approvals would be in place for this roof structure.

Appears in sound condition, but storm suitability not assessed.

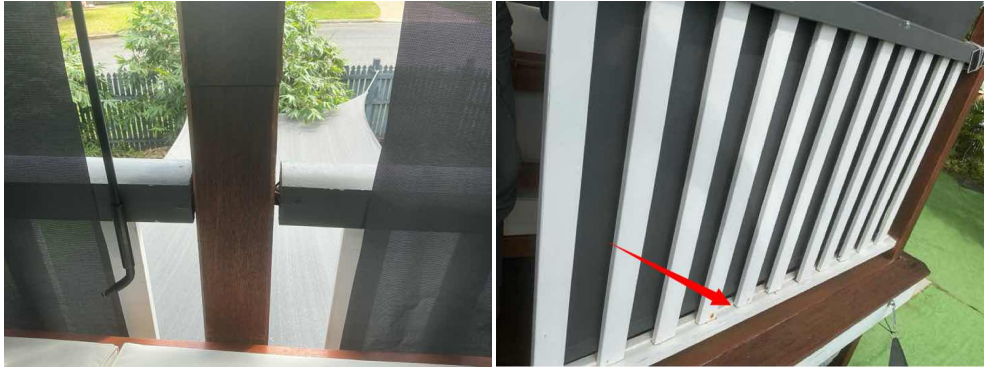
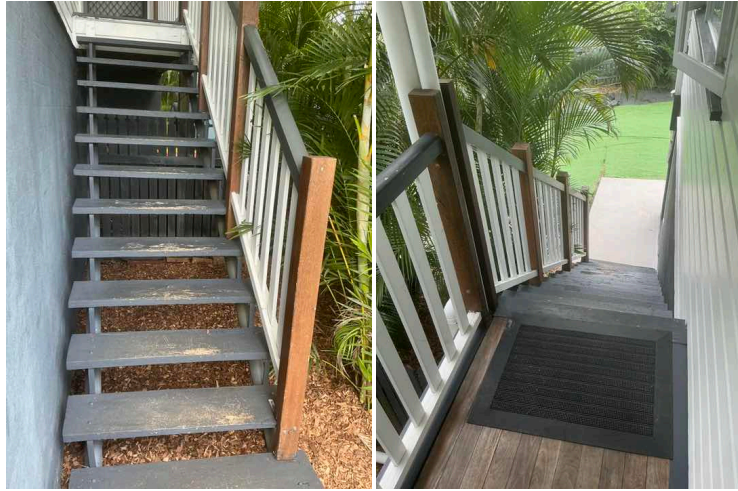
Section	Location	Name	Comment
STAIRS- PERGOLA- BALCONIES- DECKS	Decking Findings	Balustrade and Rails	#7. Timber fungal decay in areas of balustrade and/or rails. Recommendations: A qualified carpenter should be engaged for advice and recommendations. This is a safety issue and requires immediate assessment.
CONCLUSION	Condition Of Inspected Structure	The incidence of Major Defects	#14. The incidence of major defects in this residential building as compared with similar buildings is considered TYPICAL

#7. Timber fungal decay in areas of balustrade and/or rails. Recommendations: A qualified carpenter should be engaged for advice and recommendations. This is a safety issue and requires immediate assessment.

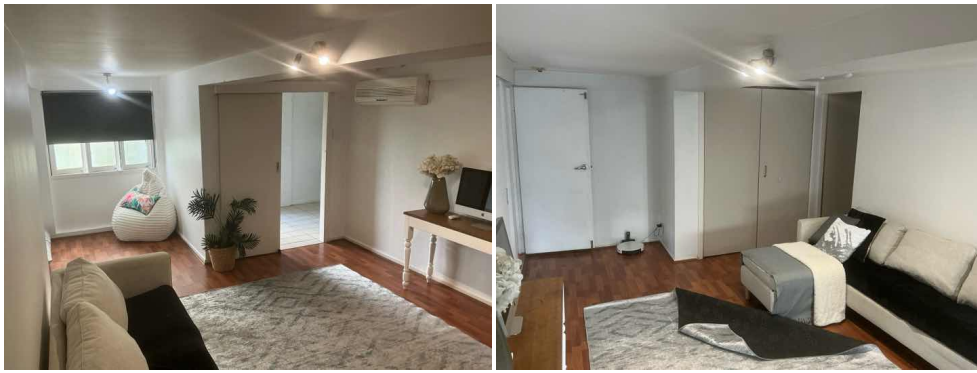
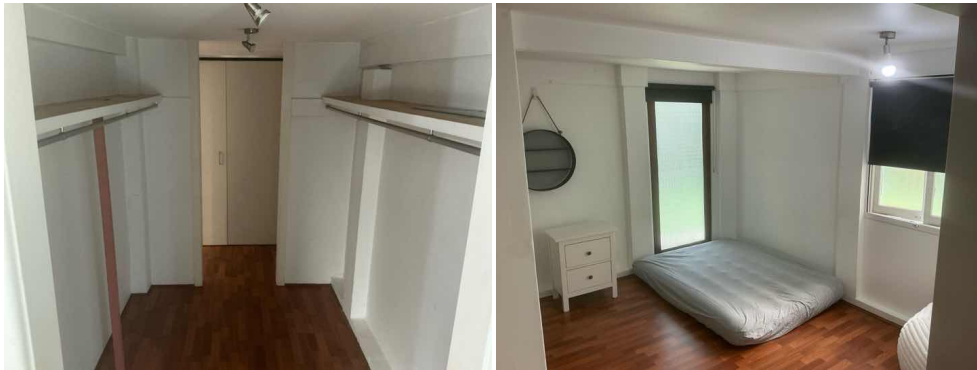
Rumpus Room

The rumpus room is in serviceable condition with no notable structural defects sighted.

#8. The cupboard doors require adjustment to operate correctly. contact a lic carpenter.

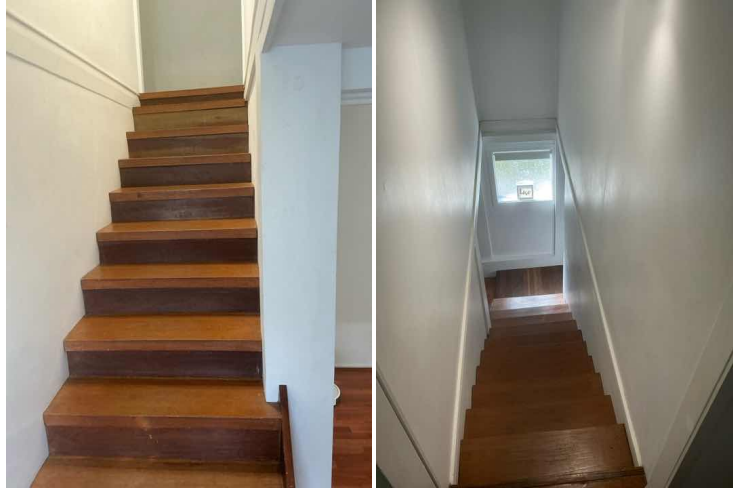
Internal Stair Case

#9. There is no appropriate handrail present on the staircase. A handrail is required where the overall height of the staircase is greater than 1 m. This should be rectified as it is a safety concern.

The top step is shorter in height than the main staircase. This offers a trip hazard. This requires assess and repair as required.

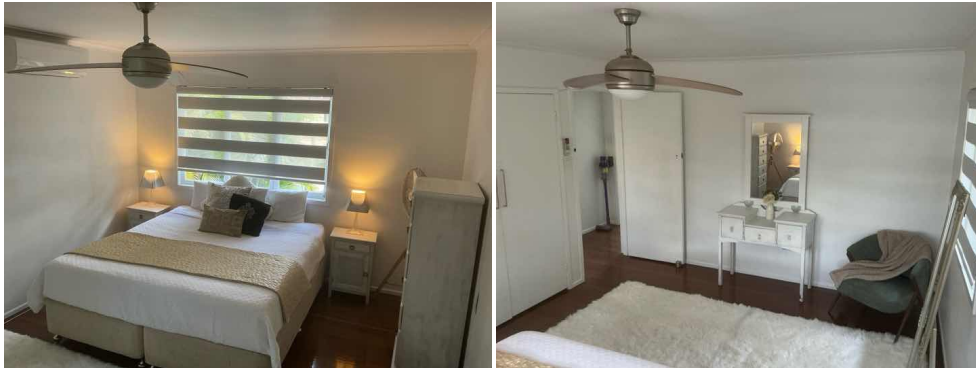
Bedroom 1

This bedroom is in serviceable condition with no notable structural defects sighted.

#10. Bedroom door not latching when closed. Minor adjustments required. Contact a lic carpenter.

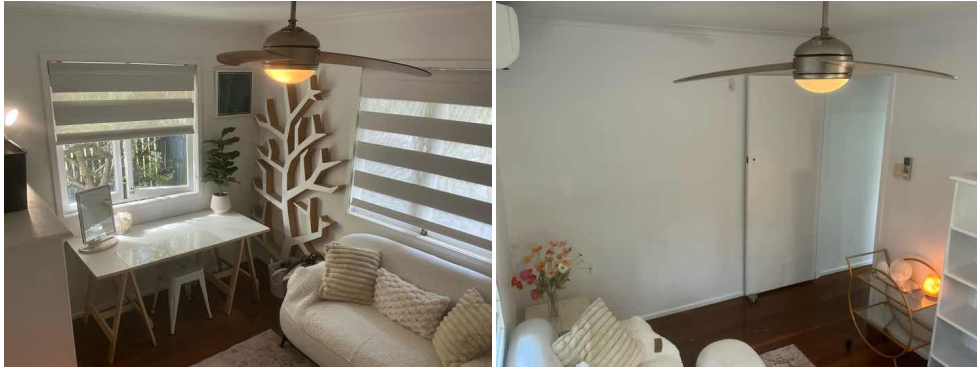
Bedroom 2

This bedroom is in serviceable condition with no notable structural defects sighted.

#11. Bedroom door not latching when closed. Minor adjustments required. Contact a lic carpenter.

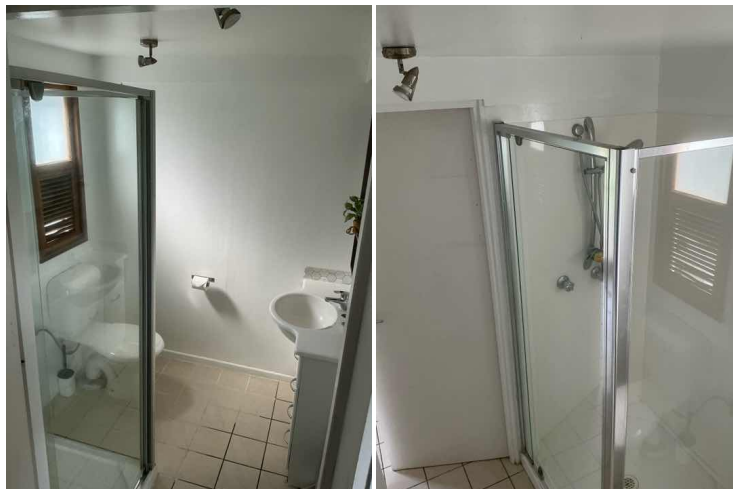
Downstairs

This bathroom indicates that no council records are in place. A check with local council records should be made.

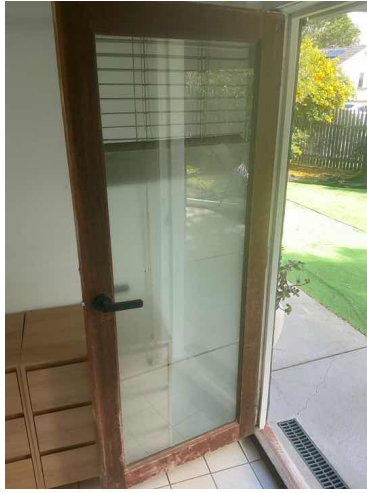
Door

#13. The laundry door is aged and weathered. Assess and repair/ replace as required.

Contact a lic carpenter.

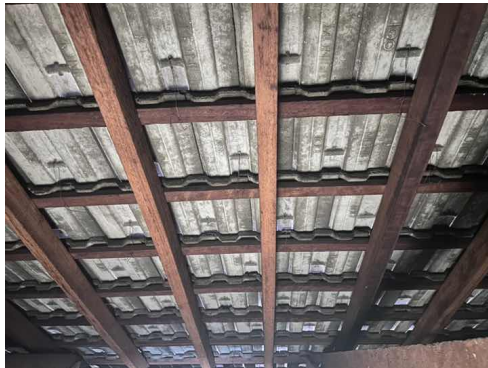
There is no sarking installed. Sarking is the layer of reflective film material installed during construction underneath the roofing material. It provides a moisture barrier and minimal insulation. The installation of sarking is not a building requirement.

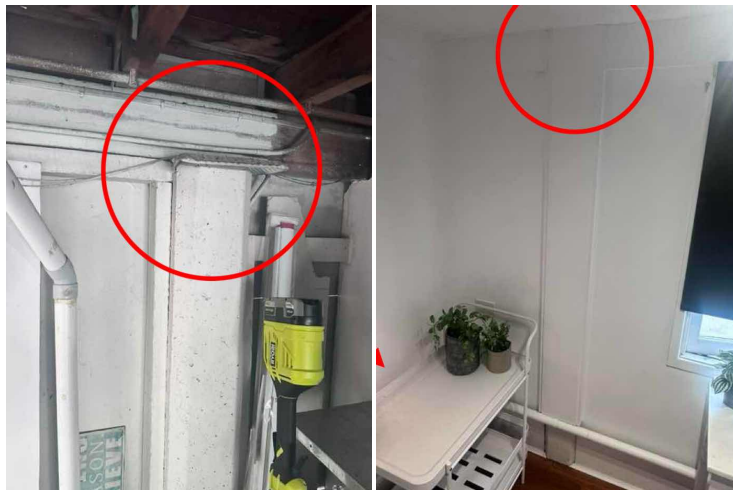
The Termite Shields Appear To Be

Areas where the ant capping is breached by covering and enclosing. This provides a concealed entry point for termites in an area that is unable to be visually inspected. Activity or damage may exist in concealed areas such as the enclosed stumps downstairs inside. Photo to example concealed vs exposed stump and cap.
