Inspection Report

10 Furley St, Aspley, QLD

Pest And Building InsP-ection

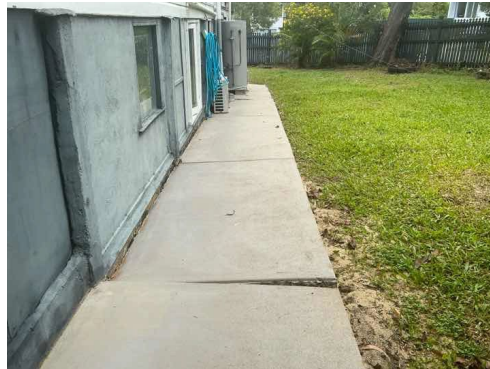
Pathways Condition

#1. There is visible subsidence in the footpath. Further assessment required and rectification may be necessary. Contact a lic Builder or Concretor.

This footpath subsidence allows water to drain towards the building and into the foundation.

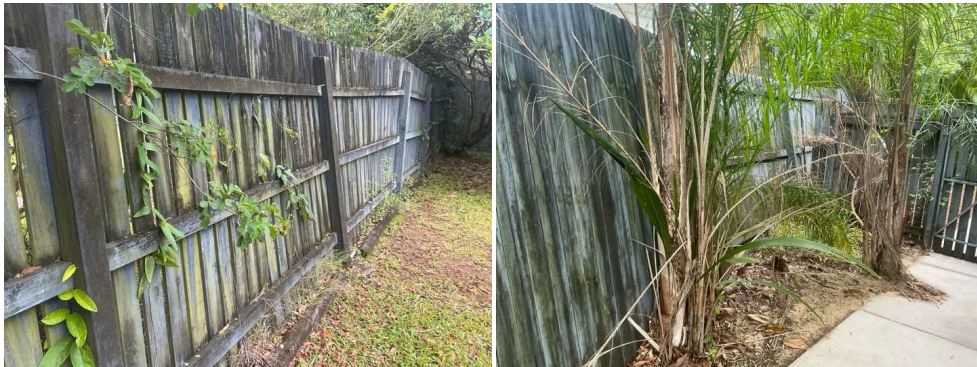
Fences & Gates

#2. General age to fence components - Recommendations: General upkeep and maintenance. A qualified fencing contractor should be engaged for repairs

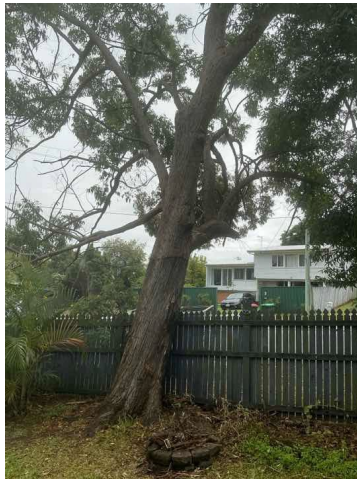
Trees

#3. Large native tree with visible termite damage. Contact a lic arborist to assess tree and trim or remove as required.

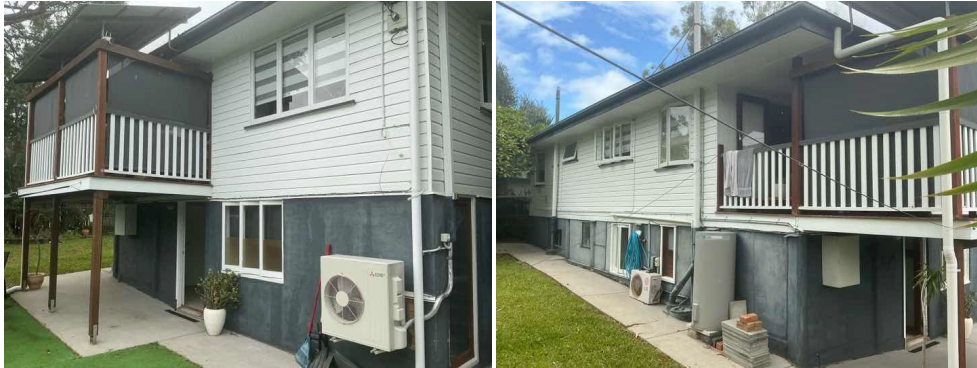
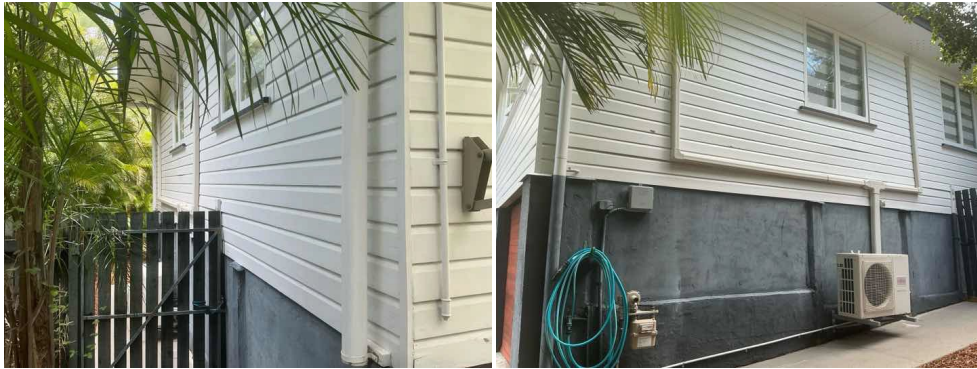
On visual inspection, the general condition of the exterior walls is serviceable for the age.

#4. General age visible to the exterior paint surfaces. Cleaning of exterior required to assess paint condition. Mouldy areas to be treated accordingly. Sealants and fillers showing signs weather exposure.

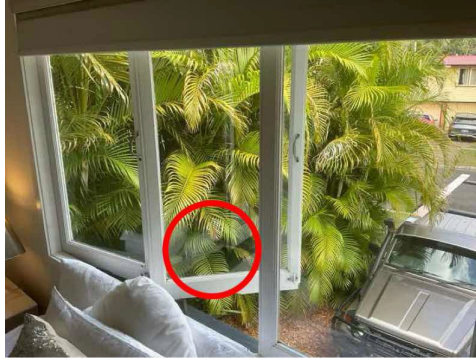
#5. Selected upstairs windows are able to be fully opened. This was compliant at the time of construction and technically no requirement to rectify. Current building code has identified a fall risk and requires a limited opening of 125 mm or secure screening to be in place.

Contact a lic Builder, Glazier to assess and rectify.

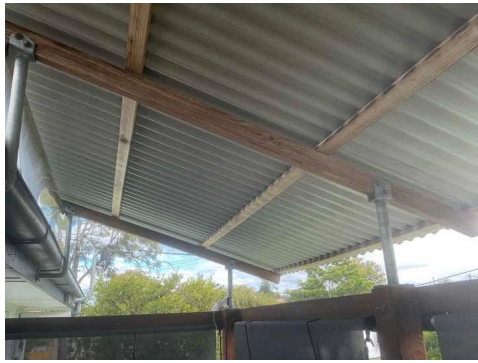
Deck Framework

#6. Lightweight roof frame, certain timber sizes are smaller than required and specified on the plan.

Appears in sound condition, but storm suitability not assessed.

The roof structure cannot be walked on.

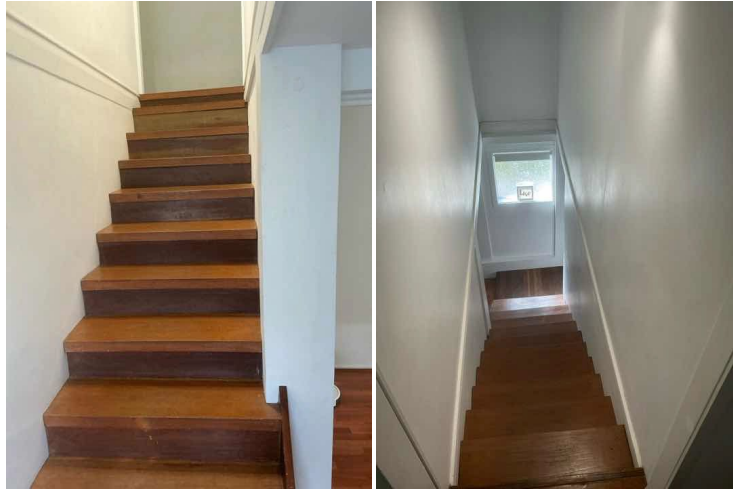
Internal Stair Case

#7. There is no appropriate handrail present on the staircase. A handrail is required where the overall height of the staircase is greater than 1 m. This should be rectified as it is a safety concern.

The top step is shorter in height than the main staircase. This offers a trip hazard. This requires assess and repair as required.

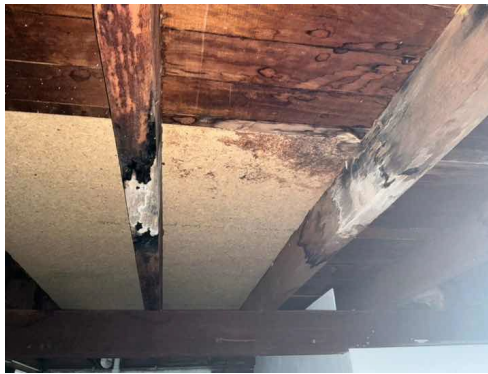
Minor decay and aged water staining below bathroom. No high moisture readings were measured.

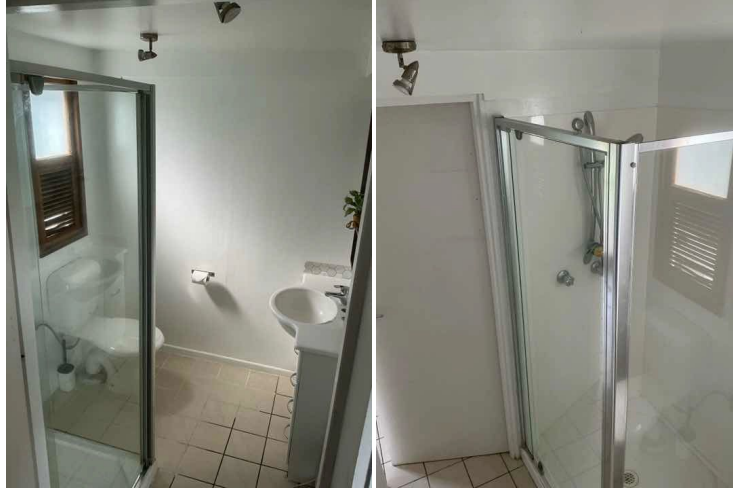
Downstairs

This bathroom indicates that no council records are in place. A check with local council records should be made.

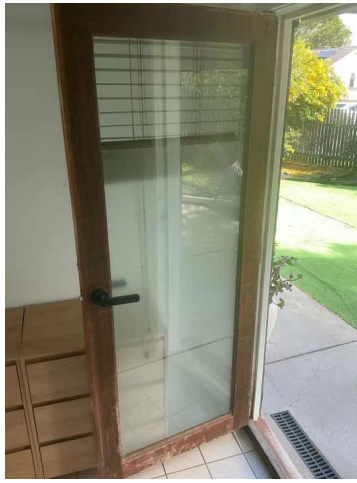
Door

#9. The laundry door is aged and weathered. Assess and repair/ replace as required.

Contact a lic carpenter.

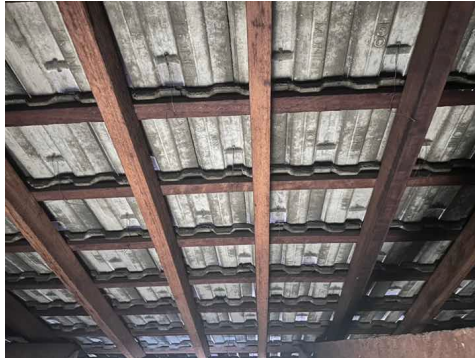
There is no sarking installed. Sarking is the layer of reflective film material installed during construction underneath the roofing material. It provides a moisture barrier and minimal insulation. The installation of sarking is not a building requirement.

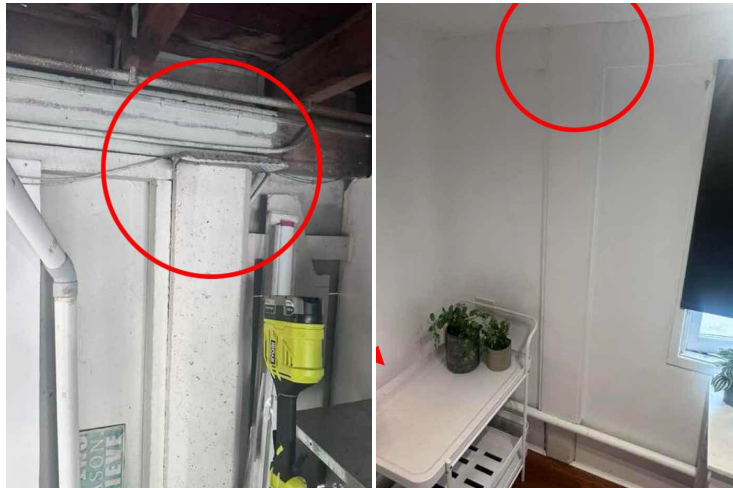
Areas where the ant capping is breached by covering and enclosing. This provides a concealed entry point for termites in an area that is unable to be visually inspected. Activity or damage may exist in concealed areas such as the enclosed stumps downstairs inside. Photo to example concealed vs exposed stump and cap.
