Inspection Report

BPP Inspections

5 Croker St, Aspley, QLD

Pest And Building InsP-ection

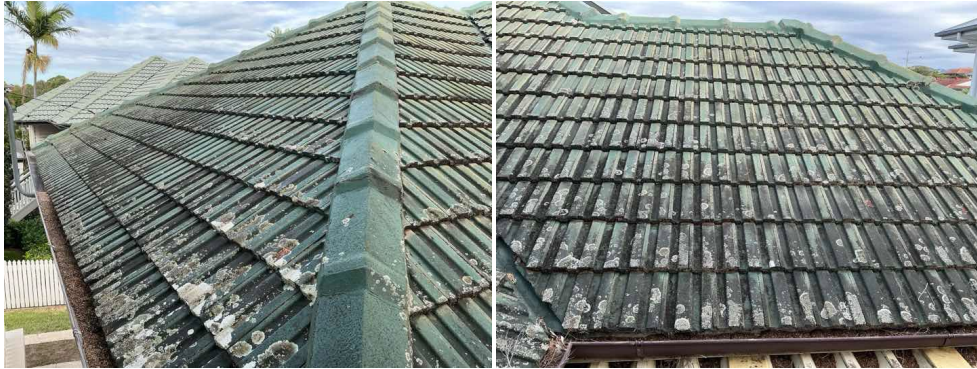
Not inspected as too high to reach by ladder. Viewed from a distance.

There is visible lichen growth across the roof. This requires cleaning and treating. This will cause staining and early deterioration of the roof surface.

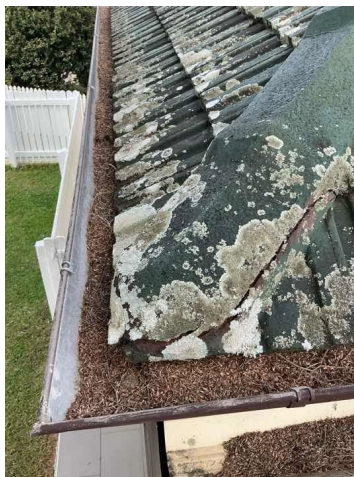
#1. Debris in guttering areas- this requires cleaning out to prevent blocking of down pipes and leaking into eaves and fascia. Recommendations: Have gutters cleaned and assessed by a plumber for adequate fall. Also regularly clean to prevent ponding. Ponding water will contribute to rust.

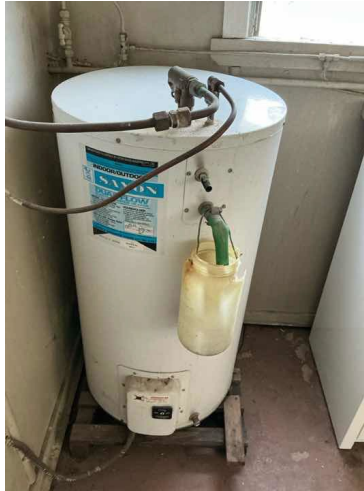
The hot water system appears to be in a serviceable condition. No specific tests other than running the hot water from a tap was carried out. No determination has been made as to the suitability or adequacy of the hot water system in relation to capacity or otherwise.

Due to the visible age of the unit, a more detailed inspection is recommended by a lic plumber and gas fitter.

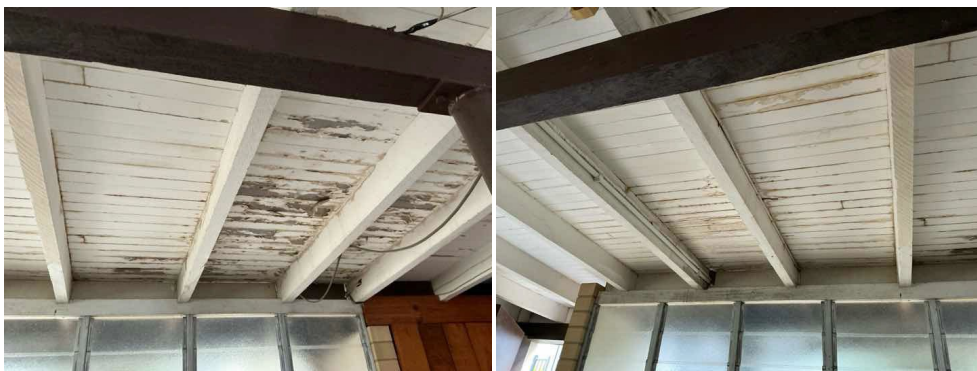
#2. Damaged was observed to the underside of the floorboards of which reason is unknown. The floor Above appears to be stable. If this changes replacement of the affected boards is recommended.

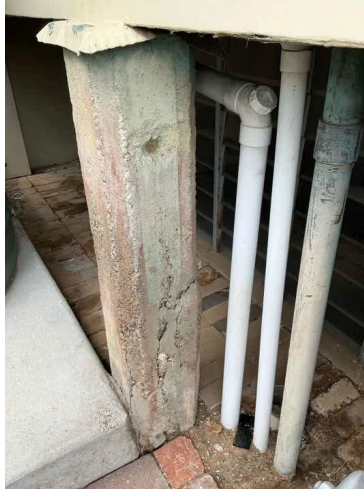
The concrete stumps are aged. Cracking and decay is evident. Monitor for change yearly and repair/ replace as required.

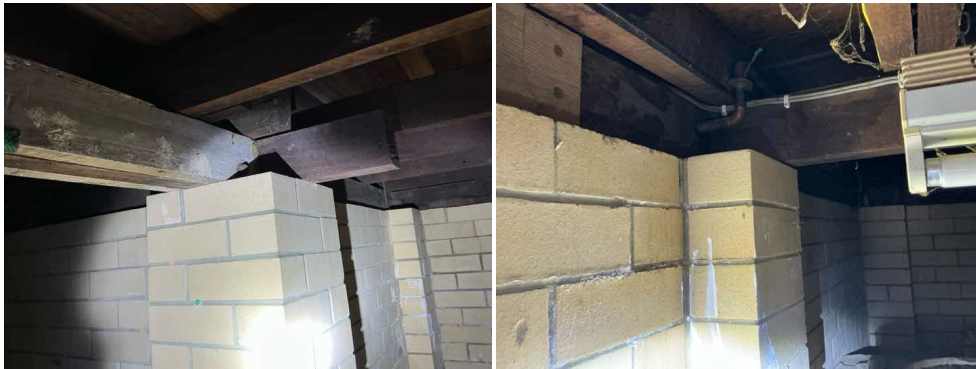
The termite shields (ant caps) are inadequate
