# Inspection Report

## BPP Inspections

**21 Ellerdale St, Aspley, QLD**

### Pest And Building InsP-ection

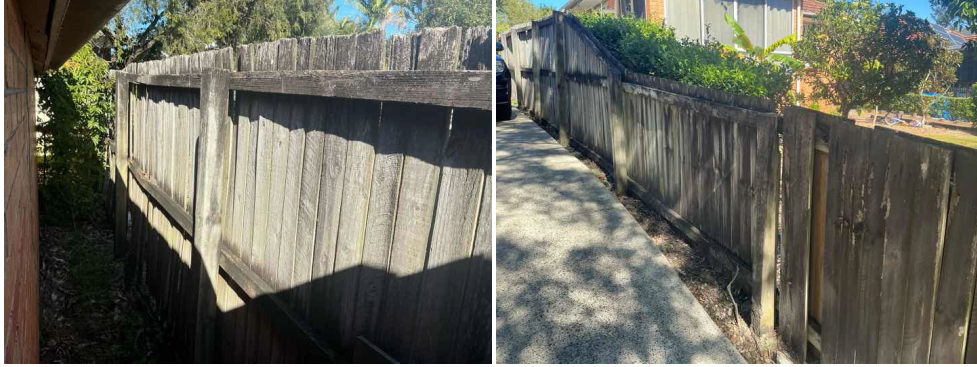
#1. General age to fence components - Recommendations: General upkeep and maintenance. A qualified fencing contractor should be engaged for repairs

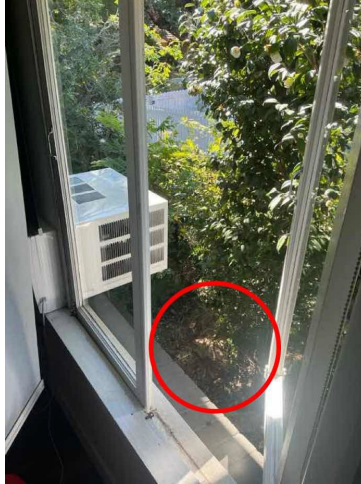
Age observed to window components. Maintenance required. Assess each window and improve sealants and lubricants to mechanical components.

#3. Selected upstairs windows are able to be fully opened. This was compliant at the time of construction and technically no requirement to rectify. Current building code has identified a fall risk and requires a limited opening of 125 mm or secure screening to be in place.

Contact a lic Builder, Glazier to assess and rectify.

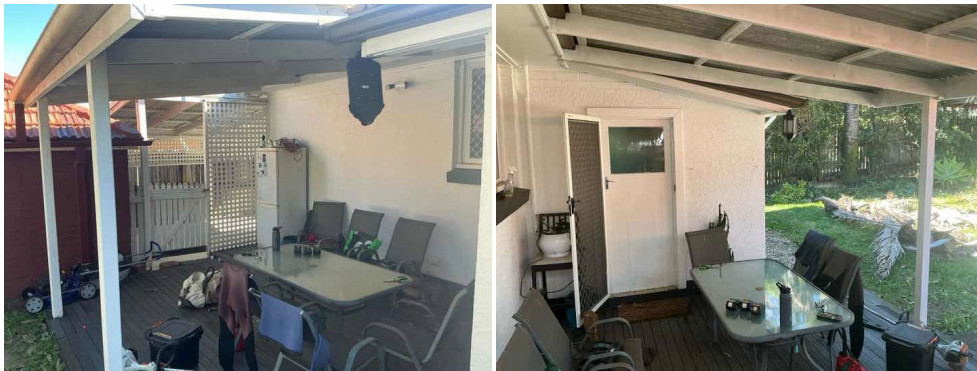
The deck frame is built down at ground level. The area underneath is inaccessible. Defects and termite damage may exist in inaccessible areas. These areas require constant pest management for insects and rodents. This area could be viewed from the outside only by torchlight.

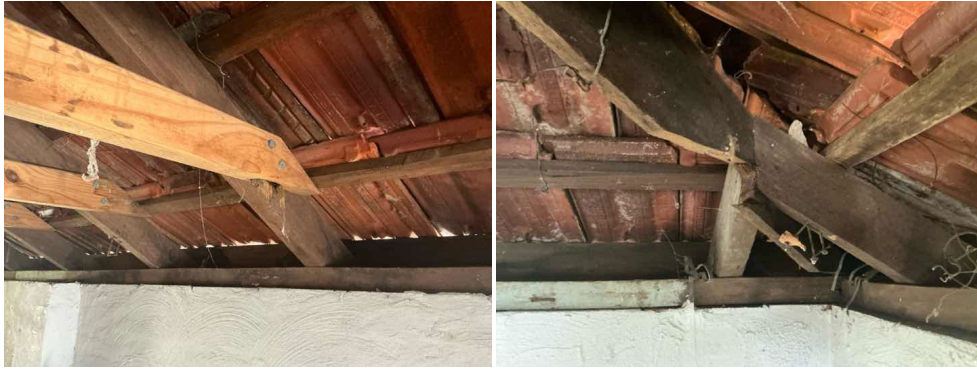
Crack visible to brick wall.

Termite damage to ceiling Timbers.

Further assessment required.

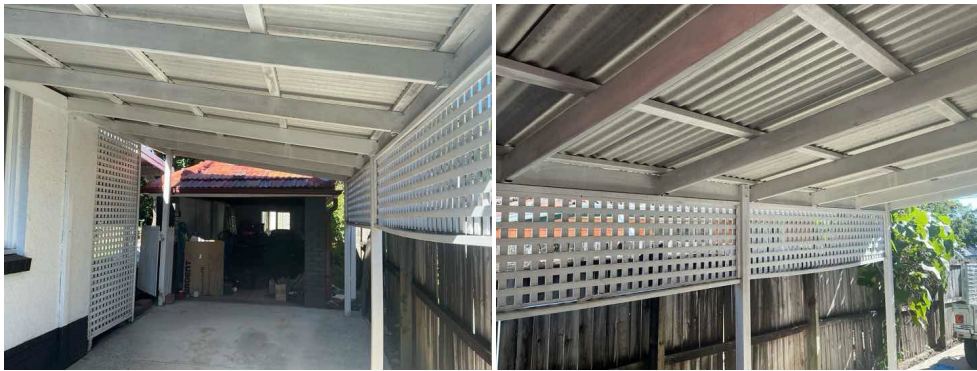
Lattice requires additional support.

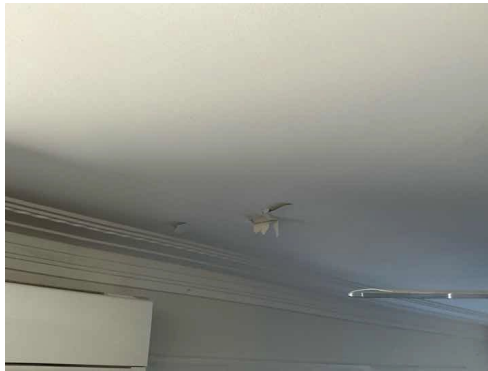
#4. Ceiling paint flake/deterioration is evident. Recommendations: General maintenance / painting as required.

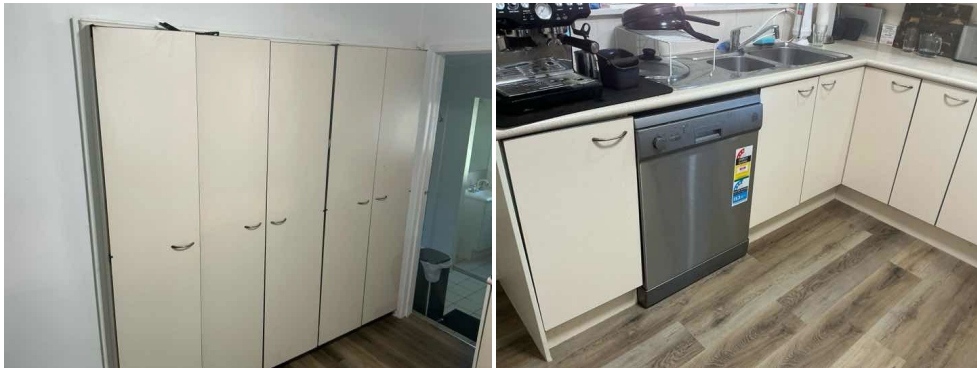
#5. Adjustment to cabinet doors required, in some instance hinges may need to be replaced.

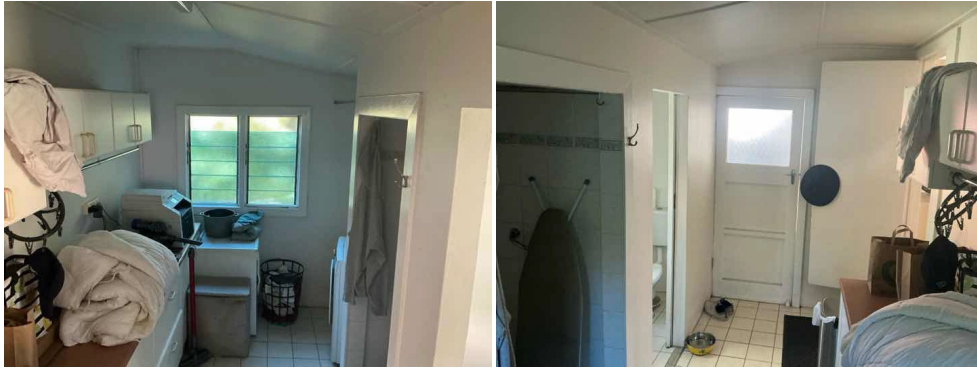
#6. Toilet door not latching when closed. Minor adjustments required. Contact a lic carpenter.

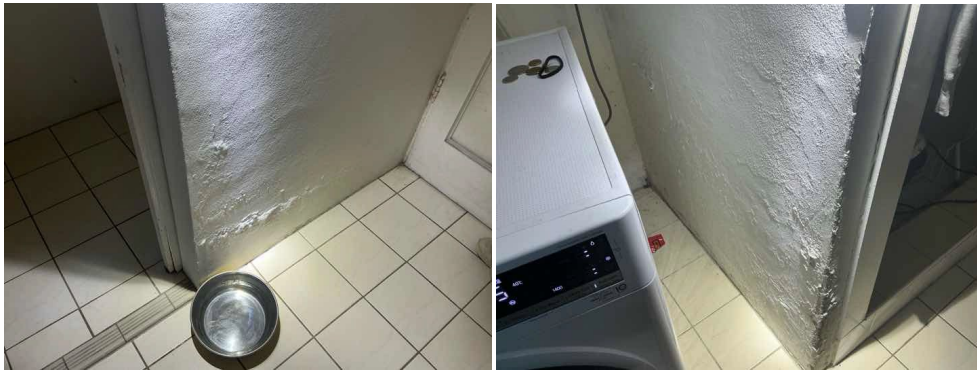
#7. Scaling and blistering to the lower sections of the brick walls. This is consistent where rising damp has been occurring for a historic period. Further assessment required with varying methods of treatment.

Contact a lic Builder or specialist in damp remediation.

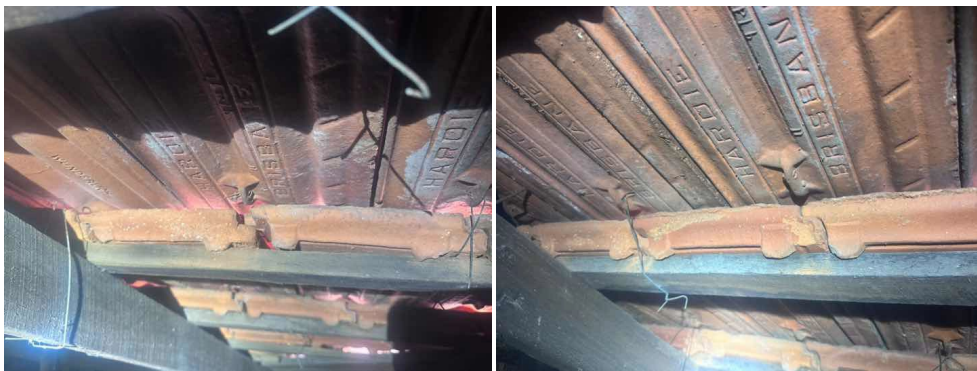
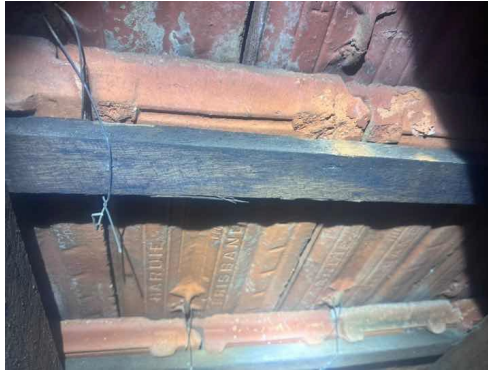
#8. Age and decay visible to the locating lugs on the tiles. This can be common with aged terracotta and monitoring for change is required. Terracotta roof tiles require special care when walked on, and decay on these lugs makes this more important.

Contact a lic roof tiler to assess and offer specialist advice.

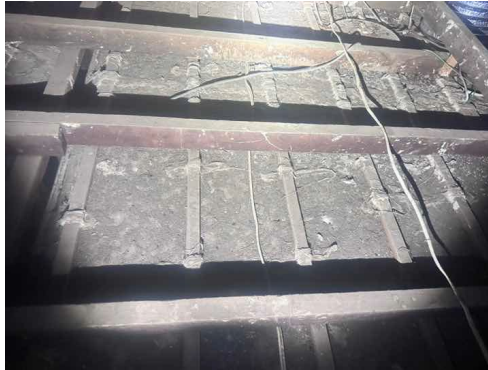
No insulation installed. Recommendations: Engage insulation contractor to assess.

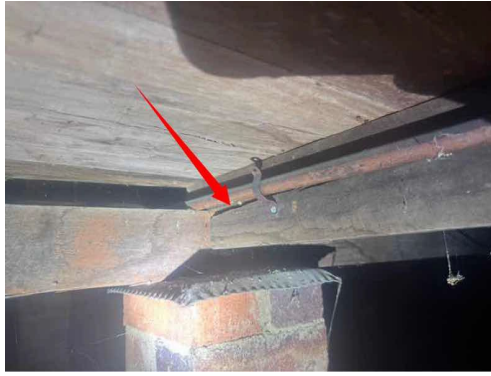
#9. There is a split in the floor supporting joist below the bathroom.

This requires further support to prevent further damage and bathroom floor movement.

Contact a lic Builder/ Carpenter to assess and repair.

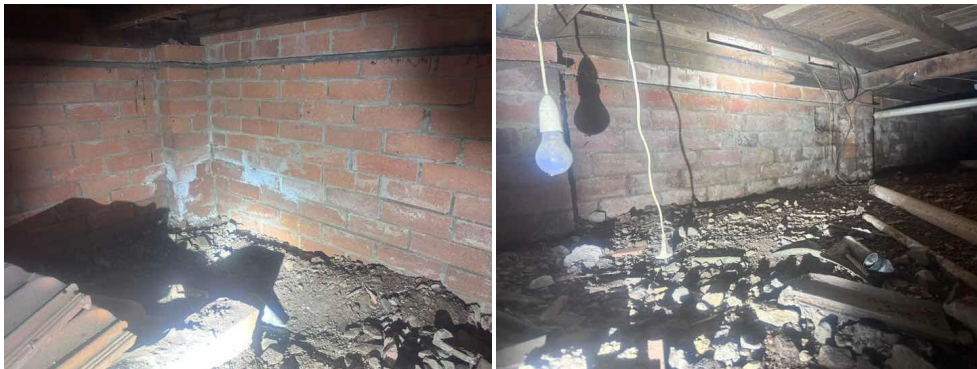
#10. High moisture and efflorescence salting was visible to the brickwork. This has been occurring for a historical period of the building. Monitor for change throughout seasonal weather variations. Further investigation and Repairs can be carried out if concerns are current.

Assess and repair ventilation and improve all drainage and damp conditions.
