# Seller disclosure statement

39 Victory Street, Zillmere QLD 4034

## Inspection Address

**39 Victory St, Zillmere, QLD**

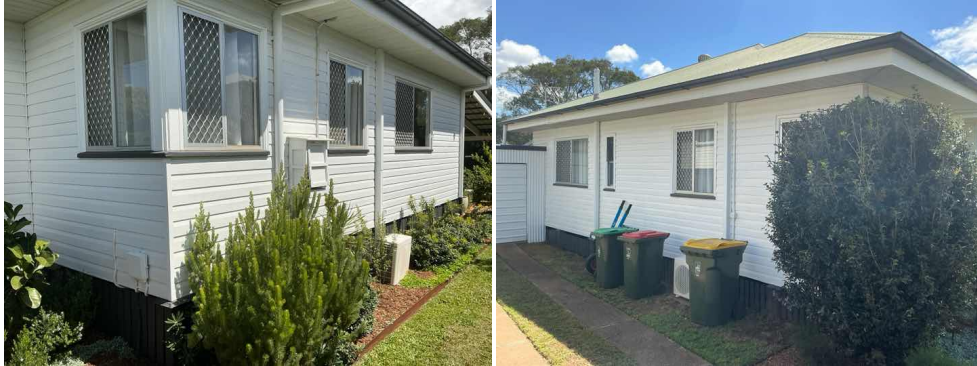
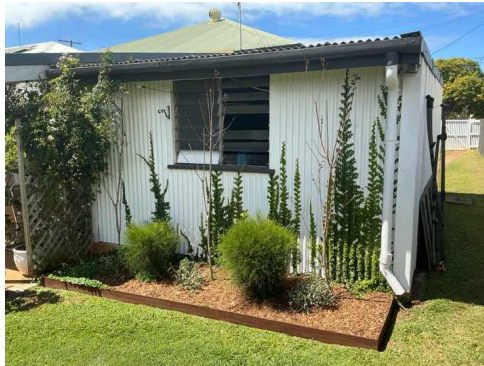
Asbestos cladding to the garage walls.

Asbestos is present in this building it is found in fibrous products. Asbestos is a safety hazard if renovations or damage to the material occurs. Contact a licensed asbestos specialist for further advice and repairs.

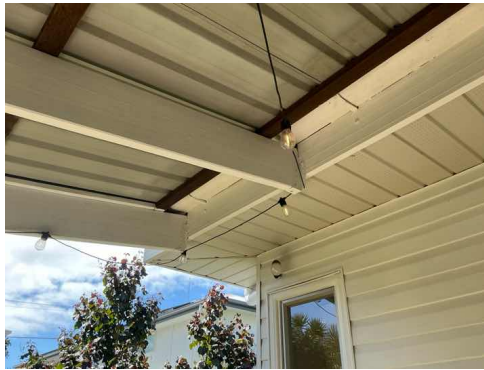
### Column or Post Condition

The connection of the pergola rafters to the main building fascia appear minimal. It cannot be determined the support behind the fascia that supports these connections. The rafter to fascia connections appear to be in a serviceable condition.

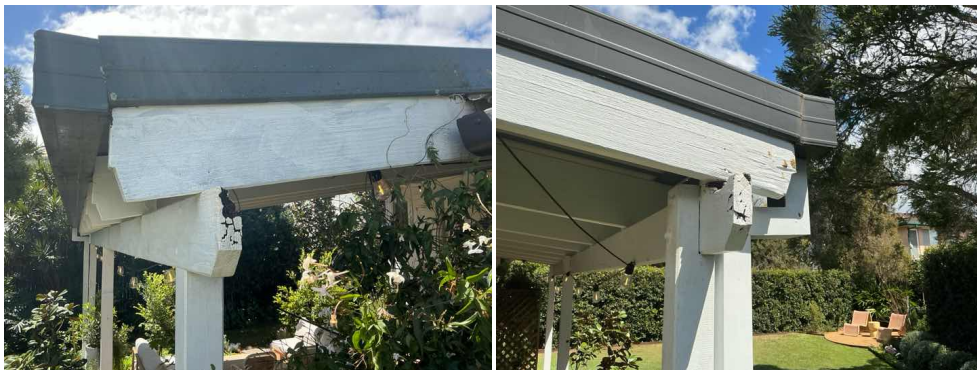
### Ceiling Lining Condition

#2. Timber decay apparent. Recommendations: A qualified carpenter should be engaged to replace or protect all affected timbers.

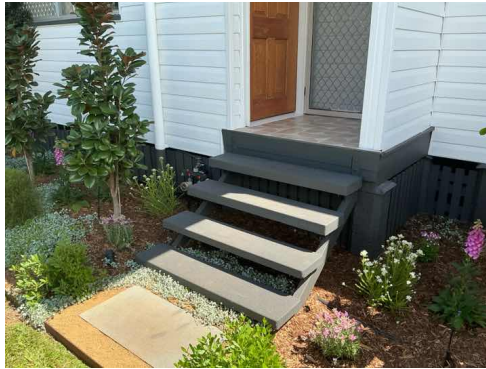
| Section | Location | Name | Comment |
|---|---|---|---|
| STAIRS-PERGOLA-BALCONIES-DECKS | Stairs & Steps | Overall Condition | #3. Whilst there is no requirement for a handrail to stairs and floor heights up to 1m. In the interest of managing safety, a handrail is recommended to main entry stairs.<br>. |

#3. Whilst there is no requirement for a handrail to stairs and floor heights up to 1m. In the interest of managing safety, a handrail is recommended to main entry stairs.

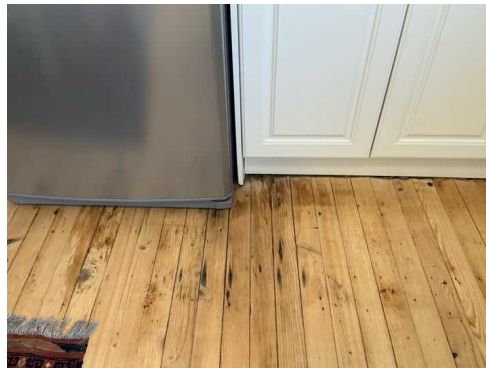
#### Floor

| Section | Location | Name | Comment |
|---|---|---|---|
| KITCHEN & LAUNDRY | Kitchen and Meals Area | Floor | #5. Decay noted to the timber floor. Historical timber decay, minor damage. |

#5. Decay noted to the timber floor. Historical timber decay, minor damage.

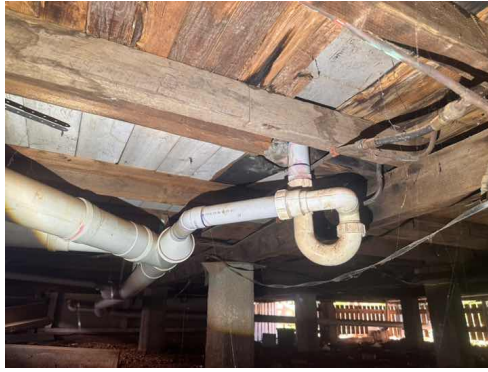
#### Floor Timbers

Timber fungal decay evident to floor boards - Recommendations: A qualified carpenter should be engaged for advice and recommendations.

This appears aged staining and damage from previous leaking bathroom . No high moisture or water leak visible.

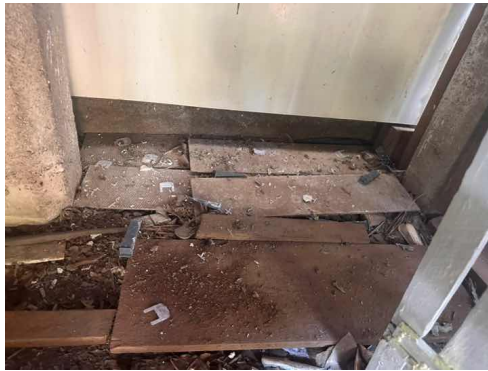
| Section | Location | Name | Comment |
|---|---|---|---|
| SUBFLOOR | Sub-Floor Observation. | Dampness | #6. The underside of the residence is lower than the external ground level. This situation may cause external stormwater runoff to enter the sub floor area. The sub floor area should be monitored in times of heavy rainfall. Additional site drainage may be required |
| SUBFLOOR | Sub-Floor Observation. | Subfloor Cleanliness | #7. There was debris and other material in the subfloor, we recommend cleaning these to aid with ventilation and reduce the likely hood of rodents and pests. |

#6. The underside of the residence is lower than the external ground level. This situation may cause external stormwater runoff to enter the sub floor area. The sub floor area should be monitored in times of heavy rainfall. Additional site drainage may be required

#7. There was debris and other material in the subfloor, we recommend cleaning these to aid with ventilation and reduce the likely hood of rodents and pests.

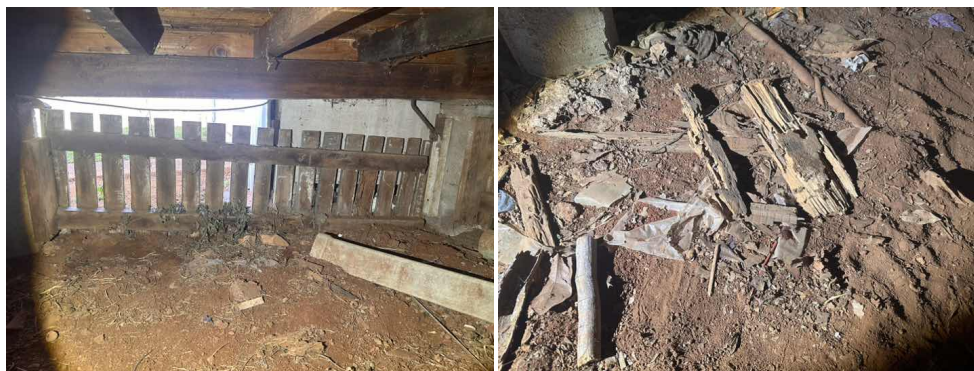
Sub floor timber

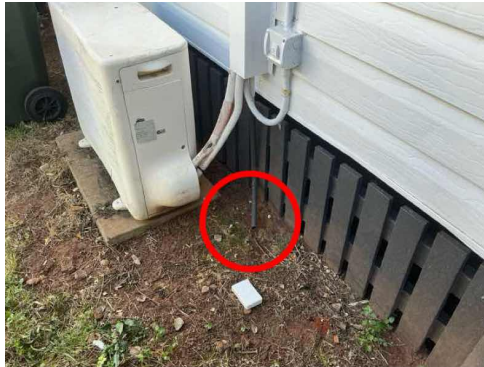
| Section | Location | Name | Comment |
|---|---|---|---|
| CONDUCTIVE CONDITIONS | 4.1 Hot Water Unit Overflow | Was the Air Conditioner Sufficiently Drained | #10. The air conditioning drain was draining onto the building perimeter ground surface. This adds constant excessive ground moisture providing conducive conditions for termites. Divert drain and connect to stormwater discharge points where possible.<br>. |

#10. The air conditioning drain was draining onto the building perimeter ground surface. This adds constant excessive ground moisture providing conducive conditions for termites.

Divert drain and connect to stormwater discharge points where possible.
