# Building and Timber Pest Inspection Report VR

Inspection Date: Mon, 01 Jun 2026

Property Address: 45 Collings St, Geebung QLD 4034, Australia

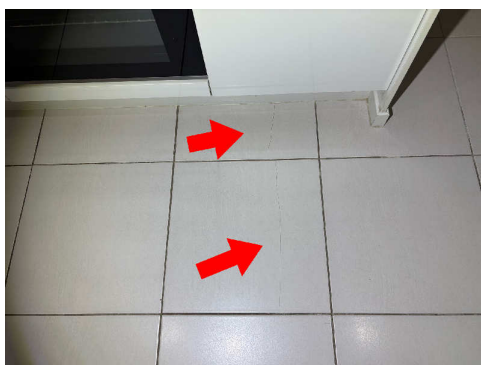
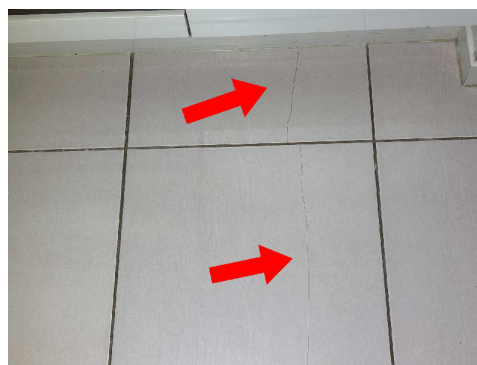
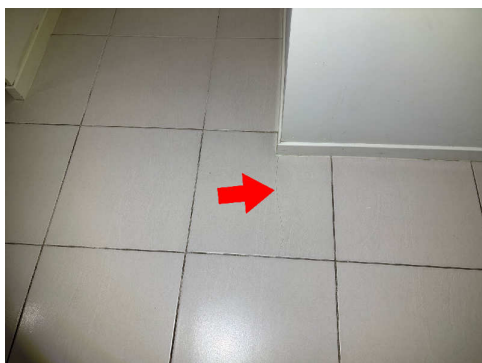
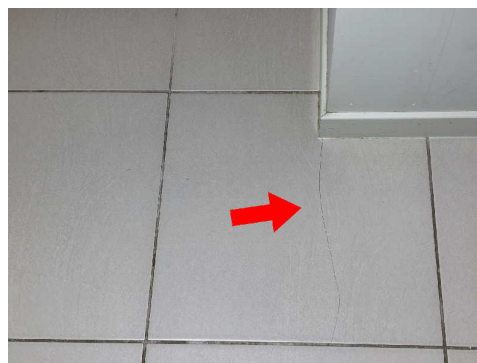
#### Finding 3.01

Finding: Kitchen - cracked tiles

Information: At the time of the inspection it was noted that several tiles were cracked on the kitchen floor. This appears to be purely an aesthetic issues and could be attended to at the clients discretion. The tiles may have cracked because they are drummy and something has been dropped on them.

A tiler or building maintenance professional would be able to carry out the necessary works.

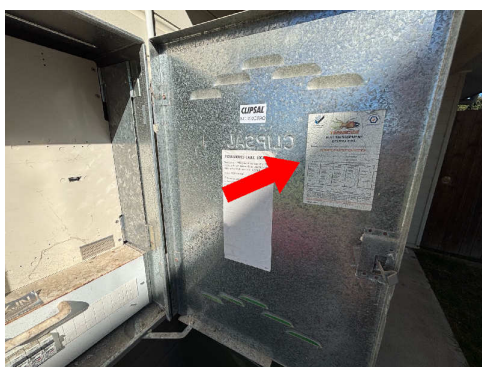
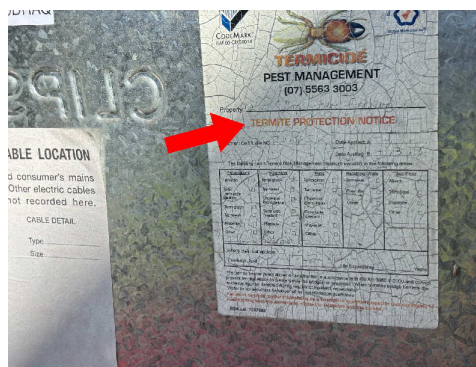
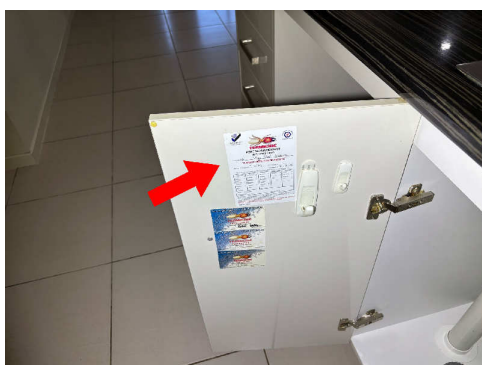
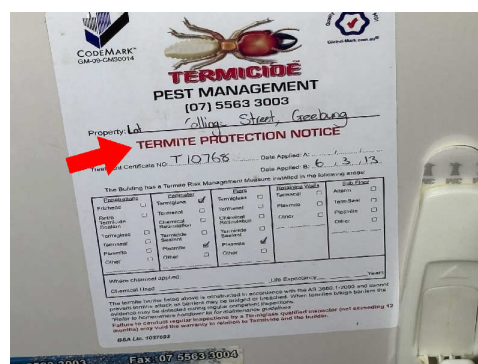
#### **Finding 9.01**

Finding: Evidence of a physical termite management system was identified.

At the time of the inspection, evidence of a physical termite management system was found by way of a durable notice in the electricity meter box and in the kitchen sink cabinet.

A physical termite barrier was installed to the perimeter and piers during construction. The durable notice is date the 06/03/2013.

A physical termite barrier does not stop or eliminate termites. A physical termite barrier is designed to exposed concealed termite activity which will be found during a visual inspection.

The client should consider a chemical termite treatment system as additional protection for the dwelling.

A termite and timber pest technician should be engaged to carry out annual termite inspections as per AS 3660 in order to further protect the dwelling. Annual termite inspections must be carried out in partnership with any termite treatment system, physical or chemical, as no termite treatment system can be expected to be 100% effective.

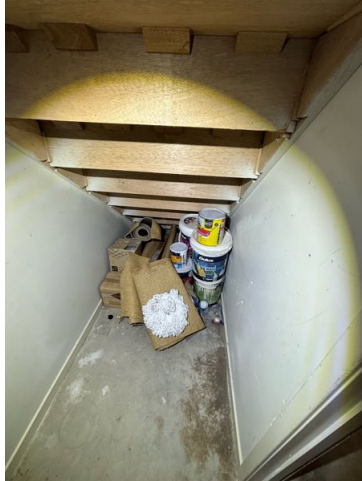
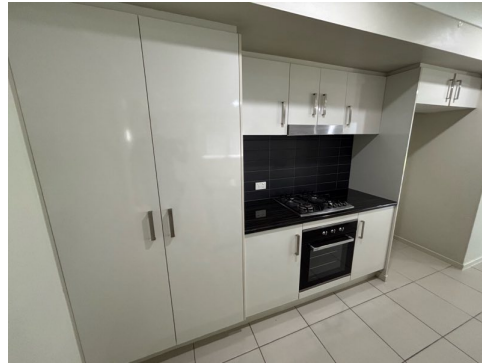
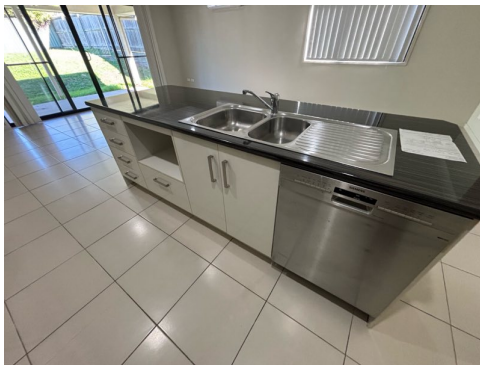
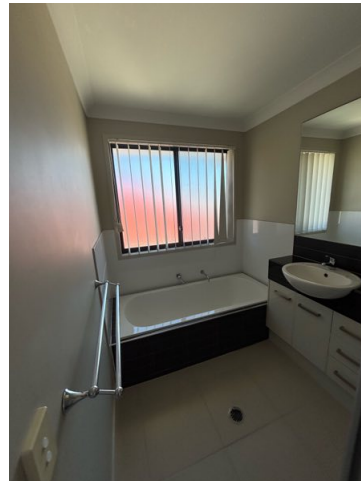
Finding: Obstructions and Limitations - Internal areas

Information: These photographs are an indication of the obstructions and limitations which impeded full inspection of the property of the internal areas at the time of inspection. These obstructions can hide an array of defects and should be removed to allow full inspection to be carried out. A re-inspection is recommended once the areas are made accessible.

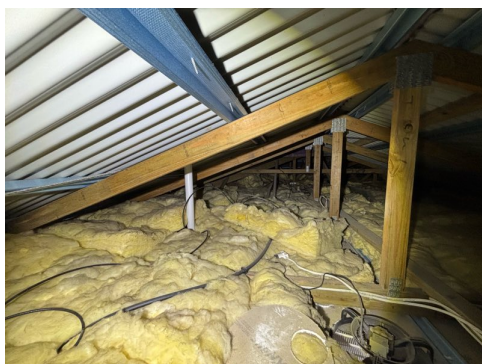
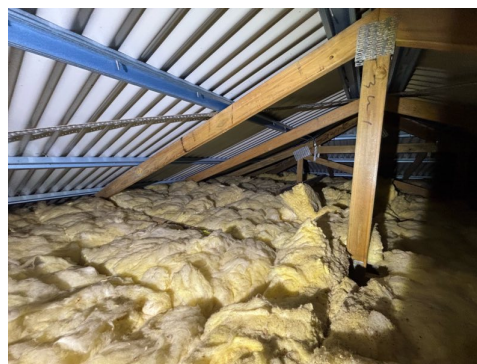
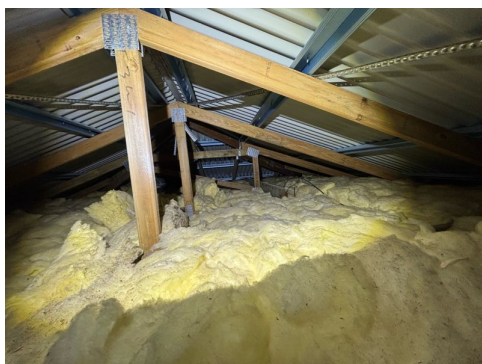
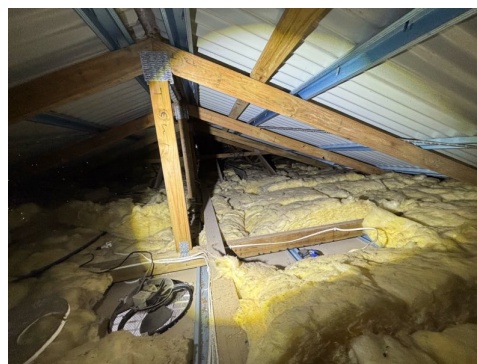
Finding: Obstructions and Limitations - Roof cavity

Information: These photographs are an indication of the obstructions and limitations which impeded full inspection of the property of the roof cavity at the time of inspection. These obstructions can hide an array of defects and should be removed to allow full inspection to be carried out. A re-inspection is recommended once the areas are made accessible.
