Building and Timber Pest Inspection Report VR

Inspection Date: Tue, 28 Apr 2026

Property Address: 17 Benyon St, Wavell Heights QLD 4012,
Australia

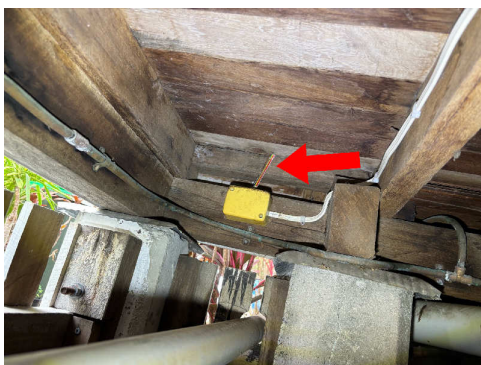
Finding: Subfloor - damaged electrical cable

Information: At the time of the inspection, it was noted that an electrical cable under the kitchen in the subfloor area has been damaged. The cables appear to have been chewed and as a result the active/live wire has been exposed.

This presents a safety hazard.

A licensed electrician must be engaged to replace the damaged wire. This must be done immediately.

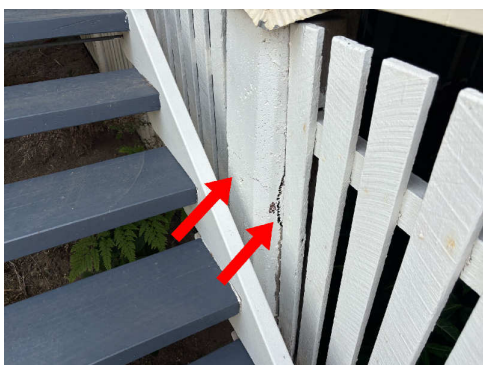
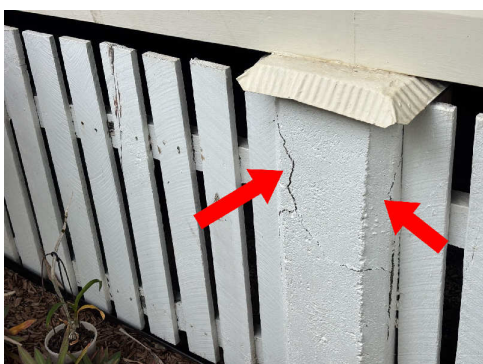
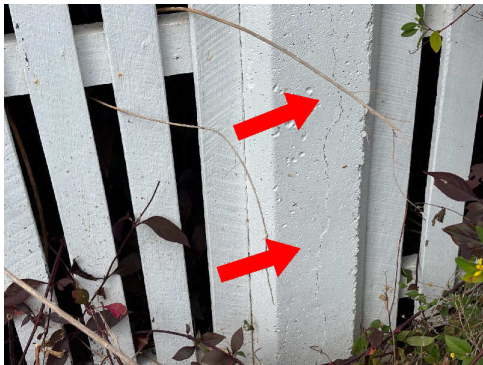
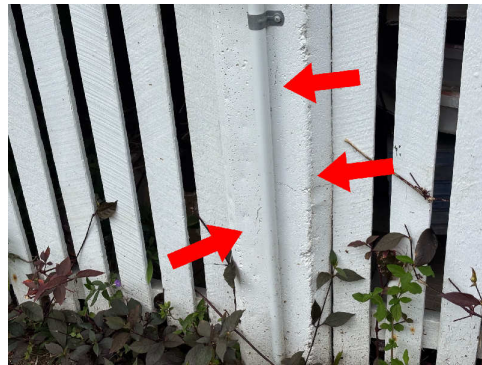
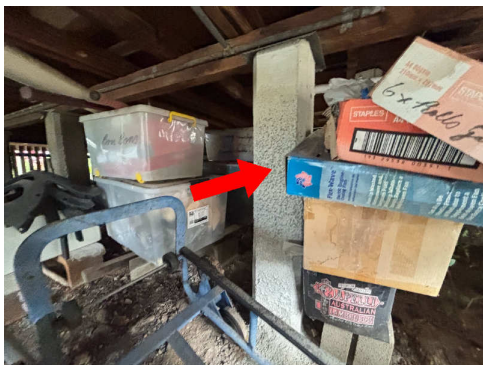
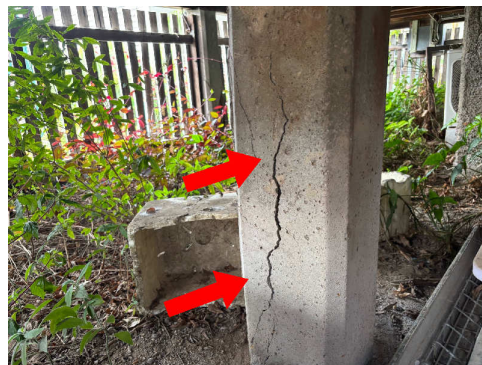
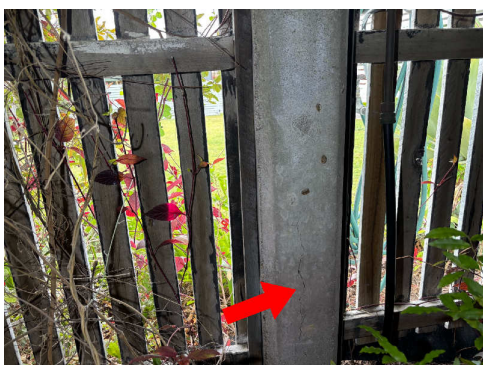
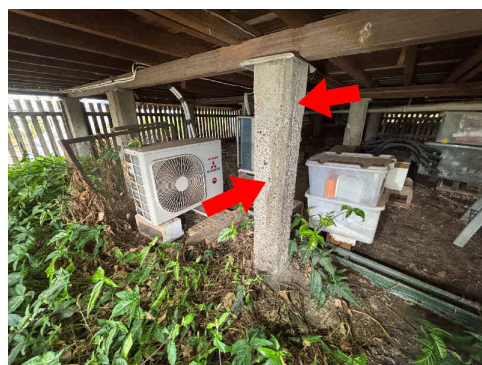
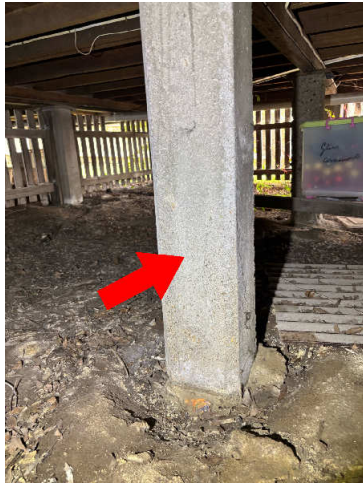
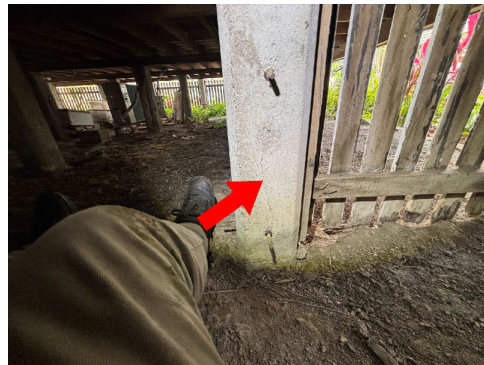
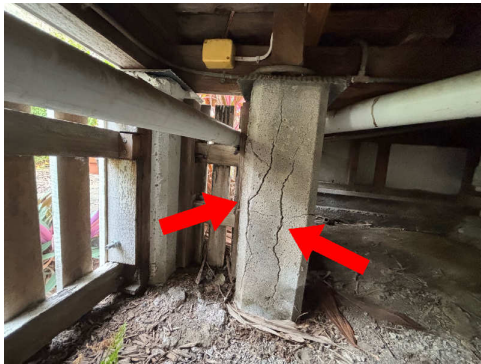
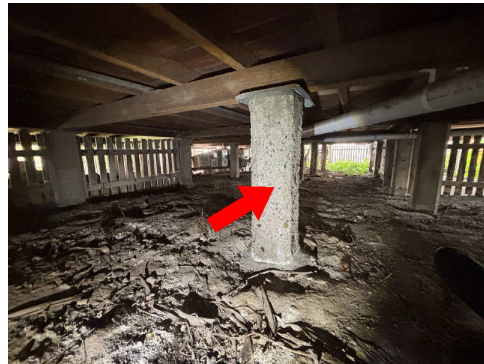
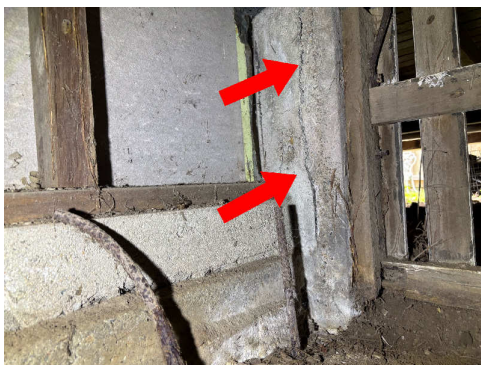
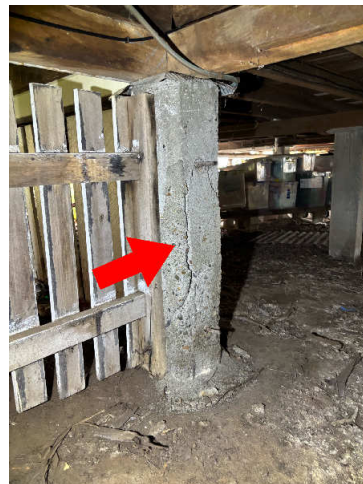
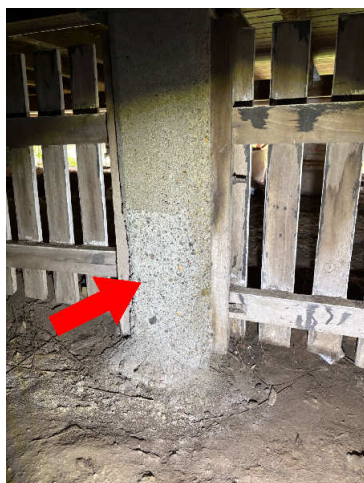
Finding 2.01

Finding: Concrete Stumps - Spalling

At the time of the inspection, it was noted that the majority of the concrete stumps to the subfloor structure were found to be affected by spalling, indicating that their structural integrity has been affected.

Spalling refers to concrete deterioration and threatens the building's supportive structure.

The cause of spalling can range from inferior quality concrete, improper concrete curing, chemical reactions to alkaline in the soil, or corrosion of steel reinforcement within the concrete, which is commonly known as concrete cancer.

The stumps are failing in their structural purpose, likely leading to a range of major and minor defects. Further damage to the stumps and structure may be imminent if left unattended.

Spalling was noted to concrete stumps in the subfloor area. A house re-stumping specialist should be engaged to assess the concrete stumps and determine which of the affected concrete stumps require replacement.

An appointment with a registered builder specialising in re-stumping is required immediately to assess the condition of the concrete stumps and provide advice on remedial works. This defect should not be left unmanaged.

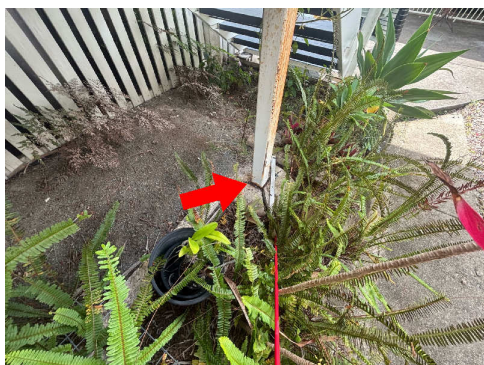
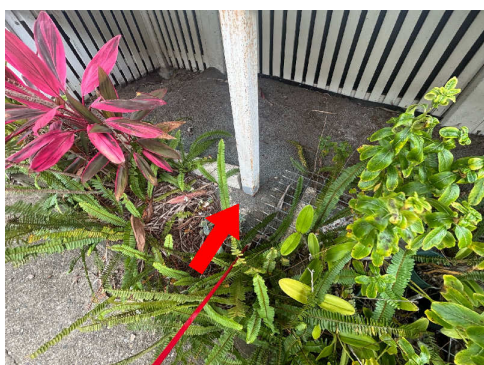
Finding 3.01

Finding: Entry deck - evidence of rust

Information: At the time of the inspection, it was noted that there was evidence of rusting to the steel posts supporting the entry deck. The front post has rusted to the extent of splitting the concrete at the base. The back post appears to have surface rust.

These steel posts need to be replaced. This has been noted as a minor defect due to the ease of access for replacement. If left on-addressed, this will become a major defect.

The steel posts under the front deck are rusting and require replacement.

A licensed builder specialising in house re-stumping must be engaged to replace these two steel posts. This should be done as a matter of urgency.

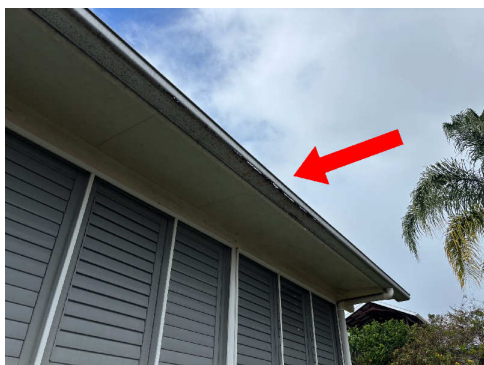
Finding 3.02

Finding: Gutters - rusting

Information: At the time of the inspection, it was noted that the gutter on the right hand side of the dwelling has rusted as such leaking in numerous areas. Gutters need to be in good working order to drain the roof properly.

If gutters are leaking , moisture may get to areas of the building that are meant to be keep dry. Damage to building elements may result of moisture ingress.

A licensed roof plumber should be appointed to inspect the gutters and advise on necessary rectification works. This should be done as a matter of urgency.

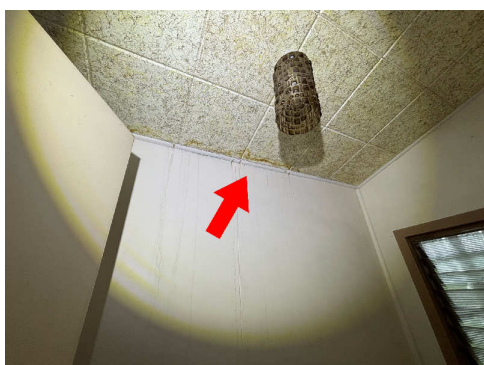
Finding 3.03

Information: At the time of the inspection, it was noted that there was evidence of moisture ingress in the laundry/toilet area. The moisture readings taken during the inspection, indicate that this is from an inactive leak. This may have occurred prior to the metal roof covering being replaced.

The client should monitor these areas for any change in appearance. A building maintenance professional or painting contractor could be engaged to repair the affected areas.

This can be done at the clients discretion.

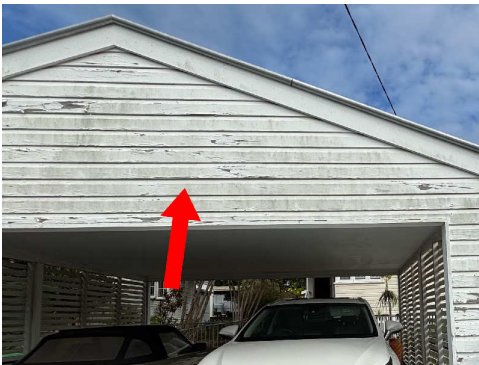
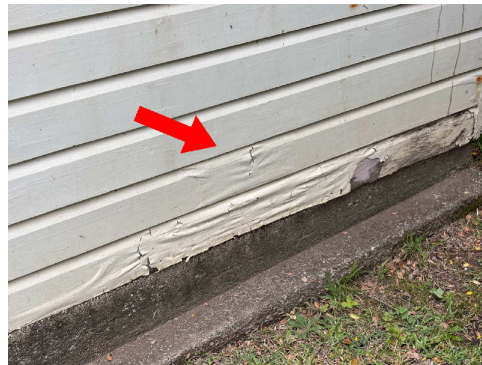
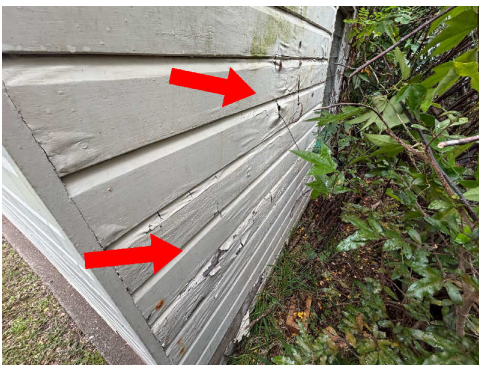
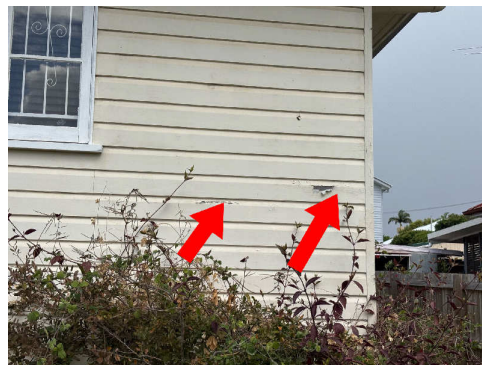
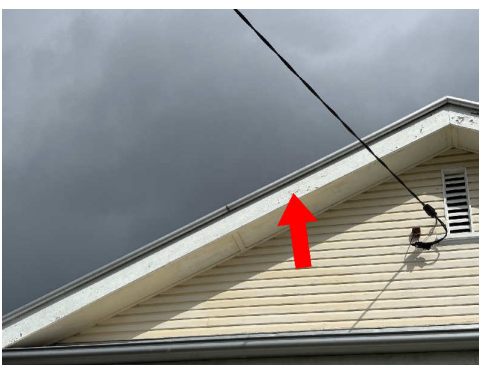
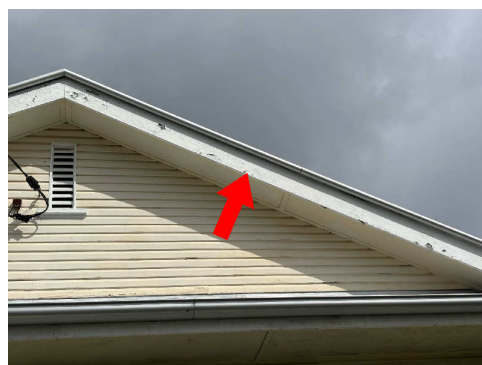
Finding 3.04

Information: At the time of the inspection, it was noted that the paint to sections of the exterior of the dwelling, carport and garage was peeling.

Peeling paint can be caused by moisture, poor preparation or age.

A painter or building maintenance professional could be engaged to rectify these issues. This can be done at the clients discretion.

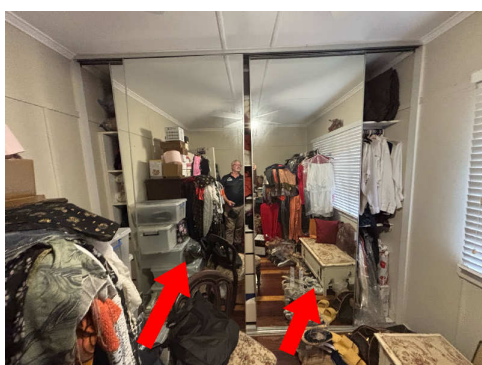
Finding 3.05

Finding: Bedroom 3 - wardrobe doors
 Information: At the time of the inspection, it was noted that the mirrored wardrobe doors in bedroom 3 were not able to be used as they are off their tracks.

This may be due to an issue with the rollers.

A building maintenance professional should be engaged to replace any affected rollers and place the wardrobe doors back on their tracks. This should be done as a short term priority.

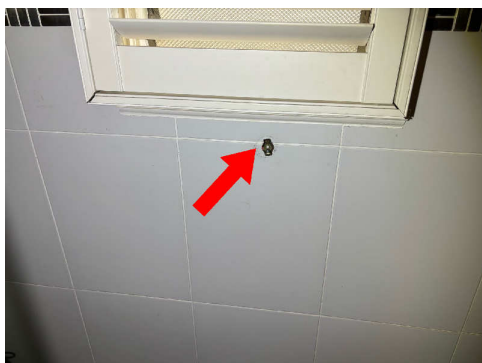
Finding 3.06

Information: At the time of the inspection, it was noted that the toilet roll holder in the bathroom was incomplete. The main part of the toilet roll holder was on the floor. This may be due to general wear and tear.

A building maintenance professional could be engaged to replace the parts or install a new toilet roll holder. This can be done at the clients discretion.

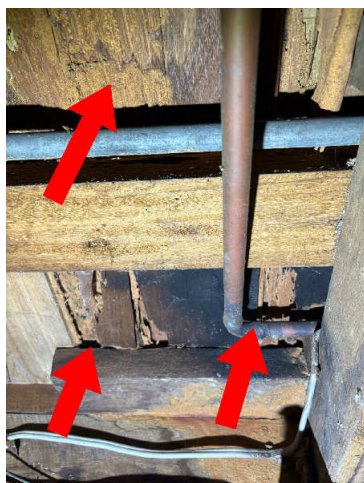
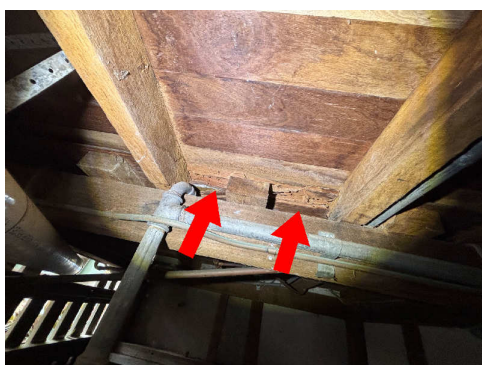
Finding: Evidence of termite damage

Information: At the time of the inspection, it was noted that there was termite damage to timber floorboards under the stove in the kitchen. No active termites were found in this area during the inspection.

Evidence of termite damage was found to the timber floorboards under the stove in the kitchen. No active termites were found in this area during the inspection.

It is strongly recommended that a chemical termite treatment system be installed to protect the dwelling.

It is advised that the area be visually inspected frequently to ensure that the condition of affected building materials does not worsen.

A building contractor may be appointed to provide a further invasive inspection if further damage is evident.

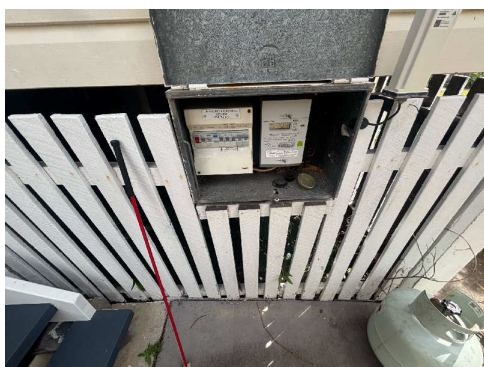
Finding 6.01

Information: At the time of the inspection, no evidence of a current chemical termite management system was found. There is a durable notice in the meter box showing a chemical treatment was carried out on the 23/09/2008 with an expected lifespan of 10 years for the underslab and perimeter and 5 years for the subfloor area. This treatment will no longer be effective. It is stated on the durable notice that termite inspections must be carried out every 6 months.

At the time of inspection, it appeared as though no termite management system has been installed, with no evidence to suggest preventative works taking place.

The application of a post-construction chemical termite barrier is highly recommended for all properties, particularly if live termite activity has been found on the site previously. Such barriers are highly effective in preventing termite attack on any timber building elements throughout the property.

The client may consider gaining further advice from a pest controller as to the costs and procedures involved with this application. It is recommended that obtaining such advice be a short-term priority.

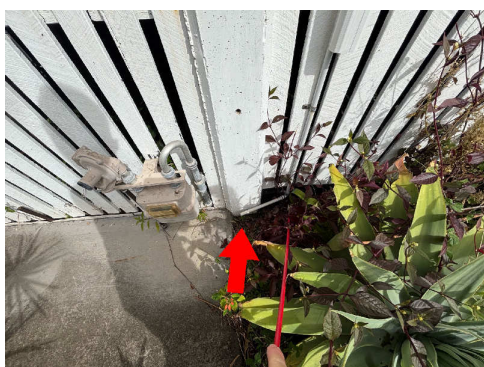
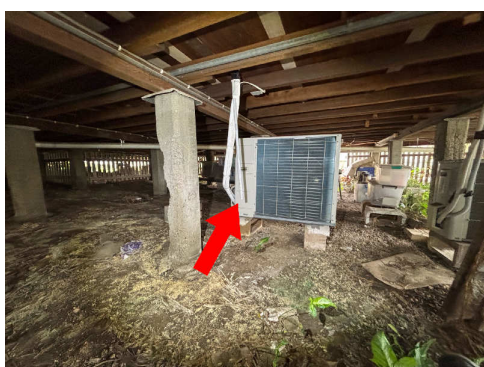
Finding 6.02

Building:	Main Building
Location:	All External Areas
Finding:	Air conditioner - Disconnected overflows

Information: At the time of the inspection, it was noted that the air conditioner drain overflows to all the units were not connected to the storm water drainage and as a result are draining next to the foundations of the dwelling.

Air conditioning overflows that are not connected to the storm water drainage and are draining near the foundation can create excessive moisture in the surrounding area.

Such leaking creates an environment which is conducive to an array of defects, including water damage to associated building elements and the attraction of termite or timber pest infestation.

It is highly recommended that a licensed plumber be appointed to connect the A/C overflow in order to prevent such an environment from being created. These minor works should be carried out as soon as possible.

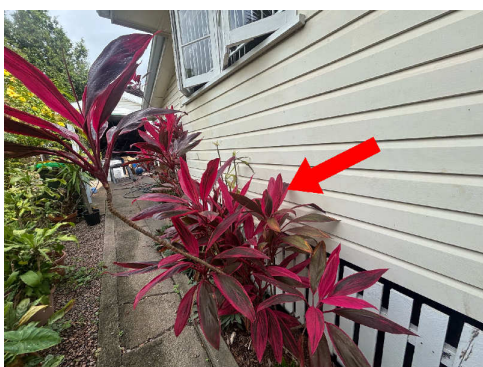
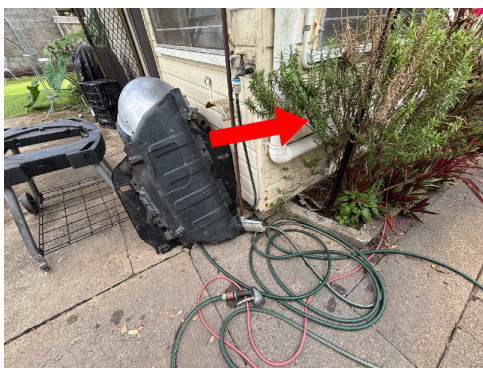
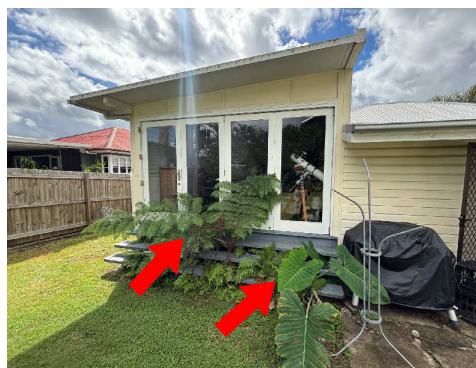
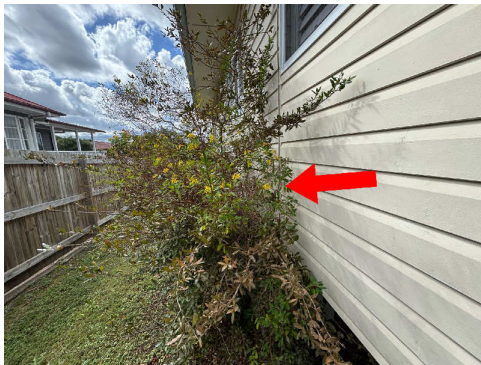
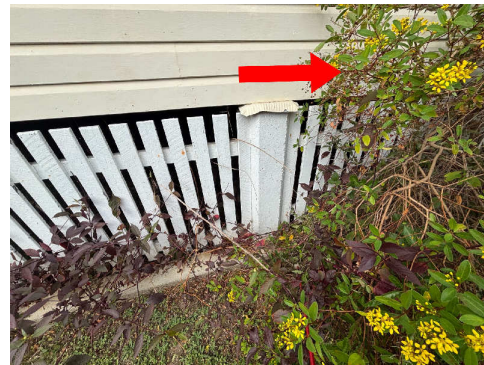
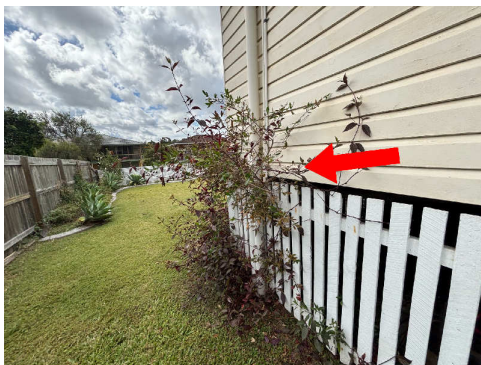
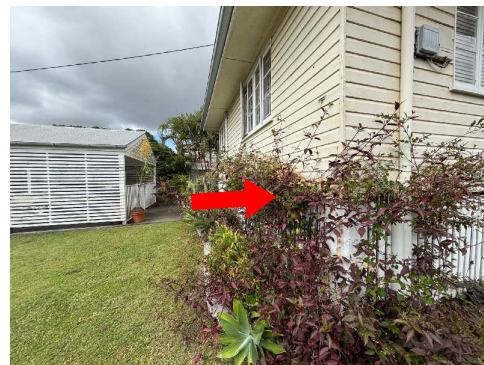
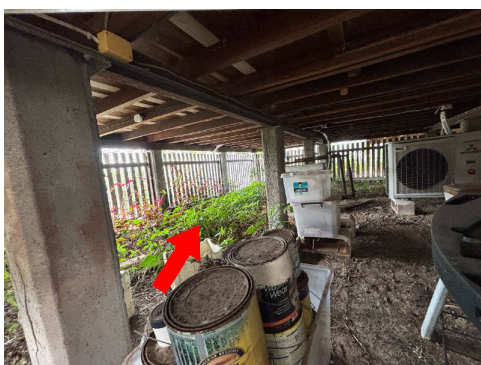
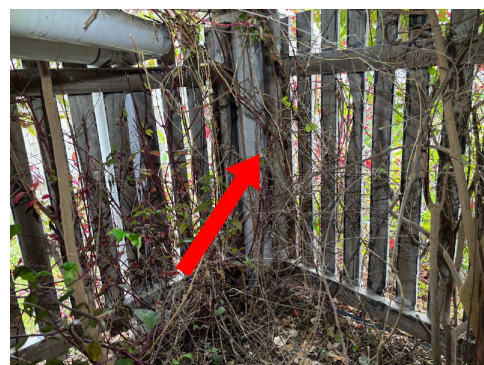
Finding 6.03

Information: At the time of the inspection, it was noted that there was vegetation touching the building and garage in several locations.

This creates a potential access point for termites to enter the building undetected. The vegetation hinders visual termite inspections. This is a conducive condition for termite activity.

The client is to ensure that the vegetation is trimmed back to prevent undetected termite entry to the building. This should be done as a matter of urgency.

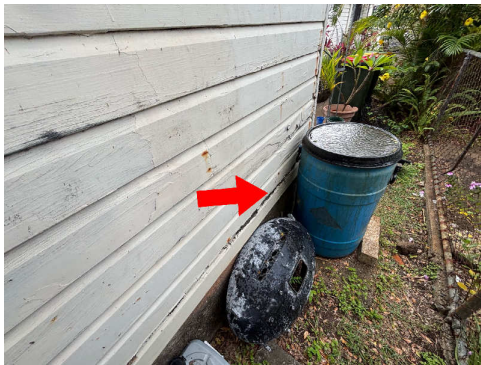
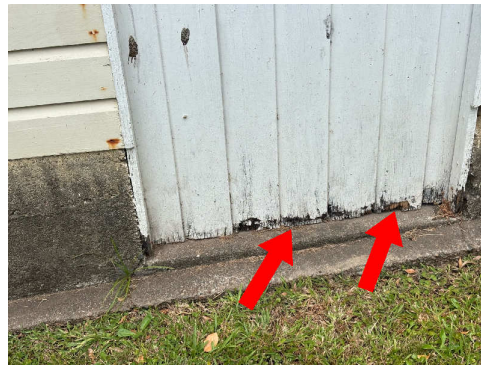
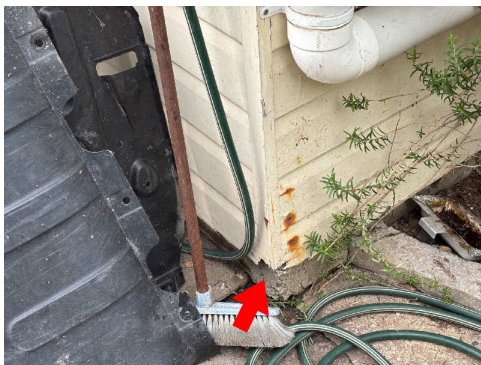
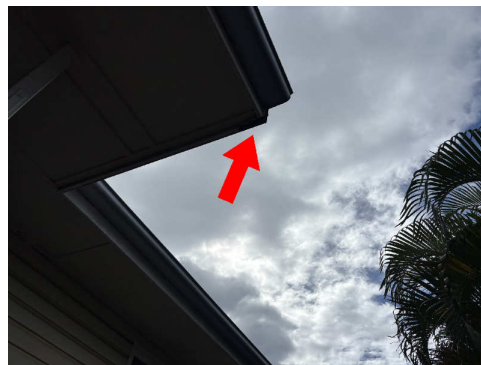
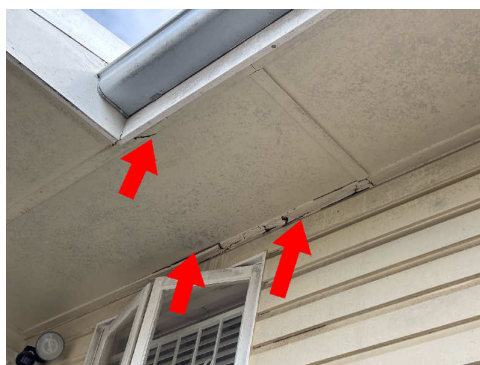
Finding: Wood rot

Information: At the time of the inspection, it was noted that there were examples of wood rot to timber building elements found around the dwelling. Examples were found to weather boards on the garage and dwelling. The bottom of the garage door. Mouldings and fascia near the entry area. This may be due to the age of the timber building elements and general weathering.

This building element shows evidence of wood rot. Wood rot, also known as Fungal Decay, occurs when timbers and other cellulose building materials are exposed to damp conditions on an ongoing basis.

Wood rot is often associated with general damp problems and is evidenced by a 'musty' smell or mould and mildew occurring on surfaces. If left unmanaged, damp conditions can lead to further health problems and the decay of timbers will continue.

Early intervention and regular maintenance, particularly of exterior timbers, will prolong the useful life of these building elements. Prior to any works being performed, the cause of the moisture that has created the visible wood rot should be identified and addressed in a suitable manner. Replacement of affected timbers may then be a necessary step in protecting surrounding building elements from such deterioration.

A qualified carpenter or registered builder may also be required to replace affected building materials.

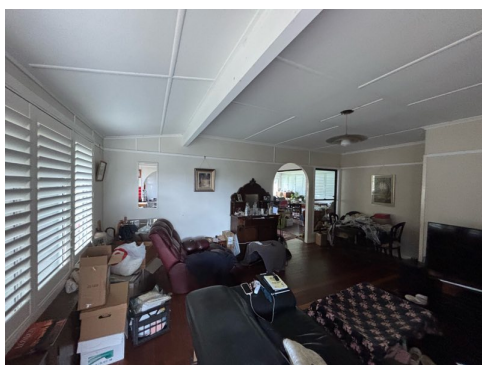
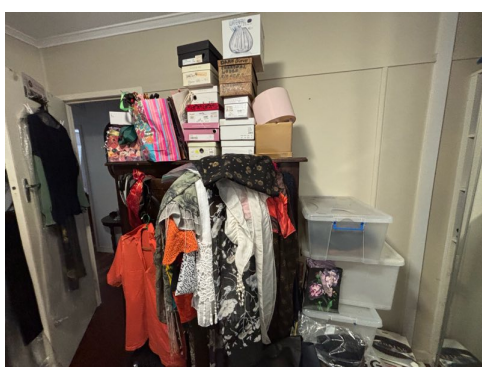
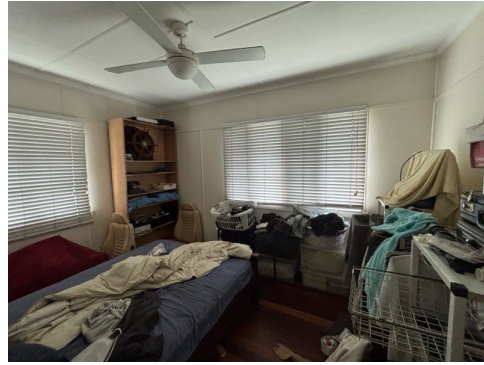
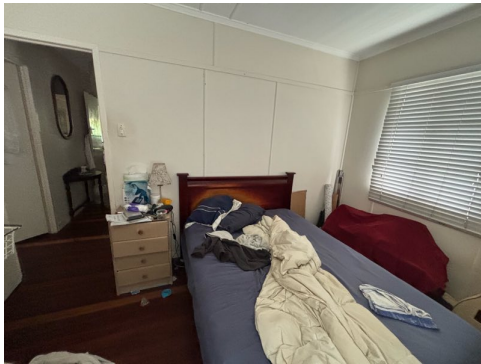
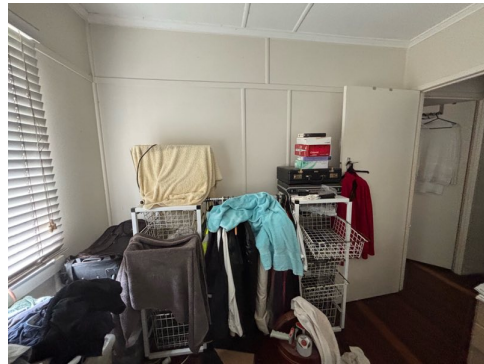
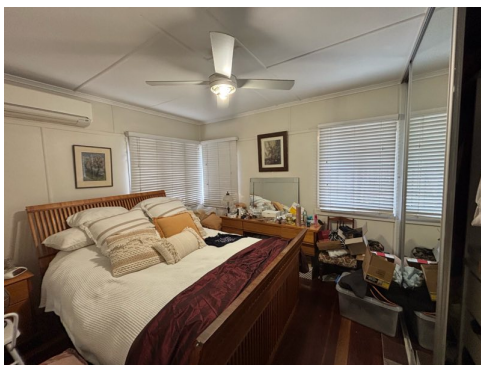
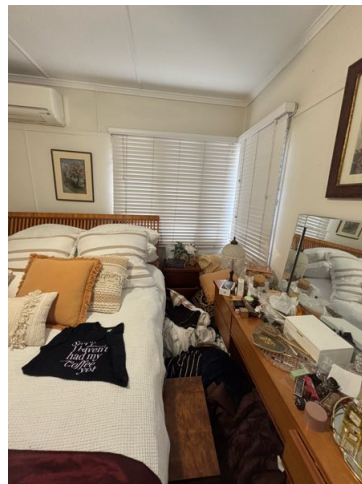
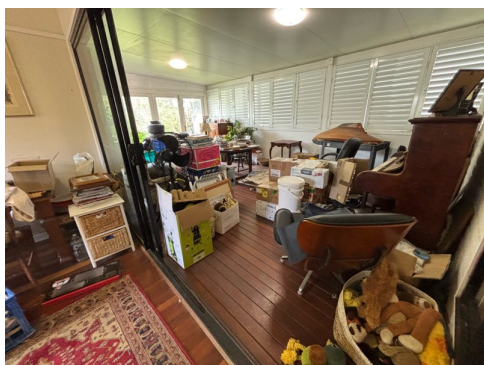
Finding: Obstructions and Limitations - Internal areas

Information: These photographs are an indication of the obstructions and limitations which impeded full inspection of the property of the internal areas at the time of inspection. These obstructions can hide an array of defects and should be removed to allow full inspection to be carried out. A re-inspection is recommended once the areas are made accessible.

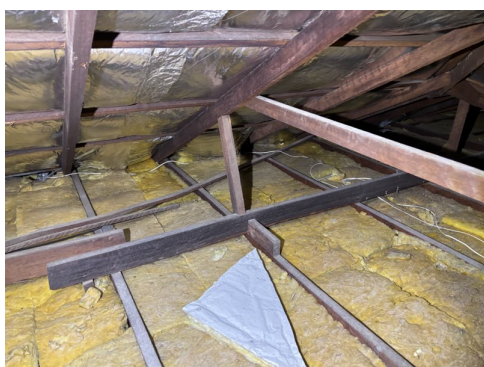
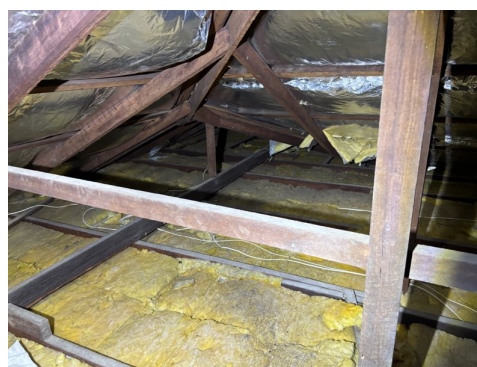
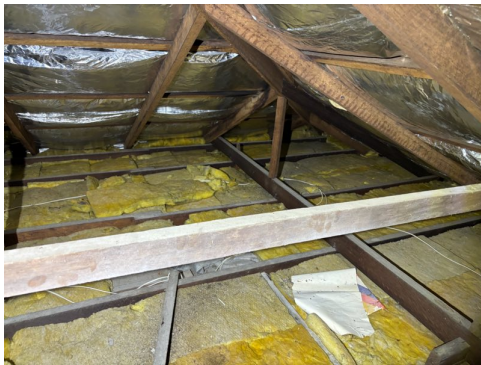
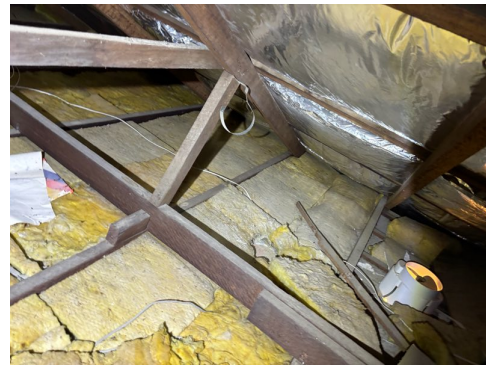
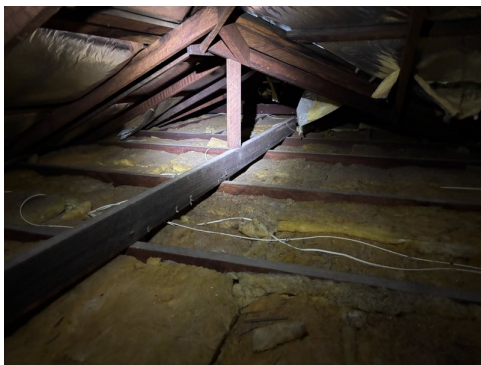
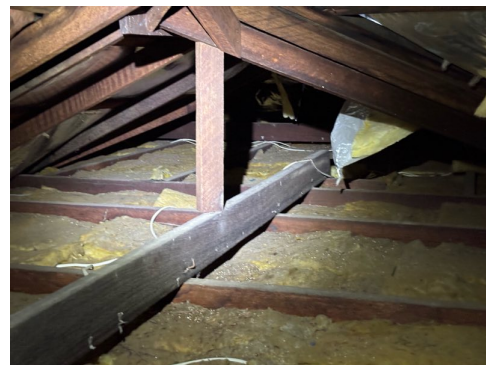
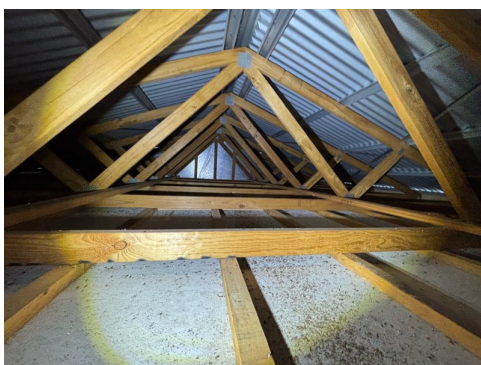
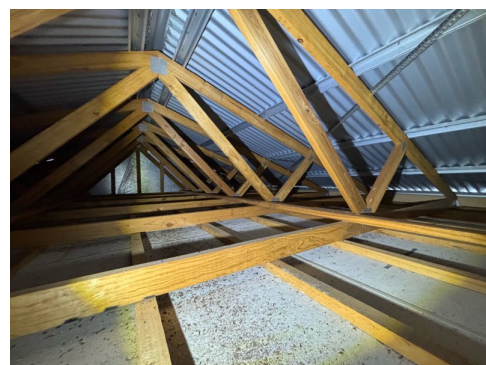
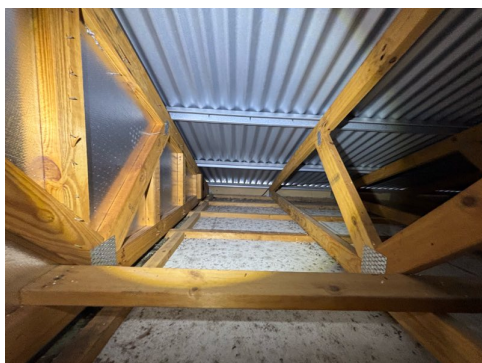
Finding: Obstructions and Limitations - Roof cavity

Information: These photographs are an indication of the obstructions and limitations which impeded full inspection of the property of the roof cavity at the time of inspection. These obstructions can hide an array of defects and should be removed to allow full inspection to be carried out. A re-inspection is recommended once the areas are made accessible.

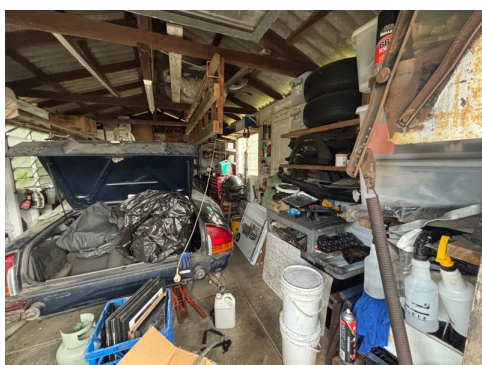
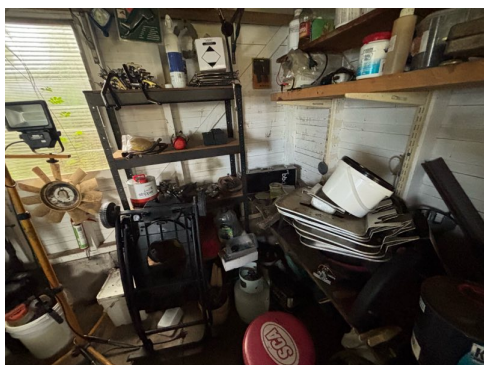
Finding: Obstructions and Limitations - External areas

Information: These photographs are an indication of the obstructions and limitations which impeded full inspection of the property of the external areas at the time of inspection. These obstructions can hide an array of defects and should be removed to allow full inspection to be carried out. A re-inspection is recommended once the areas are made accessible.

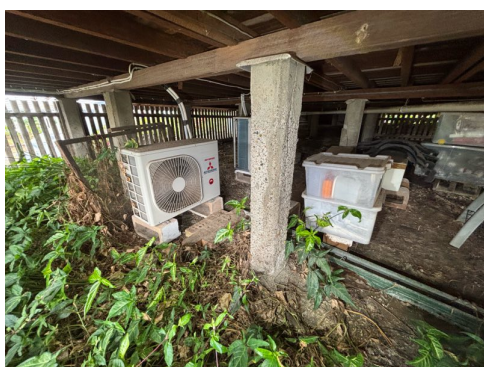
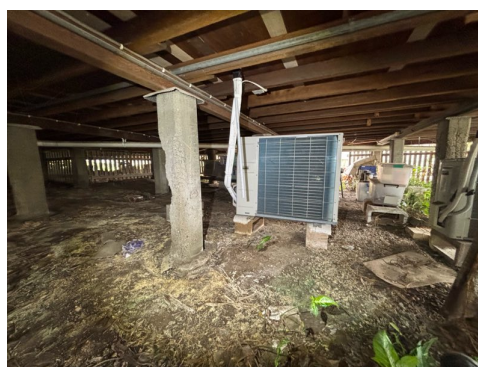
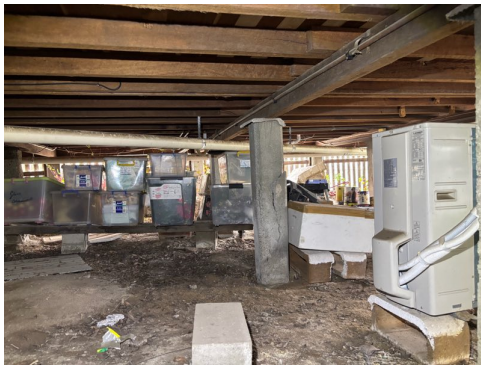
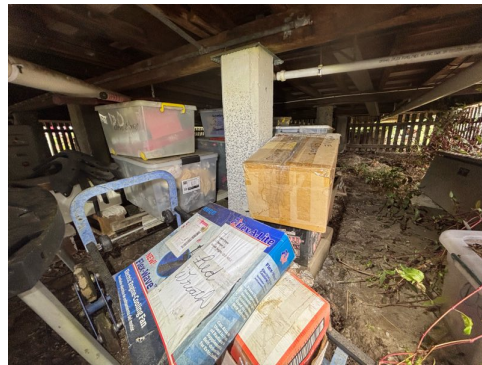
Finding: Obstructions and Limitations - Sub floor cavity

Information: These photographs are an indication of the obstructions and limitations which impeded full inspection of the property of the sub floor cavity at the time of inspection. These obstructions can hide an array of defects and should be removed to allow full inspection to be carried out. A re-inspection is recommended once the areas are made accessible.
