Inspection Report

BPP Inspections

10 Centre St, Aspley, QLD

Pest And Building InsP-ection

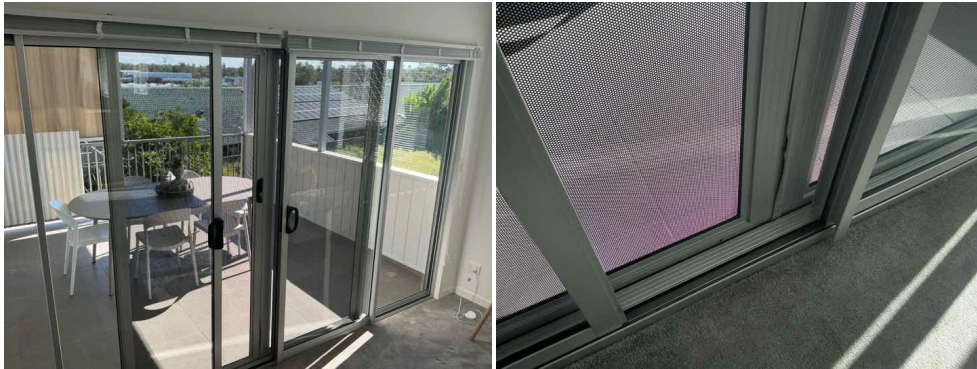
#1. The door rollers require maintenance to operate freely. Minor impact damage to the aluminium door edge.

Contact a lic carpenter.

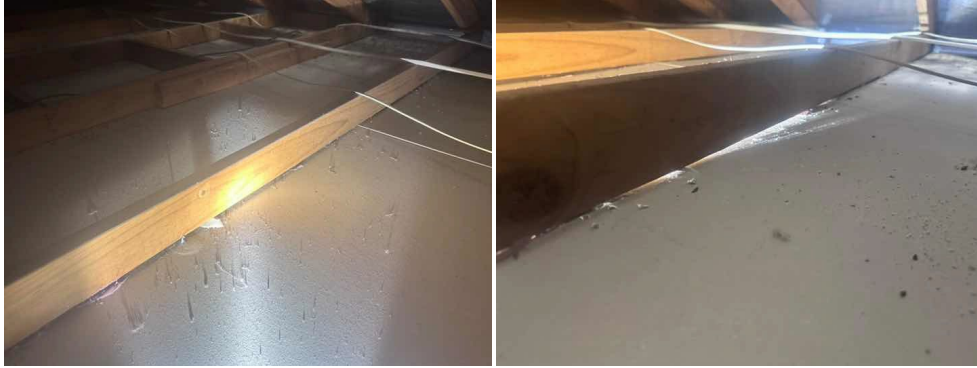
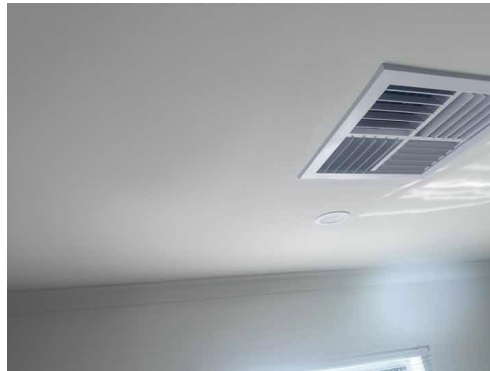
#2. Age and deflection/ sagging visible to selected ceilings throughout. This puts excessive weight on the original fasteners of the ceiling. Observed in ceiling void with gaps between timber truss and ceiling sheeting

Additional support screws may be required in areas. Contact a lic plasterer to assess and repair.

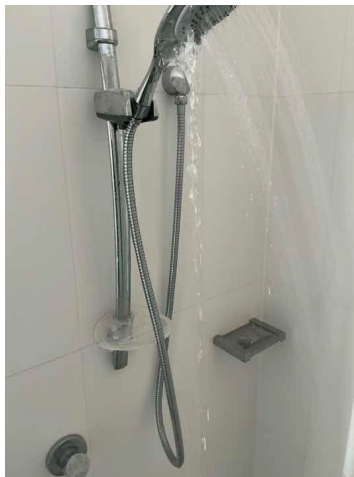
Shower And Bath

#4. Shower head is leaking. A qualified plumber should be engaged for advice and recommendations.

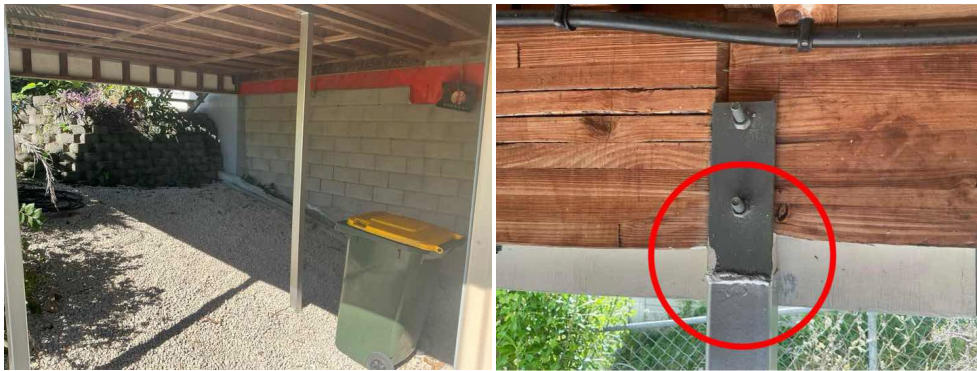
#5. On inspection, defects were present that will require further assessment.

Assess and install welded lugs to post to spread the load across more of the timber beam.

Contact a lic Builder to assess and repair as required.

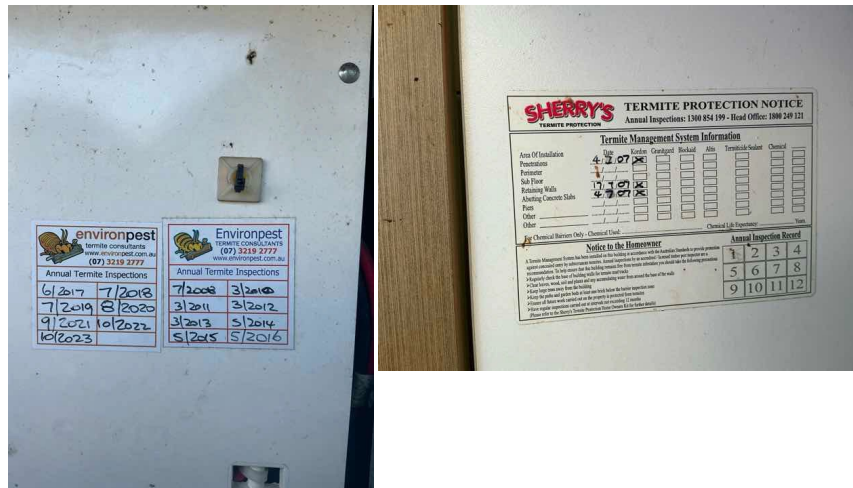
The durable notice is a permanent record of the previous treatment or termite barrier that has been carried out on a building.

We recommend that you read and understand this notice. Contact details should be clear. But regardless contact a licensed pest control technician to maintain the integrity of the barrier or treatment.
