# Seller disclosure statement

Property address     37 Alexander Street, Zillmere, Queensland 4034  
(referred to as the  
“property” in this  
statement)

## Inspection Address

**37 Alexander St, Zillmere, QLD**

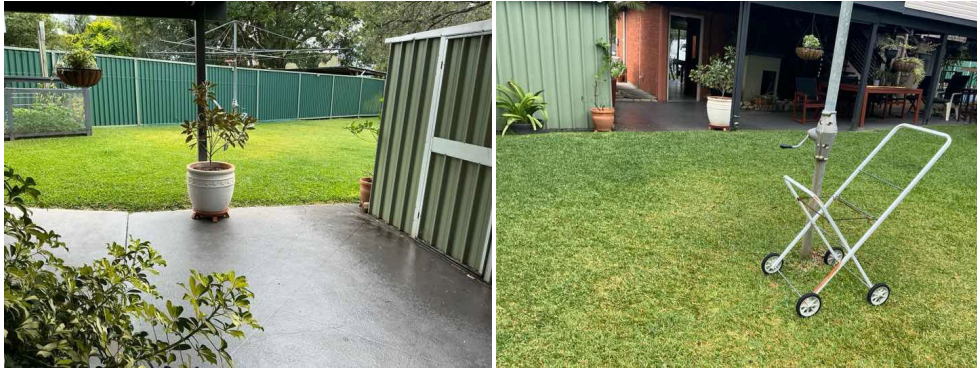
#1. The ground levels along the perimeter walls at the rear of the home did not appear to fall away from the property walls sufficiently due to the natural landscape and contour. Recommendations: This will need to be assessed during a period of rainfall and if surface water appears to be entering the sub floor if applicable or ponding against the perimeter walls, engage a plumber or landscaper to assess and rectify as required. All drains should be regularly checked by a plumber and kept clean of debris to allow surface water to be carried away from the dwelling.

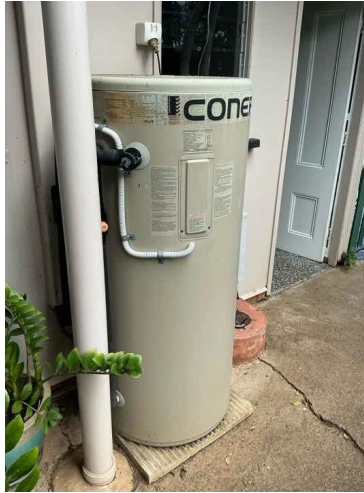
The hotwater unit gives an appearance of age and will likely require replacement in the foreseeable future.

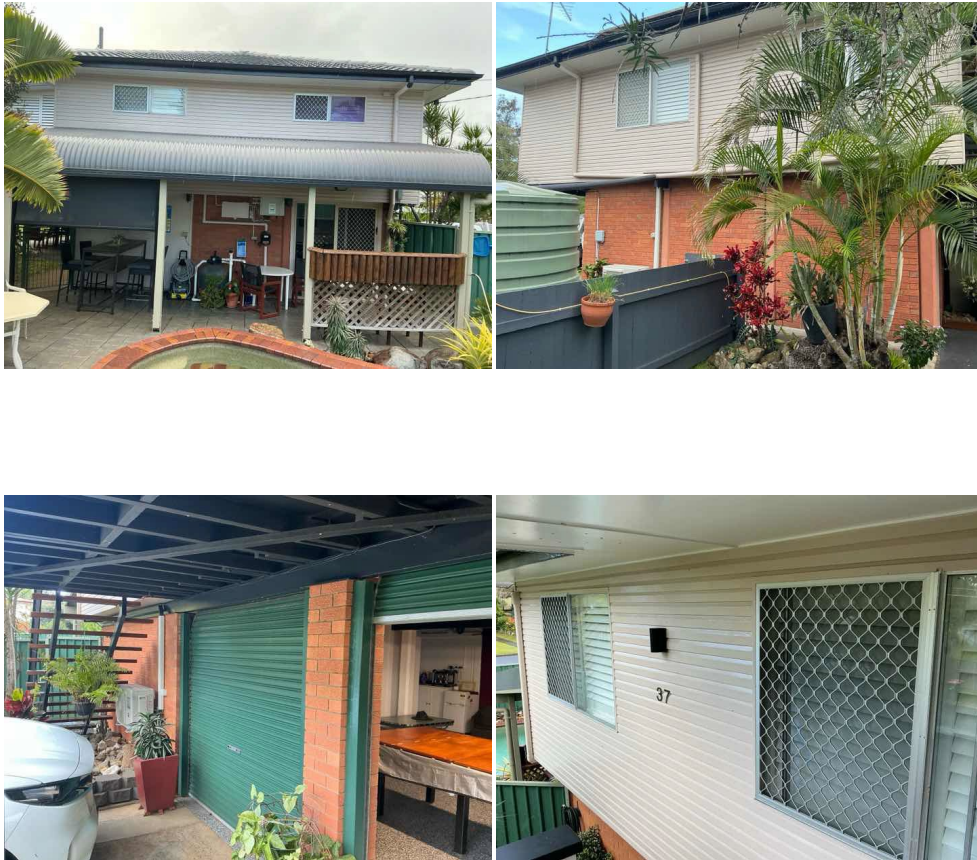
The building is a brick veneer base lower storey with lightweight cladding to the upstairs.

On visual inspection, the general condition of the exterior walls is serviceable for the age.

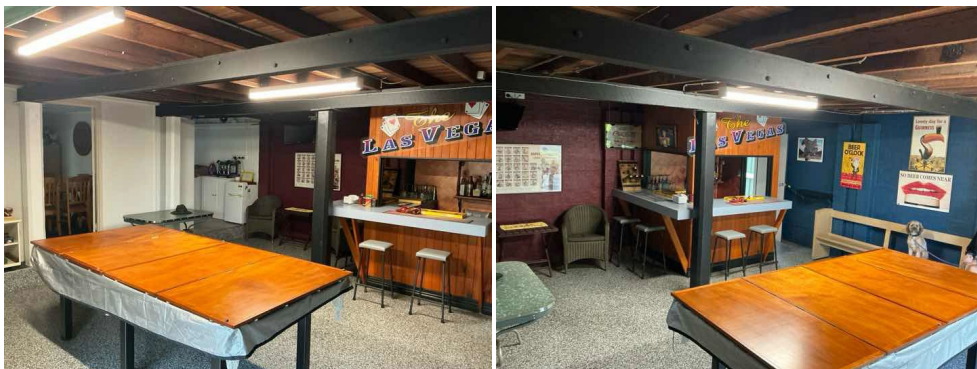
The rumpus room is in serviceable condition with no notable structural defects sighted.

Removal of support posts has occurred during the history of the building. The deflection appears minimal. No ability to fully inspect beam loading, supports or foundations is possible within this inspection.

Contact a lic Engineer to assess if required.

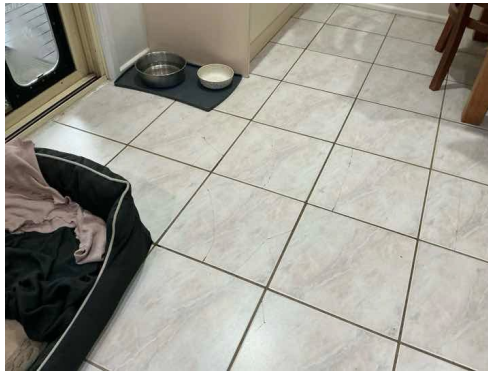
#3. Cracked floor tile, minor, assess and repair as required.

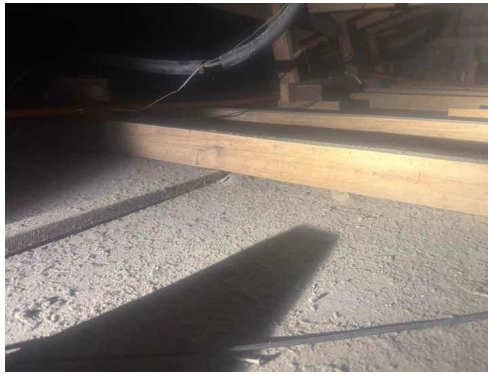
No insulation installed. Recommendations: Engage insulation contractor to assess.

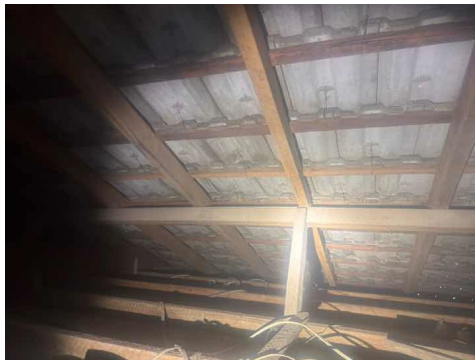
There is no sarking installed. Sarking is the layer of reflective film material installed during construction underneath the roofing material. It provides a moisture barrier and minimal insulation. The installation of sarking is not a building requirement.

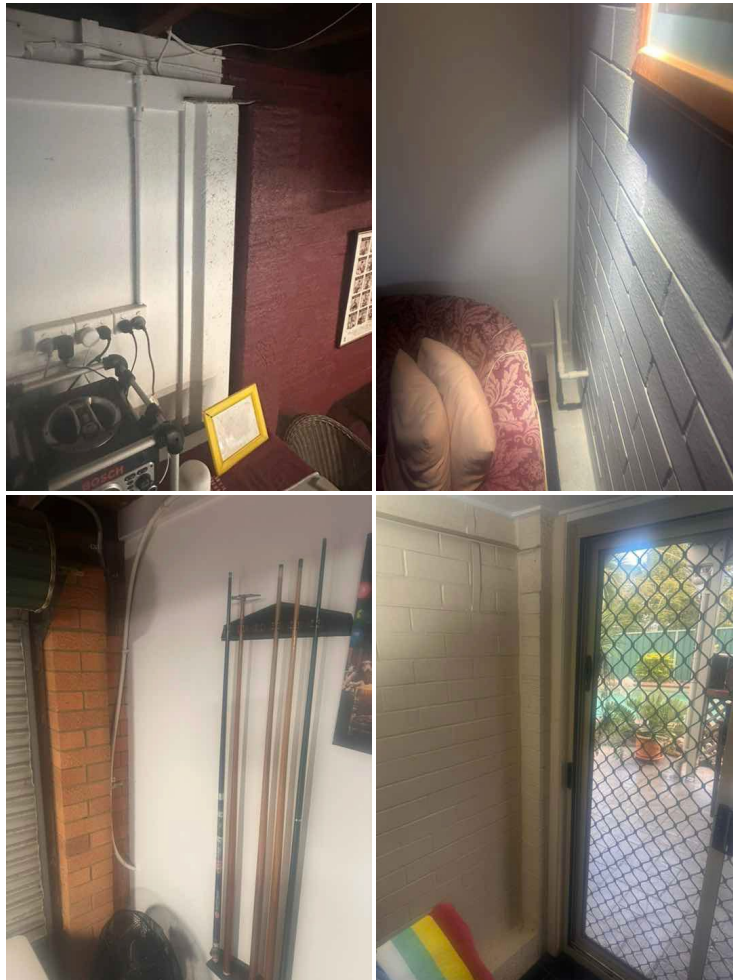
The termite shields ( ant caps ) are inadequate

Areas where the ant capping is breached by covering and enclosing. This provides a concealed entry point for termites in an area that is unable to be visually inspected. Activity or damage may exist in concealed areas such as the downstairs areas where walls are unprotected.
