Inspection Report

BPP Inspections

68 Rushworth St, Bald Hills, QLD

Pest And Building InsP-ection

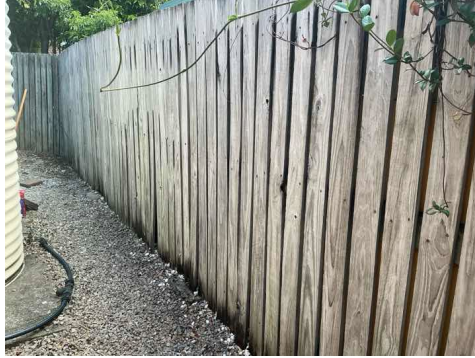
#1. General age to fence components - Recommendations: General upkeep and maintenance. A qualified fencing contractor should be engaged for repairs

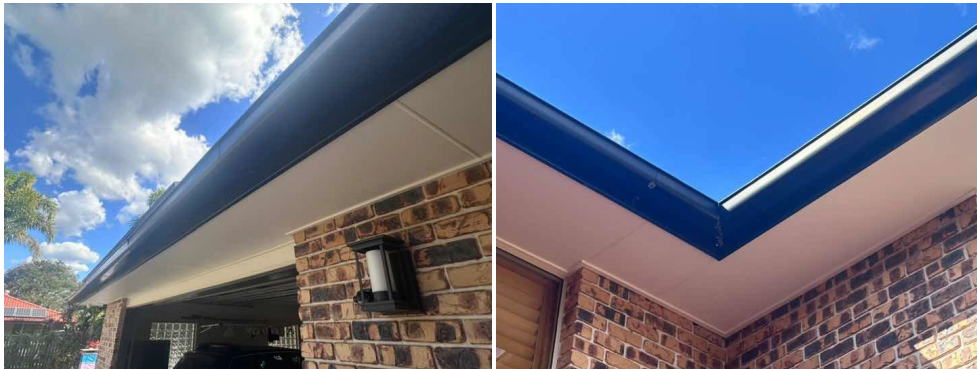
Gutter Findings

#2. Gutter surface rust in sections where joined. The rust is yet to penetrate and repairs/sealing may be an option. Recommendations: A qualified roof plumber should be engaged for advice and recommendations.

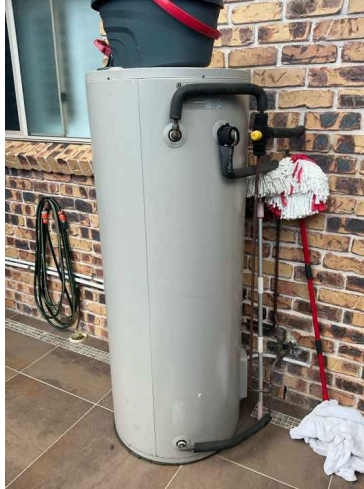
Hot Water Unit Findings

The hot water system appears to be in a serviceable condition. No specific tests other than running the hot water from a tap was carried out. No determination has been made as to the suitability or adequacy of the hot water system in relation to capacity or otherwise.

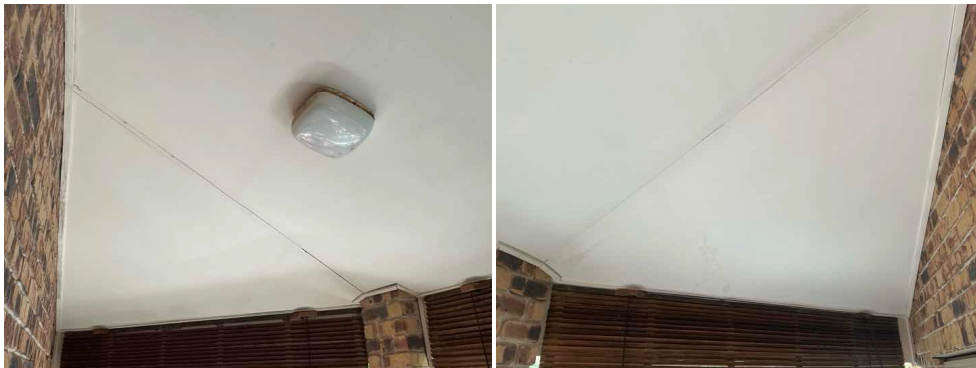
Frame Condition

#3. General movement observed to the ceiling joins , minor paint peel to plaster.

Contact a lic painter to assess and repair.

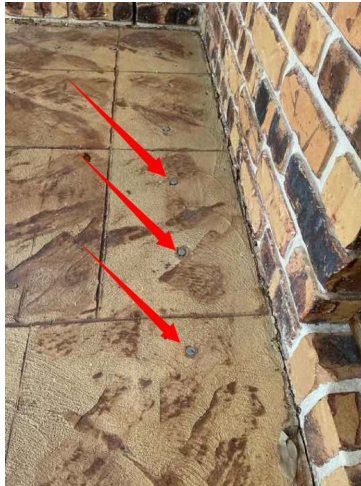
Yes, Drill Holes (Chemical Treatment) was seen at the property

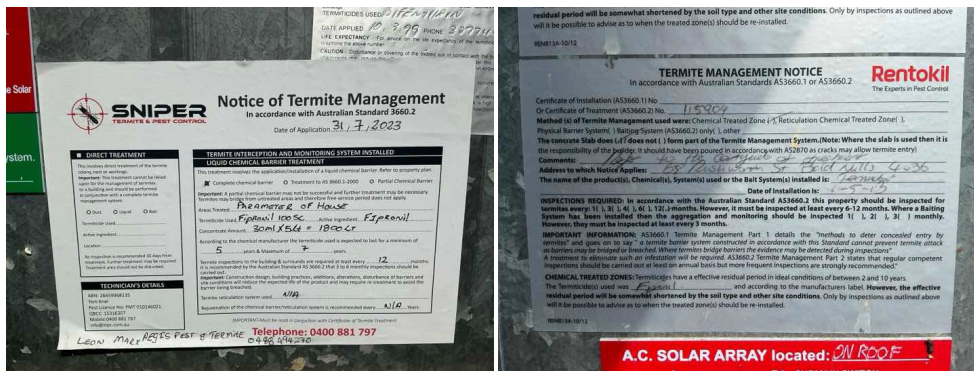
3.4 Durable Notice

The durable notice is a permanent record of the previous treatment or termite barrier that has been carried out on a building.

We recommend that you read and understand this notice. Contact details should be clear. But regardless contact a licensed pest control technician to maintain the integrity of the barrier or treatment.
