# Inspection Report

## BPP Inspections

9 Daffodil Close, Zillmere, QLD

### Pest And Building InsP-ection

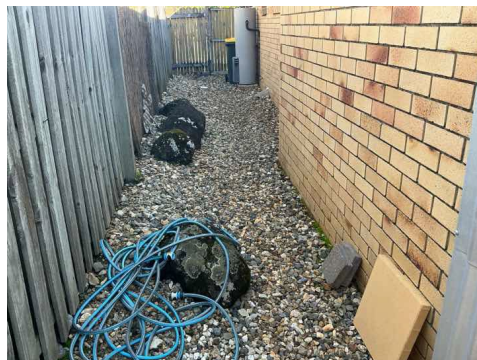
#2. The ground levels along the perimeter walls at the side of the home did not appear to fall away from the property walls sufficiently due to the natural landscape and contour. Recommendations: This will need to be assessed during a period of rainfall and if surface water appears to be entering the sub floor if applicable or ponding against the perimeter walls, engage a plumber or landscaper to assess and rectify as required. All drains should be regularly checked by a plumber and kept clean of debris to allow surface water to be carried away from the dwelling.

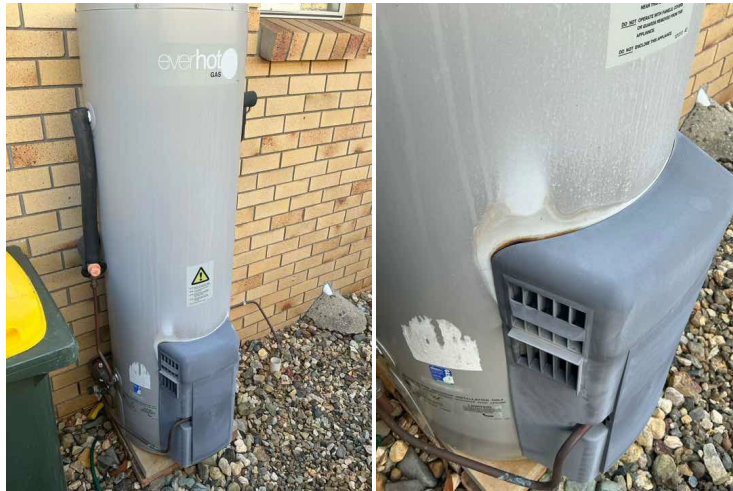
The hotwater unit gives an appearance of age and will likley require replacement in the foreseeable future.

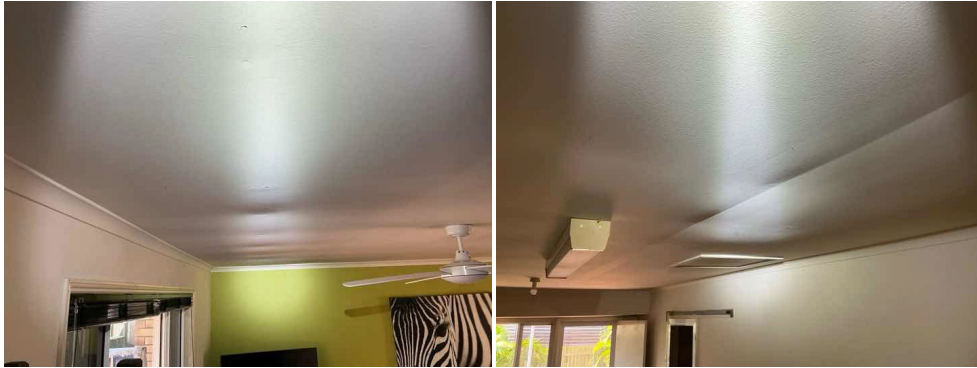
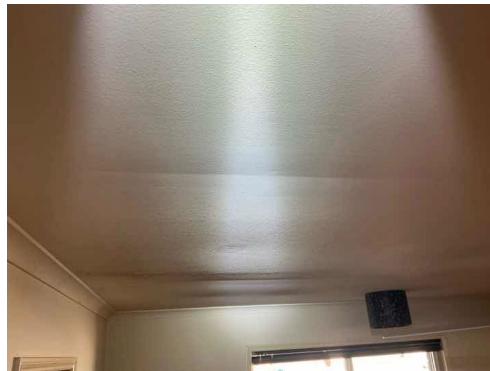
#3. Age and deflection/ sagging visible to selected ceilings throughout. This puts excessive weight on the original fasteners of the ceiling.

Additional support screws may be required in areas. Contact a lic plasterer to assess and repair.

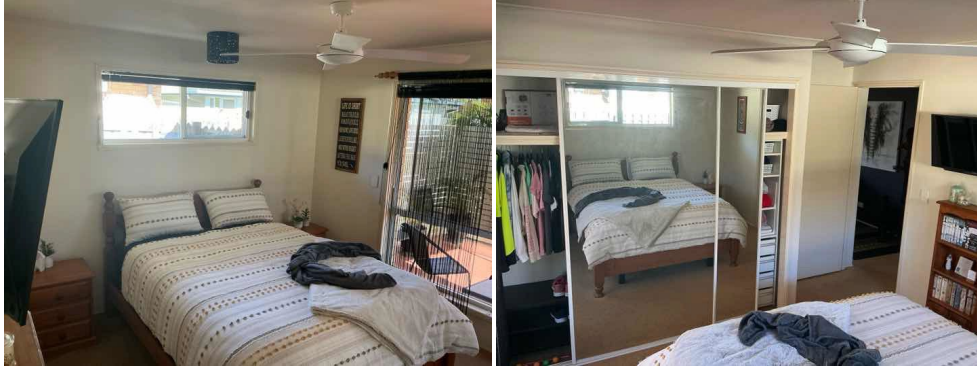
#4. Bedroom door binding when closed. Minor adjustments required. Contact a lic carpenter.

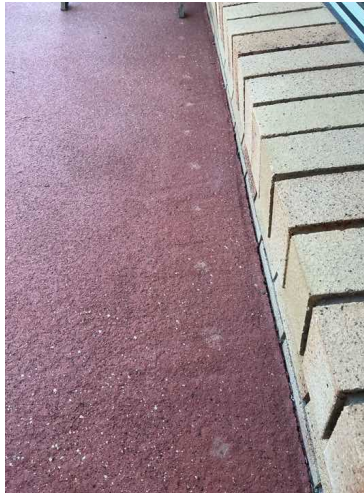
Yes, Drill Holes (Chemical Treatment) was seen at the property

In this case we strongly recommend that you engage the services of a licensed pest control technician to access and undertake an assessment of the property, to determine the procedure and costs involved with the installation of the recommended method of barrier installation, and termite control method.
