# Seller disclosure statement

9 Daffodil Close, Zillmere QLD 4034

## Inspection Address

9 Daffodil Close, Zillmere, QLD

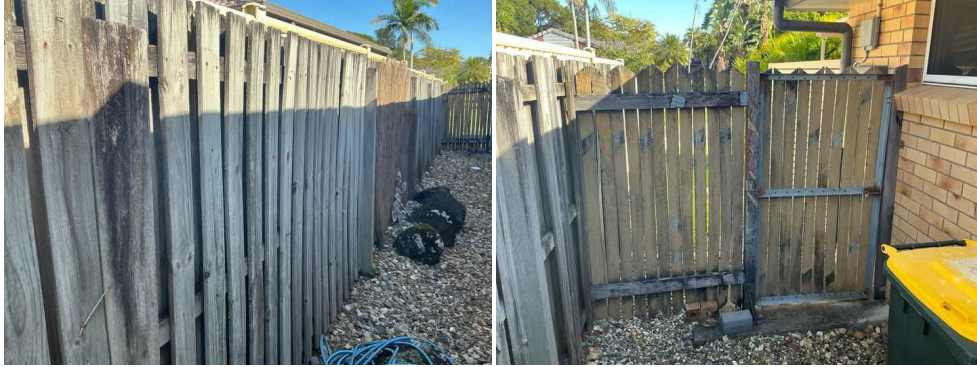
#1. General age to fence components - Recommendations: General upkeep and maintenance. A qualified fencing contractor should be engaged for repairs

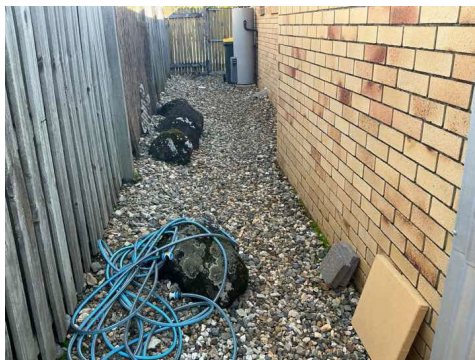
#2. The ground levels along the perimeter walls at the side of the home did not appear to fall away from the property walls sufficiently due to the natural landscape and contour. Recommendations: This will need to be assessed during a period of rainfall and if surface water appears to be entering the sub floor if applicable or ponding against the perimeter walls, engage a plumber or landscaper to assess and rectify as required. All drains should be regularly checked by a plumber and kept clean of debris to allow surface water to be carried away from the dwelling.

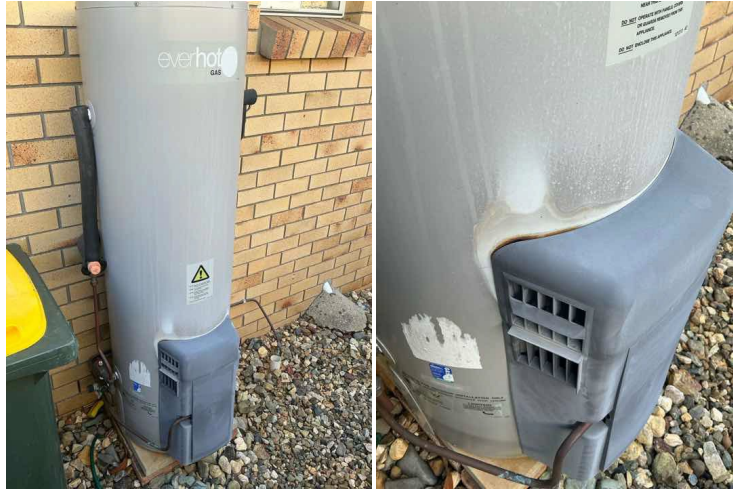
The hotwater unit gives an appearance of age and will likely require replacement in the foreseeable future.

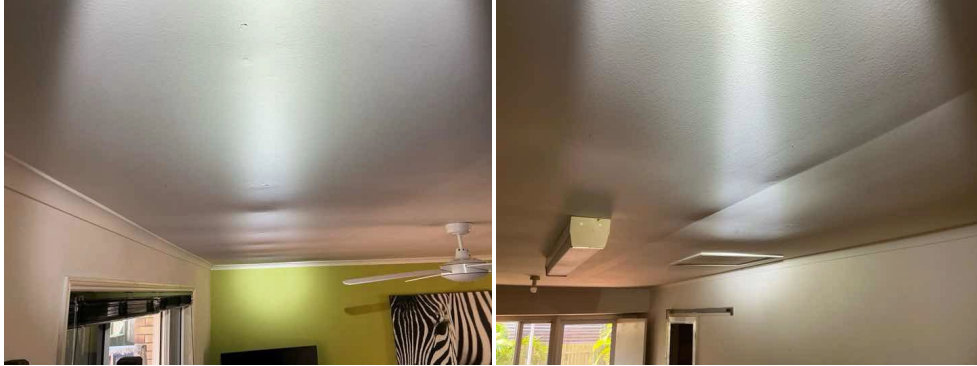
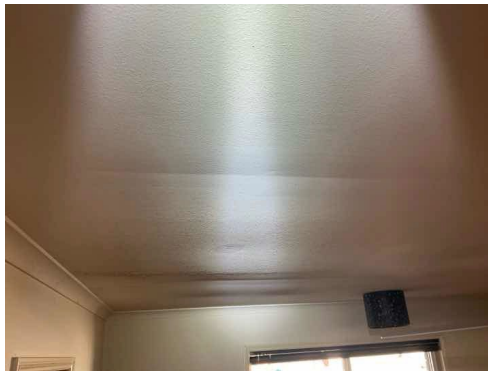
#3. Age and deflection/ sagging visible to selected ceilings throughout. This puts excessive weight on the original fasteners of the ceiling.

Additional support screws may be required in areas. Contact a lic plasterer to assess and repair.

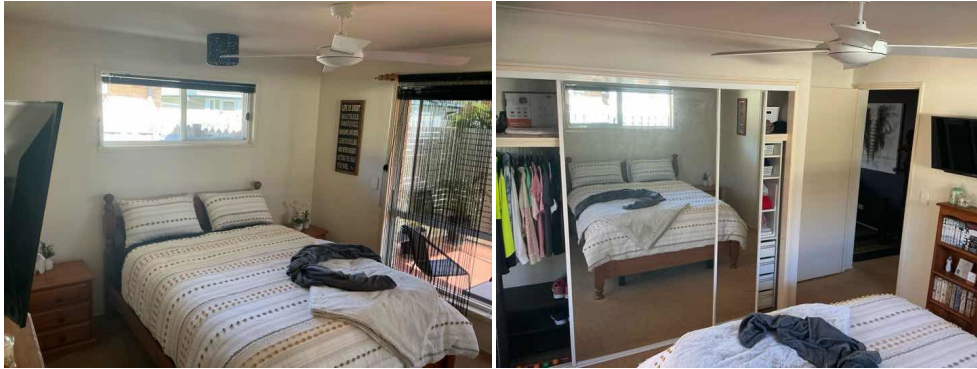
#4. Bedroom door binding when closed. Minor adjustments required. Contact a lic carpenter.

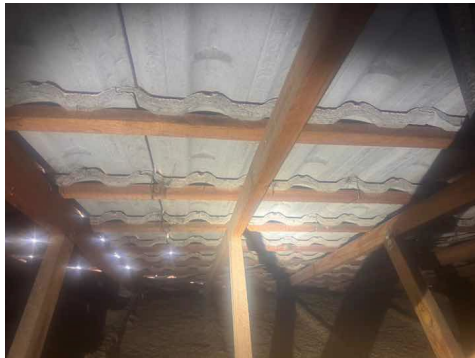
There is no sarking installed. Sarking is the layer of reflective film material installed during construction underneath the roofing material. It provides a moisture barrier and minimal insulation. The installation of sarking is not a building requirement.

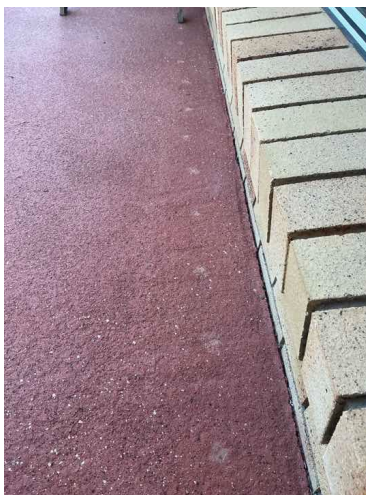
Yes, Drill Holes (Chemical Treatment) was seen at the property
