# Inspection Report

## BPP Inspections

**60 Gilles St, Zillmere, QLD**

### Pest And Building InsP-ection

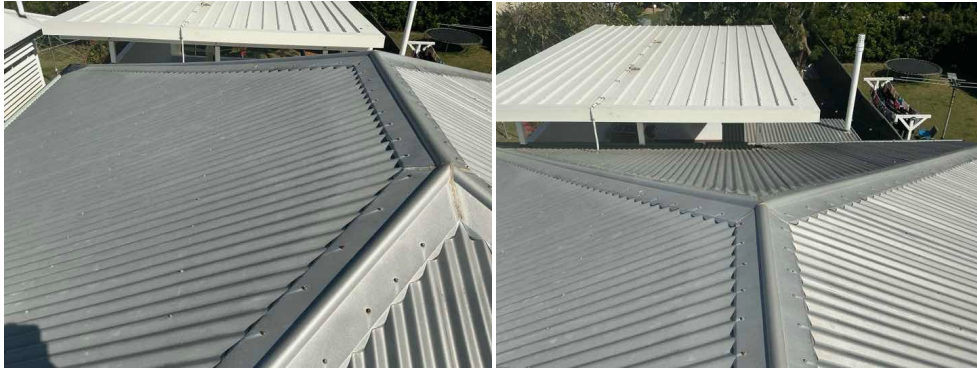
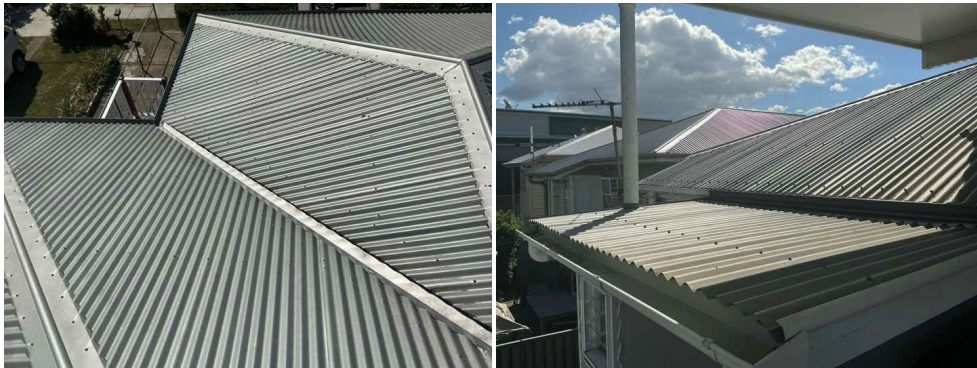
Of the visible areas, the general condition of the roof is in serviceable condition for the age.

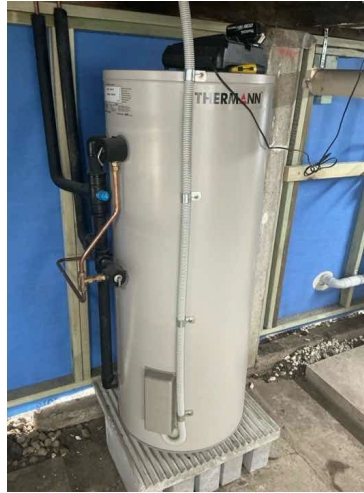
The hot water system appears to be in a serviceable condition. No specific tests other than running the hot water from a tap was carried out. No determination has been made as to the suitability or adequacy of the hot water system in relation to capacity or otherwise.

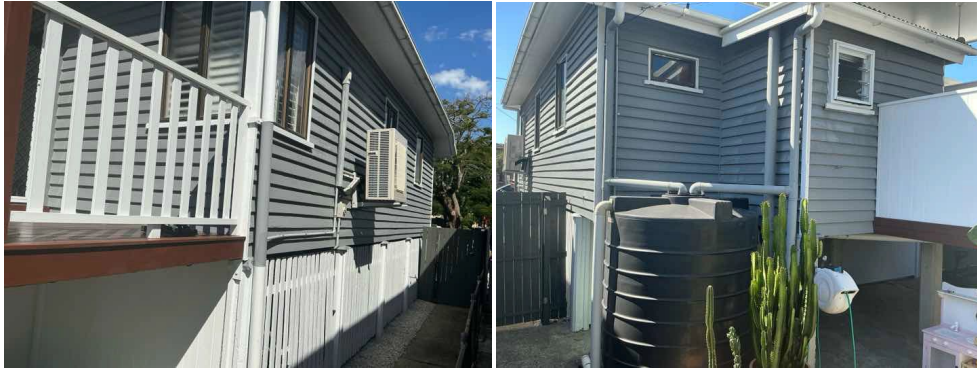
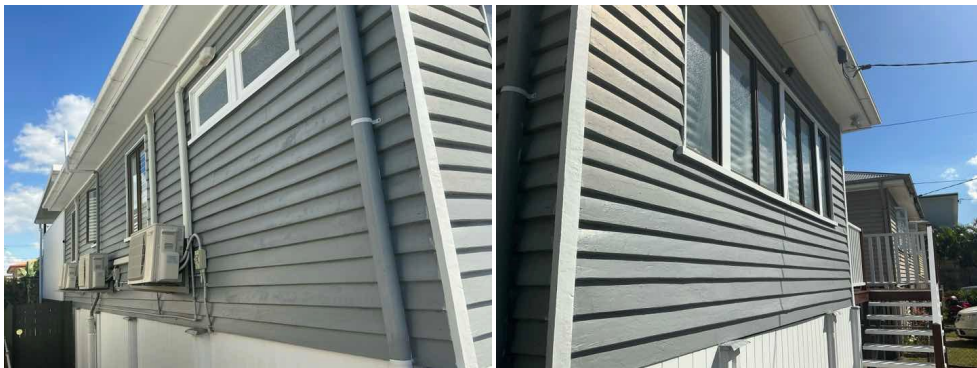
On visual inspection, the general condition of the exterior walls is serviceable for the age.

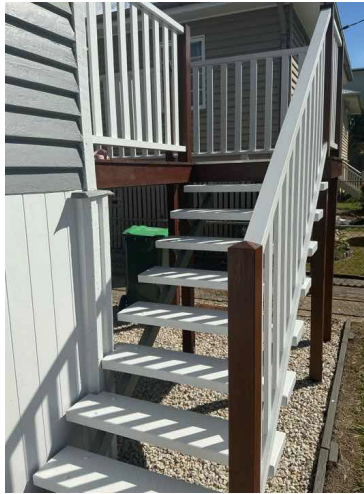
#1. There is no handrail present on the house edge of the staircase. The maximum allowable opening is 125mm for a height greater than 1 m. This should be rectified as is a safety concern.

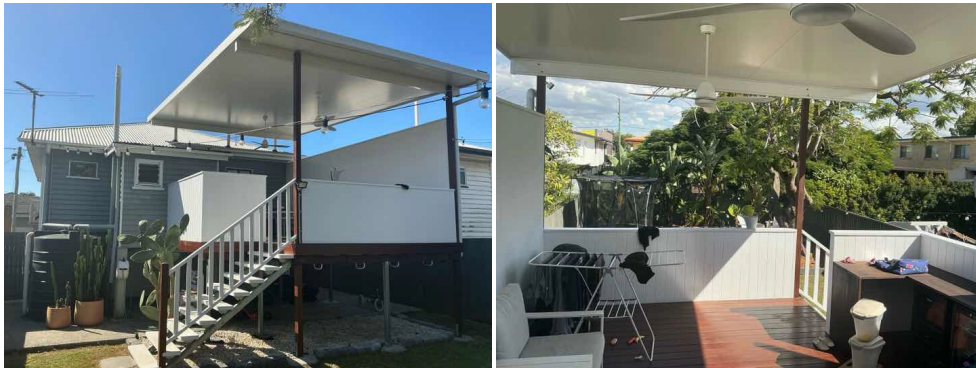
Of areas visible, the decking appears to be in a serviceable condition.

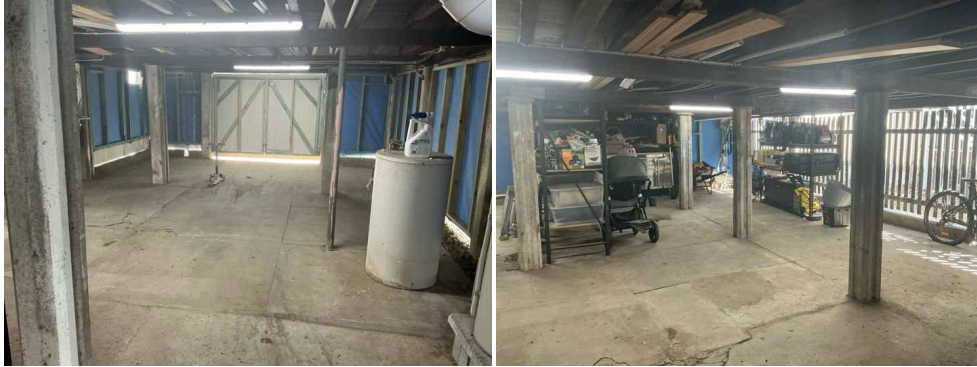
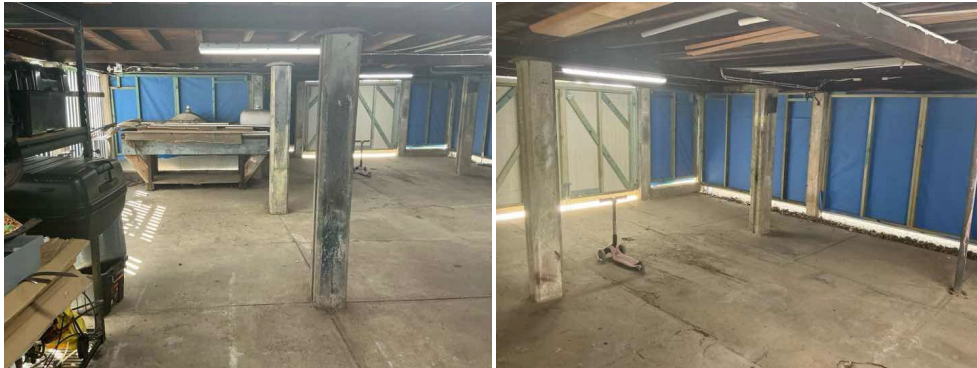
Of areas accessible and visible, the subfloor and components appeared to be in a serviceable condition.
