**BRISBANE BUILDING  
& PEST INSPECTIONS**

# **Pre Purchase Building and Timber Pest Report**

Inspection Date: 19 Jun 2026

Property Address: 22 Gawain Road Bracken Ridge 4017

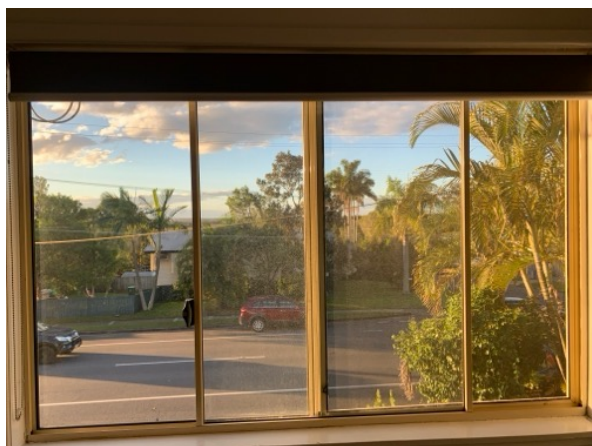
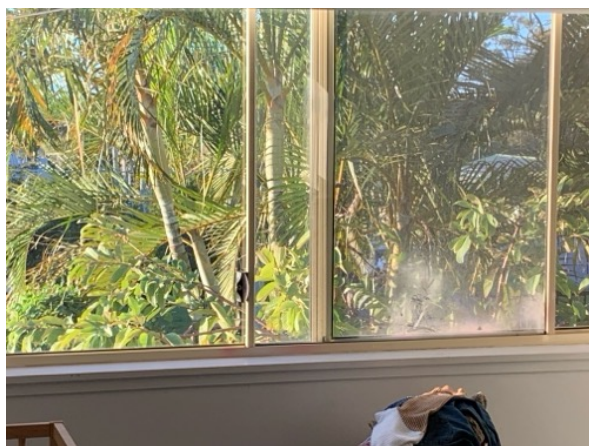
### Serious Safety Hazard 1.01

If the lowest part of window opening is less than 1700mm from floor level and 2metres above ground from the sill. If it is reasonable for a person to access the opening ie double bunks and a gap a 125 sphere can push through a window limiter is required.

A simple fly screen is not sufficient. Recommend installing window limiters to prevent potential falls from height.

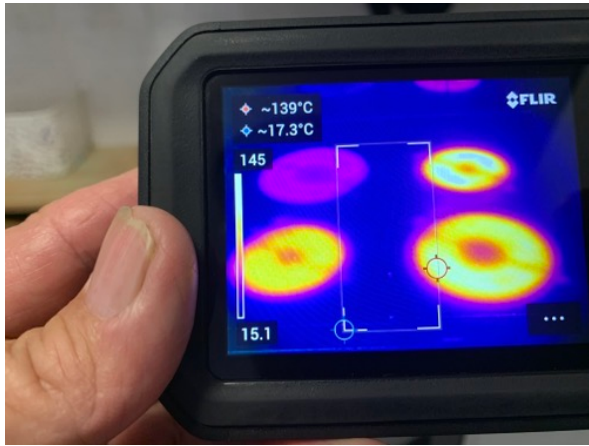
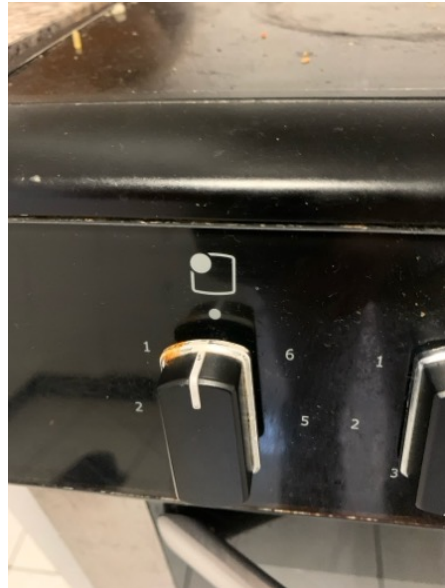
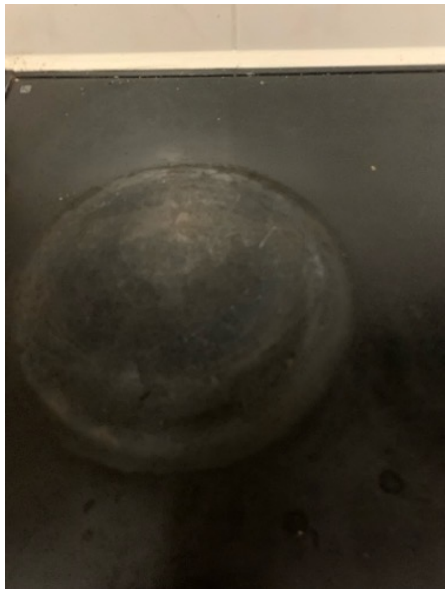
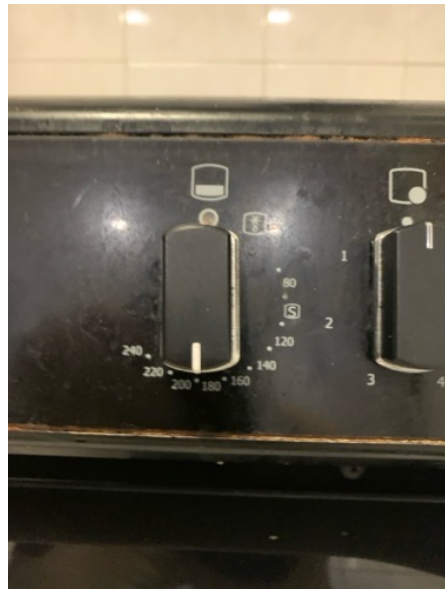
### Serious Safety Hazard 1.02

**Location:** Kitchen

**Finding:** Oven

In the kitchen, there is a critical safety issue concerning the stovetop and oven. The thermal image indicates that the rear left burner does not function correctly, potentially leading to uneven heating or non-responsive temperature control, which poses a risk of fire or injury. Additionally, the dials located at the front of the stovetop and above the oven require immediate adjustment and repair. These controls are crucial for the precise management of cooking temperatures and must comply with the necessary safety standards. It is strongly recommended that the faulty components be assessed and repaired by a licensed and practicing appliance electrician. The necessary adjustments should align with the applicable safety standards, ensuring all repairs adhere to AS/NZS 60335 standards, which govern the safety of household electrical appliances. Failure to address these issues promptly could compromise safety, operational efficiency, and compliance with regulatory standards.

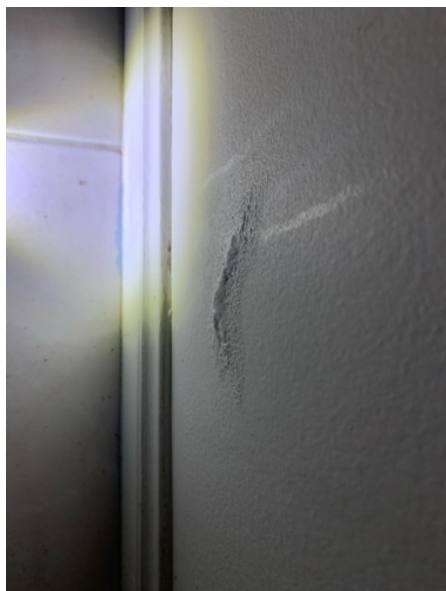
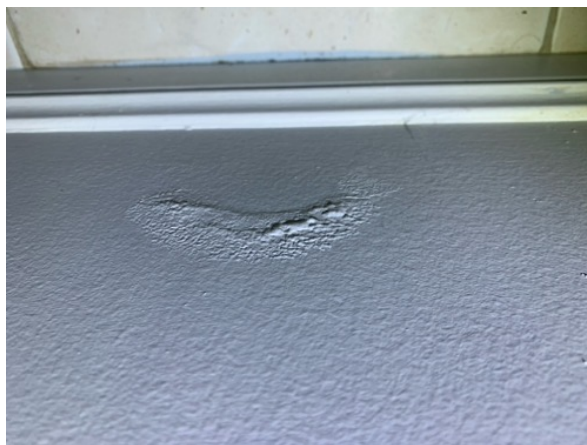
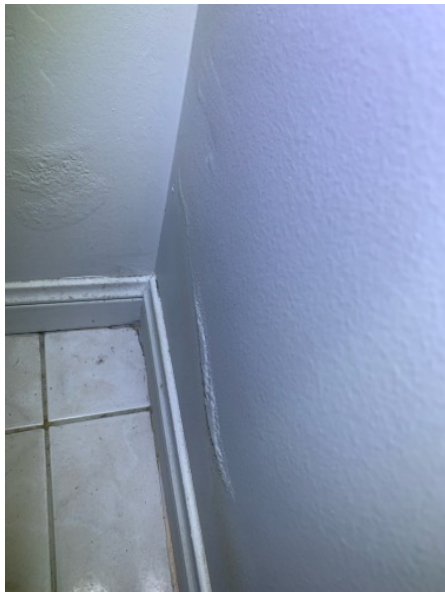
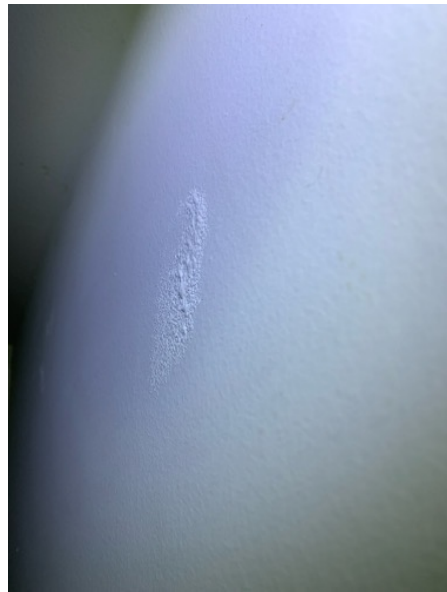
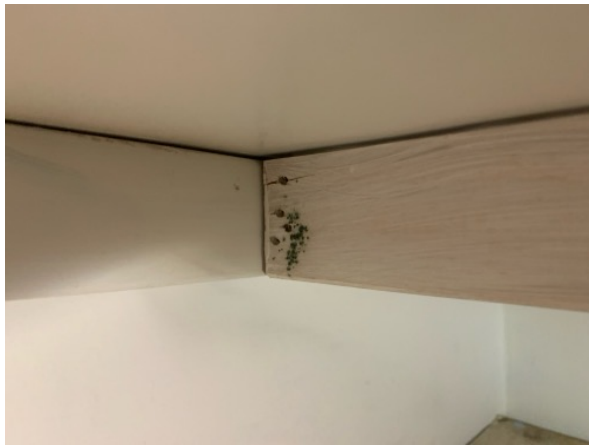
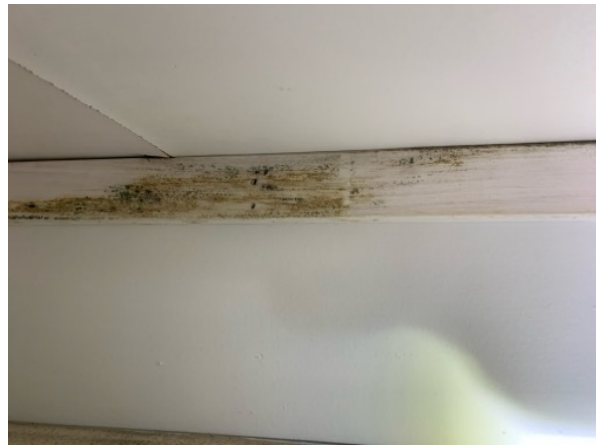
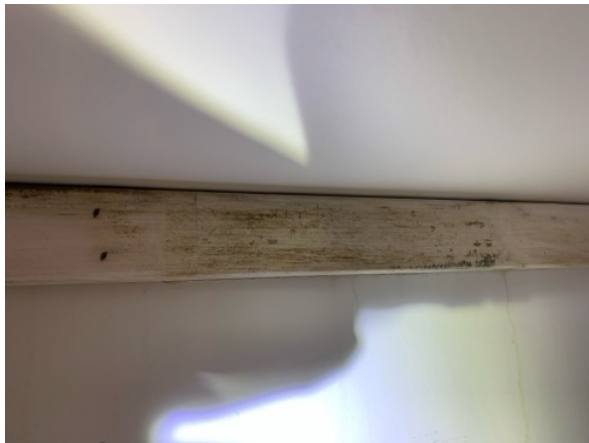
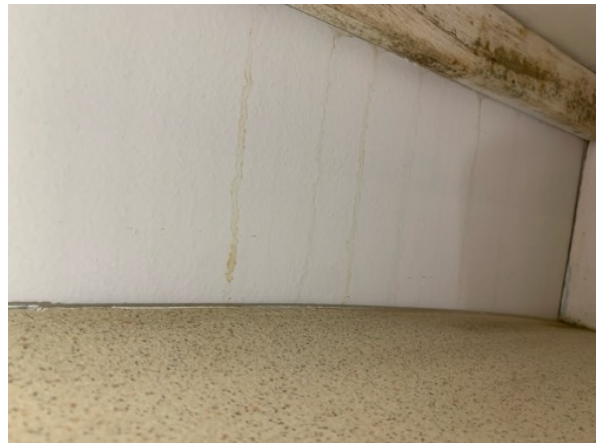
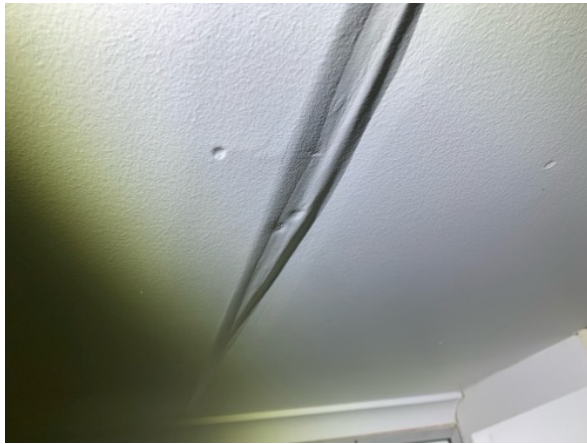
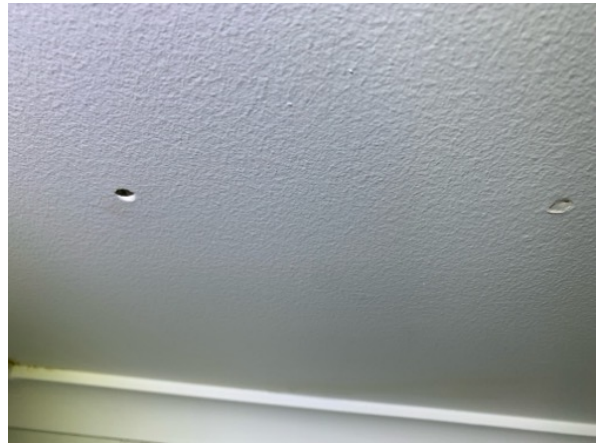
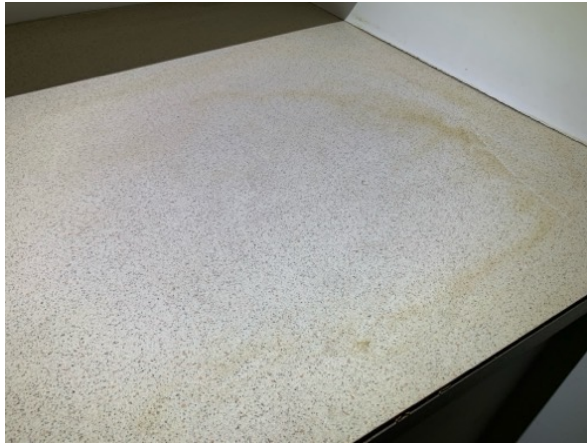
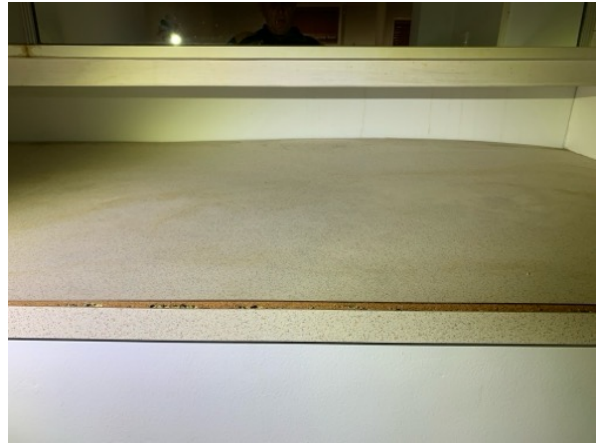
## Major Defect 2.01

Upon inspection of the designated area behind the bar on the ground floor, several defects indicating significant water damage and ongoing moisture issues have been identified. The plaster walls exhibit signs of paint bubbling, which can be symptomatic of underlying water infiltration, although no mold is currently visible. Further deterioration is evidenced by water tracks along the walls and a noticeable sag in the ceiling structure, which necessitates a comprehensive plumbing inspection to ascertain potential leakage sources. This deficiency is further apparent in the timber framework, particularly on the upper floor level above this area, displaying clear water stains and swelling consistent with prolonged exposure to moisture.

The shelving unit situated within the affected area also shows signs of severe water damage. The particle board material of the shelves exhibits staining and expansion, indicative of recurring exposure to moisture, which is coupled with evident swelling. Such impairments suggest that the water damage is not a one-time occurrence but rather an ongoing issue requiring immediate attention.

In alignment with [mention any relevant national standards, e.g., AS 4349.1], it is recommended to conduct a thorough plumbing inspection. This should include removing a portion of the ceiling sheet to facilitate a detailed examination of the waterproofing and any waste pipes servicing bathrooms or kitchens located above the affected region. For remedial action, any detected leaks should be rectified promptly, and the damaged building materials should be replaced to prevent future structural degradation and potential health hazards associated with prolonged moisture exposure.

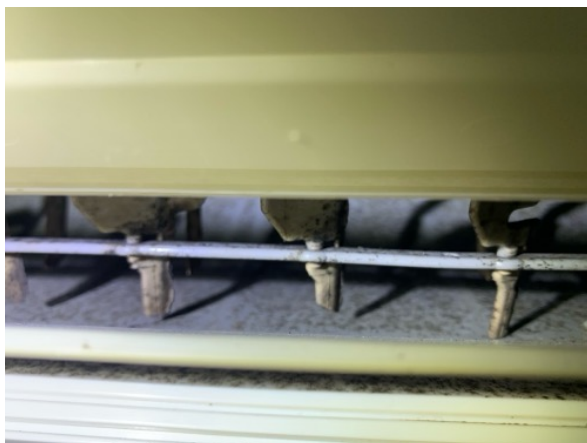
## Major Defect 2.02

**Location:** Living area

**Finding:** Air conditioning system - Maintenance

During the inspection, it was observed that there is evidence of dust and mould present within the air conditioning system. This is a potential defect that requires attention and maintenance. The accumulation of dust and mould in the air conditioning system can lead to poor indoor air quality and may pose health risks to occupants, particularly those with respiratory conditions or allergies.

It is recommended that the air conditioning system be thoroughly cleaned and maintained by a qualified professional to ensure optimal performance and to mitigate any potential health hazards associated with the presence of dust and mould.

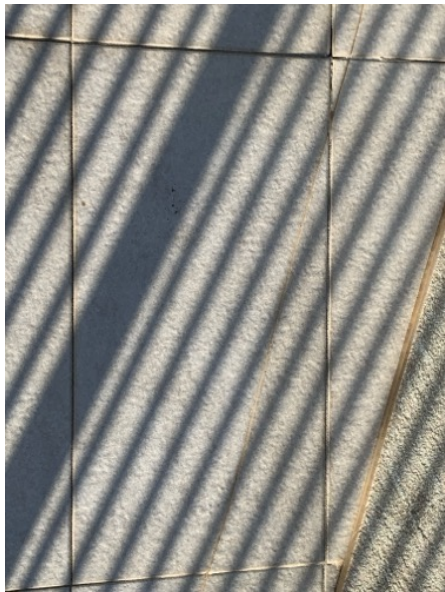
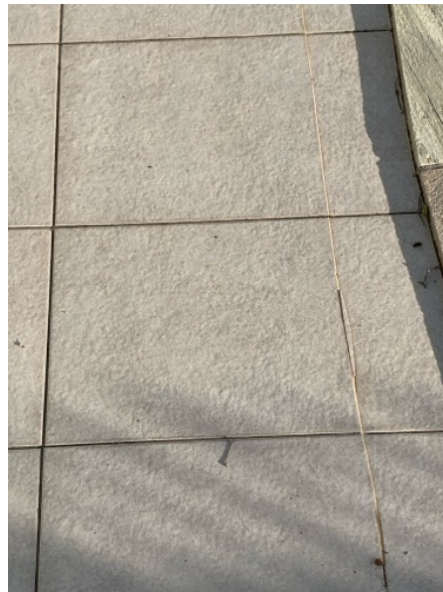
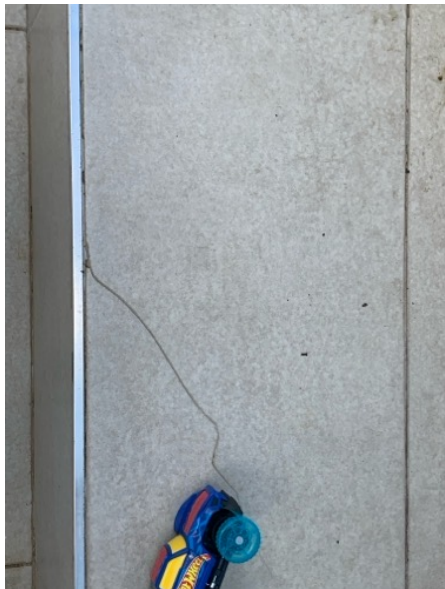
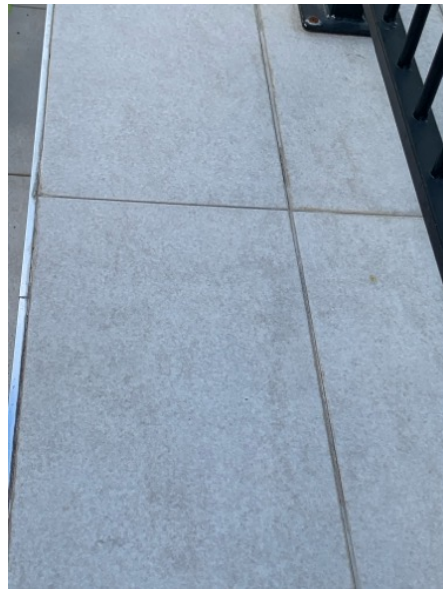
### Minor Defect 3.01

**Finding:** Tiling

Upon inspection of the rear of the property, a notable defect has been identified in the form of numerous drummy tiles located in the covered patio area and around the side of the pool. This condition typically arises from suboptimal installation practices, specifically inadequate adhesive application. The lack of sufficient adhesive coverage not only compromises the structural integrity of the tiling but also poses potential safety hazards. In accordance with the relevant standards, particularly AS 3958.1-2007 Ceramic Tiles – Guide to the Installation of Ceramic Tiles, it is advisable that the affected areas be promptly addressed. Remedial action should include the careful removal and re-installation of the affected tiles, ensuring full adhesive coverage to prevent future occurrences. A qualified tiling professional should be engaged to undertake this task, ensuring adherence to the aforementioned standards and guaranteeing the longevity and safety of the tilework.

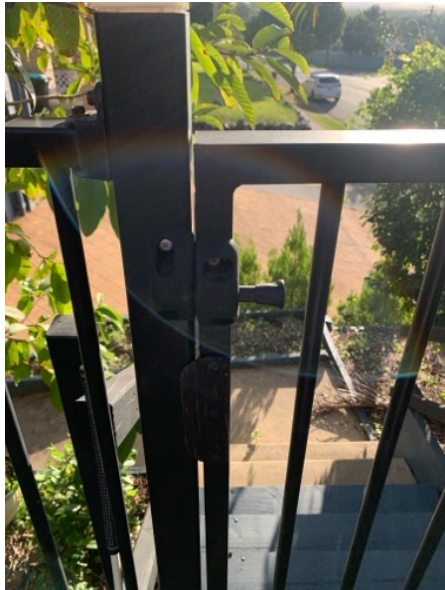
## Minor Defect 3.02

**Location:** Front Stairs

**Finding:** Gate

The gate located at the front stairs is experiencing binding on the frame, resulting in operational difficulty. Adjustment is necessary to enhance its function and ensure smooth access. It is recommended to realign or adjust the hinges and latch mechanism to rectify the binding issue, adhering to AS 1926.1 standards. This remedial action will restore proper operation and maintain compliance with relevant safety regulations.

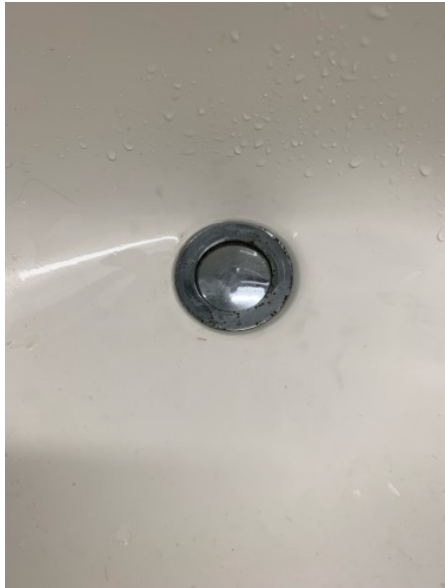
### Minor Defect 3.03

**Location:** Ground Floor

**Finding:** Plunger plug - Degraded

During the assessment of the property, it was observed that the plunger plug in the bathroom basin exhibited a defect of sticking. The plunger plug, when pressed down to close the drain, did not smoothly return to its original position upon release. Instead, it remained partially or fully depressed, impeding the proper drainage of water from the basin. This defect may result in inconvenience and potential water overflow if not promptly addressed. It is recommended that a qualified plumber be engaged to rectify this issue and ensure the proper functioning of the plunger plug in the bathroom basin.

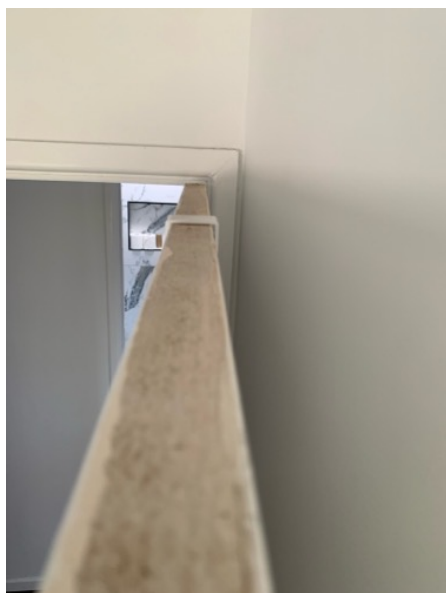
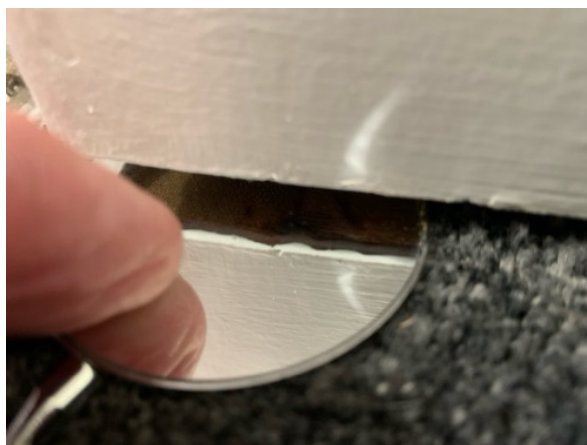
## Minor Defect 3.04

**Location:** All Internal Areas

**Finding:** Paint finish - Incomplete. Top and bottom of doors require painting.

The door located internally and exhibits a defect concerning its finishing, compromising the quality and long-term durability expected. The surfaces, particularly the top and bottom edges, have not been adequately treated, lacking the necessary priming and painting required for proper sealing. This oversight fails to safeguard the door against moisture absorption, potentially leading to issues such as warping or delamination over time. To rectify this defect, it is recommended that the door be properly primed if not pre-primed, followed by an application of an undercoat and two coats of paint on all six sides, ensuring uniform color and finish throughout. This action is aligned with the relevant standards, including AS 2311: The Painting of Buildings, which mandates complete sealing to maintain structural integrity and uphold the manufacturer's warranty. Prompt rectification is advisable to prevent potential damage and maintain compliance with standard construction practices.

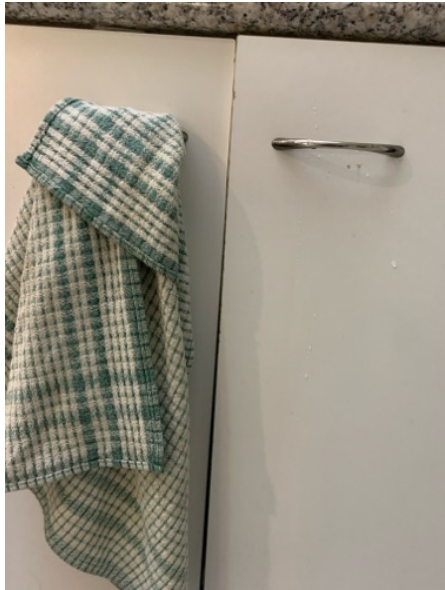
## Minor Defect 3.05

**Location:** Kitchen

**Finding:** Kitchen cupboard doors

The doors are not aligned correctly and do not shut adequately, Adjustments are required to the doors.

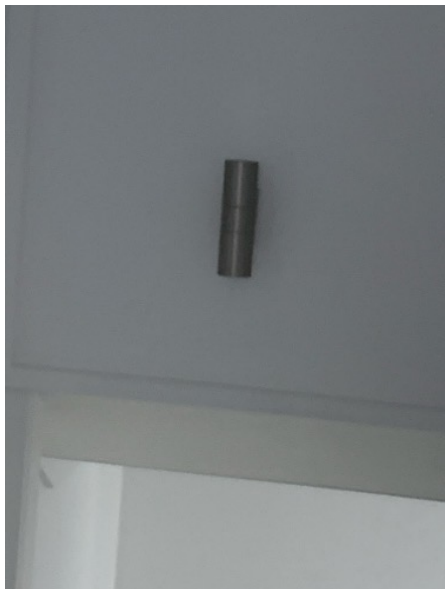
## Minor Defect 3.06

**Location:** Stairwell

**Finding:** Lighting

During the inspection of the stairwell, it was observed that the light globe had been removed due to a strobe effect occurring when the light was activated. This phenomenon may indicate potential issues with the light fixture or wiring, necessitating professional evaluation. To ensure safety and compliance with electrical standards, it is strongly recommended that a licensed and practicing electrician be engaged to inspect the wiring and repair or replace the light fixture as necessary. The presence of a strobe effect could be symptomatic of fluctuating current or incompatible bulb types, which could pose safety hazards and compromise residential lighting standards. In accordance with AS/NZS 3000:2018, electrical installations must be maintained in a manner that ensures the safety of the property occupants. Prompt remedial action is advised to mitigate any risk associated with electrical malfunction and to restore the functionality of the lighting system in the stairwell.

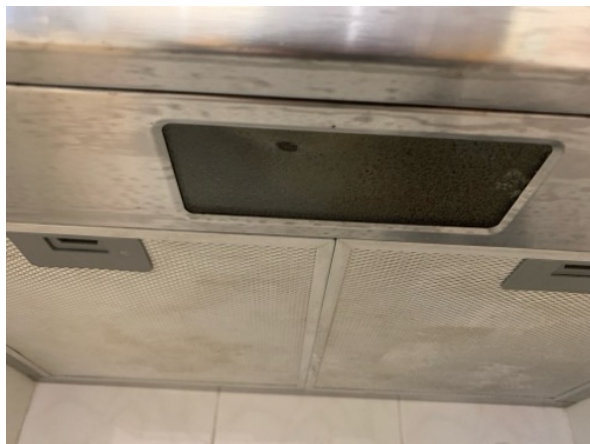
## Minor Defect 3.07

**Location:** Kitchen

**Finding:** Overhead exhaust - Blown light bulbs

Recommend replacing light bulbs to overhead exhaust, If light bulbs do not operate after replacing see a licensed electrician for fault finding.

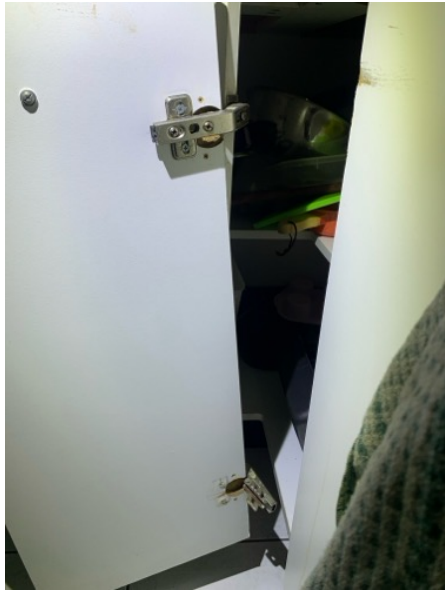
## Minor Defect 3.08

**Location:** Kitchen

**Finding:** Cupboards

Upon inspection, it was observed that the internal kitchen cupboard doors exhibit significant damage, specifically related to the hinges, which are notably loose. This condition compromises the structural integrity and functionality of the doors, potentially leading to further deterioration if left unaddressed. It is imperative to engage a licensed cabinetmaker to conduct necessary repairs or replacements, ensuring alignment with relevant industry standards such as AS 4386-2000 for domestic kitchen assemblies. Immediate remedial action should involve the tightening of existing hinges or replacing them if they have sustained irreparable damage. Additionally, it is advisable to inspect all similar fixtures within the kitchen to preemptively address any potential issues, thereby maintaining optimal kitchen functionality and safety. Failure to undertake these repairs may result in exacerbated damage or operational hazards, impacting the overall usability of the kitchen. Timely intervention will preserve the aesthetic and practical quality of the kitchen space.

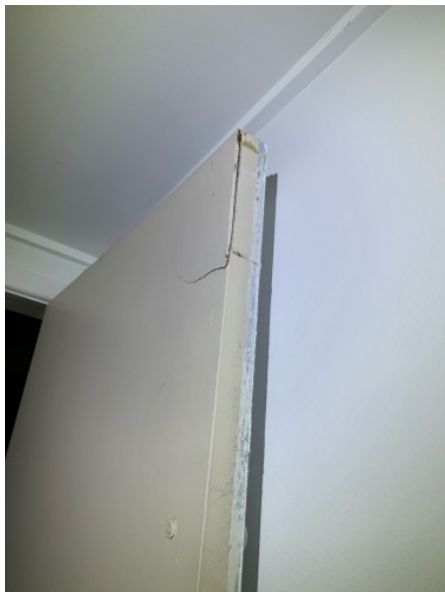
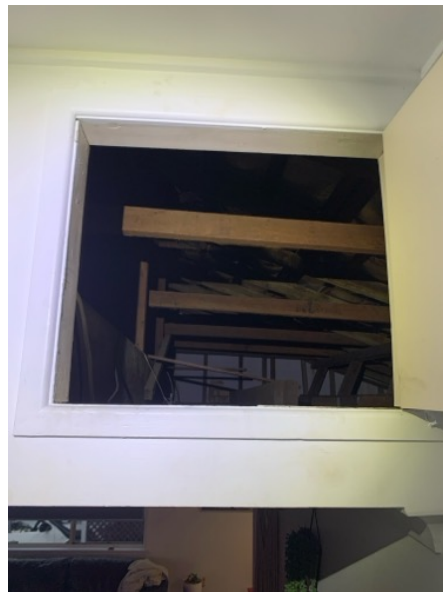
### Minor Defect 3.09

**Location:** Top Floor Ceiling

**Finding:** Access door

During the inspection of the top floor ceiling, it was observed that the access door to the roof space is improperly fitting, with noticeable binding on the frame which makes operation difficult. This issue compromises ease of access, potentially hindering necessary maintenance or inspections within the roof space. Such defects could worsen over time, leading to further structural issues or accessibility challenges. For remedial action, it is recommended that a licensed, practicing carpenter be engaged to assess and rectify the binding of the access door. This may involve adjustments to the frame or door to ensure smooth operation and compliance with current standards. The work should adhere to relevant provisions outlined in AS 1684.2 - Residential Timber-Framed Construction, ensuring all modifications meet established safety and construction standards. Proper repair will restore functionality and prevent potential damage or inconvenience in the future.

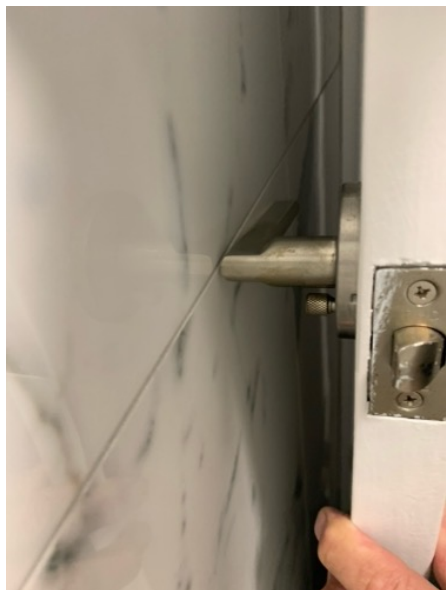
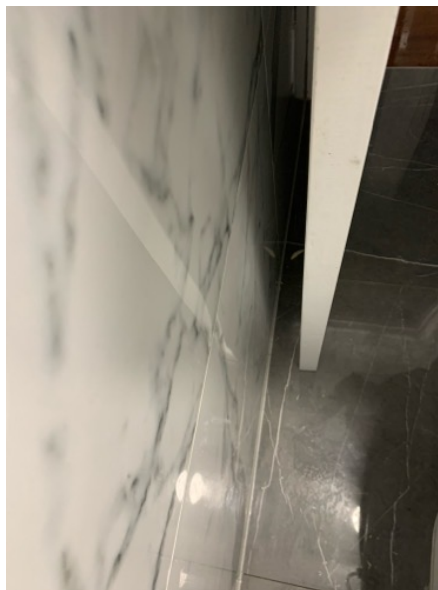
## Minor Defect 3.10

**Location:** Toilet

**Finding:** Door stop - Missing

The door stop is missing or is inadequate to stop the door handle from damaging the wall. Re-installation or replacement of the door stop is advised as soon as possible to prevent any subsequent damage to the door or associated structures. A general handyman may be appointed to perform these works at client discretion.

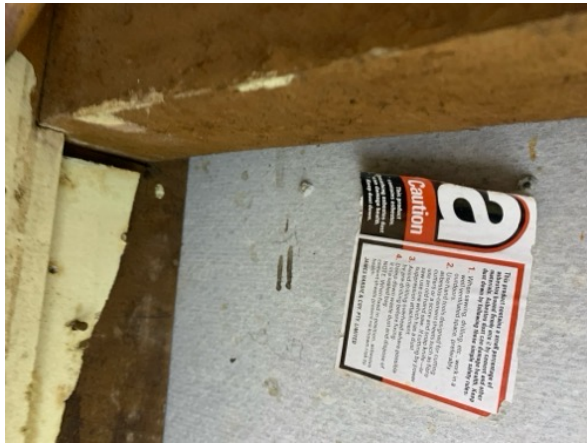
## For your information 4.02

**Location:** All areas

**Finding:** Suspect asbestos Identified on Site

Reporting on Asbestos is outside the Scope of this Report. This suspected defect is highlighted as a caution only. We suspect, based on our experience in the building industry, that there is a higher risk of the identified building element containing asbestos. We RECOMMEND that you consider a separate Asbestos Inspection and Condition Audit, which includes the taking of samples to confirm the presence of Asbestos. Note: without an asbestos report it is recommended that suspected asbestos materials be treated as asbestos.

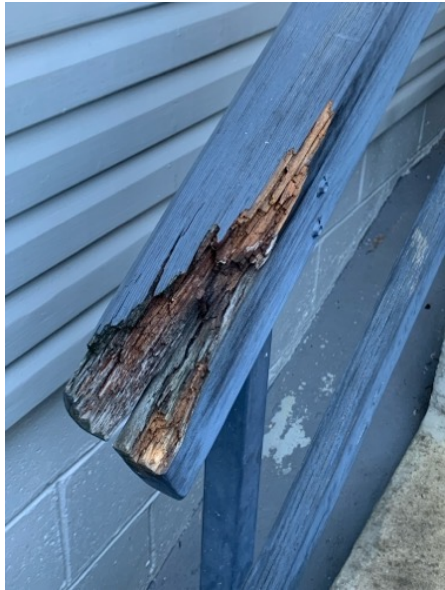
**Finding:** Handrail

The inspection has identified wood decay in the timber handrail located on the right-hand side stairs, necessitating repair. This structural defect poses a potential safety risk and requires attention from a licensed practicing carpenter. Remedial action should involve replacing or treating the affected timber in accordance with the relevant Australian Standards, such as AS 1684, to ensure compliance and safety. Immediate attention to rectify this issue is recommended to prevent further deterioration and potential hazards.

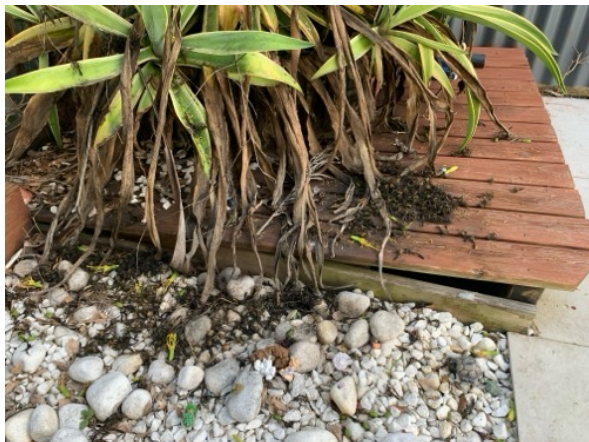
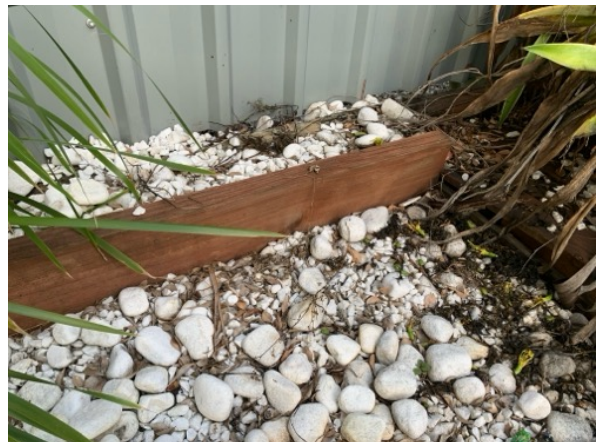
### Conditions conducive to timber pest attack 5.03

**Finding:** Timber sleepers and garden edging

The timber garden edging located in all external areas exhibits significant decay and has potential to serve as a food source for termites, although no termites were observed during the inspection. The timber in ground contact exacerbates wood decay, in contravention of the relevant standards demanding durability and resistance to pests. It is recommended to replace the timber sleepers with more durable materials or conduct regular termite inspections. Removal from ground contact is crucial to mitigate further risks associated with termite infestation and compliance with applicable building standards.
