Inspection Report

BPP Inspections

26 Grant St, Zillmere, QLD

Pest And Building InsP-ection

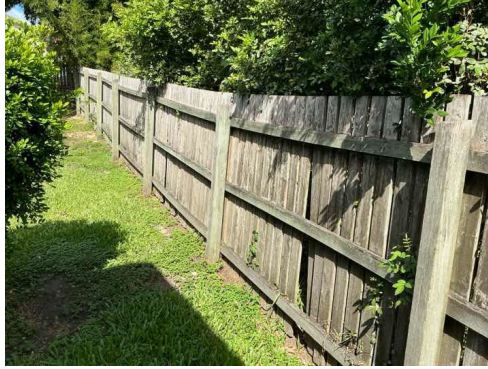
#1. General age to fence components - Recommendations: General upkeep and maintenance. A qualified fencing contractor should be engaged for repairs

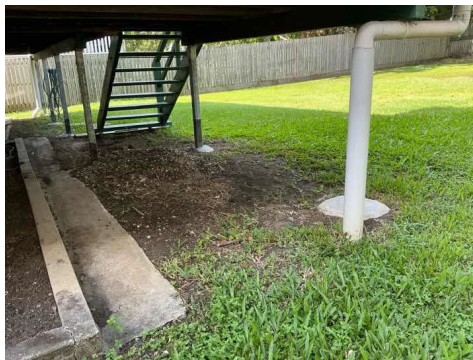
#2. The ground levels along the perimeter walls at the rear of the home did not appear to fall away from the property walls sufficiently due to the natural landscape and contour. Recommendations: This will need to be assessed during a period of rainfall and if surface water appears to be entering the sub floor if applicable or ponding against the perimeter walls, engage a plumber or landscaper to assess and rectify as required. All drains should be regularly checked by a plumber and kept clean of debris to allow surface water to be carried away from the dwelling.

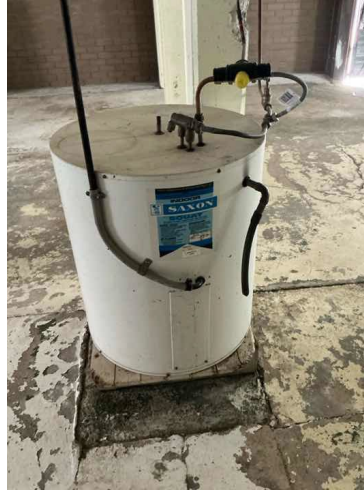
The hot water system appears to be in a serviceable condition. No specific tests other than running the hot water from a tap was carried out. No determination has been made as to the suitability or adequacy of the hot water system in relation to capacity or otherwise.

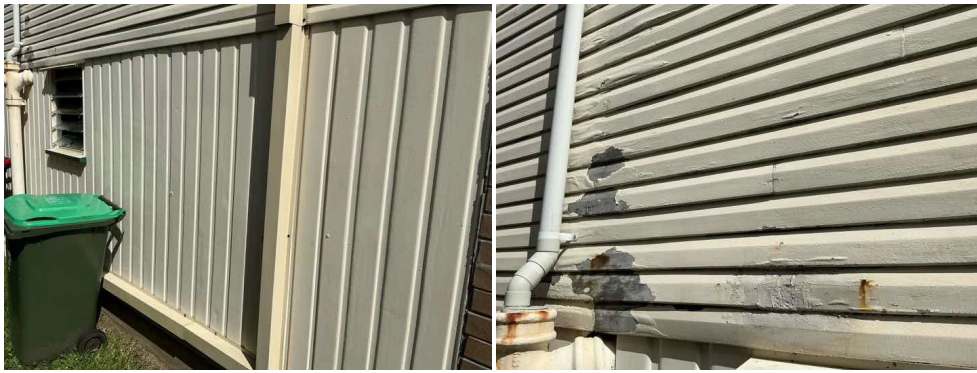
#3. General age visible to the exterior paint surfaces. Cleaning of exterior required to assess paint condition. Mouldy areas to be treated accordingly. Sealants and fillers showing signs weather exposure.

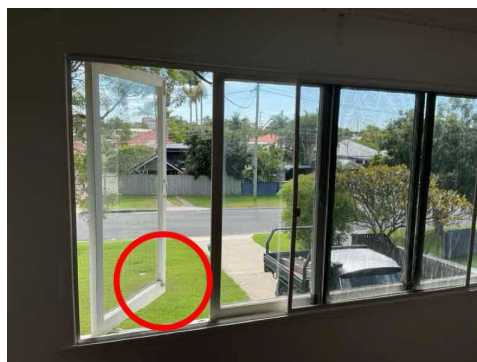
Age observed to window components. Maintenance required. Assess each window and improve sealants and lubricants to mechanical components.

#4. Selected upstairs windows are able to be fully opened. This was compliant at the time of construction and technically no requirement to rectify. Current building code has identified a fall risk and requires a limited opening of 125 mm or secure screening to be in place.

Contact a lic Builder, Glazier to assess and rectify.

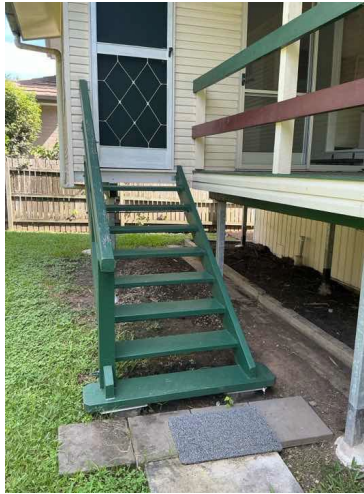
#5. There is no handrail present on the house edge of the staircase. The maximum allowable opening is 125mm for a height greater than 1 m. This should be rectified as is a safety concern.

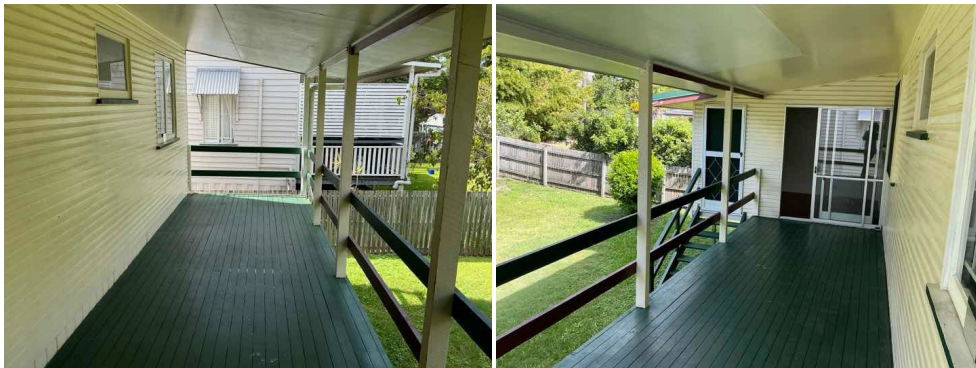
Though we are not structural engineers the veranda/s appear to be in a serviceable condition.

#6. There are early to moderate signs of timber decay visible, notably to the outer edge and floorboard joins. The tops of the timber floor support joists will be decayed and are unable to be inspected. This will require further assessment and repairs to increase longevity and safety.

Contact a lic Builder carpenter.

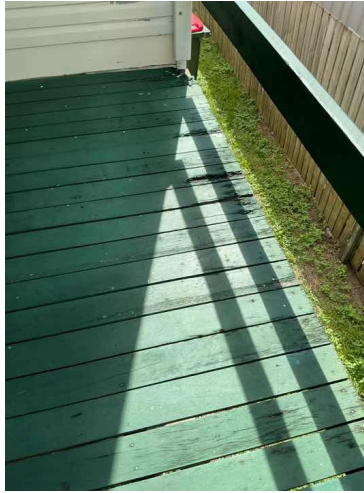
#7. Baluster rail height - Should be 1 m in height from deck/balcony/patio floor. With a maximum opening space of 125 mm. In some circumstances this regulation was non-existent dependent on the age of the dwelling and technically there is no requirement to rectify. Recommendations: We strongly advise you rectify to comply for safety concerns to young children.

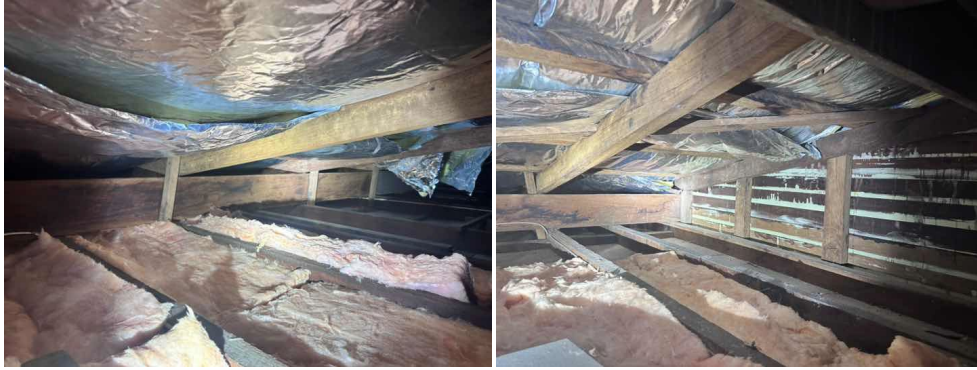
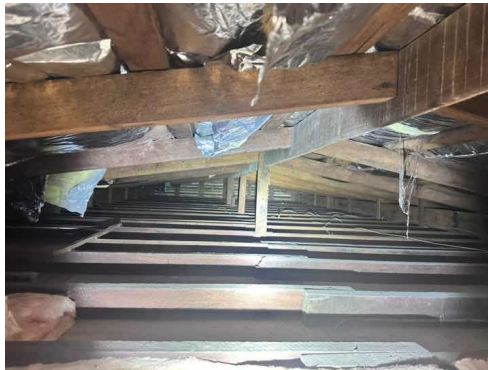
#8. The ceiling void was too confined to physically access. This was inspected from the manhole access point only. From this point the area appeared serviceable. Certain areas were unable or difficult to inspect, and as such are not included in this inspection. Invasive inspection, (areas of roof lifted) would be required to inspect these areas.

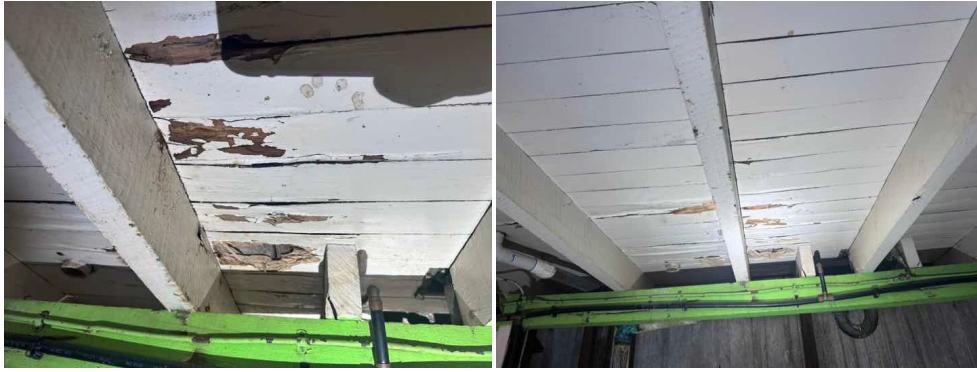
#9. Damaged was observed to the underside of the floorboards of which reason is unknown. The floor Above appears to be stable. If this changes replacement of the affected boards is recommended.

This is below the bathroom and no high moisture readings were recorded.

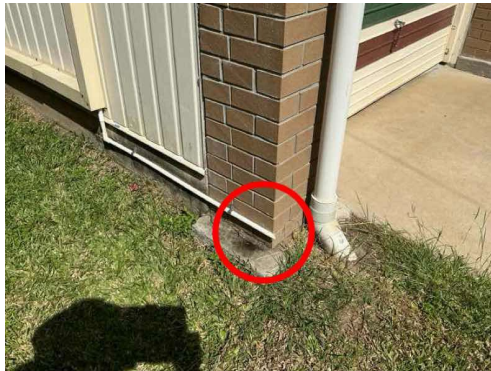
#13. The air conditioning drain was draining onto the building perimeter ground surface. This adds constant excessive ground moisture providing conducive conditions for termites.

Divert drain and connect to stormwater discharge points where possible.
