# Property Inspection Report

19 Springvale Circuit,  
Underwood

- Basic - Structural Condition Report

- Vendor Inspection

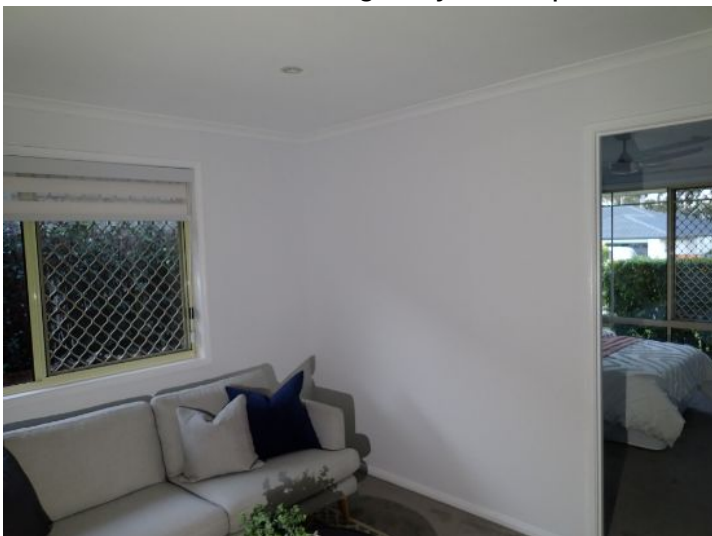
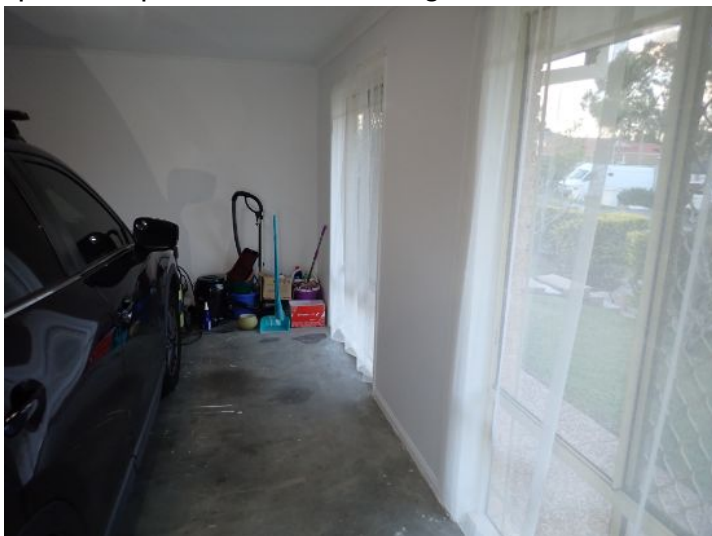
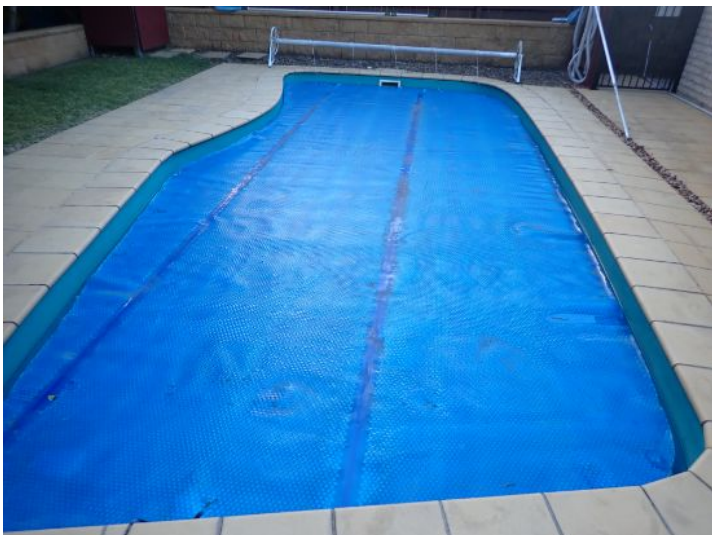
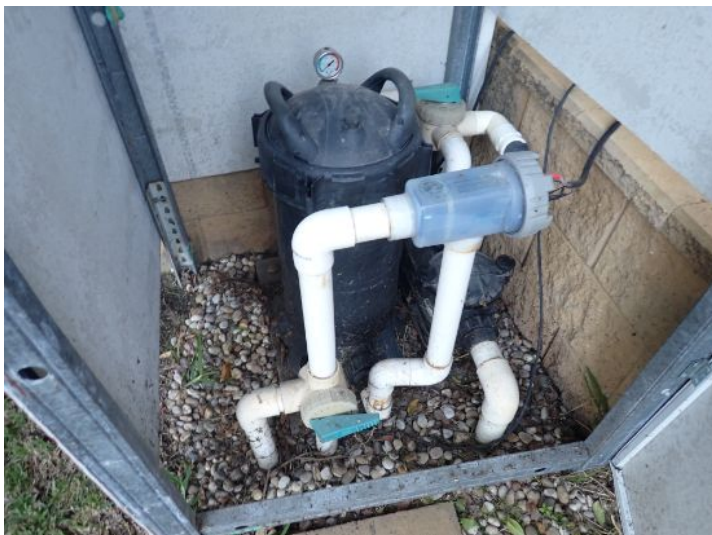
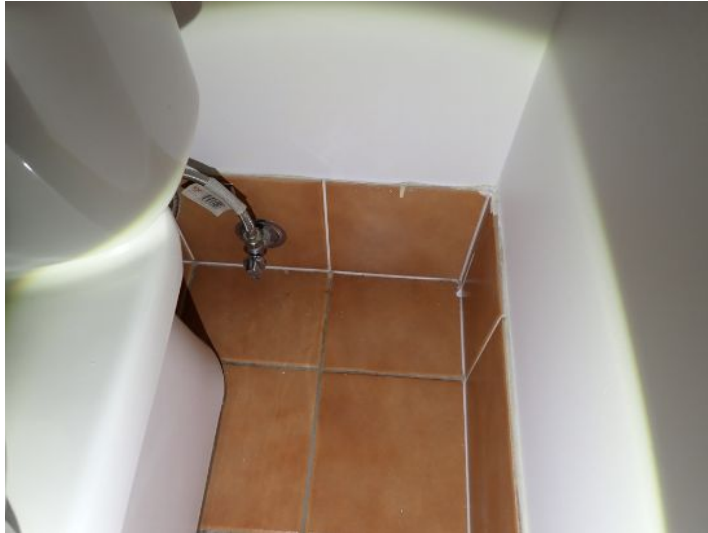
- The interior, garage visual inspection was obstructed or restricted because of obstruction due to items stored.

- A pool was noted. This was not tested as part of the inspection process and should be checked at the final pre-settlement inspection.
- We recommend all braided flexible water hoses in the property be checked regularly and replaced as required to prevent water damage.

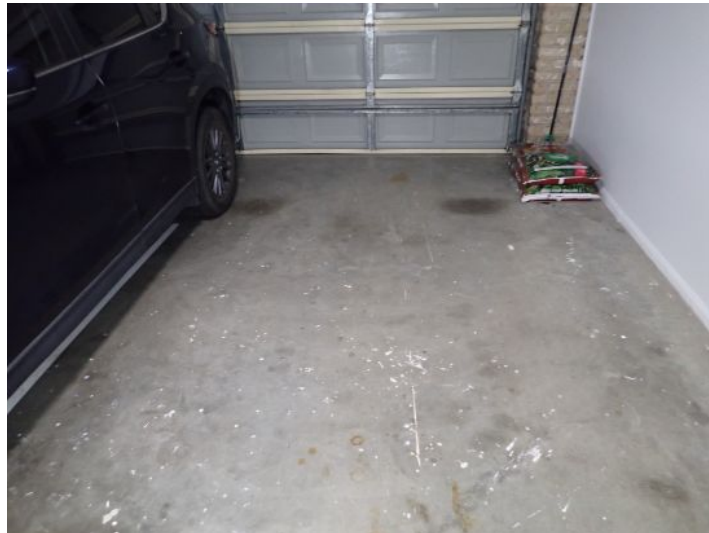
- Visible sections of the concrete slab appeared satisfactory.
- Most areas of the concrete slab not visible due to floor coverings.
- All concrete floor slabs experience some degree of cracking due to shrinkage in the drying process. In most instances floor coverings prevent recognition of cracks or settlement in all but the most severe cases. Where carpeting and other floor coverings are installed, the materials and condition of the flooring underneath cannot be determined.

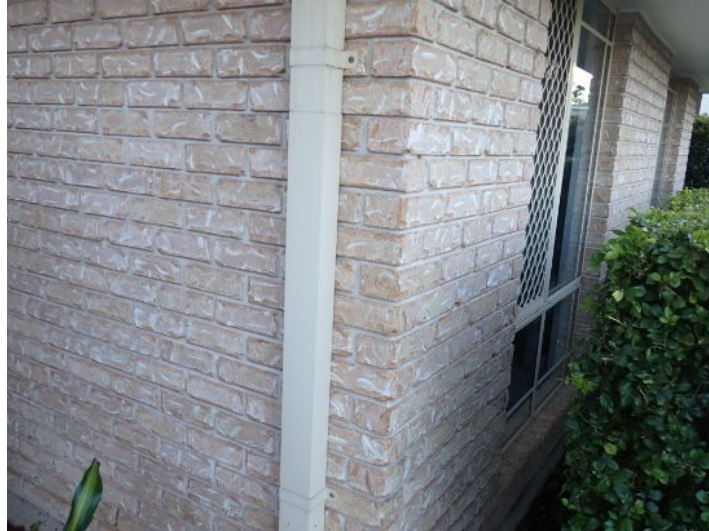
- The wall structure components appeared functional.
- Externals walls are of a timber frame and brick veneer construction.

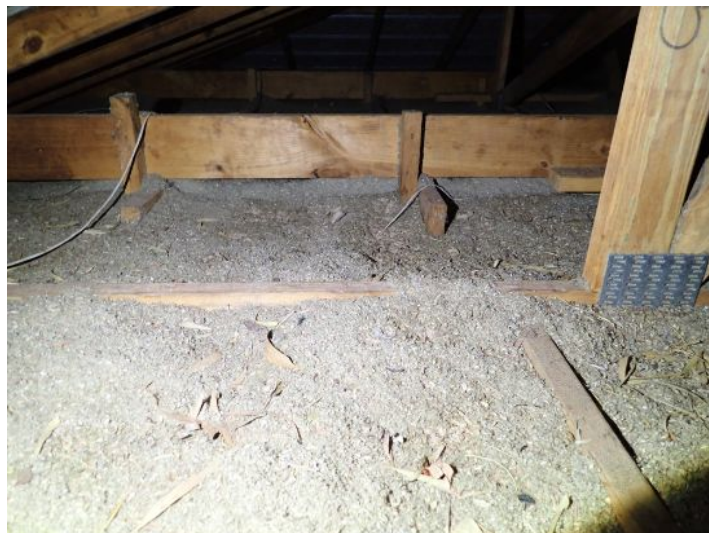
- The ceiling structure appeared functional.
- Due to the placement of insulation on the top of the ceilings it is not possible to fully inspect the condition of the ceiling structure and supports. Inspection was limited and based on what was visually accessible at the time of the inspection.

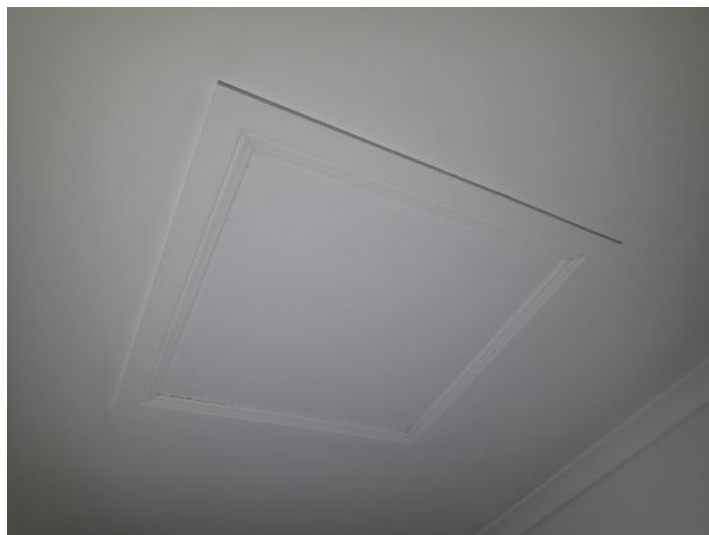
- Access was available through a manhole in the garage.
- Entering roof spaces that are heavily insulated can cause damage to the insulation and ceiling framing. Roof spaces with deep insulation cannot be safely inspected due to limited visibility of the framing members upon which the inspector must walk. In such cases, the roof space is only partially accessed, thereby limiting the review of the area from the hatch area only. Inspectors will not crawl the roof space when they believe it is a danger to them or that they might damage the roof space insulation or framing. This is a limited review of the roof space viewed from the hatch only.

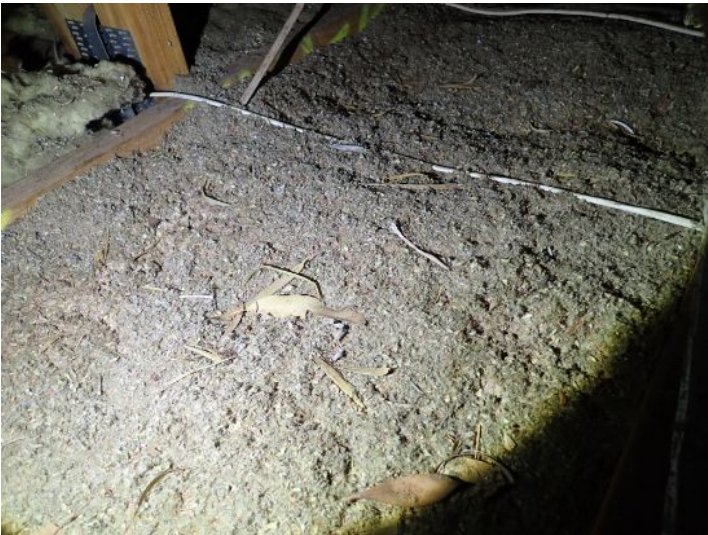
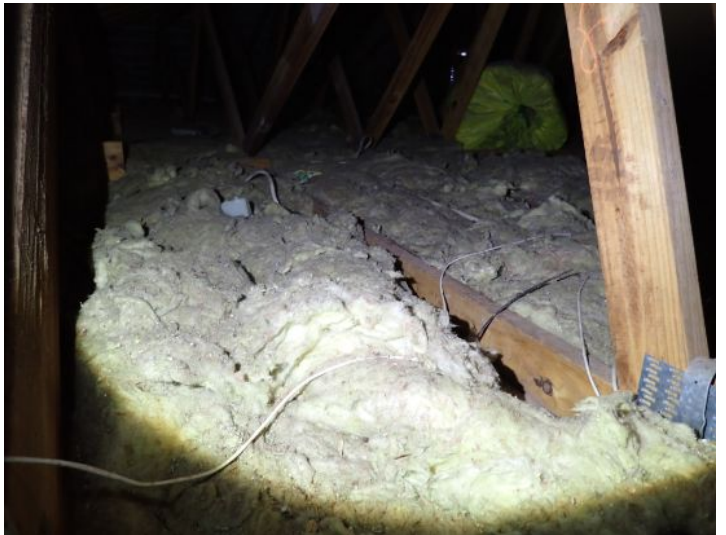
- Insulation averages about 75mm to 100mm in depth.
- Insulation appears adequate.

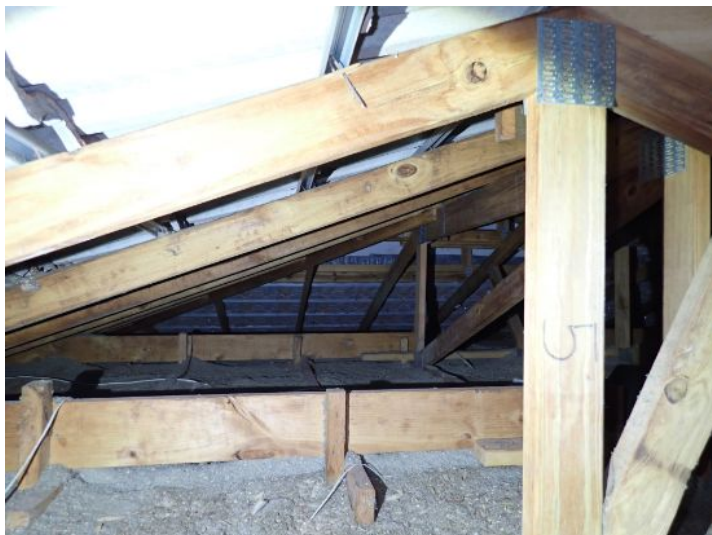
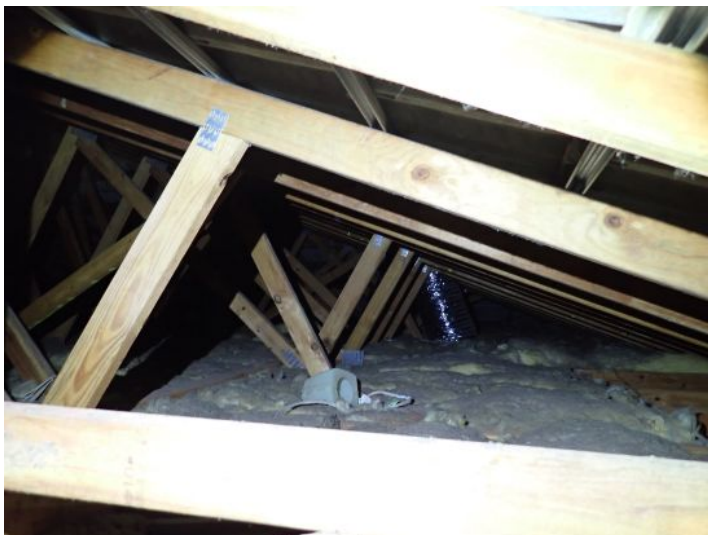
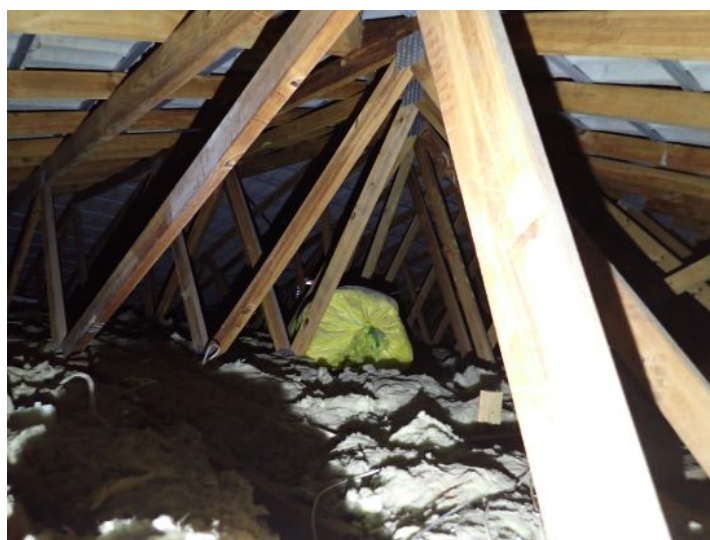
- The timber roof structure appears sound.

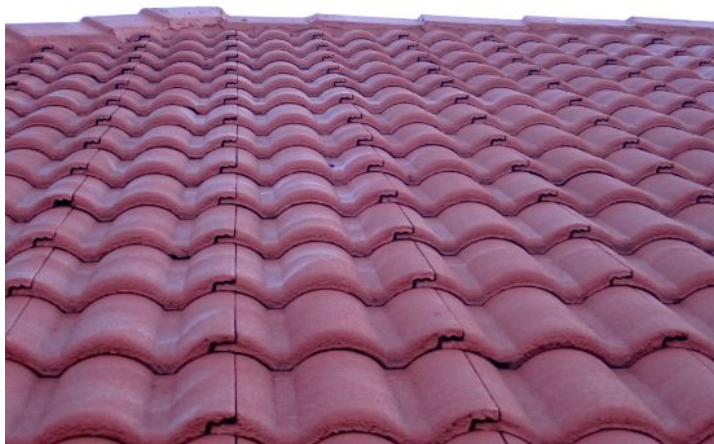
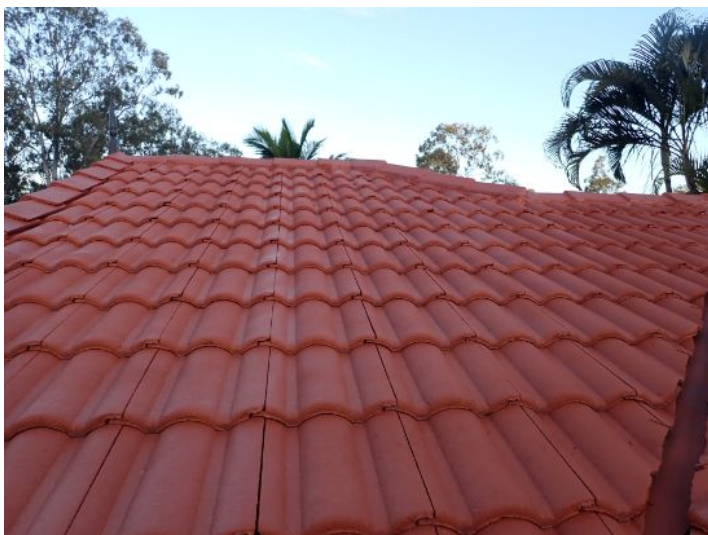
- The concrete tile roofing material appeared to be in satisfactory condition other than noted.

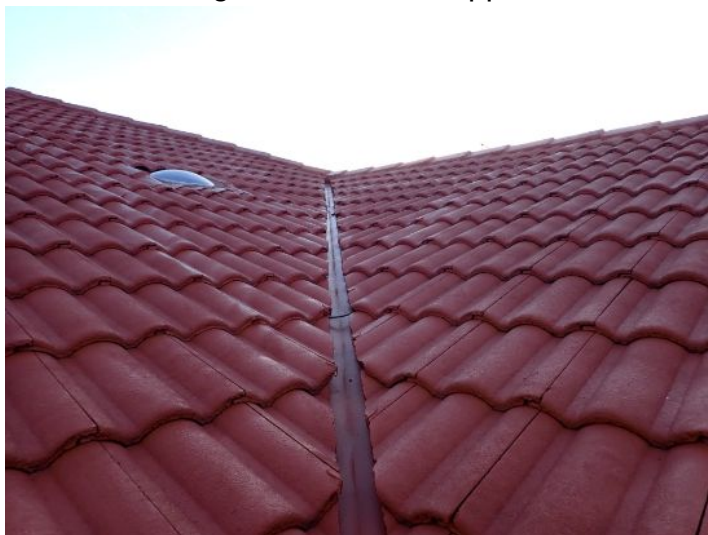
- Flashing is an impervious material (usually galvanized sheet metal) that comes in a variety of shapes and sizes and is used to cover, waterproof, and direct water away from roof penetrations and from valleys and intersections between the roof covering and other materials.
- The roof flashing, where visible, appears to be in satisfactory condition.

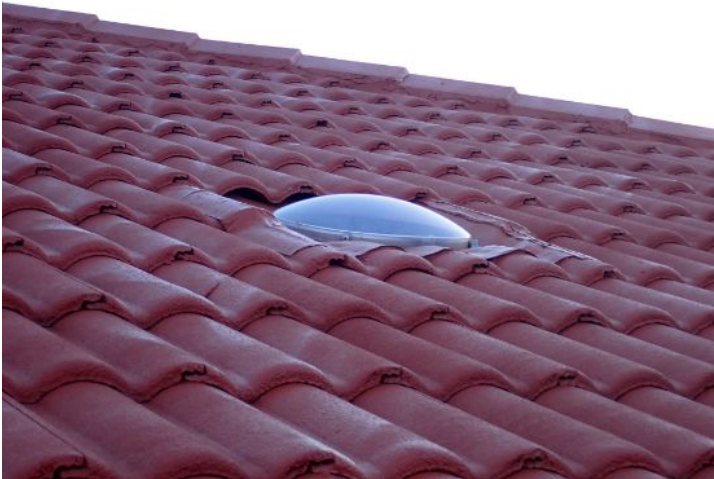
- No signs of present or past leaking around the skylight were discovered at the time of inspection.

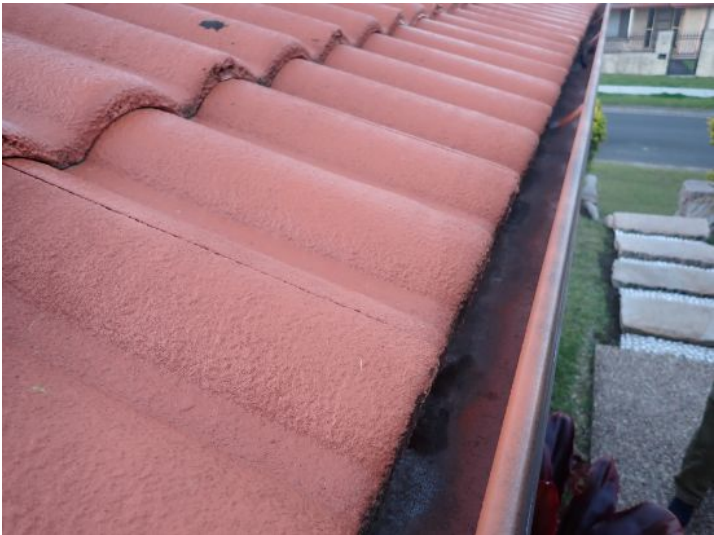
Observations:  
• No major function concerns noted at the time of inspection.

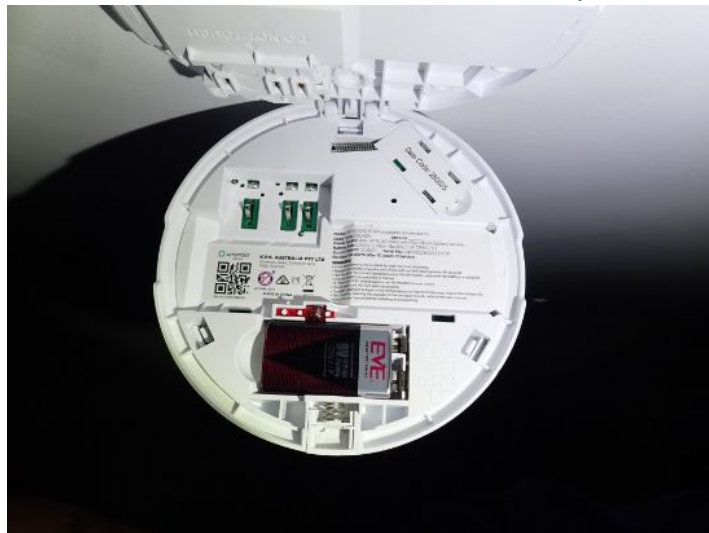
- Testing of smoke alarms is not included in this inspection. Pushing the "Test" button only verifies that there is power at the alarm--either a battery or hardwired to the house power--and not the operational workings of the alarm. The operational check is done by filling the sensor with smoke and is beyond the scope of this inspection. Battery operated smoke alarms should be checked routinely and the batteries changed frequently.
- From 1 January 2022, all dwellings being sold in Queensland require hardwired and or non-removable 10-year battery interconnected, photoelectric, smoke alarms installed in every bedroom, in hallways which connect bedrooms and the rest of the dwelling, and on each storey.
- There appears to be interconnected smoke alarms installed in the hallways and bedrooms of the home. The service replacement year is noted as 2035

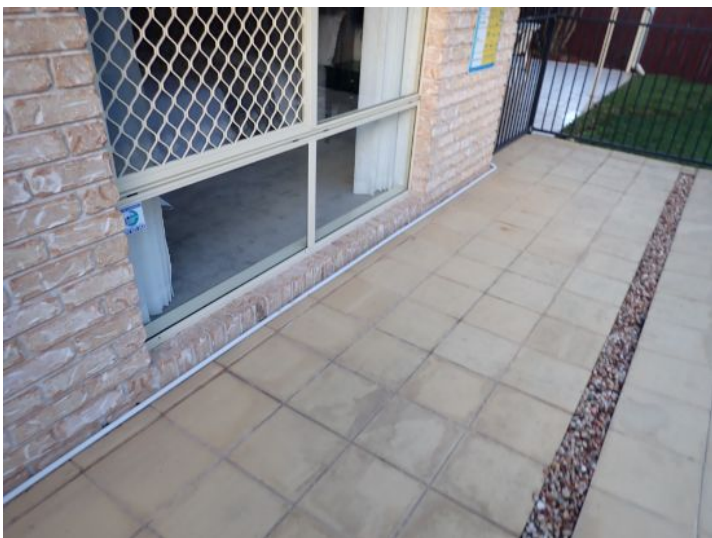
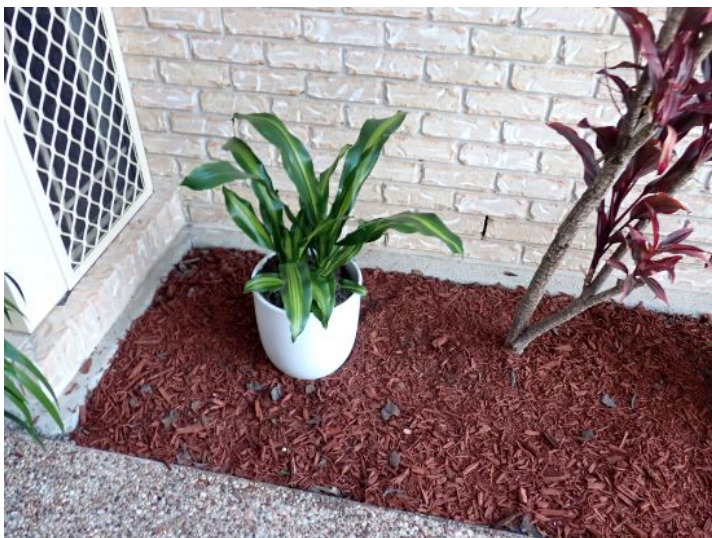
- The brick wall covering is in a satisfactory condition.

- There are a number of garden beds which are adjacent to the external walls. This can result in water moisture affecting the structure over time. It is recommended that either the beds be removed or a water barrier be placed between the garden bed and the external walls. If these beds are retained it is important that any watering is directed away from the building and kept to an absolute minimum and is controlled.

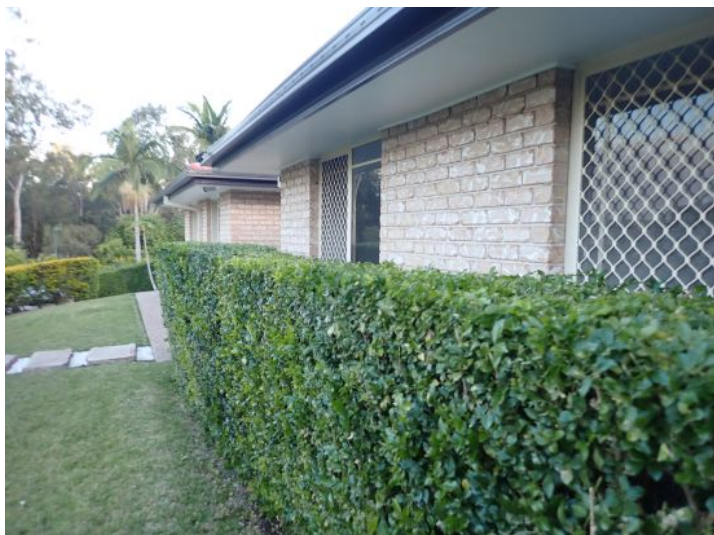
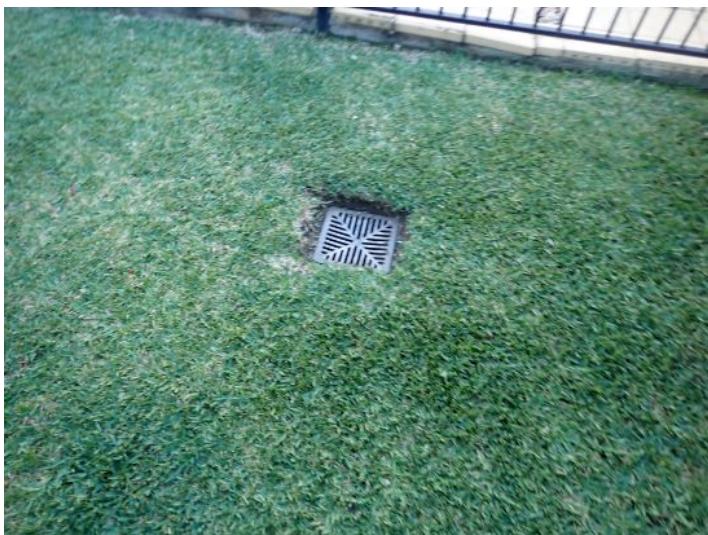
- Surface drainage conditions within 3 metres of the inspected structure appeared satisfactory given the prevailing weather conditions at the time of inspection. There was no evidence noted of water pooling at or around the building structure. These areas should be monitored during periods of heavy rainfall for a full representation of drainage conditions.

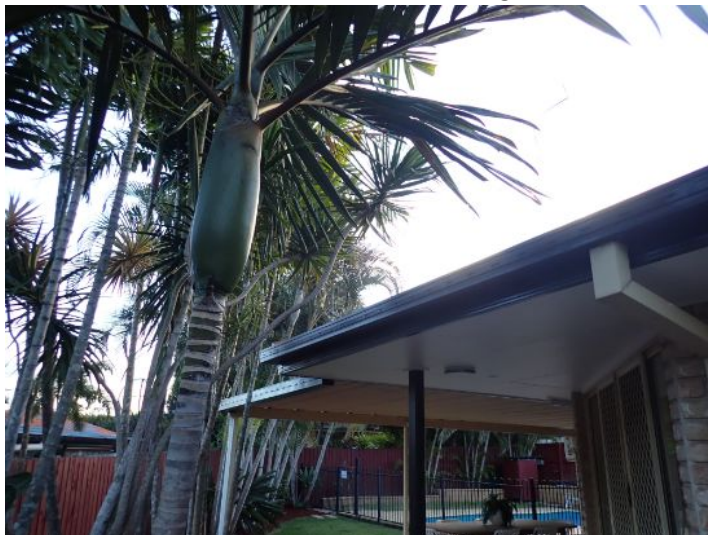
Grounds Vegetation Observations

- Trees that begin to grow too close to or overhang property should be trimmed back; this will help reduce the frequency of having to clean out the gutters which should be done on a regular basis.

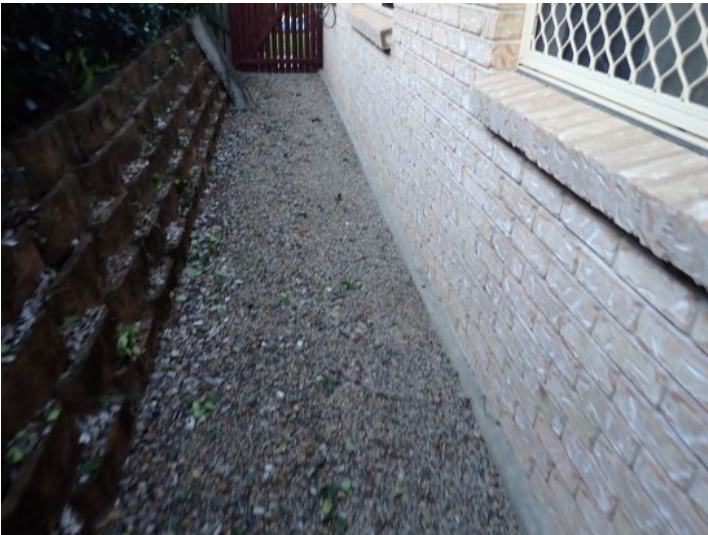
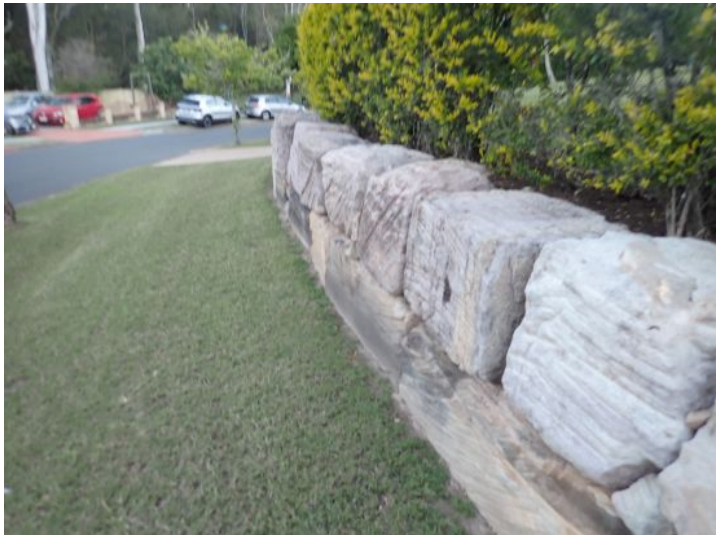
- Brickwork walls.
- Stone retaining walls noted.

- The yard walls appear to be functional and structurally sound.
- Evaluation of retaining wall strength, adequacy, and drainage falls outside the scope of a Resicert building inspection. Such evaluation will require the services of a geotechnical engineer. Our evaluation is limited to reporting significant defects that are visible and apparent at the time of the inspection.
