Inspection Report

BPP Inspections

25 Augusta St, Aspley, QLD

Pest And Building InsP-ection

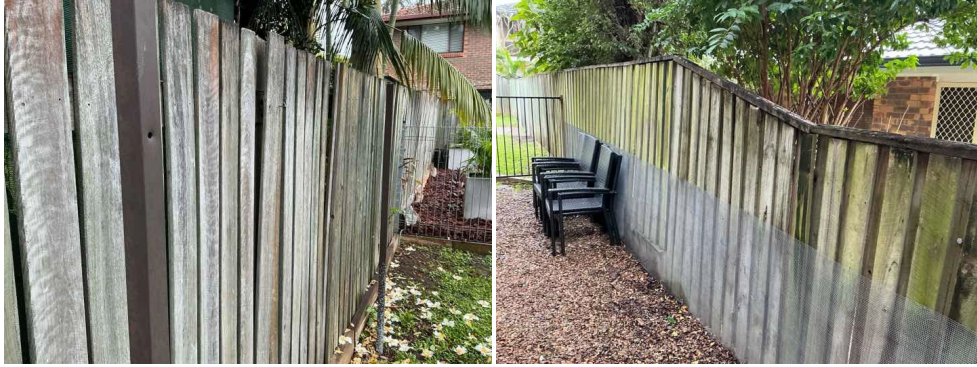
#1. General age to fence components - Recommendations: General upkeep and maintenance. A qualified fencing contractor should be engaged for repairs

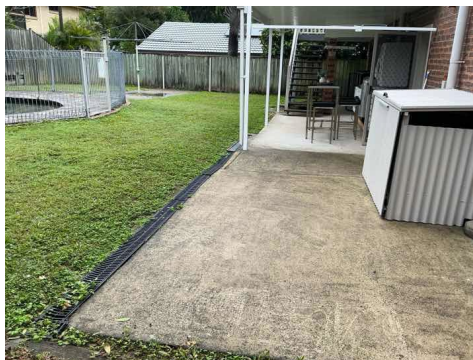
#2. The ground levels along the perimeter walls at the rear of the home did not appear to fall away from the property walls sufficiently due to the natural landscape and contour. Recommendations: This will need to be assessed during a period of rainfall and if surface water appears to be entering the sub floor if applicable or ponding against the perimeter walls, engage a plumber or landscaper to assess and rectify as required. All drains should be regularly checked by a plumber and kept clean of debris to allow surface water to be carried away from the dwelling.

Poor drainage - There is water ponding against walls. This provides conducive conditions for termite infestation. The degree of risk is high. Engage plumber to rectify.

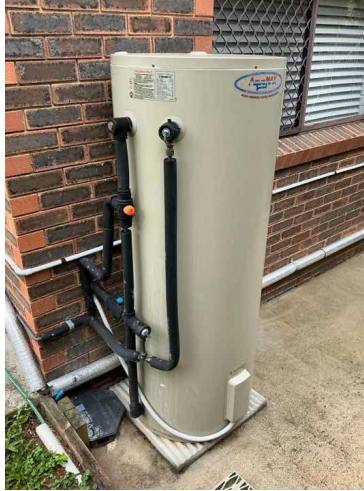
The hot water system appears to be in a serviceable condition. No specific tests other than running the hot water from a tap was carried out. No determination has been made as to the suitability or adequacy of the hot water system in relation to capacity or otherwise.

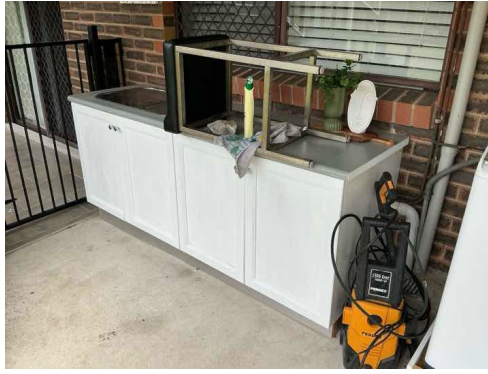
#3. There is a timber cabinet against the wall unable to maintain behind. This poses a high termite risk of entry through the weepholes. Remove cabinet or fix directly to the exterior wall and remove the back panel of the cabinet.

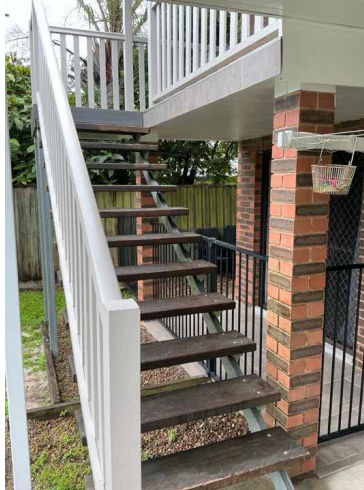
#4. There is no handrail present on the house edge of the staircase. The maximum allowable opening is 125mm for a height greater than 1 m. This should be rectified as is a safety concern.

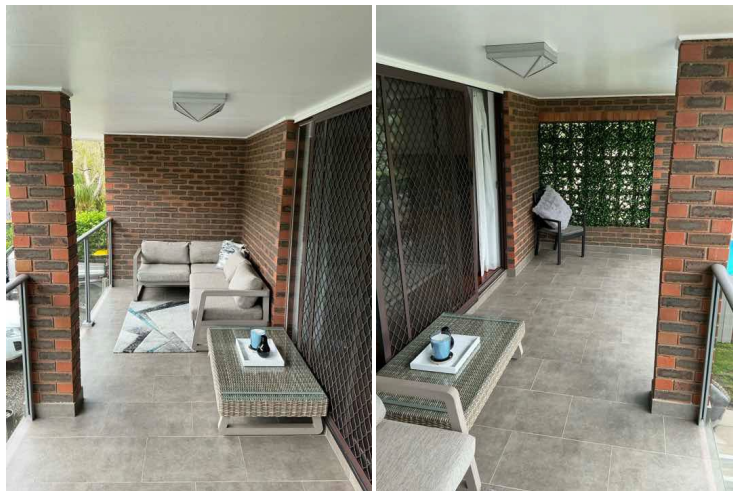
Though we are not structural engineers the balcony/s appear to be in a serviceable condition.

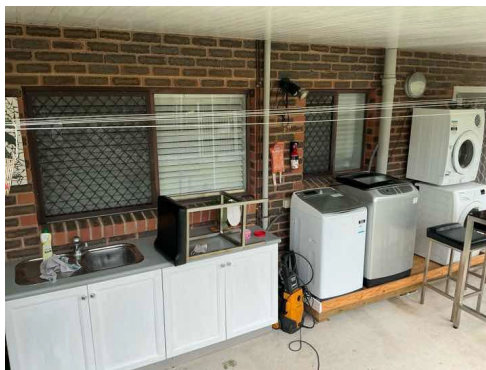
Of the visible areas, the general condition of the laundry is serviceable.

See comments regarding cabinet against wall.

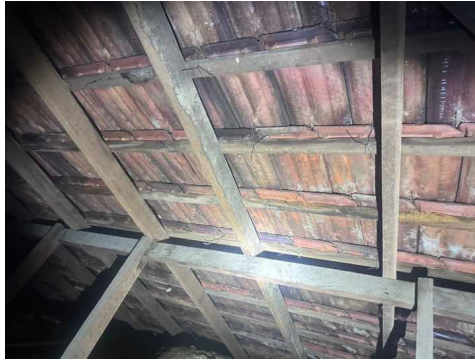
There is no sarking installed. Sarking is the layer of reflective film material installed during construction underneath the roofing material. It provides a moisture barrier and minimal insulation. The installation of sarking is not a building requirement.
