# Seller disclosure statement

34 Ellerdale Street, Aspley QLD 4034

## Inspection Address

**34 Ellerdale St, Aspley, QLD**

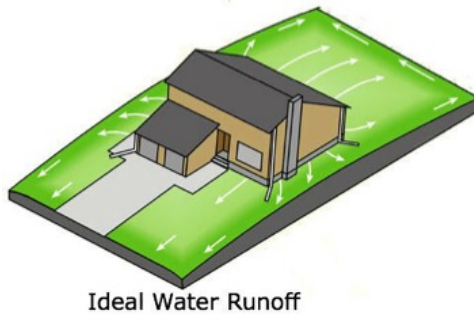
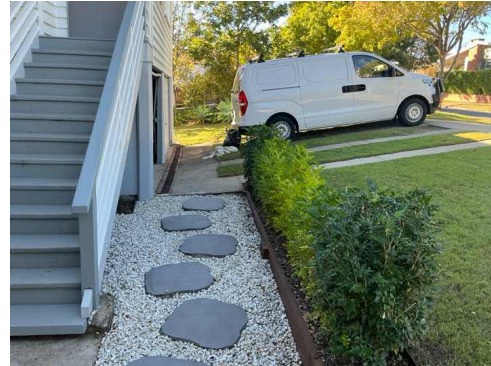
#### Drainage Findings

#1. The ground levels along the perimeter walls at the front of the home did not appear to fall away from the property walls sufficiently due to the natural landscape and contour. Recommendations: This will need to be assessed during a period of rainfall and if surface water appears to be entering the sub floor if applicable or ponding against the perimeter walls, engage a plumber or landscaper to assess and rectify as required. All drains should be regularly checked by a plumber and kept clean of debris to allow surface water to be carried away from the dwelling.

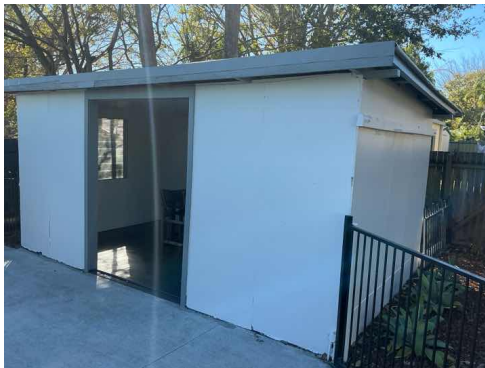
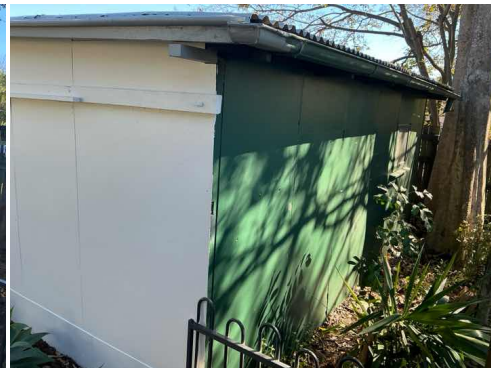
#### Shed Condition

#2. The shed is in fair usable condition. General age to sheeting and visible building components. Termite protection is required to protect the concealed timber framework.

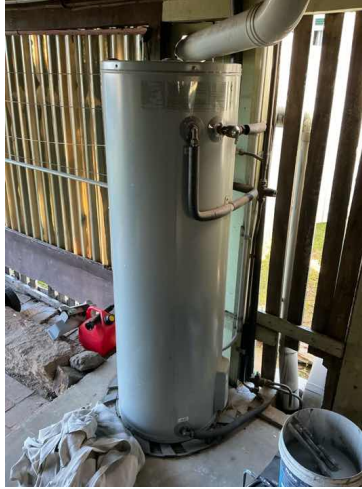
#### Hot Water Unit Findings

The hot water system appears to be in a serviceable condition. No specific tests other than running the hot water from a tap was carried out. No determination has been made as to the suitability or adequacy of the hot water system in relation to capacity or otherwise.

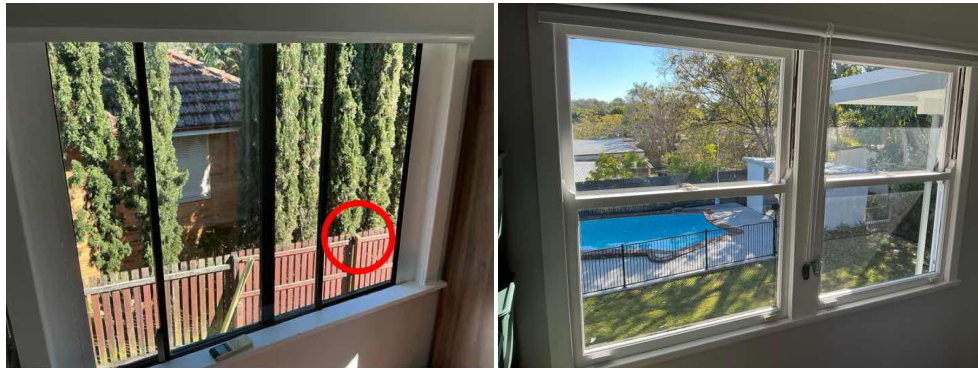
### **Overall Condition**

Age observed to window components. Maintenance required. Assess each window and improve sealants and lubricants to mechanical components.

Contact a lic Builder, Glazier to assess and rectify.

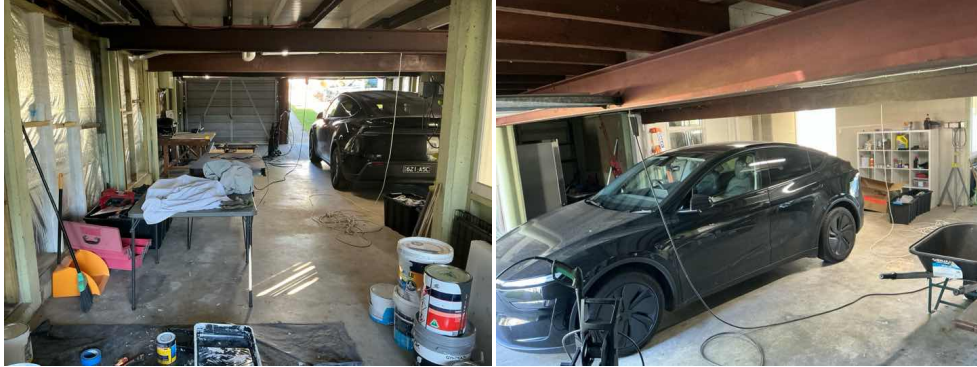
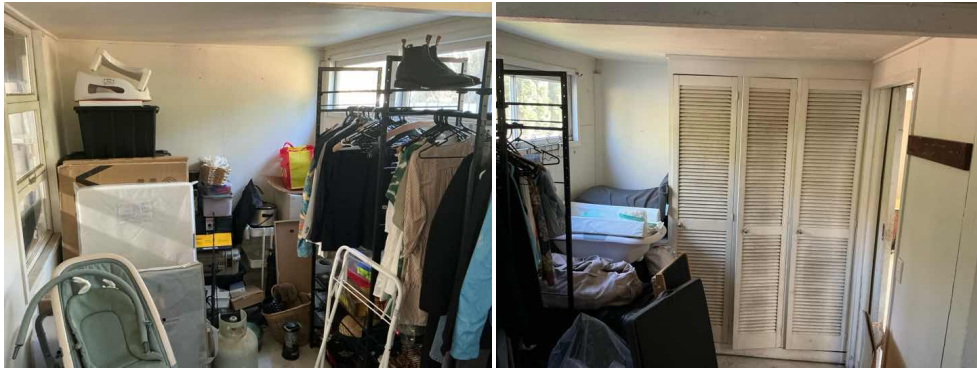
#### Overall Condition

Of accessible and visible areas, the garaging is considered to be in a serviceable condition.

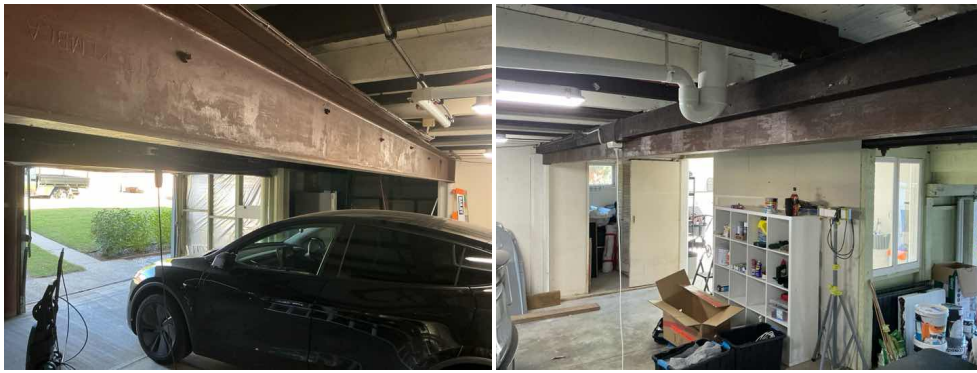
### Internal Wall Findings

#4. Original house stumps have been removed and additional support beams installed. This has added additional loading to the stumps and brick piers supporting the beams. Considering this has been done for a historical time frame no major defect can be observed. However this should be monitored over time or if concerns are current consult a lic Engineer or Builder.

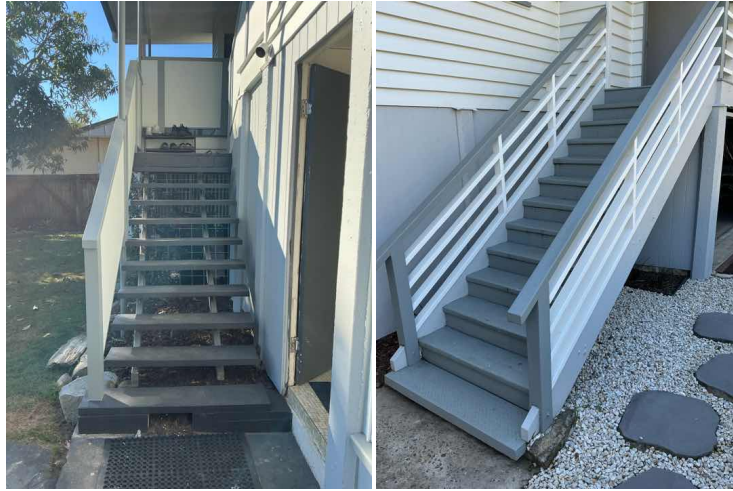
The stairs/steps appear to be serviceable with no notable defects.

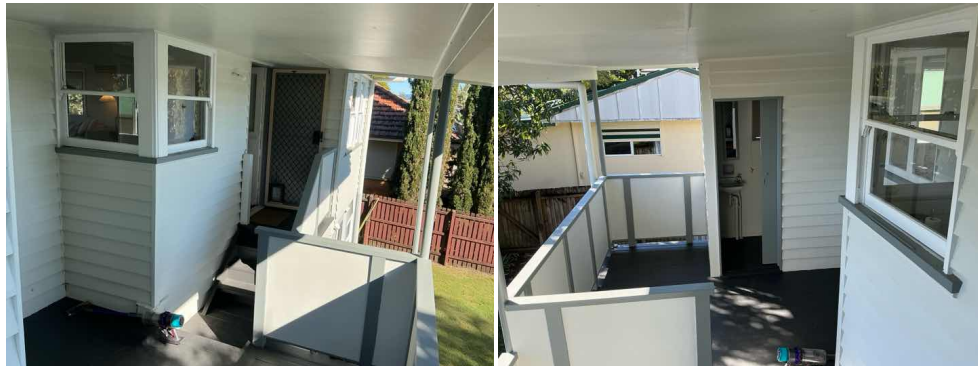
### Decking Findings

Of areas visible, the decking appears to be in a serviceable condition.

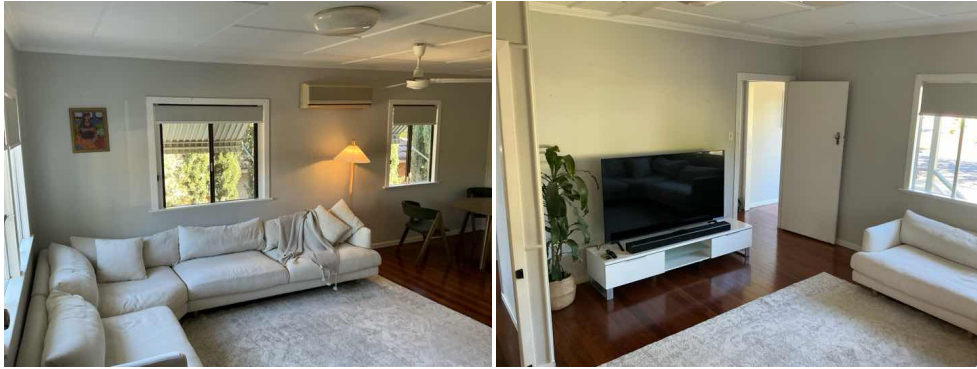
The lounge room is in serviceable condition with no notable structural defects sighted.

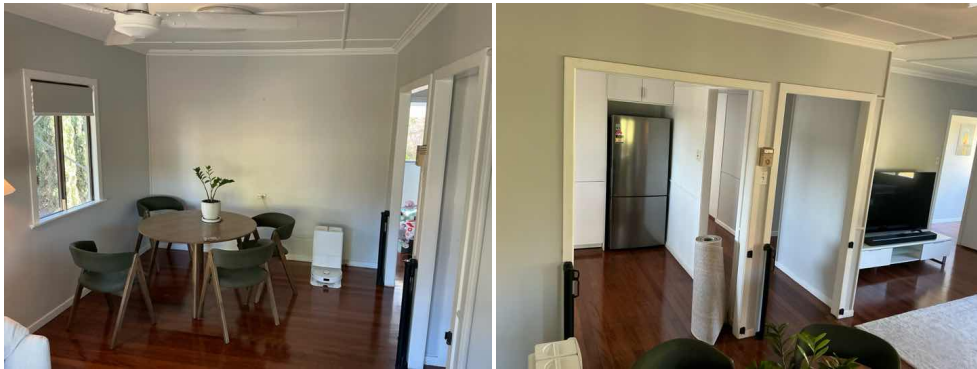
### Dining Room

The dining room is in serviceable condition with no notable structural defects sighted.

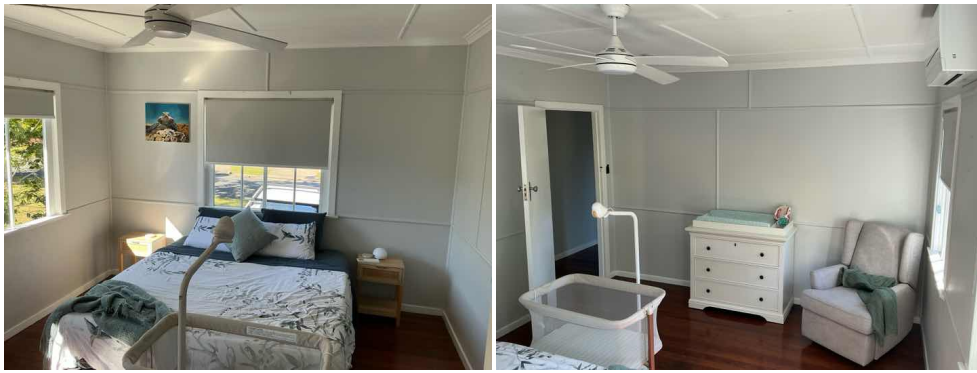
### Bedroom 1

This bedroom is in serviceable condition with no notable structural defects sighted.

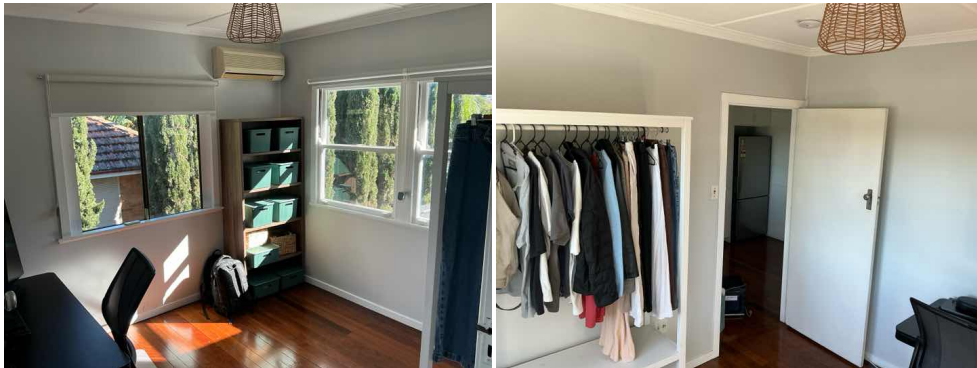
## **Bedroom 2**

This bedroom is in serviceable condition with no notable structural defects sighted.

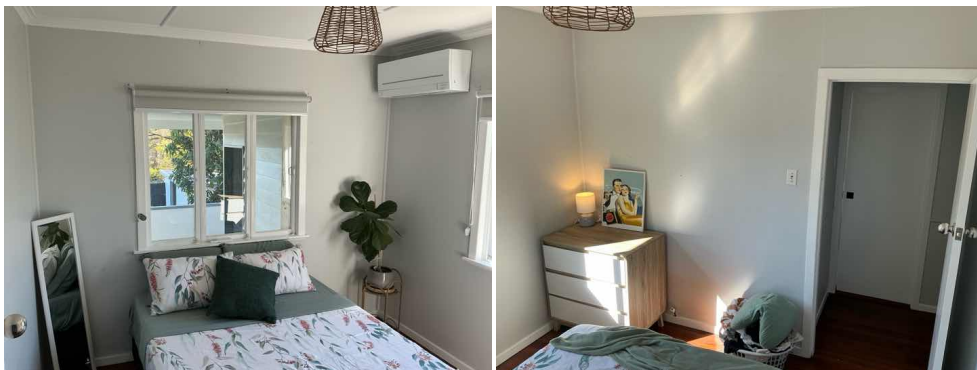
## **Bedroom 3**

This bedroom is in serviceable condition with no notable structural defects sighted.

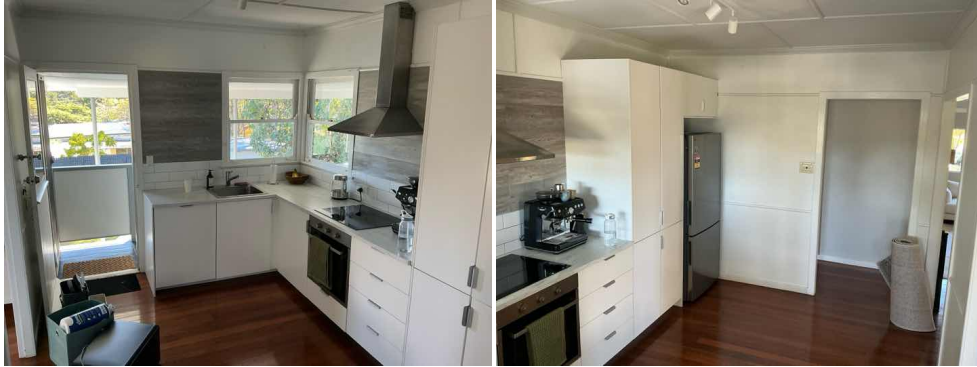
Of the visible areas, the general condition is serviceable or in reasonable condition for age of dwelling.

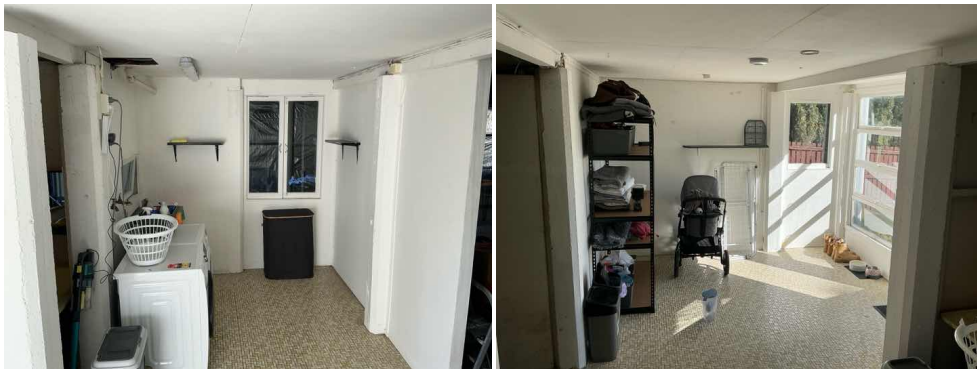
Of the visible areas, the general condition of the laundry is serviceable.

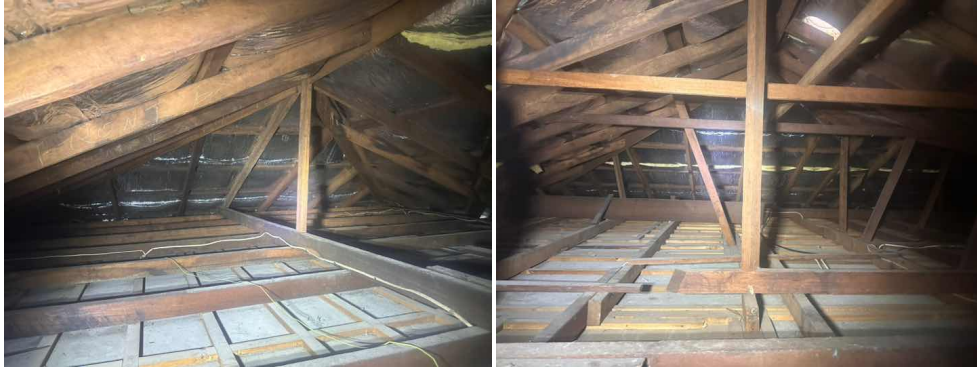
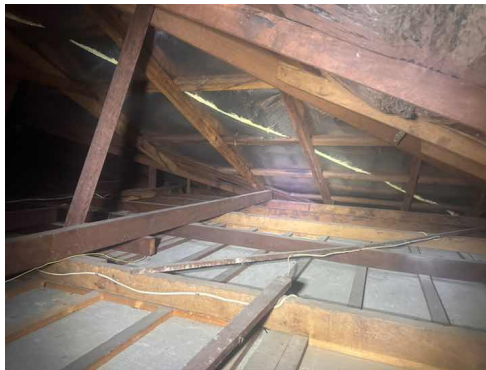
#### **Roof Frame Type**

The roof frame is a conventional timber frame.

Visible sections of the roof void is in a serviceable condition for age of this dwelling.

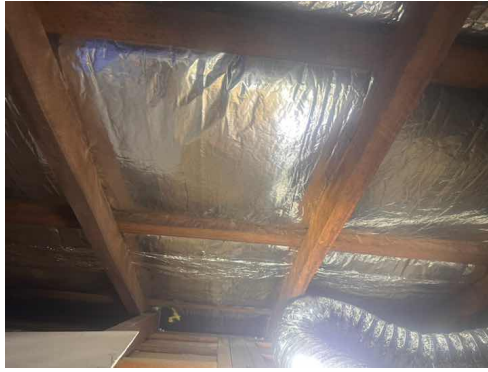
The roof space is insulated with reflective fibreglass batts under the roof cladding.

Where visible and accessible, the insulation appears to be in a serviceable condition.

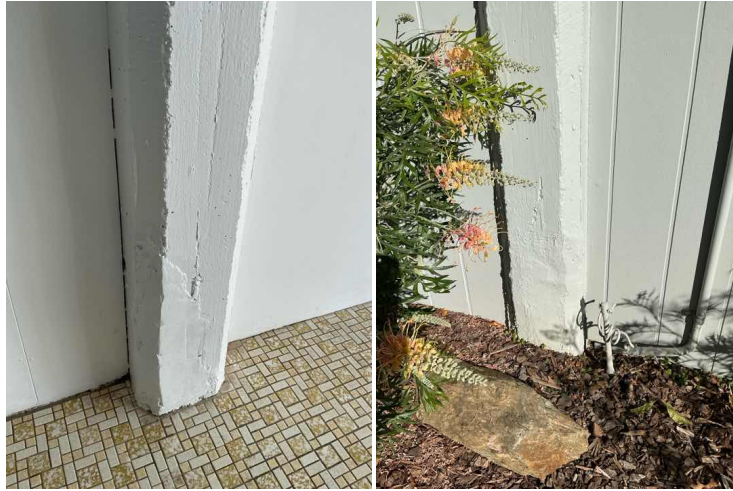
#### **Piers And Foundation Walls**

The concrete stumps are aged. Repairs from cracking and decay are evident. Monitor for change yearly and repair/ replace as required.

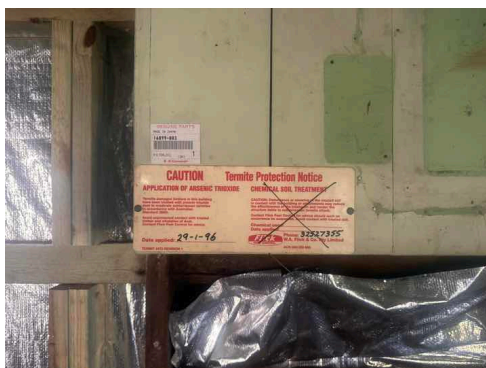
#### **Was a Treatment Notice Found**

The label in the meter box identifies a chemical treatment. This chemical treatment has past its expiration date and it would not be an active chemical providing protection.
