Inspection Report

BPP Inspections

34 Ben Lomond St, Aspley, QLD

Pest And Building Inspection

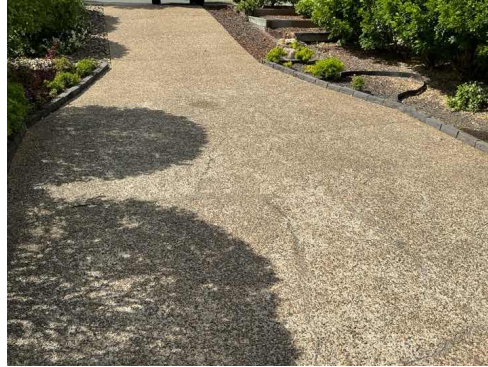
Driveway Condition

Common cracks & settlement were observed on the driveway. Maintenance is recommended. Note: Whilst these cracks appeared to be minor at the time of inspection, we strongly recommend you monitor these cracks and if worsening occurs contact a concreter for further advice.

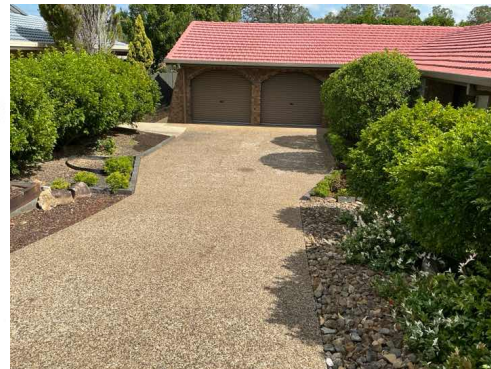
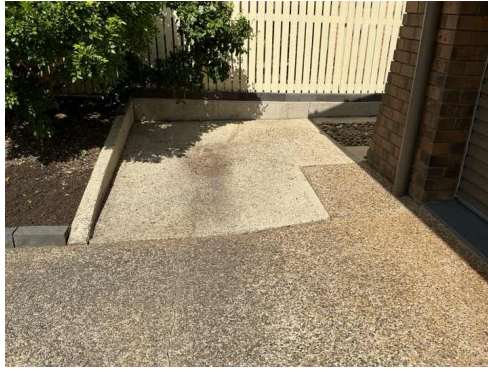
Drainage Findings

#1. The ground levels along the perimeter walls at the front of the home did not appear to fall away from the property walls sufficiently due to the natural landscape and contour. Recommendations: This will need to be assessed during a period of rainfall and if surface water appears to be entering the sub floor if applicable or ponding against the perimeter walls, engage a plumber or landscaper to assess and rectify as required. All drains should be regularly checked by a plumber and kept clean of debris to allow surface water to be carried away from the dwelling.

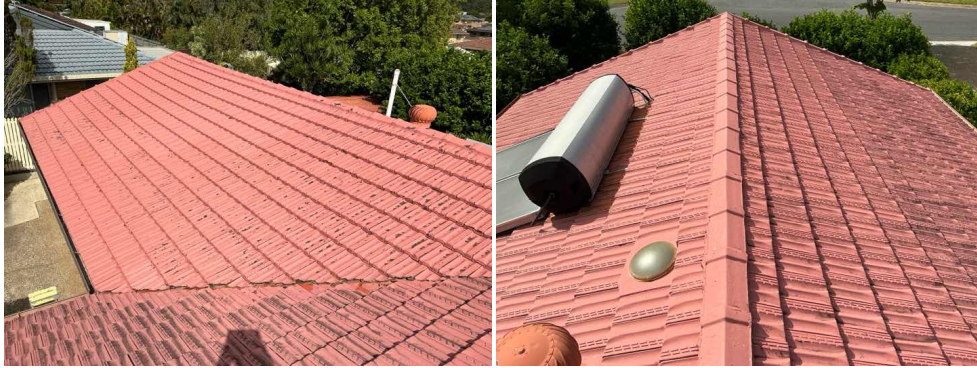
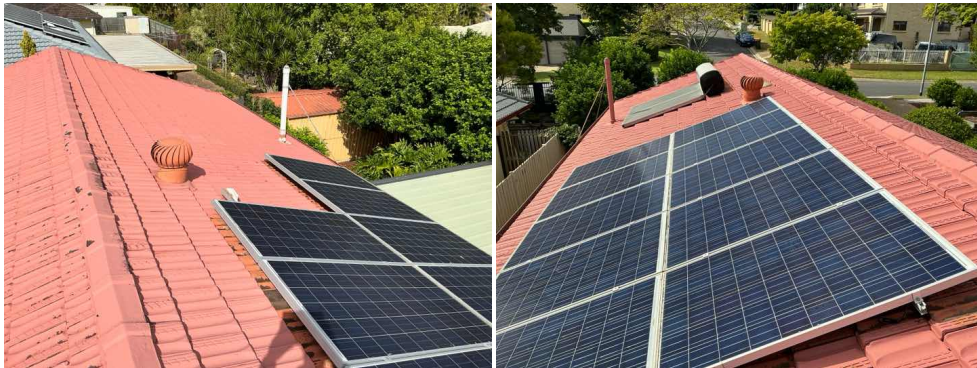
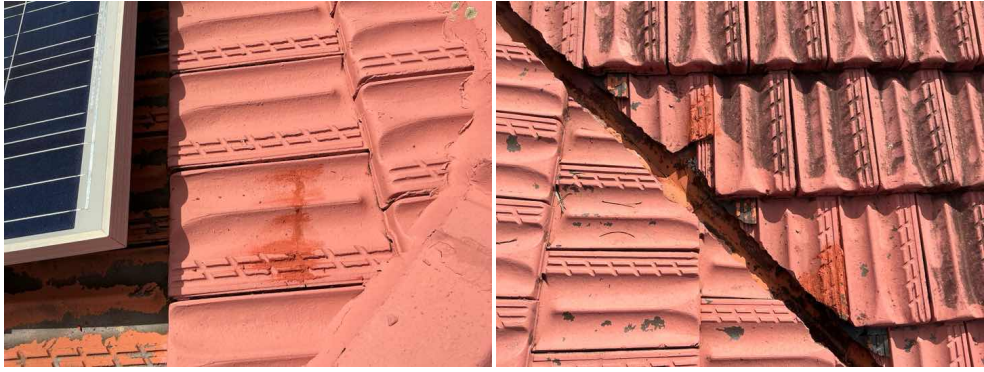
Overall Condition

Of the visible areas, the general condition of the roof is in serviceable condition for the age.

Repairs visible to cracked tiles. Change for complete tile , or regularly inspect tiles when cleaning roof/ gutter etc.

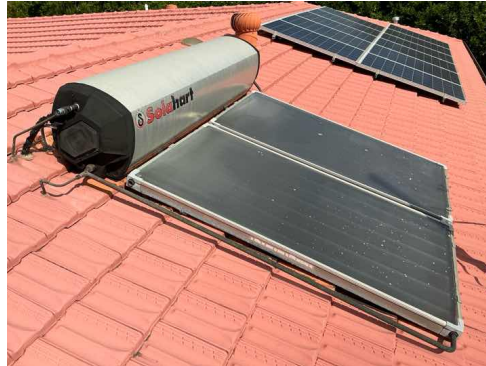
Hot Water Unit Findings

The hot water system appears to be in a serviceable condition. No specific tests other than running the hot water from a tap was carried out. No determination has been made as to the suitability or adequacy of the hot water system in relation to capacity or otherwise.

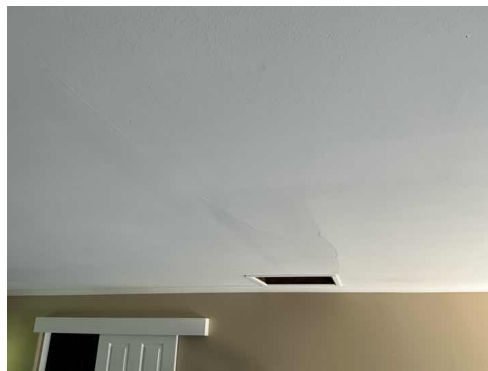
Ceiling Findings

#2. The plasterboard ceiling is aged and sagging between supports. Glue has released from its contact points leaving the sheeting supported mainly by its screw fixings. The ceiling requires an assessment by a lic plasterer to determine the process and costs involved with repair. Sagging ceilings have potential for collapse.

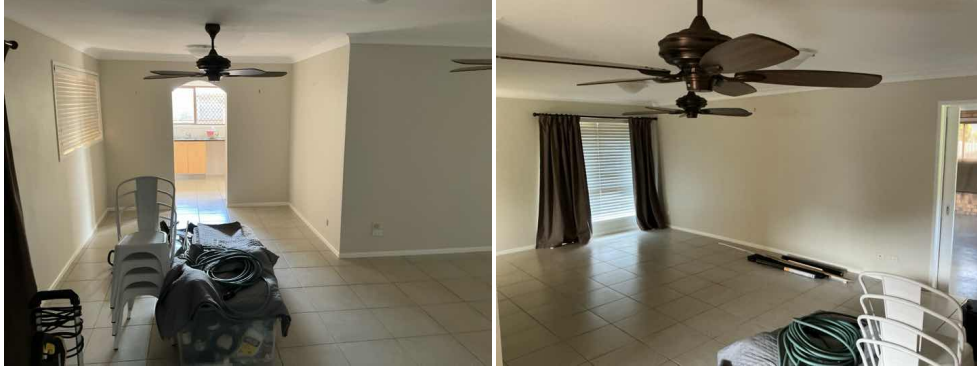
#3. Ceiling fan clearance is noted as being low to ground, assess and rectify as required.

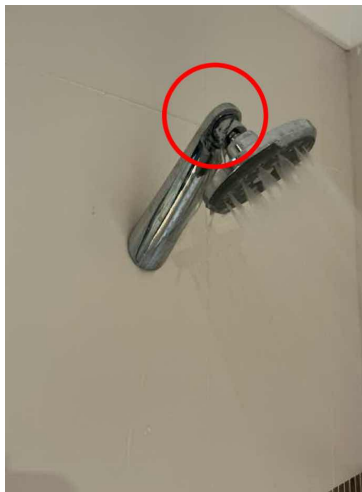
Shower And Bath

#5. Shower head is leaking. A qualified plumber should be engaged for advice and recommendations.

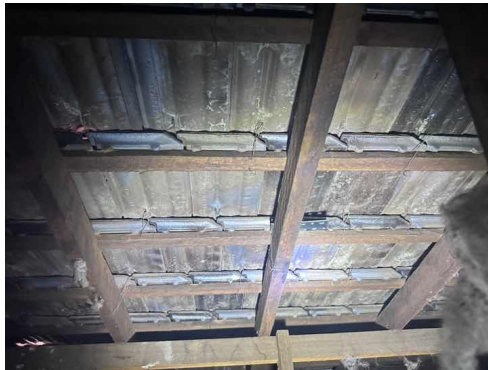
Sarking

There is no sarking installed. Sarking is the layer of reflective film material installed during construction underneath the roofing material. It provides a moisture barrier and minimal insulation. The installation of sarking is not a building requirement.

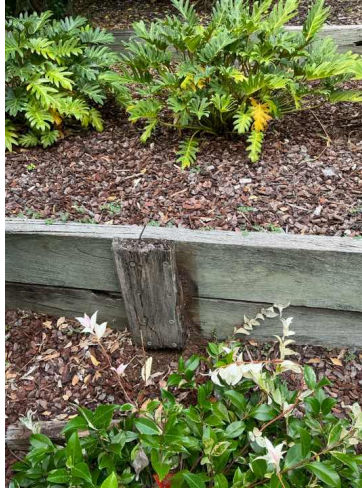
Live termites were found during the initial inspection. These were only minimally disturbed.

The termite identification has since been successfully treated by a lic pest control.
