Inspection Report

BPP Inspections

34 Ben Lomond St, Aspley, QLD

Pest And Building InsP-ection

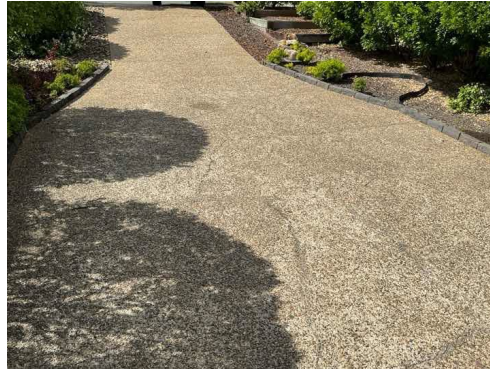
Driveway Condition

Common cracks & settlement were observed on the driveway. Maintenance is recommended. Note: Whilst these cracks appeared to be minor at the time of inspection, we strongly recommend you monitor these cracks and if worsening occurs contact a concreter for further advice.

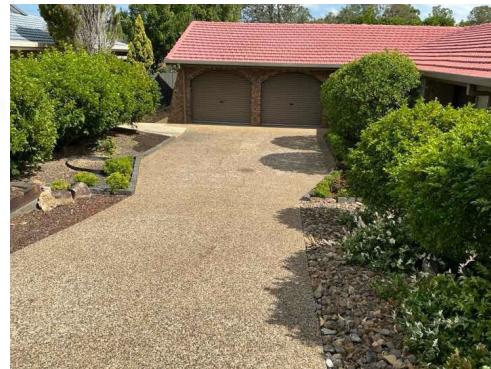
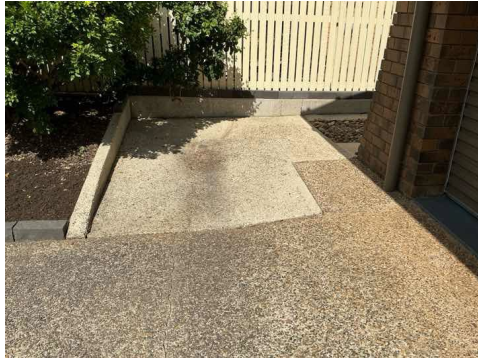
Drainage Findings

#1. The ground levels along the perimeter walls at the front of the home did not appear to fall away from the property walls sufficiently due to the natural landscape and contour. Recommendations: This will need to be assessed during a period of rainfall and if surface water appears to be entering the sub floor if applicable or ponding against the perimeter walls, engage a plumber or landscaper to assess and rectify as required. All drains should be regularly checked by a plumber and kept clean of debris to allow surface water to be carried away from the dwelling.

Poor drainage - There is water ponding against walls. This provides conducive conditions for termite infestation. The degree of risk is high. Engage plumber to rectify.

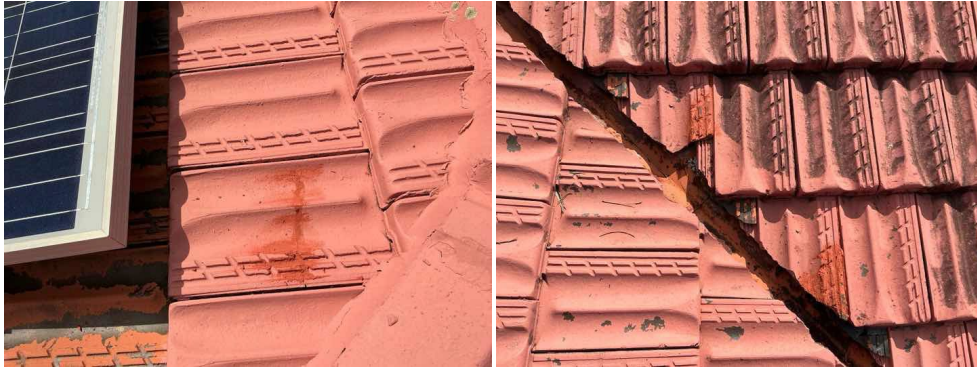
Repairs visible to cracked tiles. Change for complete tile , or regularly inspect tiles when cleaning roof/ gutter etc.

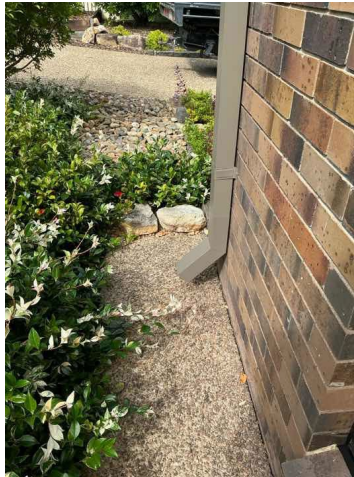
Down Pipe Findings

#2. Down pipe/s not connected to storm water discharge - Down pipes not connected to storm water have the potential to cause differential settlement to the footings, cause rising damp and is also conducive to termite infestation. Recommendations: A qualified plumber should be engaged for advice and recommendations.

Down pipes not connected to storm water. This causes moisture and excess moisture is conducive to termite infestation. The degree of risk is high. You need to engage a plumber to rectify.

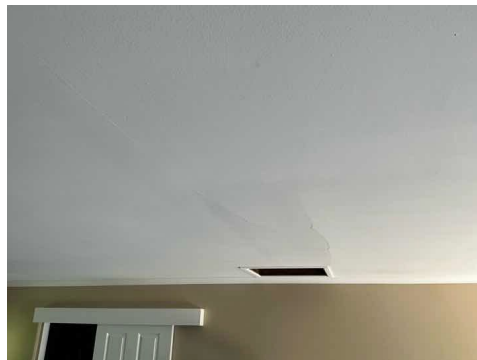
Ceiling Findings

#3. The plasterboard ceiling is aged and sagging between supports. Glue has released from its contact points leaving the sheeting supported mainly by its screw fixings. The ceiling requires an assessment by a lic plasterer to determine the process and costs involved with repair. Sagging ceilings have potential for collapse.

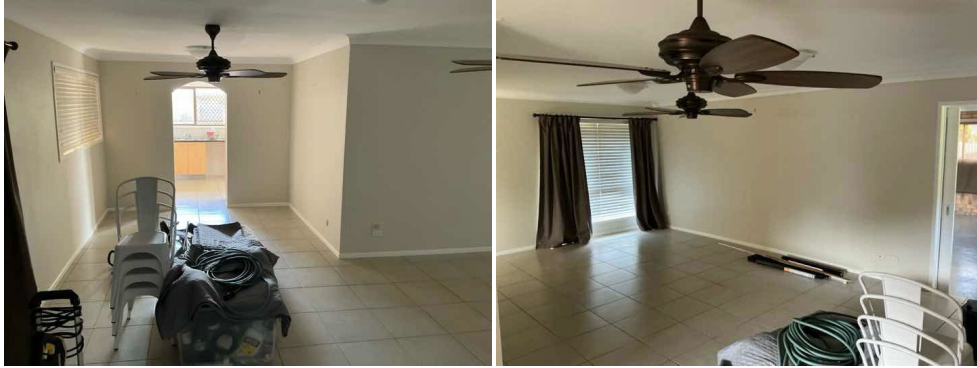
#4. Ceiling fan clearance is noted as being low to ground, assess and rectify as required.

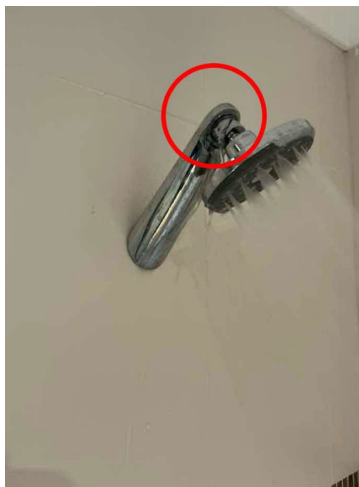
Shower And Bath

#6. Shower head is leaking. A qualified plumber should be engaged for advice and recommendations.

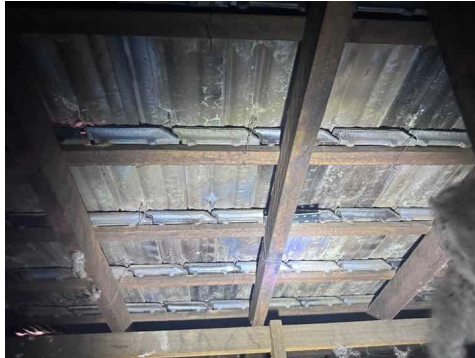
There is no sarking installed. Sarking is the layer of reflective film material installed during construction underneath the roofing material. It provides a moisture barrier and minimal insulation. The installation of sarking is not a building requirement.

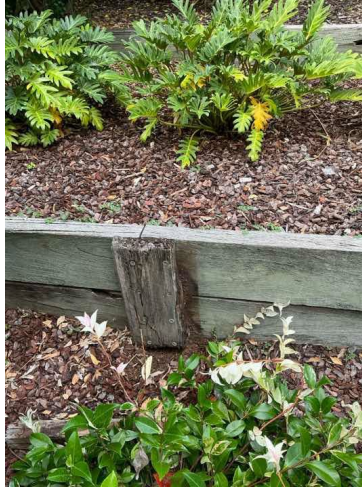
Live termites were found during the initial inspection. These were only minimally disturbed.

The termite identification has since been successfully treated by a lic pest control.
