# Inspection Report

## BPP Inspections

**52 Floramy St , Boondall, QLD**

### Pest And Building InsP-ection

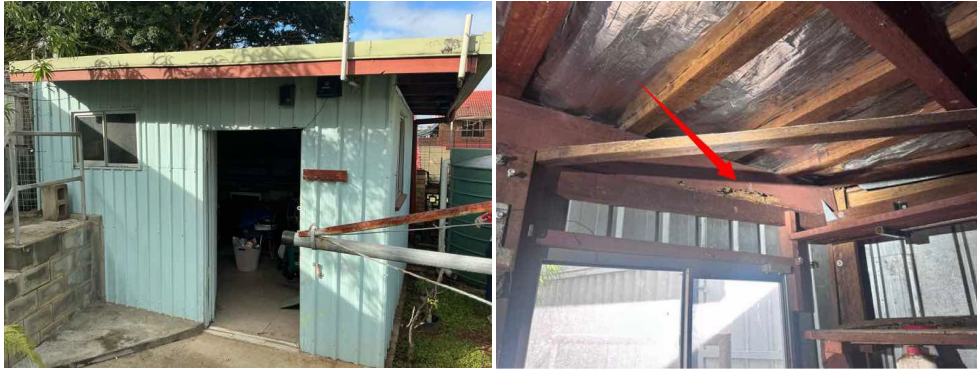
Minor termite damage to the framing timbers on the shed.

Contact a builder or carpenter to further assess and repair as required.

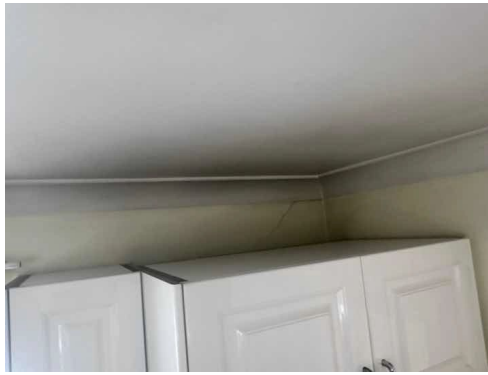
Minor cracking visible appears consistent with age of the building.

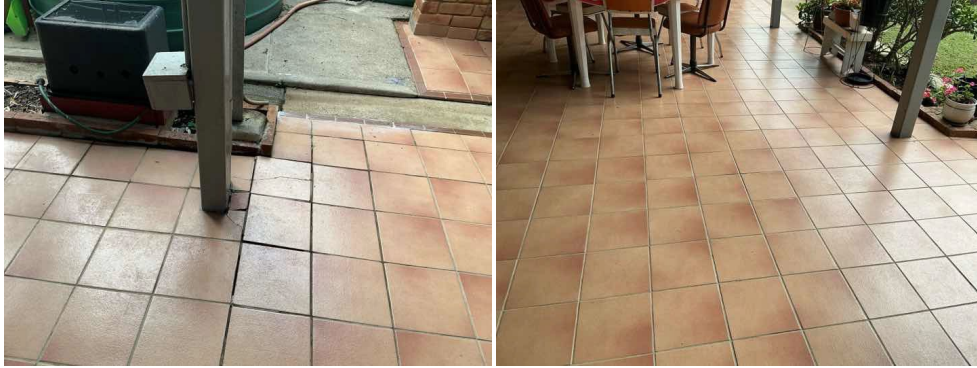
#2. The tiles to the outdoor area were tested for adhesion. Some tiles to the outdoor area were noted as "drummy" or poorly adhered. These drummy tiles are more prone to cracking from impact. Methods of retrofixing is available from specialist companies if required. Contact a lic tiler for further advice and recommendations.

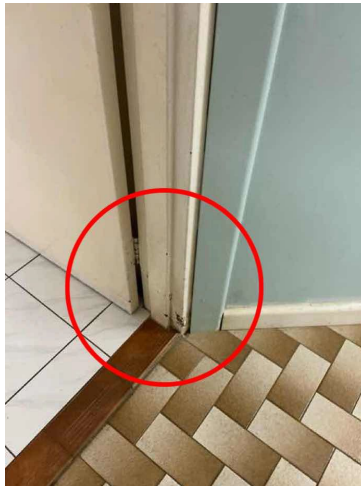
Minor rust and repairs visible to base of metal frames. Assess and repair as required.

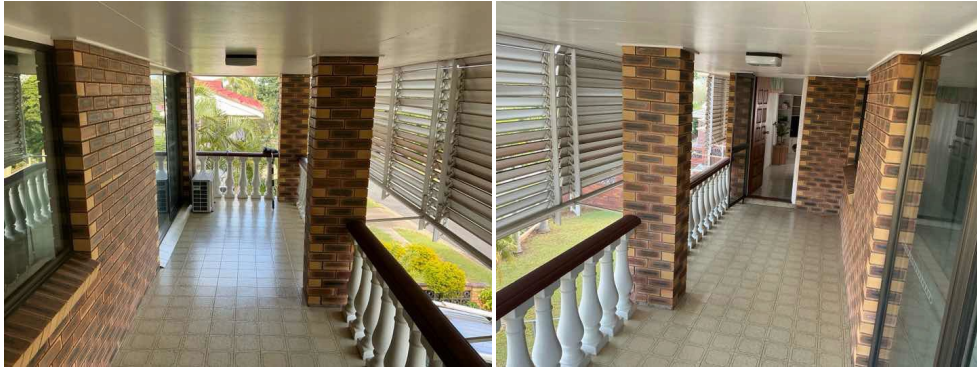
#3. The handrail is less than the current standard height of 1m. This handrail is still compliant from time of construction. It is recommended to increase the height of the handrail to current standards as this will improve safety.

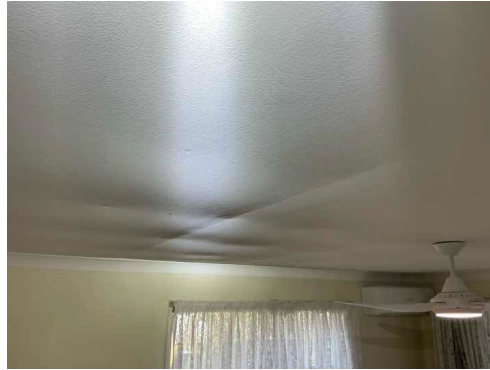
#4. General age and deflection/ sagging visible to selected ceilings. This puts excessive weight on the original fasteners of the ceiling.

Additional support screws may be required in areas. Contact a lic plasterer to assess and repair.

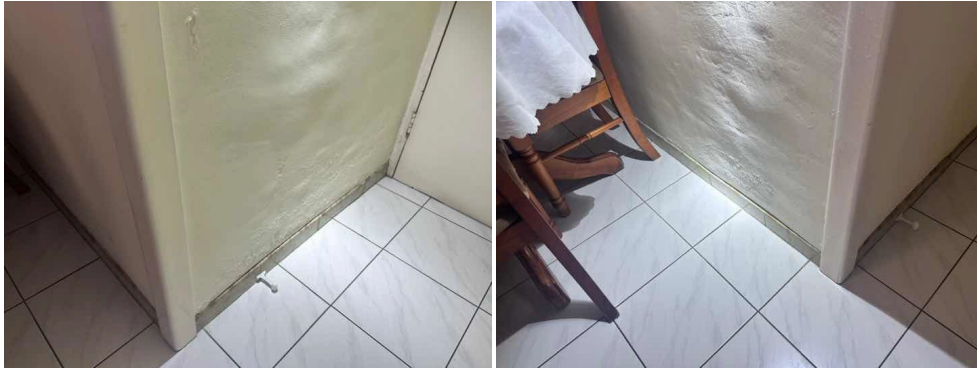
#5. There is moisture related efflorescence and paint peeling to the wall behind the shower cubicle. This suggests a leak within the waterproofing membrane, or the plumbing. Further investigation required to determine the cause and assess the repairs required.

Contact a lic Builder,Plumber.

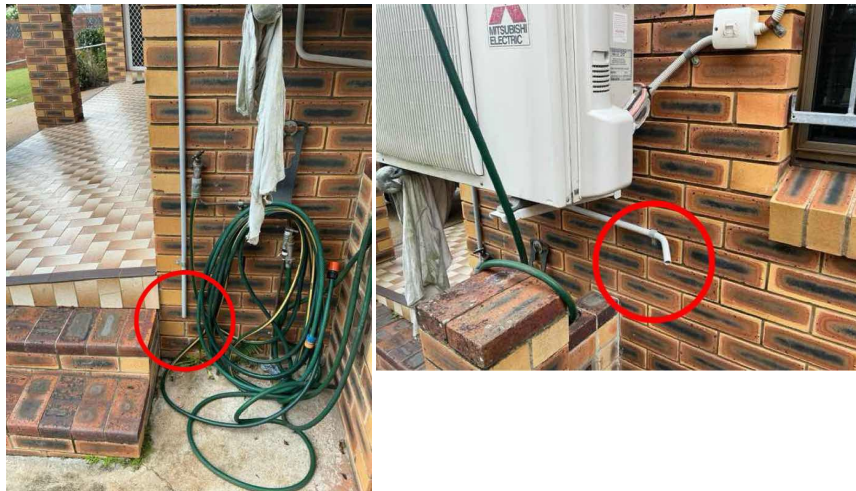
#8. The air conditioning drain was draining onto the building perimeter ground surface. This adds constant excessive ground moisture providing conducive conditions for termites.

Divert drain and connect to stormwater discharge points where possible.
