Inspection Report

Inspection Address

39 Ironbark Place, Bridgeman Downs, QLD

Pest And Building InsP-ection

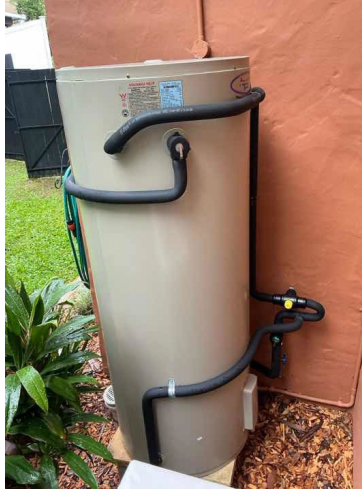
The hot water system appears to be in a serviceable condition. No specific tests other than running the hot water from a tap was carried out. No determination has been made as to the suitability or adequacy of the hot water system in relation to capacity or otherwise.

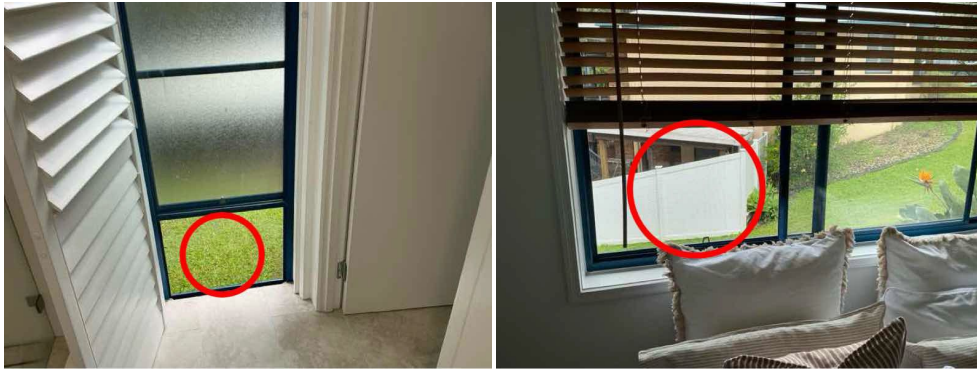
Age observed to window components. Maintenance required. Assess each window and improve sealants and lubricants to mechanical components.

#1. Selected upstairs windows are able to be fully opened. This was compliant at the time of construction and technically no requirement to rectify. Current building code has identified a fall risk and requires a limited opening of 125 mm or secure screening to be in place.

Contact a lic Builder, Glazier to assess and rectify.

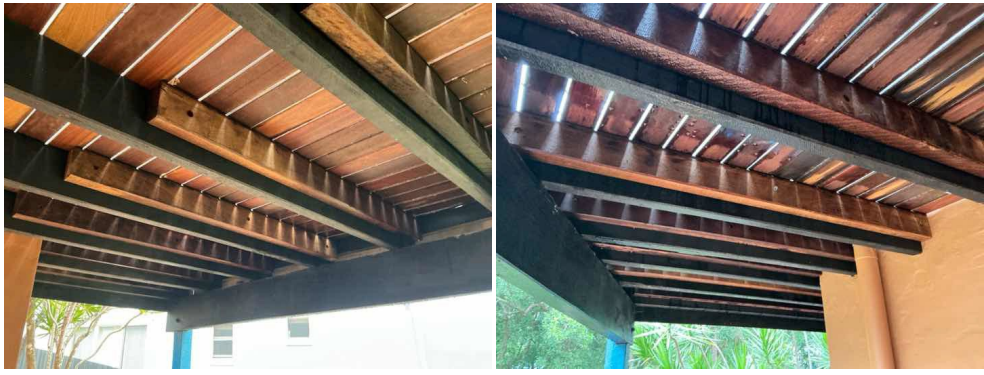
Deck Framework

#2. Additional timber support has been added to the deck floor joists. This is generally due to timber decay to the tops of the original floor joists. Inspection required annually to ensure all screwed and bolted fittings remain secure.

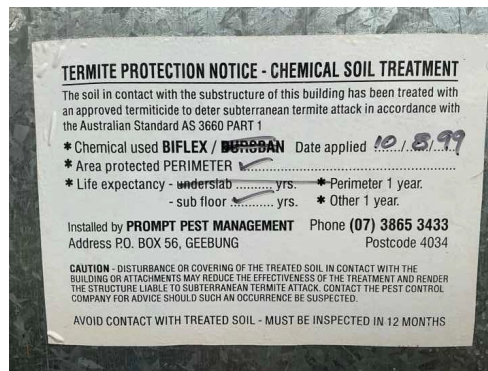
The durable notice of a building is a permanent sticker stating the method of long term termite treatment or barrier in place. This building has no durable notice. It is then clearly reported by us, that there is no effective termite barrier in place, leaving the building susceptible to hidden termite entry.

In this case we strongly recommend that you engage the services of a licensed pest control technician to access and undertake an assessment of the property, to determine the procedure and costs involved with the installation of the recommended method of barrier installation, and termite control method.

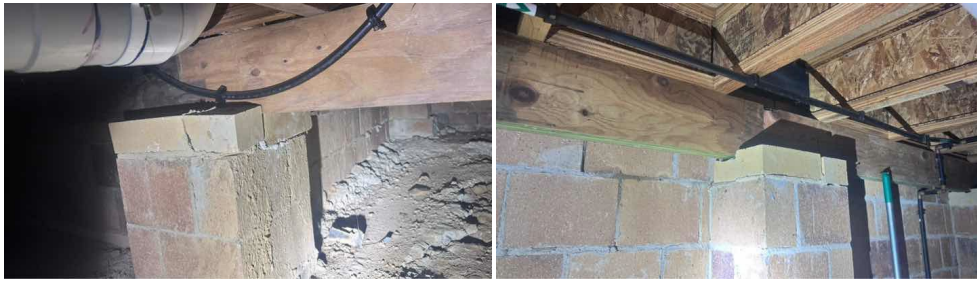
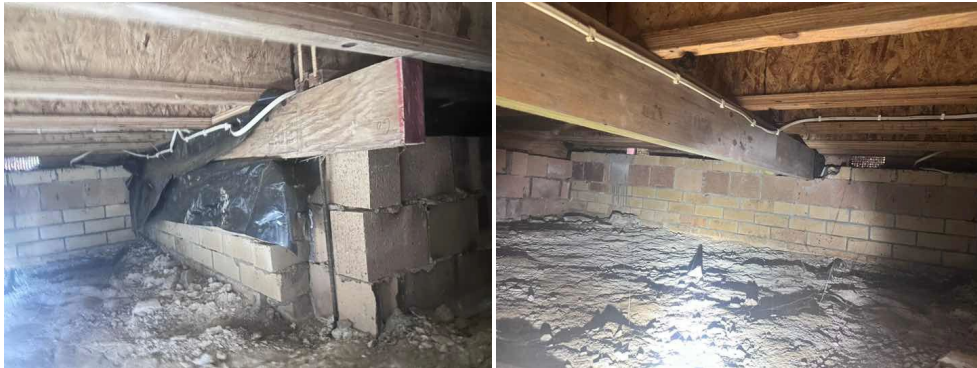
CONDUCTIVE CONDITIONS	5. Ant Capping and Termite Shields	The Termite Shields Appear To Be	#5. The termite shields (ant caps) are not installed. A chemical soil treatment is required to offer termite protection to the building. Contact a lic pest control technician. .

Contact a lic pest control to install a chemical soil treatment to the perimeter.
