Building and Timber Pest Inspection Report VR

Inspection Date: Thu, 28 May 2026

Property Address: 27 Tarm St, Wavell Heights QLD 4012,
Australia

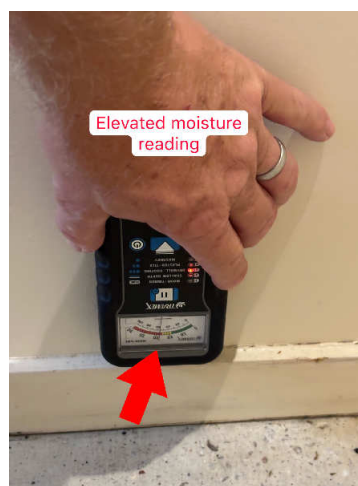
Finding: Hallway - moisture damage

Information: At the time of the inspection, it was noted that there was evidence of moisture damage to the wall lining in the hallway. This appears to have been caused by a leak from a pipe above this area. There has been a repair carried out to the pipe as shown in the attached photograph. Moisture readings taken in this area indicate that this leak is no longer active and as such is noted as a minor defect.

A building maintenance professional or painting contractor should be engaged to replace the damaged section of wall lining. This should be done as a short term priority.
