Building and Timber Pest Inspection Report VR

Inspection Date: Thu, 28 May 2026

Property Address: 27 Tarm St, Wavell Heights QLD 4012,
Australia

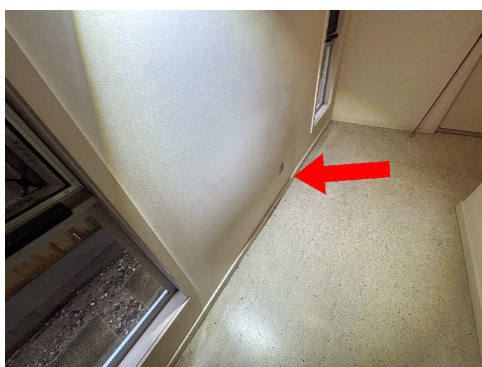
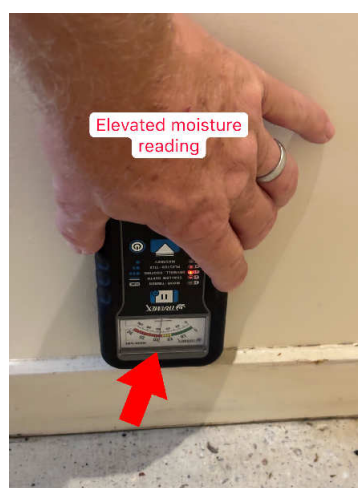
Finding: Hallway - moisture damage

Information: At the time of the inspection, it was noted that there was evidence of moisture damage to the wall lining in the hallway. This appears to have been caused by a leak from a pipe above this area. There has been a repair carried out to the pipe as shown in the attached photograph. Moisture readings taken in this area indicate that this leak is no longer active and as such is noted as a minor defect.

A building maintenance professional or painting contractor should be engaged to replace the damaged section of wall lining. This should be done as a short term priority.

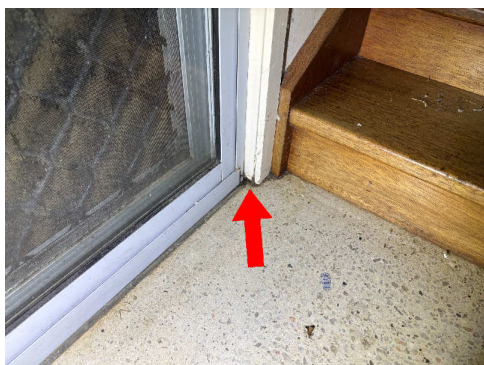
Finding 3.02

Finding: Door frames - evidence of moisture damage

Information: At the time of the inspection, there was evidence of moisture damage to a timber door frame in the front bedroom and a timber door frame in the kitchen area. The source of the moisture could not be determined.

If left unaddressed, further damage is likely to occur and may not be limited to the door frame.

A building maintenance professional or painting contractor should be engaged to repair the damaged timber door frames. This should be done as a short term priority.

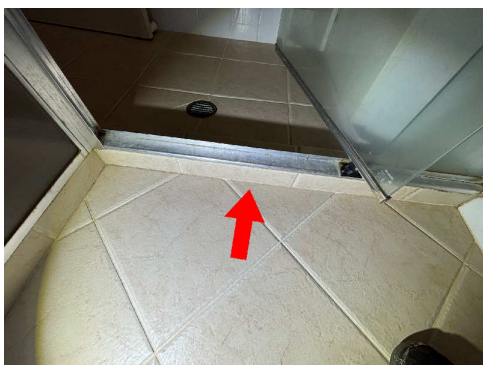
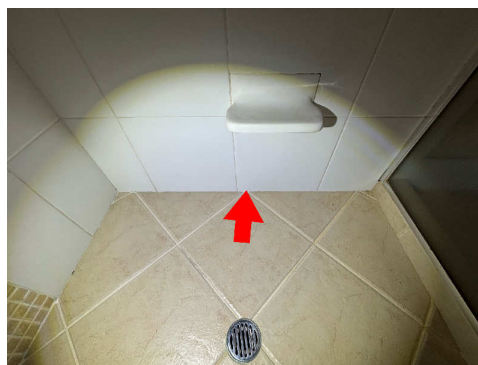
Finding 3.06

Finding: Ensuite - sealant deteriorating

Information: At the time of the inspection it was noticed that the sealant in the shower cubicle in the ensuite was deteriorating.

Sealant is used in tiled areas to prevent moisture from entering the wall cavity and causing damage to the building elements. A moist environment in the wall cavity may also be a conducive condition for termite activity.

If it is not addressed, damage to building elements will occur and would require invasive works to rectify any damage.

A building maintenance professional or sealant applicator should be appointed to replace all sealant as a matter of urgency.

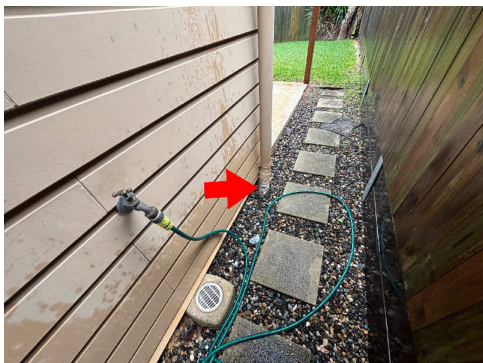
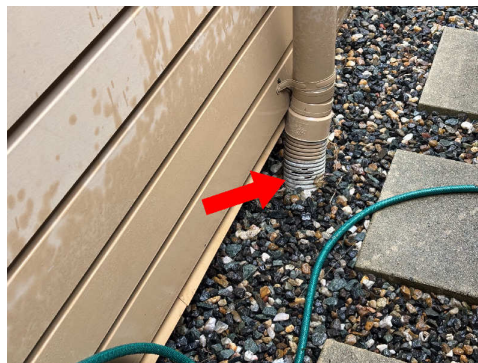
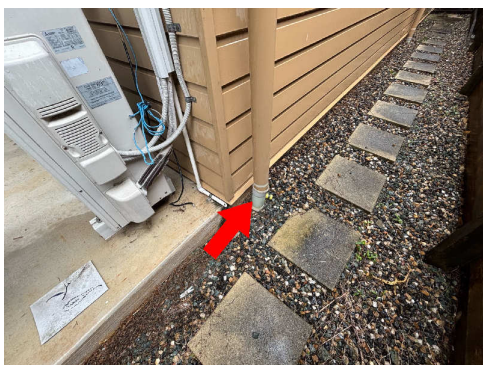
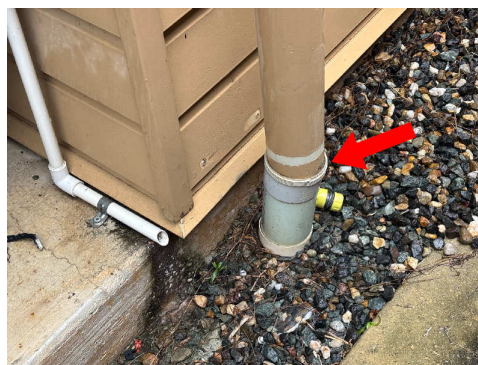
Finding 3.09

Finding: Down pipes - damaged

Information: At the time of the inspection, it was noted that the bottom section of the down pipes at the rear of the dwelling were damaged. The down pipe on the right hand side has holes to the flexible section and the base of the down pipe on the left hand side is not secure. This affects the functionality of the down pipes and allows water to escape near the foundation.

Excessive moisture next to the foundations of the dwelling creates a conducive environment for termite activity and can cause damage to the associated building materials.

A licensed plumber should be engaged to carry out this repair. This should be done as a matter of urgency.

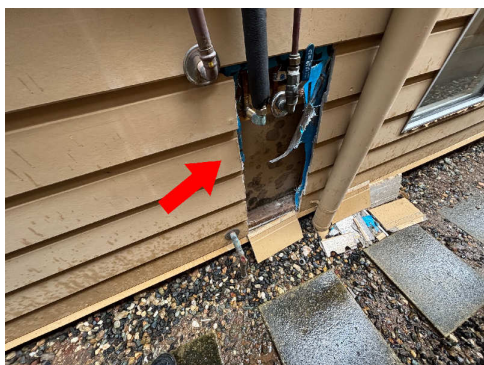
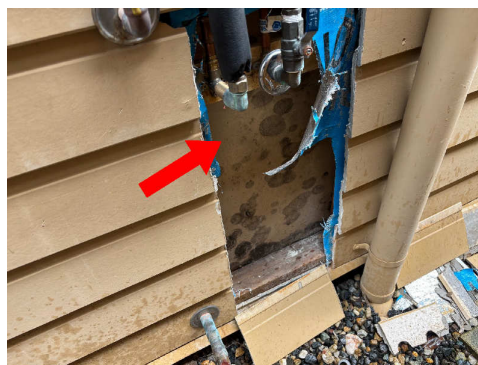
Finding 3.10

Finding: Exterior - cladding requires repair

Information: At the time of the inspection, it was noted that a section of external cladding on the right hand side has been cut open to repair a water leak.

A building maintenance professional or licensed carpenter should be engaged to repair the affected cladding. This should be done as a short term priority.

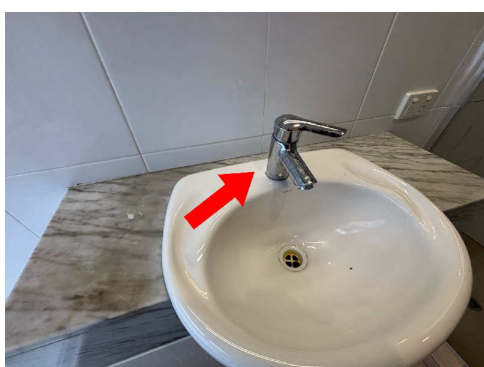
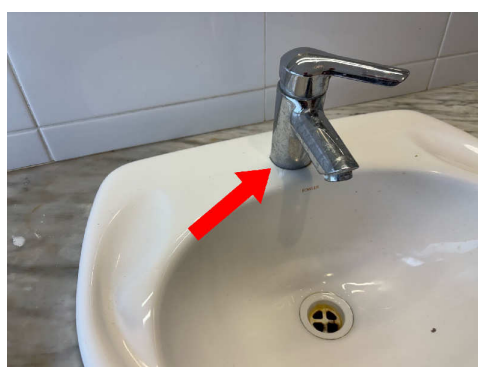
Finding 3.11

Finding: Upstairs family bathroom - loose mixer tap

Information: At the time of the inspection, it was noted that the mixer tap in the upstairs family bathroom was loose.

If left unaddressed, deterioration of the mixer tap may occur which could lead to leaks.

A licensed plumber should be engaged to re-secure the bathroom mixer tap. This should be done as a short term priority.

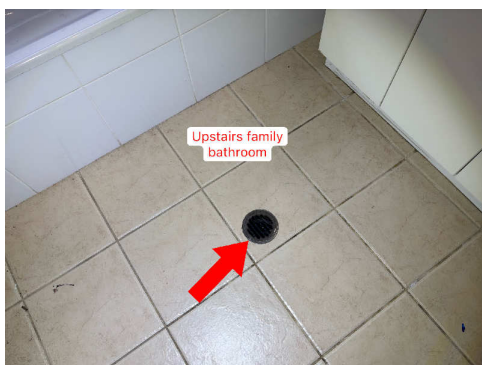
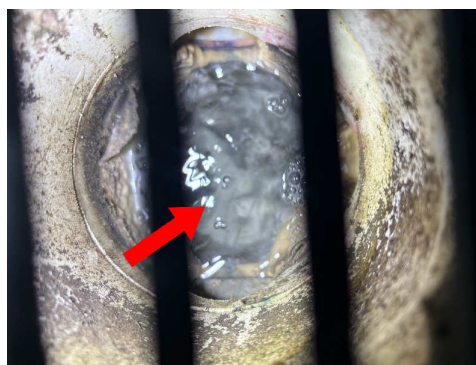
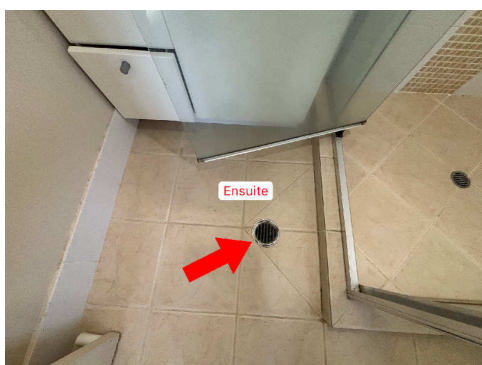
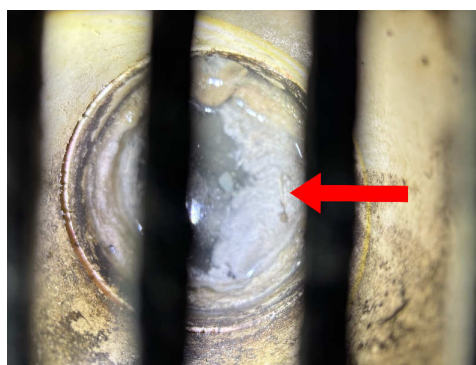
Finding 3.12

Information: At the time of the inspection, it was noted that the floor wastes in the upstairs bathrooms were partial blocked. A pungent smell emitted from both wastes when water flowed into them.

A licensed plumber should be engaged to clear any blockage of these floor wastes. This should be done as a short term priority.

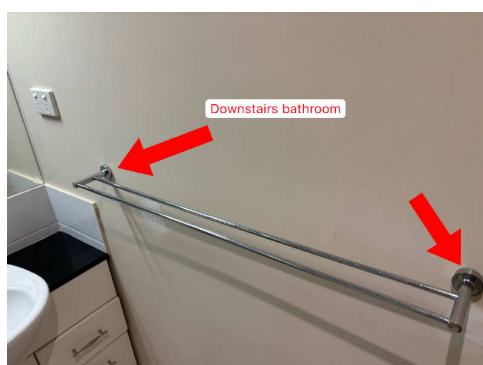
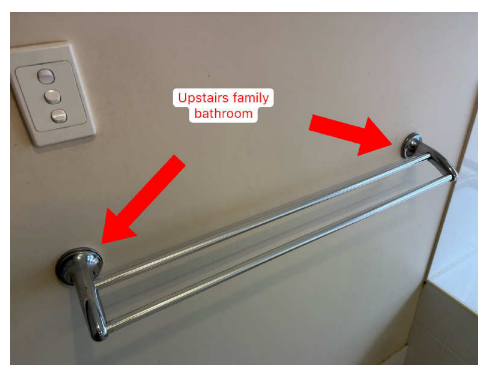
Finding 3.13

Finding: Towel rails - loose

Information: At the time of the inspection, it was noted that the towel rails in the downstairs and upstairs family bathroom were loose.

This appears to be from general wear and tear. If not addressed, the towel rail may come away from the wall.

This may require simple adjustment of the fasteners attaching the towel rails. A building maintenance professional could be engaged to carry out these minor repairs. This can be done at the clients discretion.

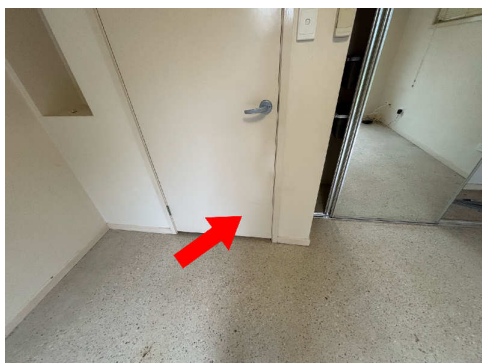
Finding 3.14

Information: At the time of the inspection, it was noted that the hinged door to the front downstairs bedroom was binding against the door jamb during normal operation. This appears to be general wear and tear.

For minor causes, a qualified carpenter or building maintenance professional should be appointed to perform minor rectification works at client discretion.

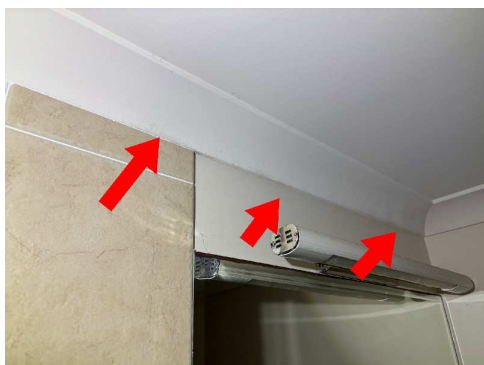
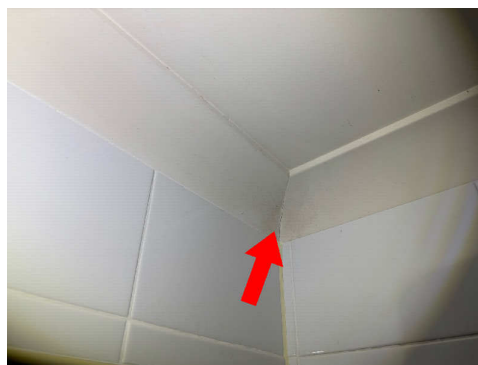
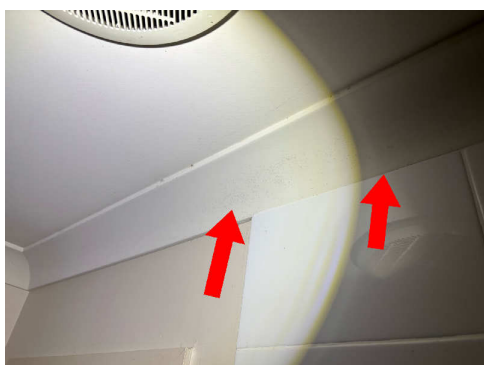
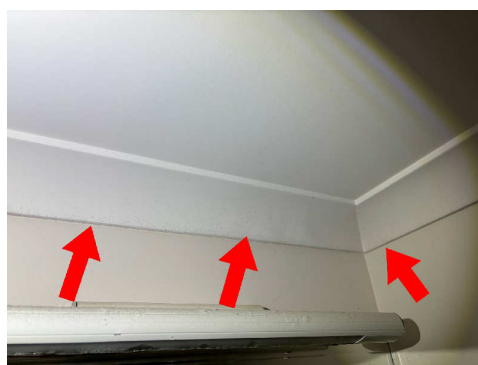
Finding 3.15

Information: At the time of the inspection, it was noted that there was signs of mould growth to sections of the cornice in the downstairs bathroom. This should be treated to ensure no further growth occurs.

Where evidence of mould growth was noted, there may be environmental, biological or health issues associated with the report.

Any mould found during the inspection should be cleaned immediately by a cleaning contractor or the homeowner as applicable.

Please note that severely affected building elements may require replacement by a registered builder or qualified carpenter.

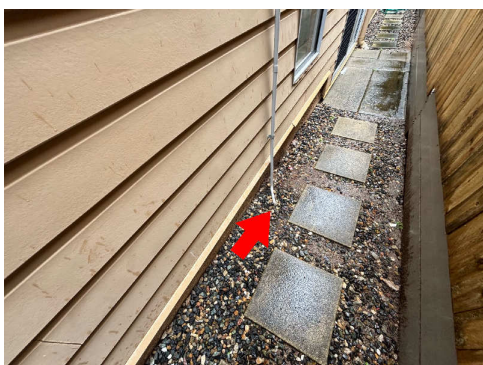
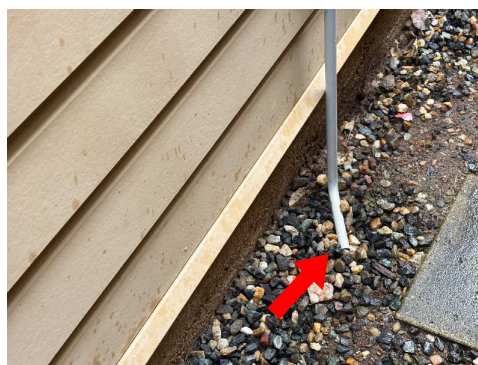
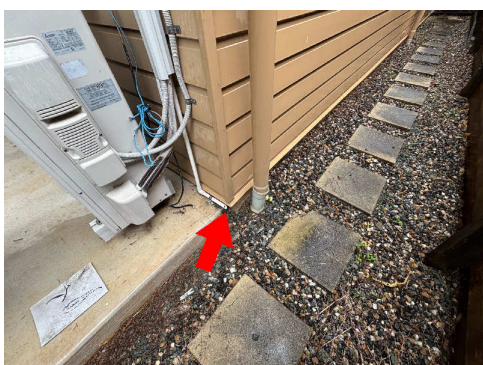
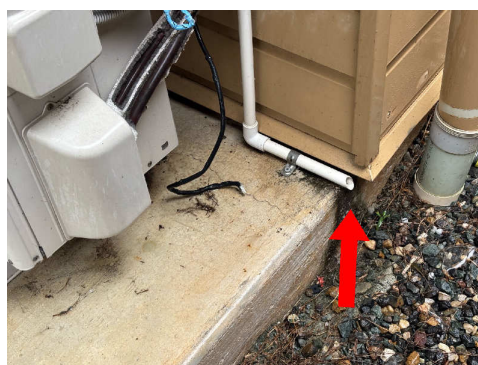
Building:	Main Building
Location:	All External Areas
Finding:	Air conditioner - Disconnected condensate drains

At the time of the inspection, it was noted that the air conditioner condensate drains to the units at the side and rear of the dwelling were not connected to the storm water drainage and as a result are draining next to the foundations of the dwelling.

Air conditioning condensate drains that are not connected to the storm water drainage and are draining next to the foundation can create excessive moisture in the surrounding area.

Such leaking creates an environment which is conducive to an array of defects, including water damage to associated building elements and the attraction of termite or timber pest infestation. Damage can be seen to the concrete beneath one of these condensate drains.

It is highly recommended that a licensed plumber be appointed to connect the air conditioner condensate drains to all the units in order to prevent such an environment from being created. These works should be carried out as soon as possible.

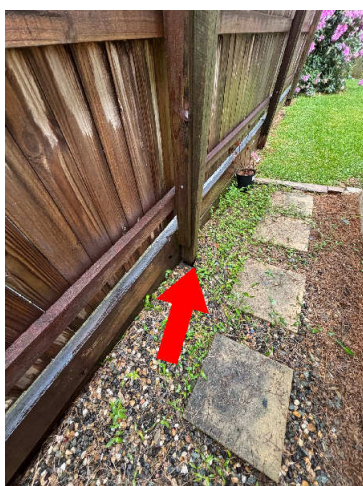
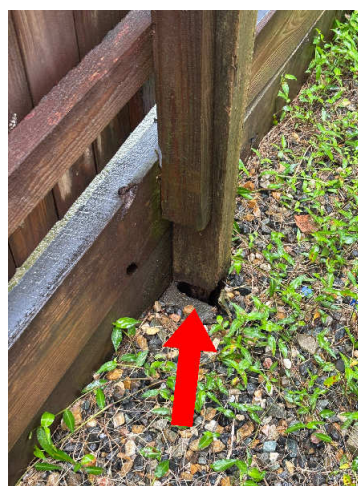
Finding 7.01

Finding: Wood rot

Information: At the time of the inspection, it was noted that there were evidence of wood rot to the base of a timber fence post on the left hand side of the property. This may be due to the age of the timber building elements and general weathering.

This building element shows evidence of wood rot. Wood rot, also known as Fungal Decay, occurs when timbers and other cellulose building materials are exposed to damp conditions on an ongoing basis.

Early intervention and regular maintenance, particularly of exterior timbers, will prolong the useful life of these building elements. Prior to any works being performed, the cause of the moisture that has created the visible wood rot should be identified and addressed in a suitable manner. Replacement of affected timbers may then be a necessary step in protecting surrounding building elements from such deterioration.

A qualified carpenter or registered builder may also be required to replace affected building materials.
