Inspection Report

BPP Inspections

2 Boronia Place, Fitzgibbon, QLD

Pest And Building Inspection

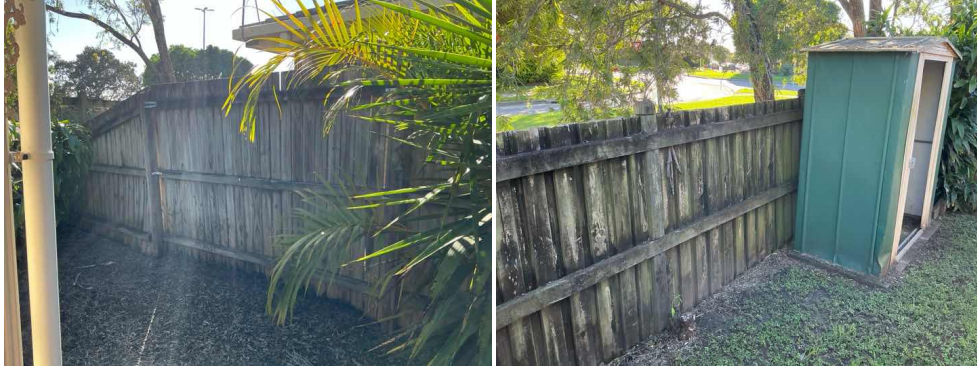
#1. General age to fence components - Recommendations: General upkeep and maintenance. A qualified fencing contractor should be engaged for repairs

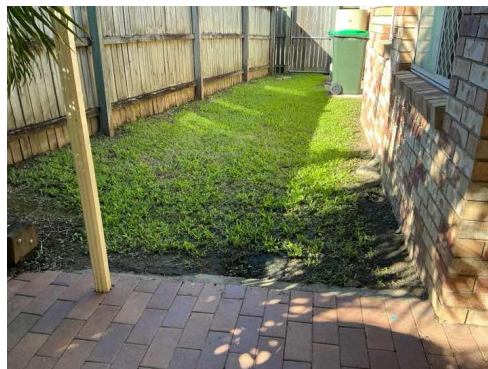
#2. The ground levels along the perimeter walls at the rear of the home did not appear to fall away from the property walls sufficiently due to the natural landscape and contour. Recommendations: This will need to be assessed during a period of rainfall and if surface water appears to be entering the sub floor if applicable or ponding against the perimeter walls, engage a plumber or landscaper to assess and rectify as required. All drains should be regularly checked by a plumber and kept clean of debris to allow surface water to be carried away from the dwelling.

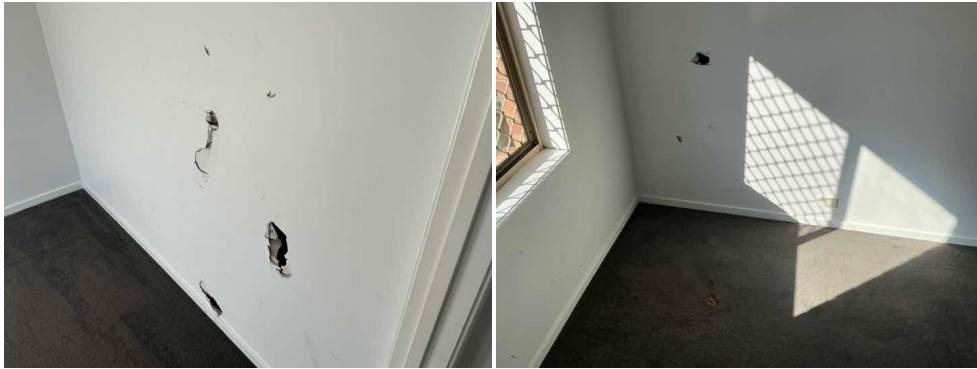
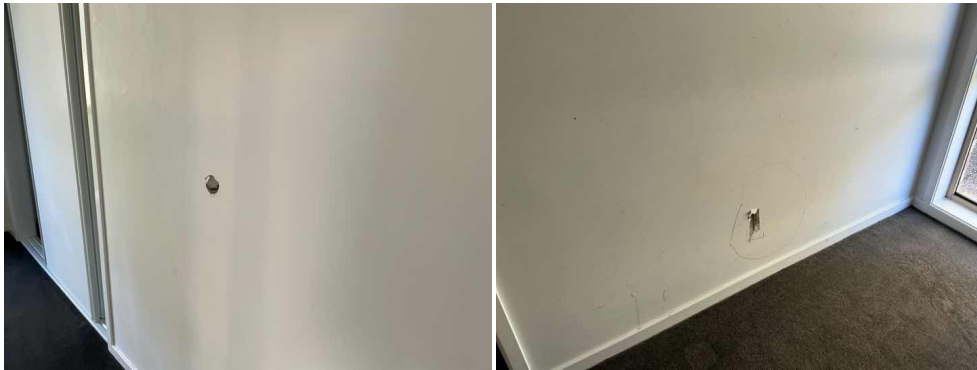
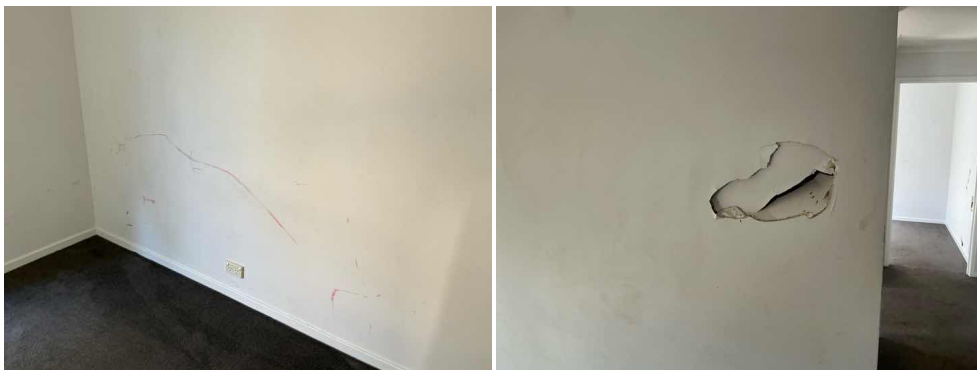
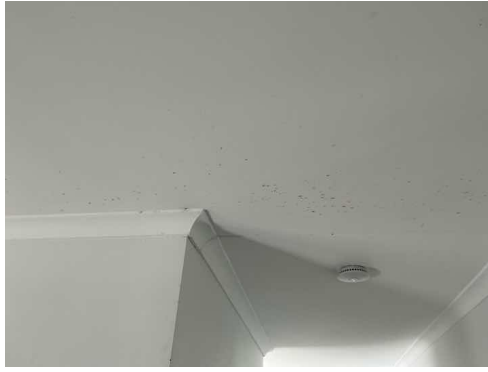
#3. Impact damage visible to selected walls throughout the building, carpet damage. This will require further assessment and repairs. Contact a lic Builder/ Plasterer.

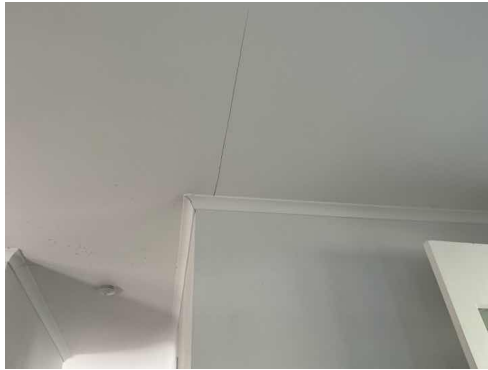
#4. Settlement Cracks Noted . These are typical and generally patch and paint will suffice, however Monitoring these cracks advised for 12 months and if become wider or longer, you will need to contact a structural engineers to assess.

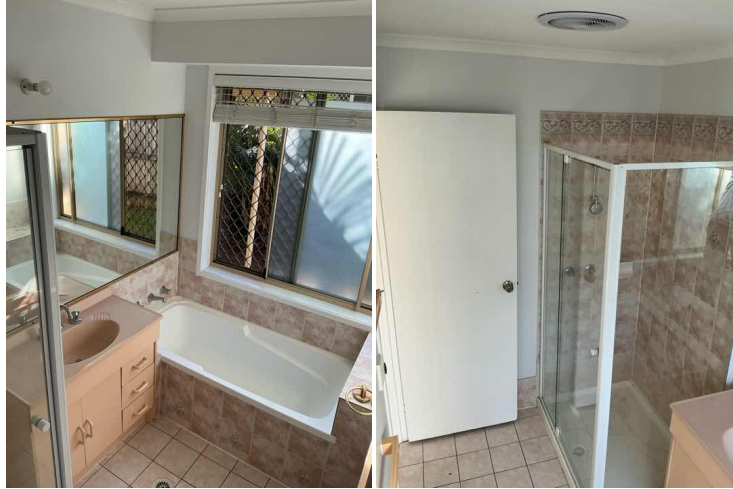
Hall

#5. General age visible to the cabinet, fittings and sealants of the bathroom. Toilet missing seat and lid.

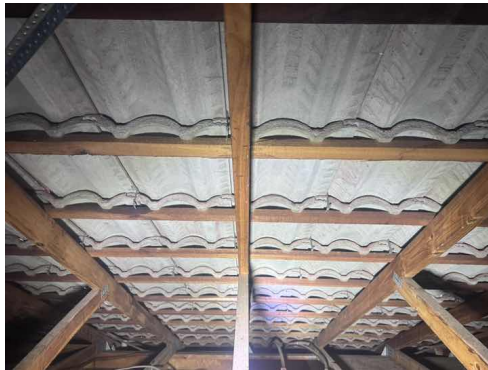
There is no sarking installed. Sarking is the layer of reflective film material installed during construction underneath the roofing material. It provides a moisture barrier and minimal insulation. The installation of sarking is not a building requirement.
