Inspection Report

10 / 276 Handford Rd, Taigum, QLD

Pest And Building InsP-ection

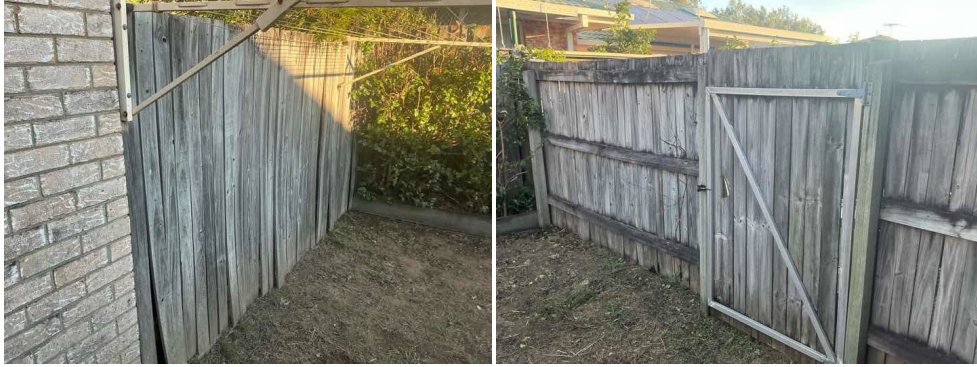
#1. General age to fence components - Recommendations: General upkeep and maintenance. A qualified fencing contractor should be engaged for repairs

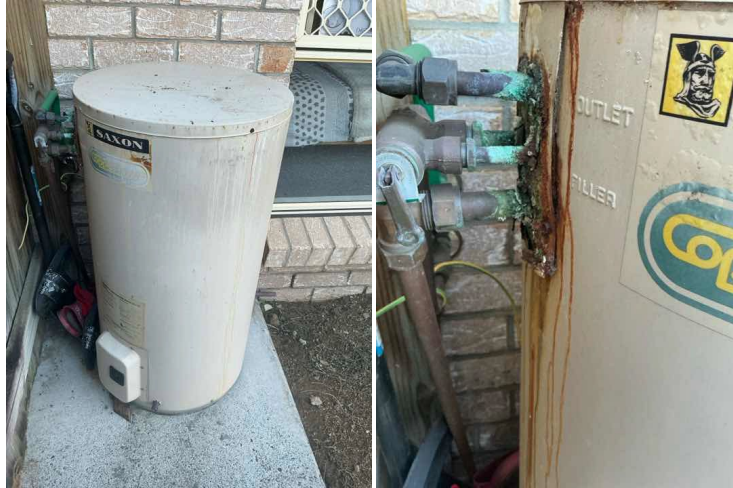
#2. Leaking observed from hot water unit at time of inspection. Recommendations: Engage a licensed plumber to assess and rectify.

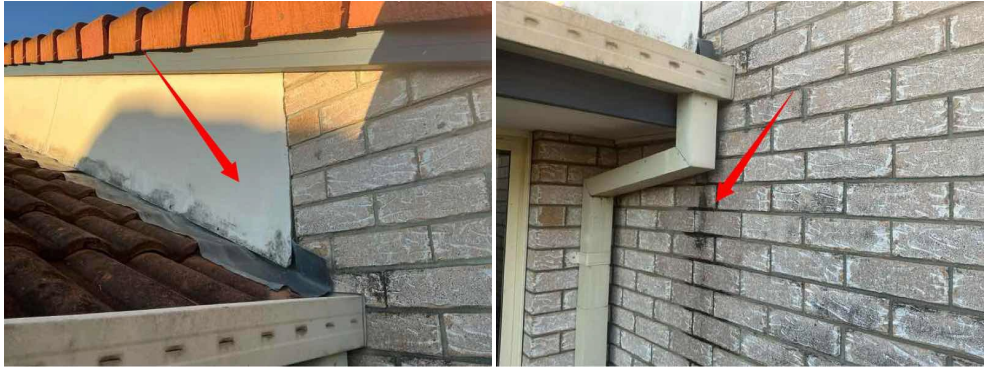
#3. General age visible to the fibro sheeting and exterior paint surfaces on the roof. Overflowing of rear gutter visible. Mouldy areas to be treated accordingly. Sealants and fillers showing signs weather exposure.

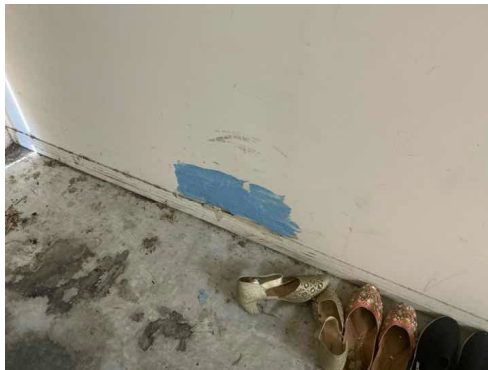
#4. Physical wall damage visible - Recommendations: Engage a licensed builder to assess/repair.

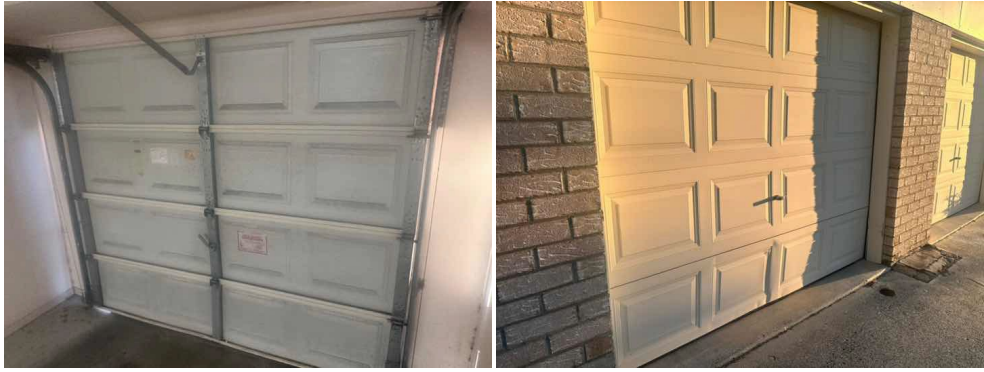
#5. Impact damage observed. Repairs/Replacement recommended.

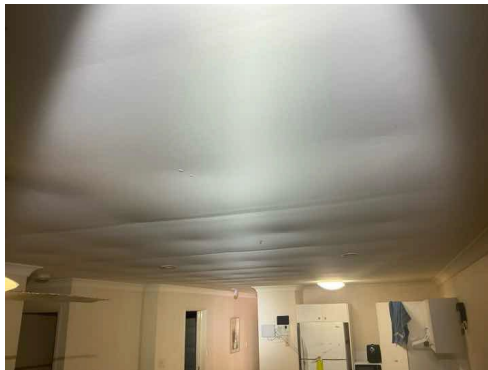
Section	Location	Name	Comment
INTERIORS	Lounge Room	Ceiling	#6. The ceiling shows visible signs of sagging plasterboard. Plasterboard ceilings, when sagging between supports, put excessive pressure on the fasteners. This excessive pressure can lead to detachment and areas of collapse. Contact a lic plasterer for a full assessment and repairs.
CONCLUSION	Condition Of Inspected Structure	The incidence of Major Defects	#9. The incidence of major defects in this residential building as compared with similar buildings is considered LOW

#6. The ceiling shows visible signs of sagging plasterboard. Plasterboard ceilings, when sagging between supports, put excessive pressure on the fasteners. This excessive pressure can lead to detachment and areas of collapse. Contact a lic plasterer for a full assessment and repairs.

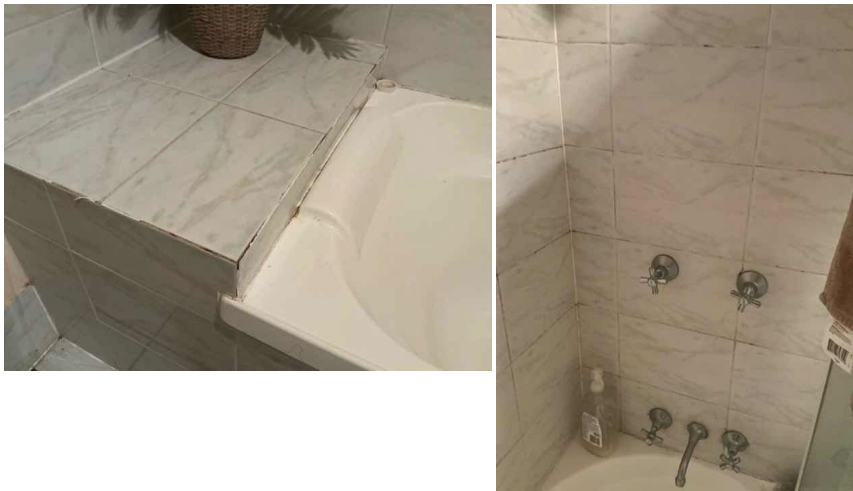
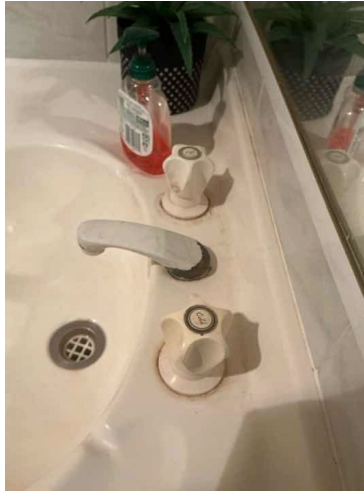
#7. General age visible to the cabinet, fittings and sealants of the bathroom.

General maintenance required.

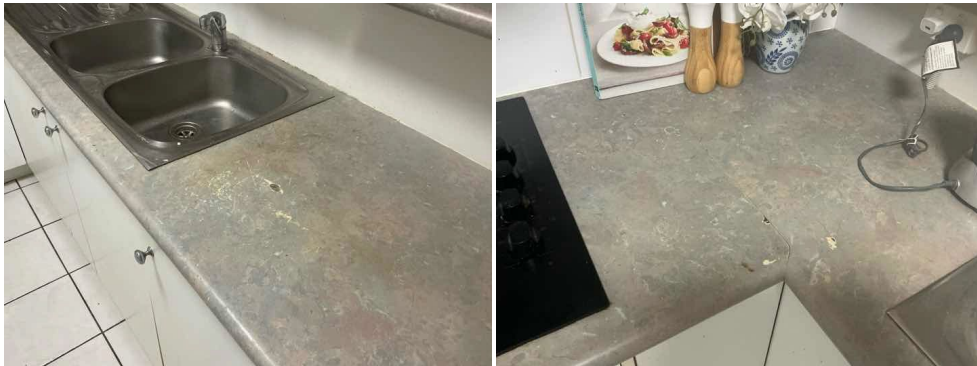
#8. Damage was noted to the bench top, contact a joinery company for repairs

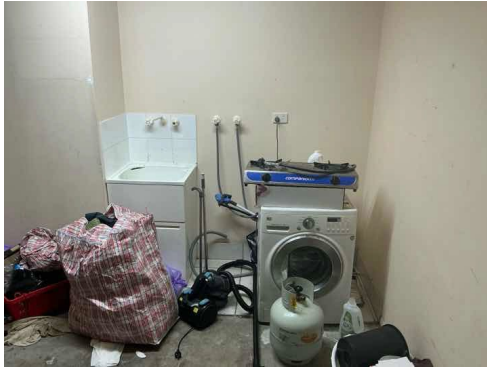
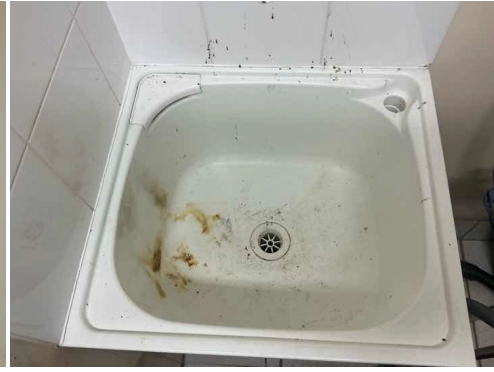
Burning stains visible to tub.

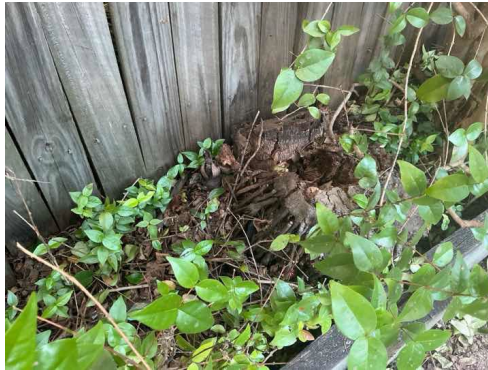
#11. Termite damage was located to timber debris and tree stumps in the garden. No damage was identified to accessible timbers of the building. Further assess and treat if required.

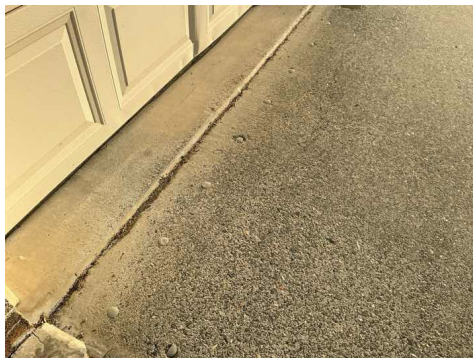
Yes, Drill Holes (Chemical Treatment) was seen at the property

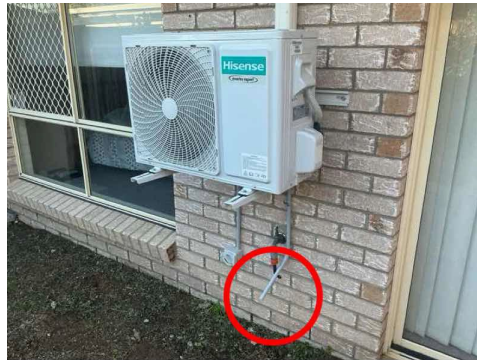
#12. The air conditioning drain was draining onto the building perimeter ground surface. This adds constant excessive ground moisture providing conducive conditions for termites.

Divert drain and connect to stormwater discharge points where possible.
