# Inspection Report

## BPP Inspections

## Inspection Address

**Unit 2, 270 King St, Caboolture., QLD**

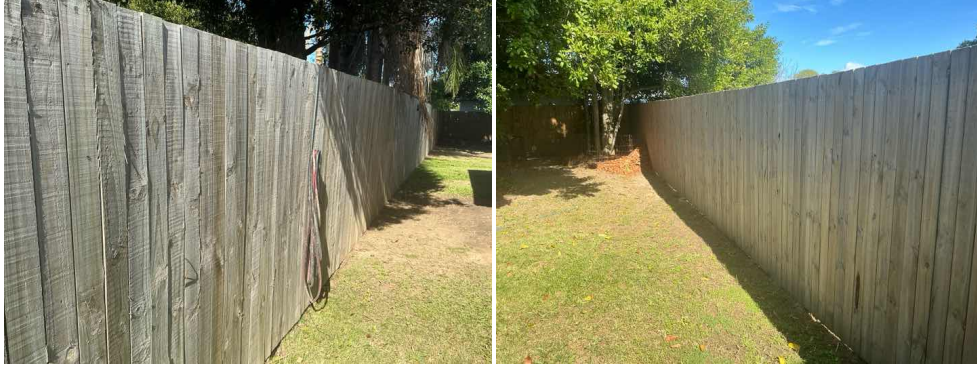
Of the visible areas, the general condition of the fences and gates is serviceable for the age of dwelling.

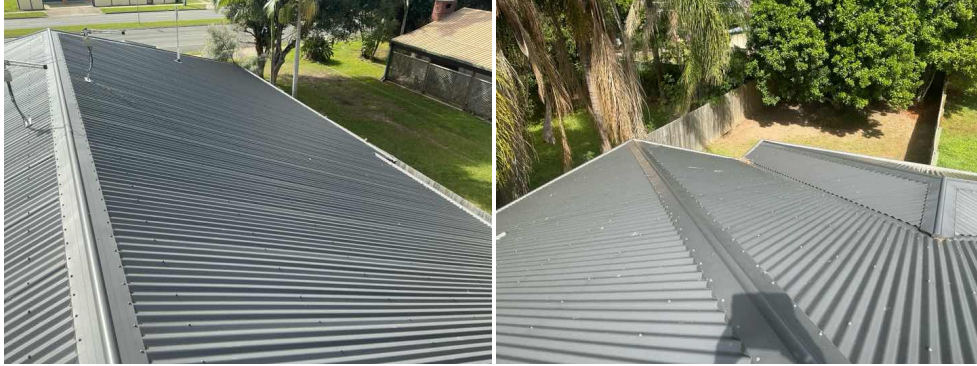
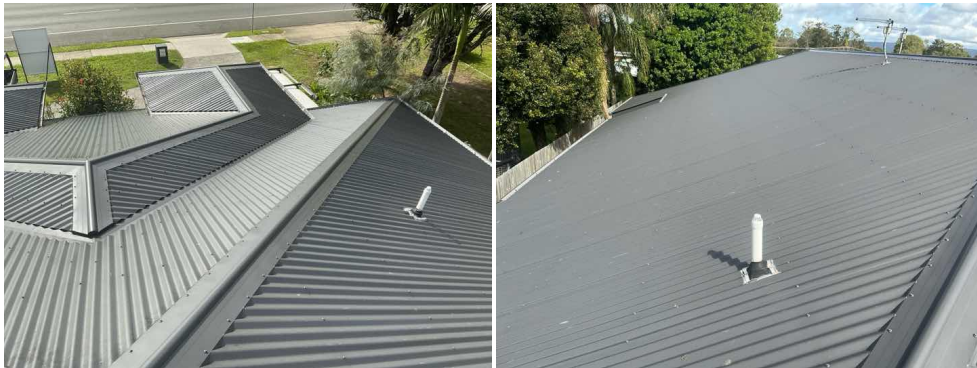
Of the visible areas, the general condition of the roof is in serviceable condition for the age.

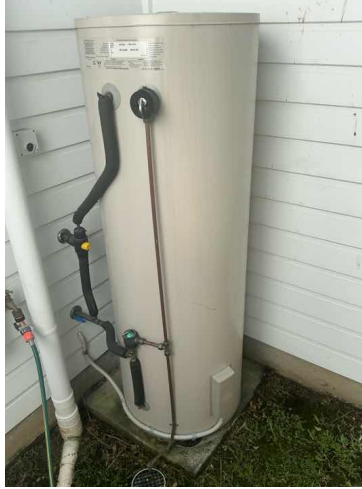
The hot water system appears to be in a serviceable condition. No specific tests other than running the hot water from a tap was carried out. No determination has been made as to the suitability or adequacy of the hot water system in relation to capacity or otherwise.

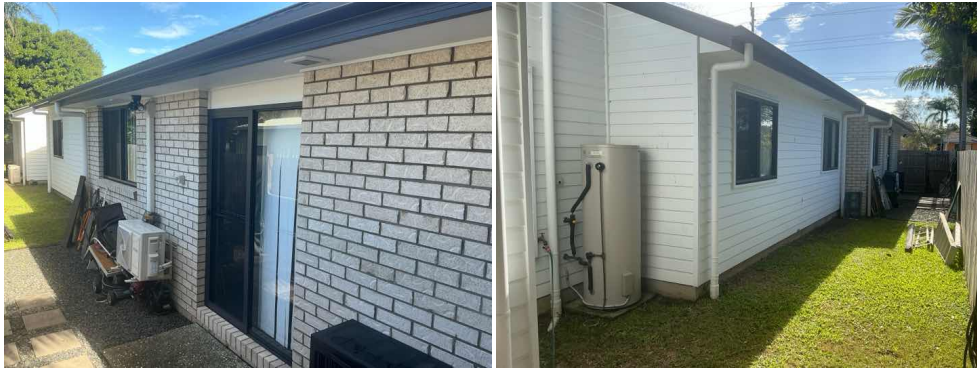
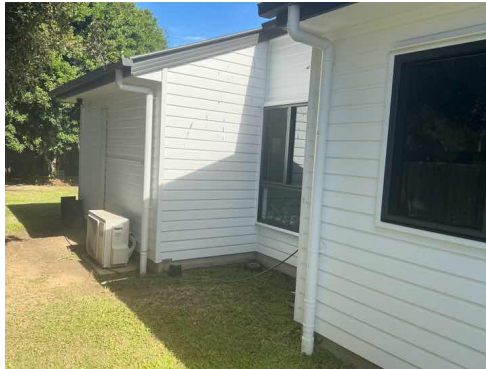
On visual inspection, the general condition of the exterior walls is serviceable for the age.

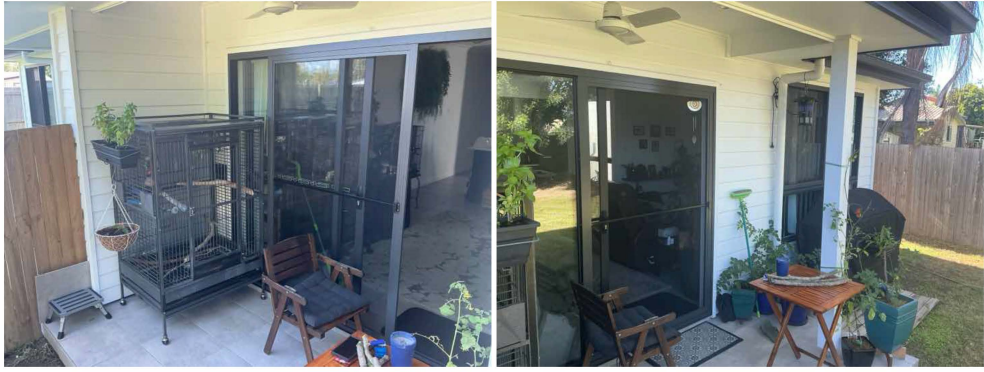
Visible sections of the Alfresco area are serviceable or in reasonable or condition for the age of this dwelling.

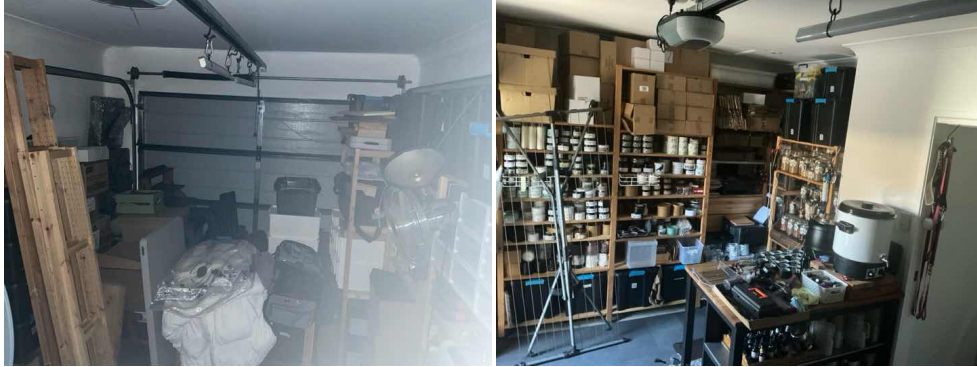
Of accessible and visible areas, the garaging is considered to be in a serviceable condition.

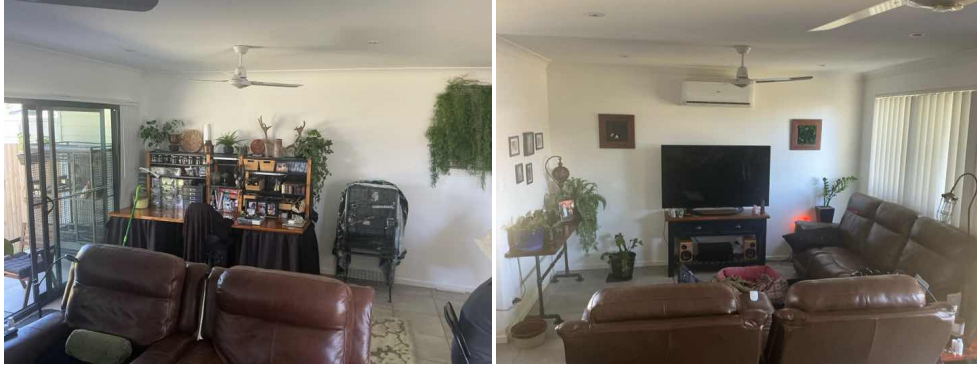
The lounge room is in serviceable condition with no notable structural defects sighted.

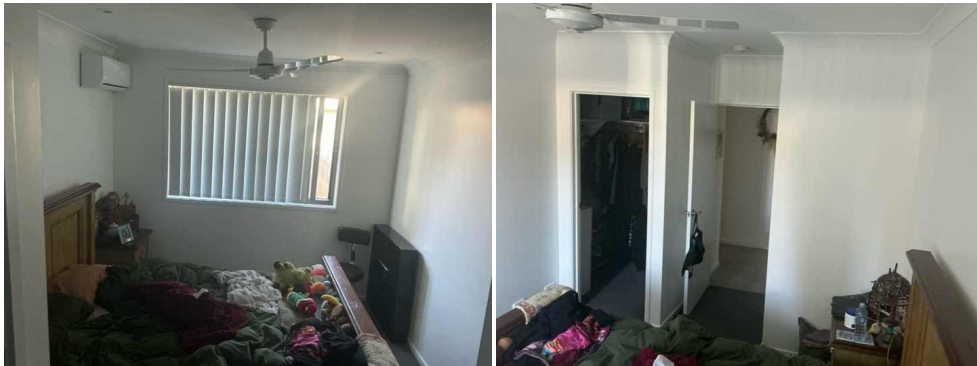
## Bedroom 1

This bedroom is in serviceable condition with no notable structural defects sighted.

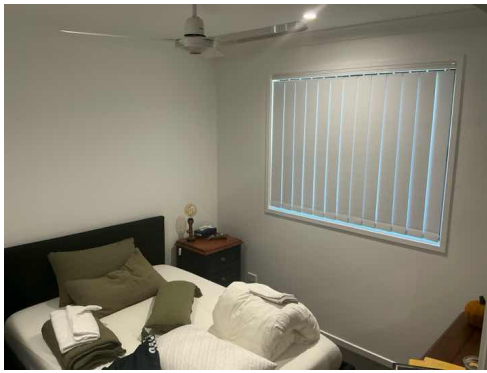
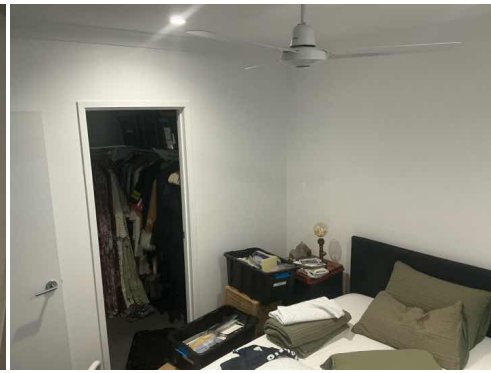
## Bedroom 2

This bedroom is in serviceable condition with no notable structural defects sighted.

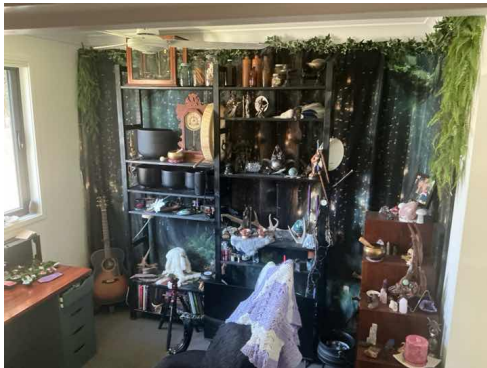
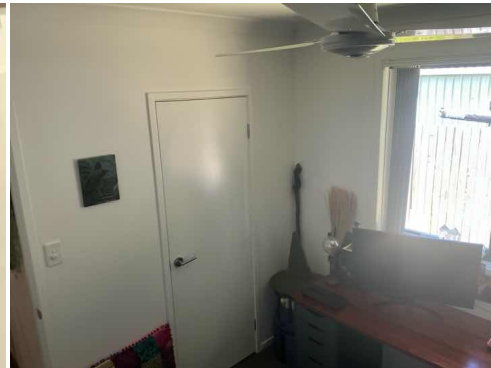
### **Bedroom 3**

This bedroom is in serviceable condition with no notable structural defects sighted.

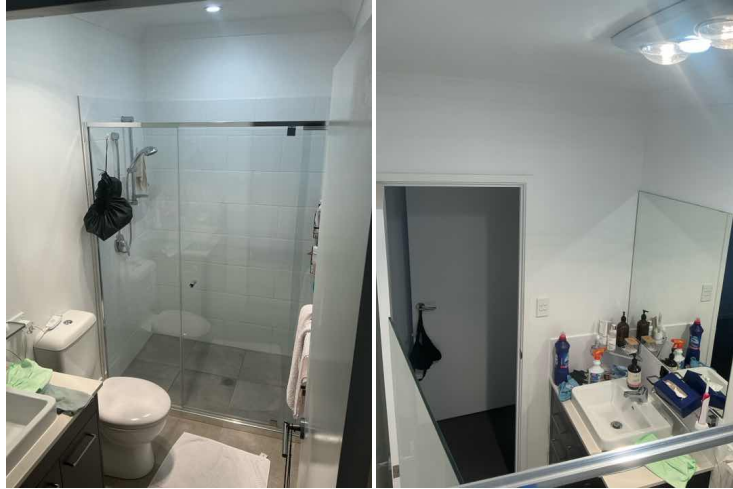
Master bedroom

Of the visible areas, the general condition of this bathroom is serviceable or in reasonable condition for age of dwelling.

#1. Exhaust fan not operational. Assess and repair as required.

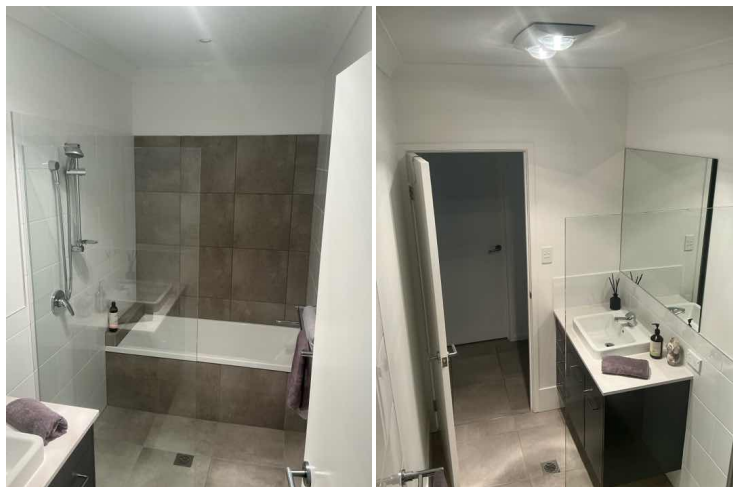
Hall

Of the visible areas, the general condition of this bathroom is serviceable or in reasonable condition for age of dwelling.

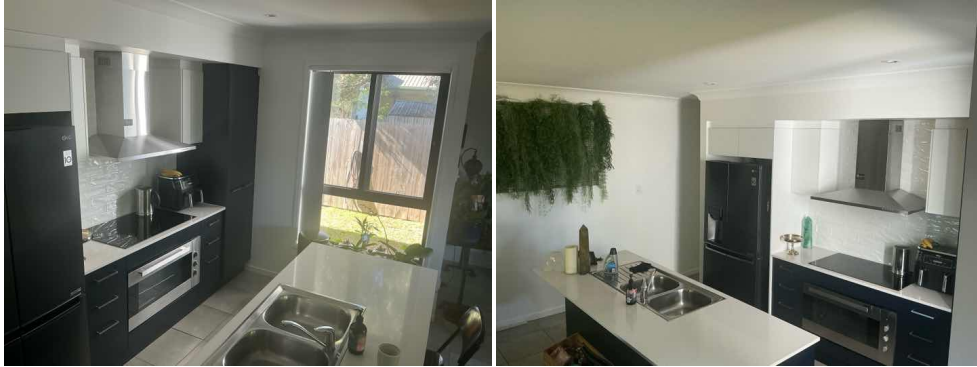
Of the visible areas, the general condition is serviceable or in reasonable condition for age of dwelling.

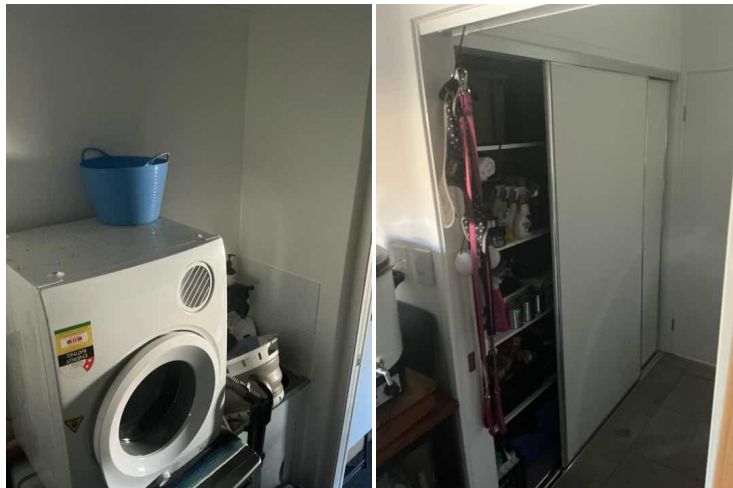
Of the visible areas, the general condition of the laundry is serviceable.

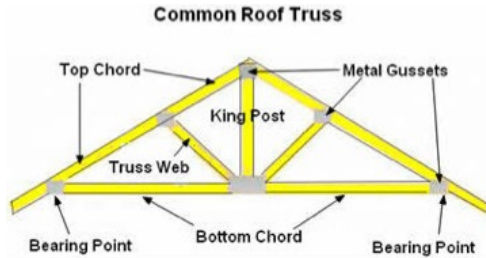
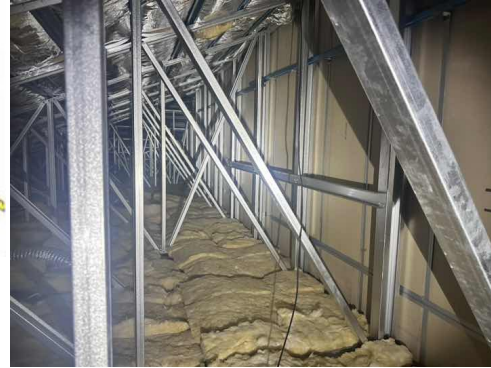
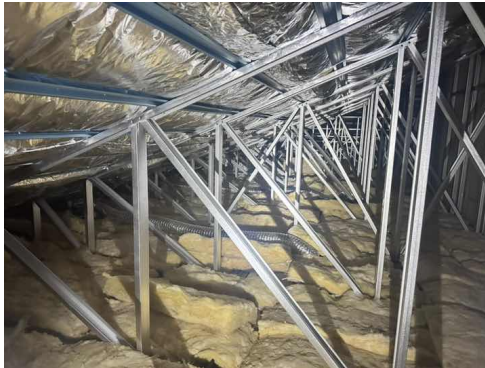
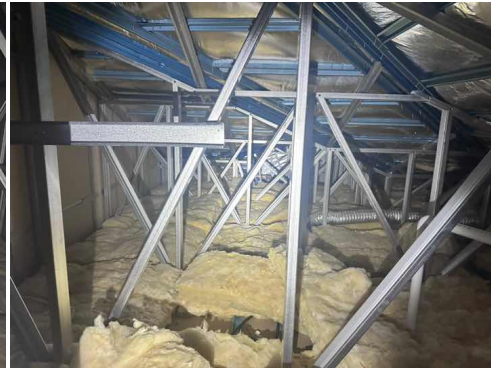
The roof frame is a truss timber frame.

Visible sections of the roof void is in a serviceable condition for age of this dwelling.

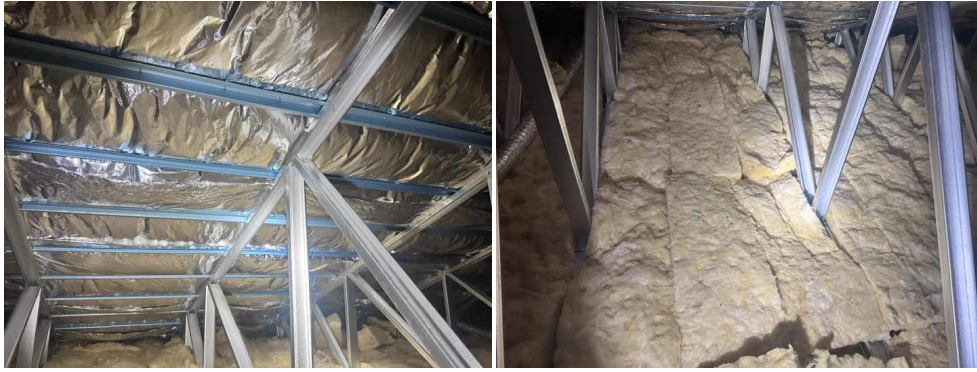
The roof space is insulated with reflective fibreglass batts under the roof cladding.

Where visible and accessible, the insulation appears to be in a serviceable condition.

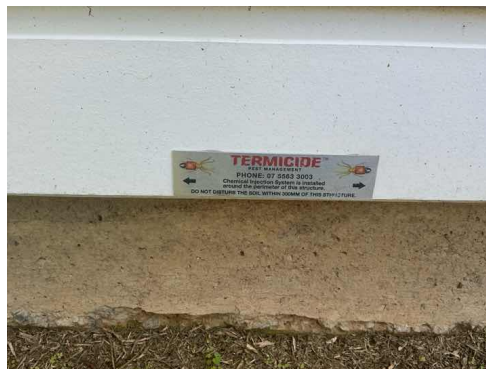
The building has a chemical reticulation system installed. This system if installed and maintained correctly is designed to to manage concealed termite risk. Investigate with the vendor regarding previous chemical application evidence and the location of the fill points for the system.
