# **BUILDING AND TIMBER PEST INSPECTION REPORT**

32 Nottingham Street, Berkeley.

# BUILDING AND TIMBER PEST INSPECTION REPORT TO AS4349.1 2007 & AS4349.3 2010

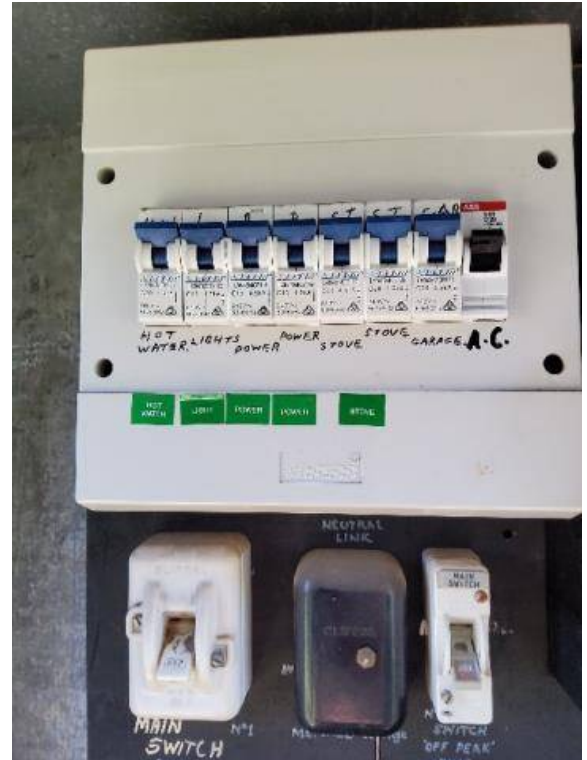
- Not present. This is considered a major safety hazard and requires immediate installation. We recommend an electrician be engaged to install a new safety switch and also check all electrical wiring / fittings & fixtures.

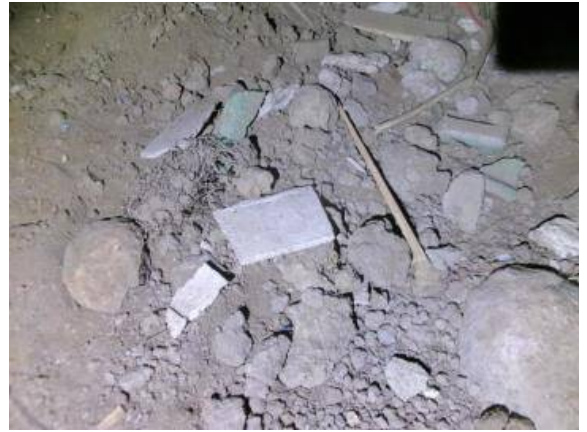
- Evidence of loose fibrous cement sheet debris within the subfloor area. This debris is likely to have Asbestos containing materials. We recommend an Asbestos audit be conducted to the property. If these sheets are tested positive for traces of Asbestos then this is a safety hazard and immediate action to remove / seal the asbestos will be required.

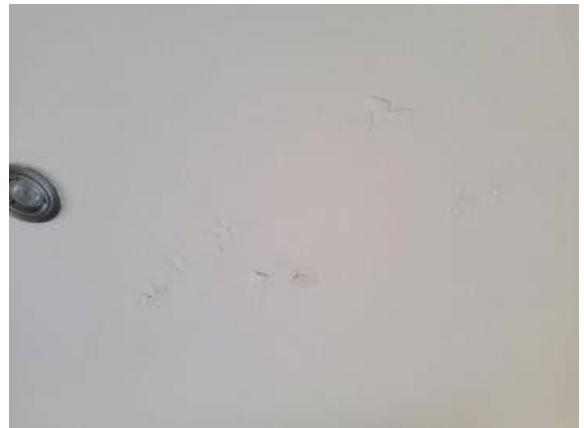
Signs of past water penetration to the living room ceiling. I would recommend you make further enquiries with the current owner regarding past repairs.

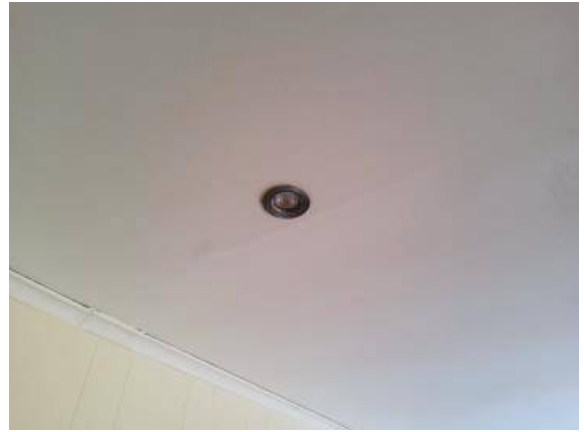
Undulations to some sheet joints. Undulations to ceiling sheeting is an indication of slight sagging to the sheeting and / or a lack of back blocking to the joins. You should monitor, you may require to have the ceiling sheeting refitted / set / painted.

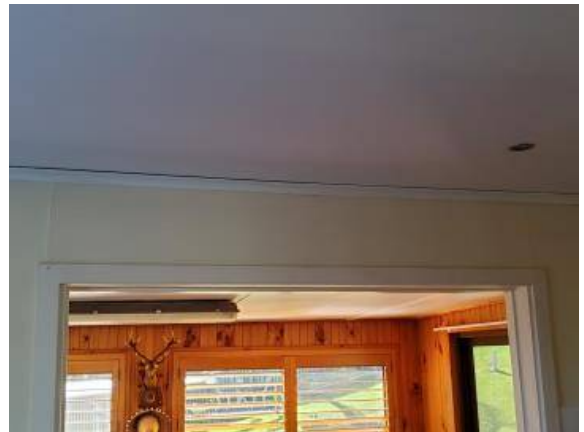
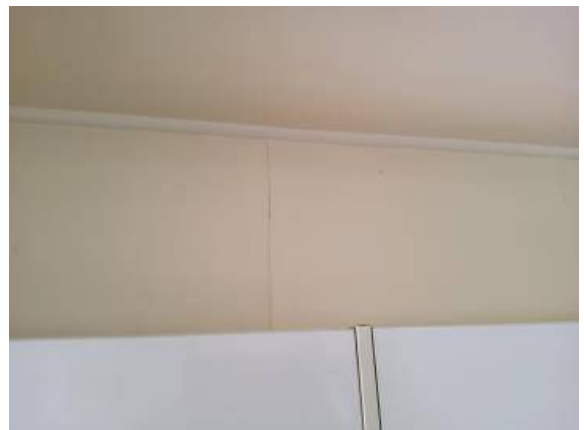
Cracks to some wall sheeting. These cracks can be filled / sealed / painted.

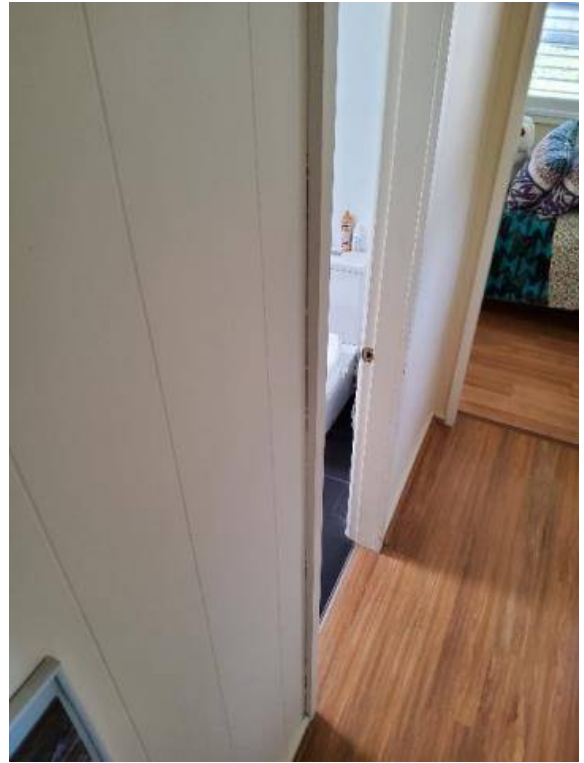
Gaps / separation to some skirting boards require refitting / filling / sealing.

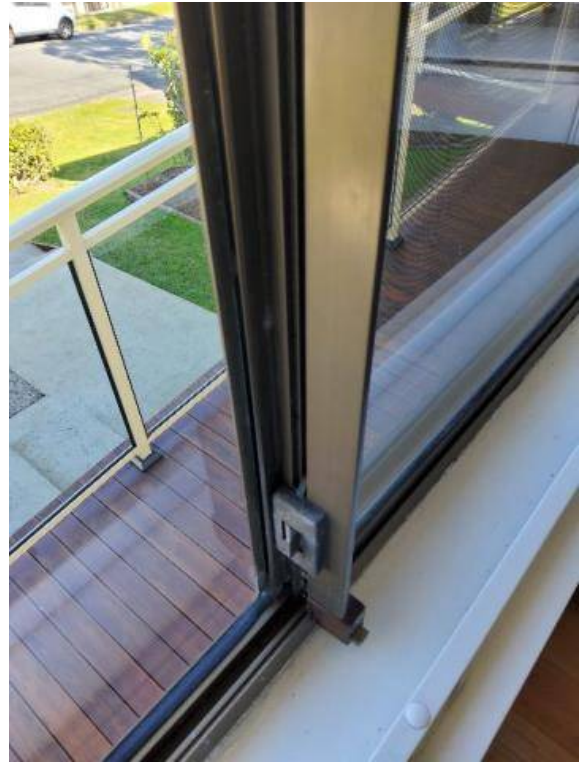
Some glazing seals require repair / re-fixing.

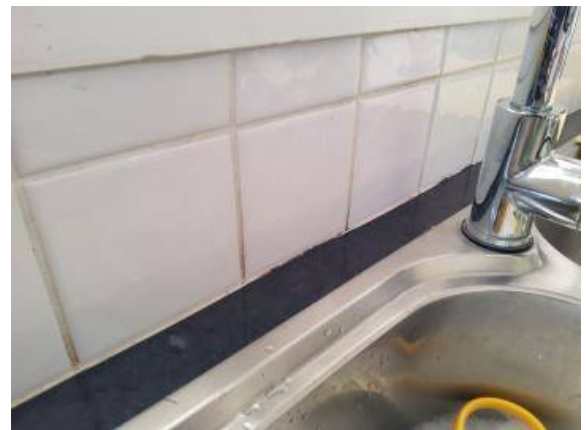
Junctions of bench tops and splashback tiles require resealing with silicone.

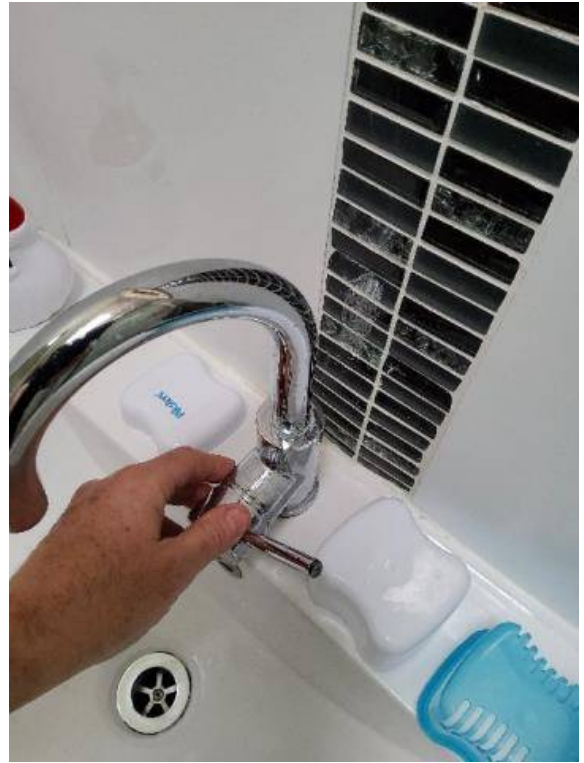
Various tapware may require new washers / reseating.

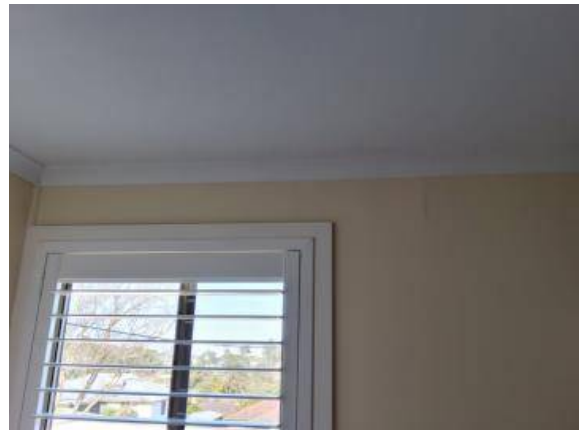
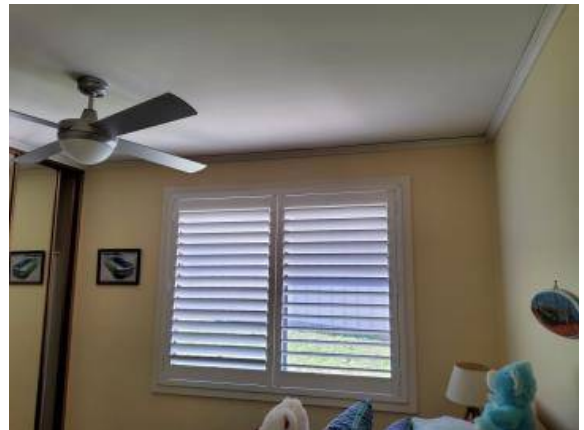
Wall vents to external walls require clearing / exposing.

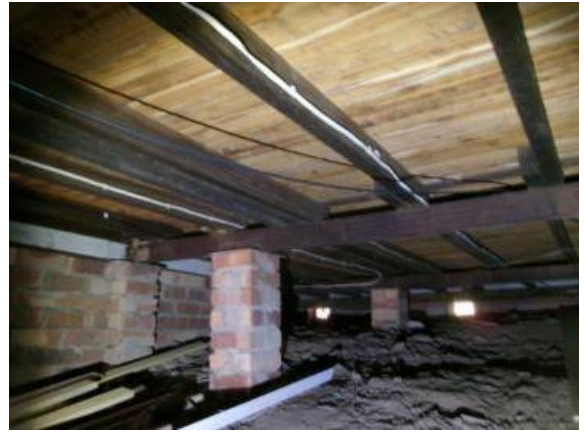
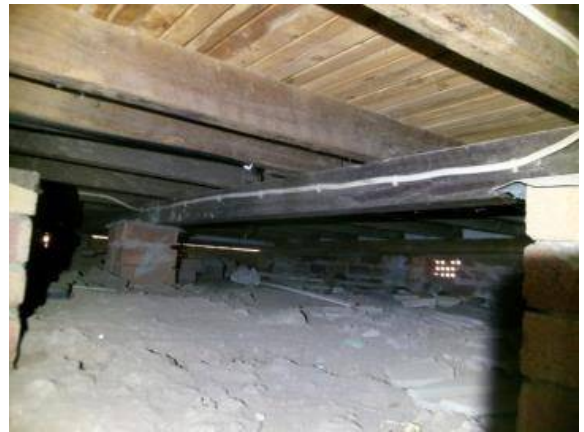
Older sub floor frames do not comply with current wind ratings. This framing is in satisfactory / typical condition for the age / construction date. Some sections show of deflection / movement away from their seated position. Some areas may require re-bracing, fitting in the future.

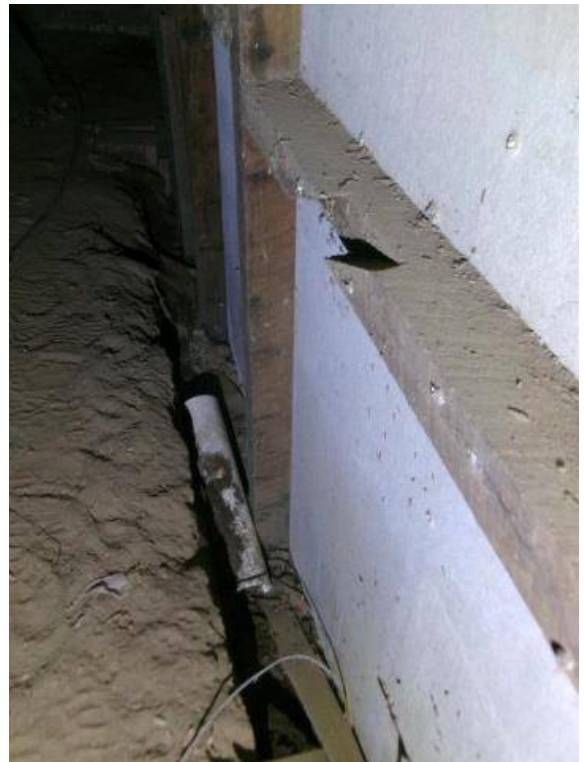
Various screening and framing timbers are buried / in-contact with the ground. Any timbers that are in-ground contact are subject to wood decay and concealed termite entry. We recommend modifications be made so that these timbers have a minimum 75mm clearance off the ground / soil.

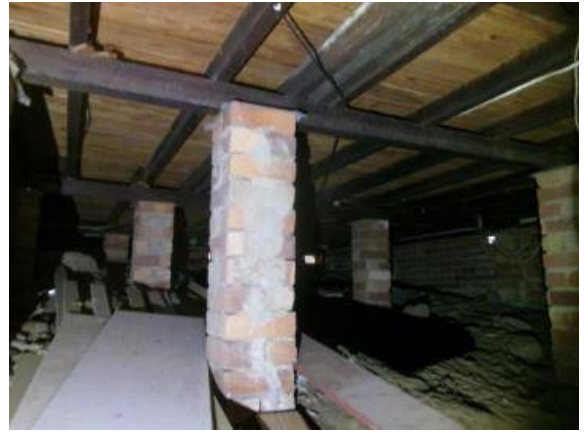
Some piers show signs of subsidence / movement. The movement is consistent with the age and construction type.

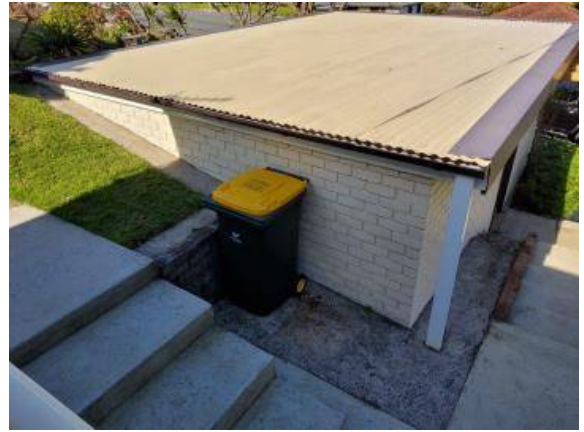
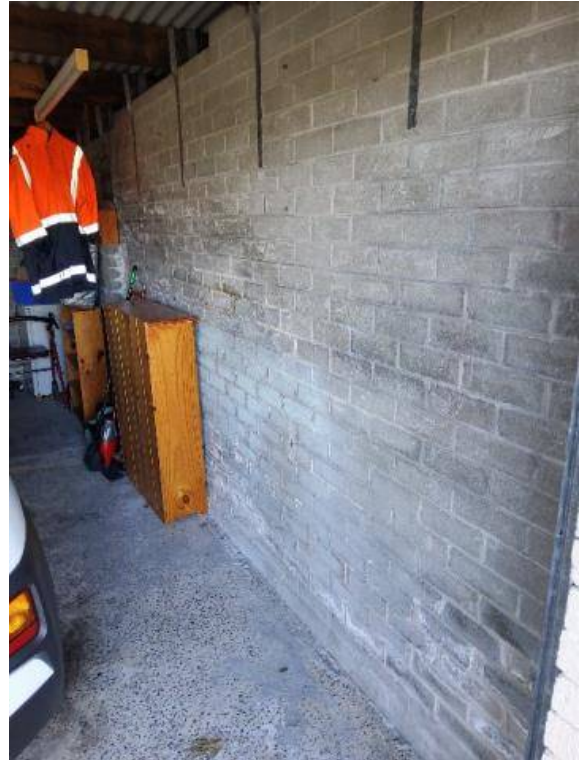
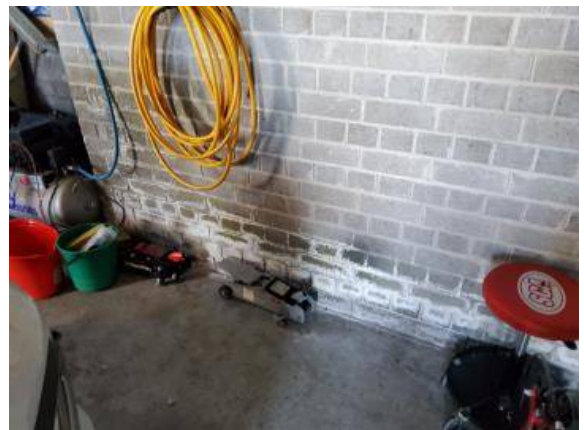
Large areas of the internal slab are below external ground level and highly subject to water penetration / ingress. You should monitor and have a licenced plumber / drainer to further inspect if / when the internal area experience flooding / pooling.

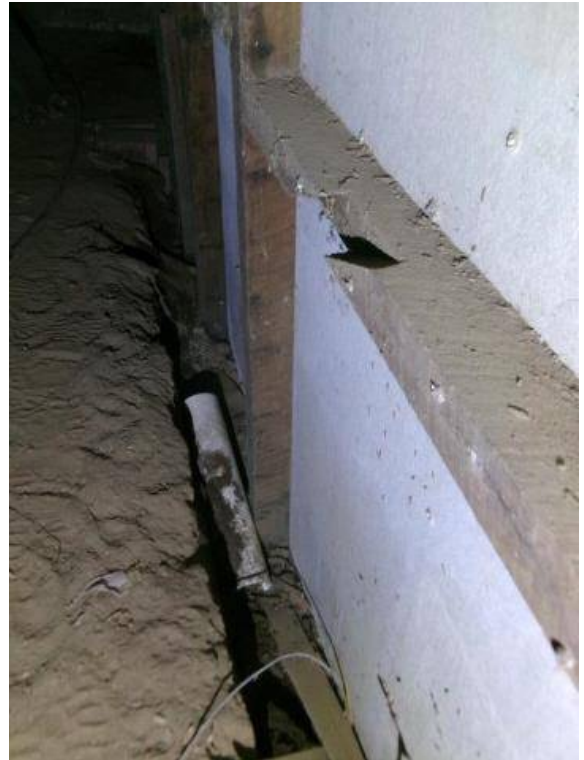
- Some timber screening is in contact with soil. These should be modified so that timber to soil contact does not occur as timbers in contact with soil are highly attractive to termite attack.
