BUILDING AND TIMBER PEST INSPECTION REPORT

15 Crawford Avenue, Gwynneville.

BUILDING AND TIMBER PEST INSPECTION REPORT TO AS4349.1 2007 & AS4349.3 2010

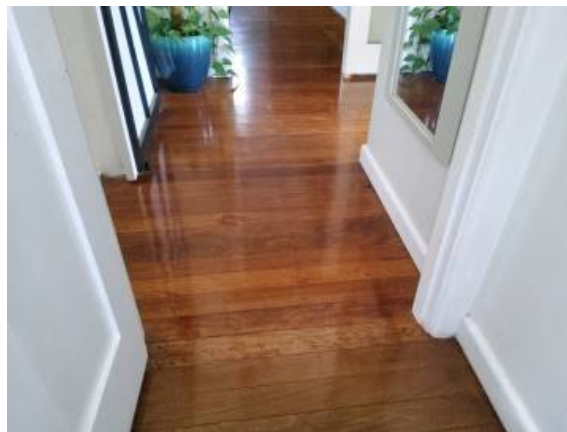
Squeaky Flooring

Squeaky flooring to some areas require refixing. We recommend a carpenter be engaged to assess the floor to remove the squeak.

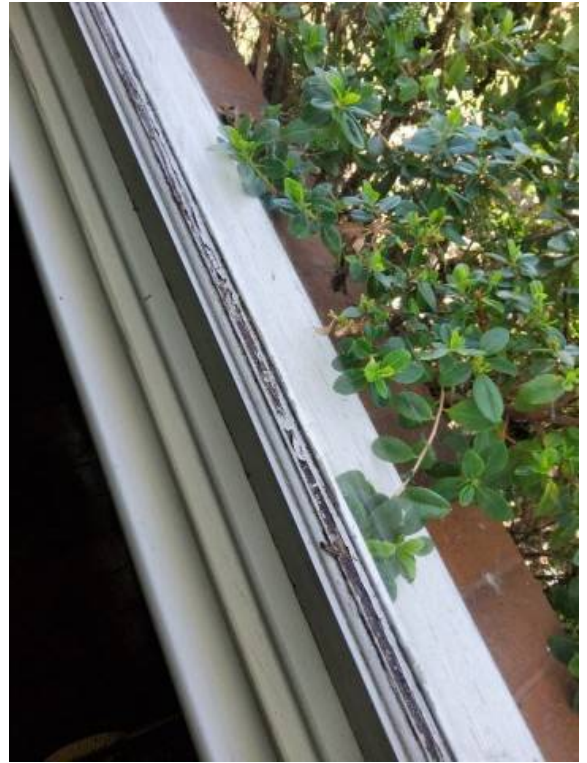
Putty / Water Staining

Some timber frames show signs of weather damage and require repair / repainting.

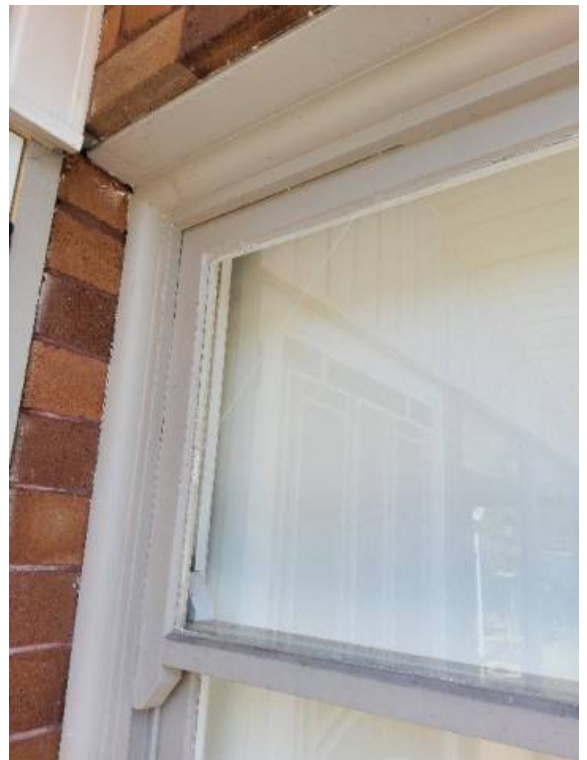
Broken Glass

Cracked back room window requires replacement.

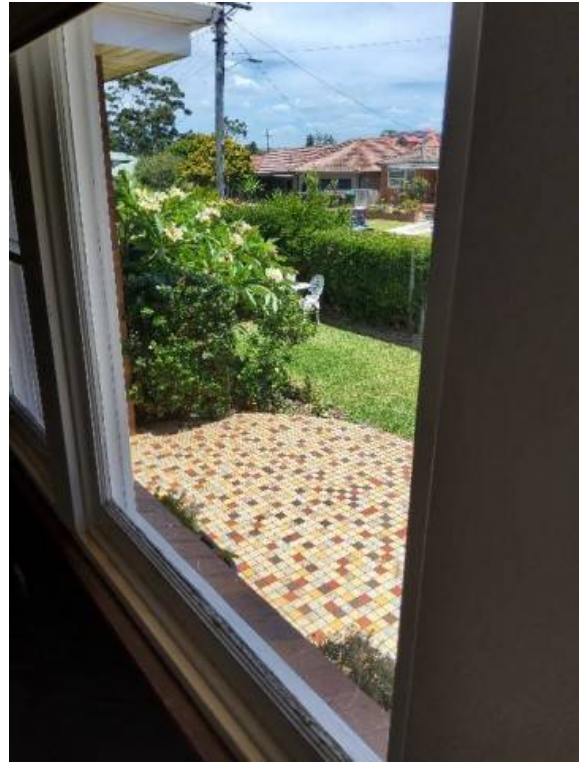
Glazing / Seals / Corrosion

Due to the age of the property, it appears the large glass panels are not to current safety requirements (non-safety glass/laminated). This inspection is a visual inspection only, and as such we don't generally comment on areas of compliance. Window / glazing compliance relates to a number of performance criteria including energy efficiency, structural and water performance, bush fire attack levels, acoustics, ventilation and compliance and materials. If you have concerns over the windows / glazing compliance within the property we highly recommend you contact the Australian Window Association.

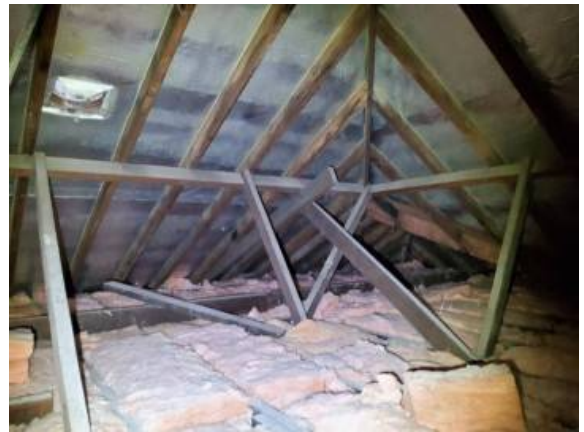
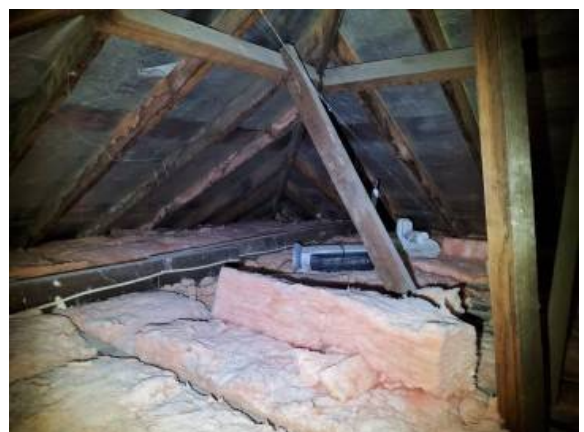
Roof Space & Framing - Condition

Older roof frames do not comply with current wind ratings. This roof is in satisfactory / typical condition for the age / construction date. Some sections show of deflection / movement away from their seated position. Some areas may require re-bracing, fitting in the future.

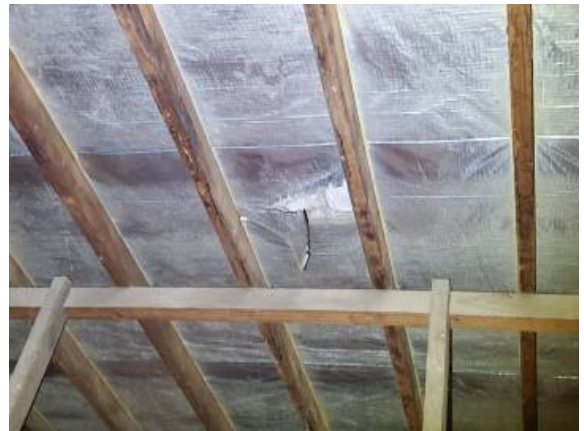
Sarking

Present, Under tiles, Some sarking paper requires refixing.

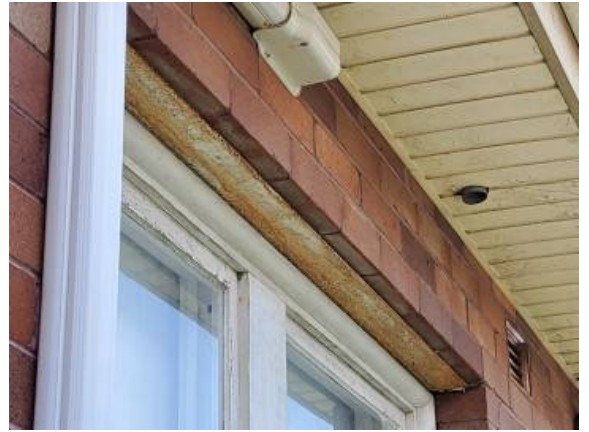
STEEL LINTELS

Rust to some lintels requires repair / repainting with Killrust or equivalent.

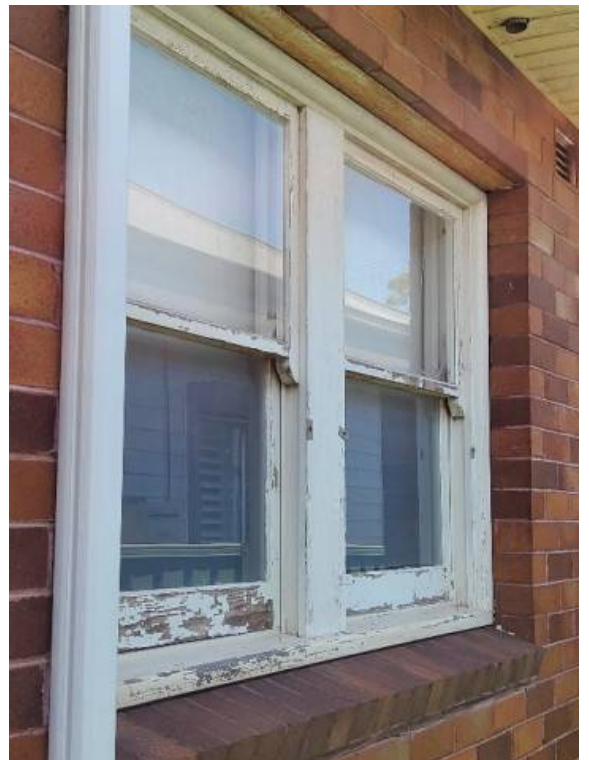
Some frames and sashes show signs of weather damage and require repair / repainting.

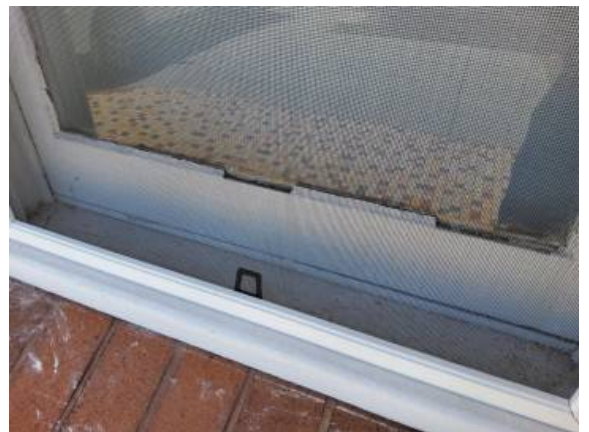
Some glazing seals require repair / refixing.

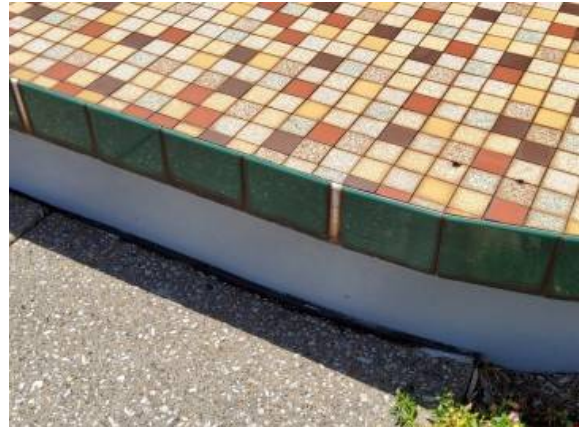
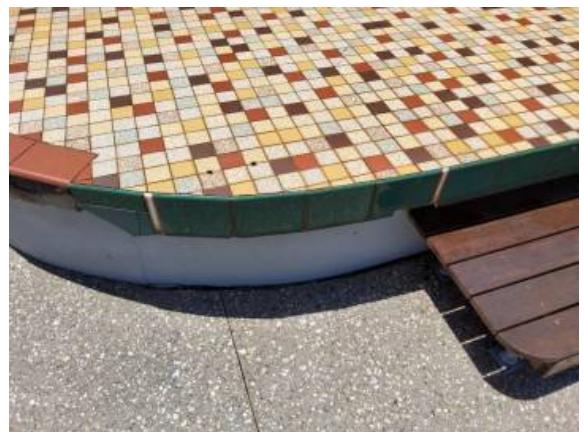
Extensive cracked front patio tiles require replacement.

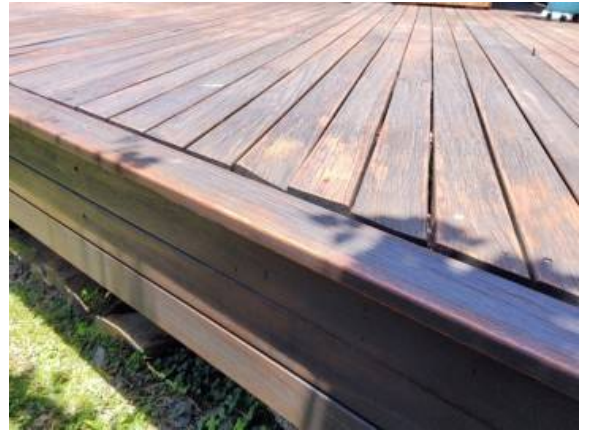
Some decking timbers show of lifting and require refitting to the joists.

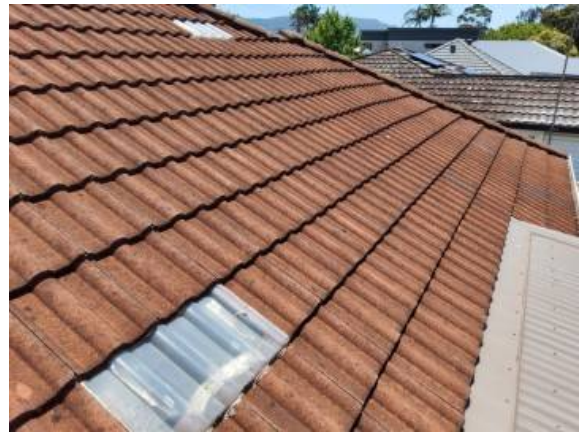
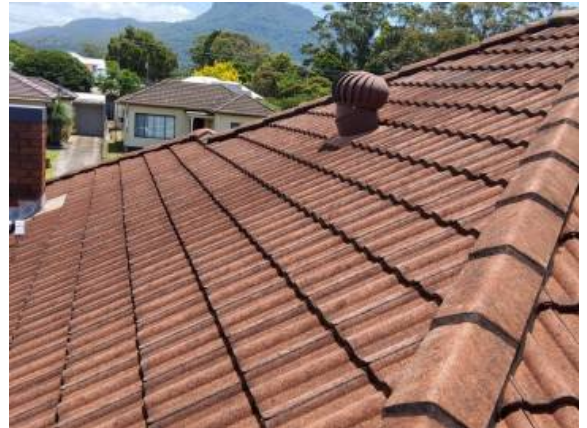
The tile surface shows of delaminating / loss of surface colour and may require resealing / resurfacing.

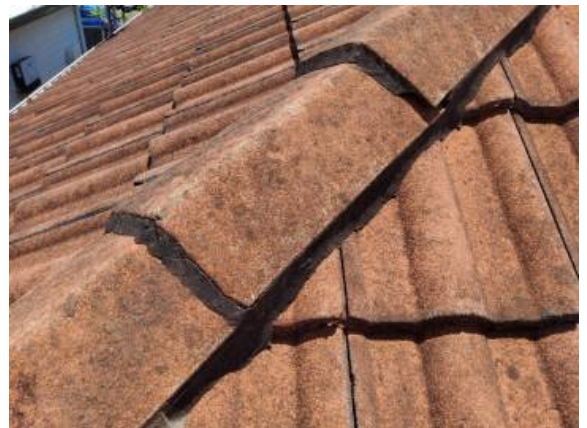
Some pointing to ridge and hip capping tiles is cracking and requires refixing / repointing.

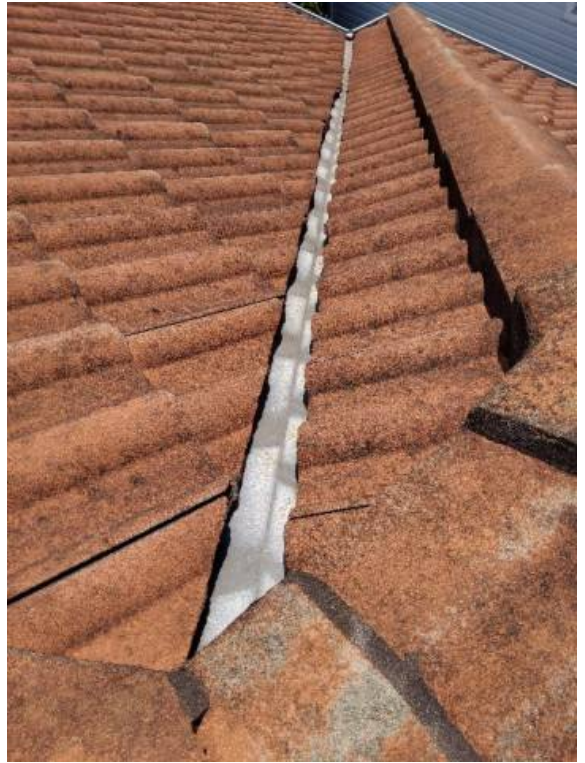
Rust, Surface rust to some valley flashings requires repair / painting with Killrust or equivalent.

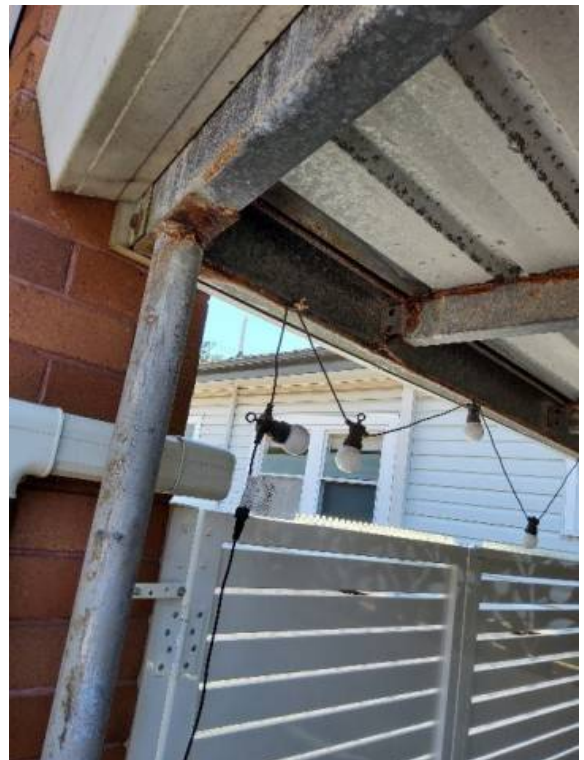
Extensive rust to the carport framing requires kill rust coating / resealing or replacement.

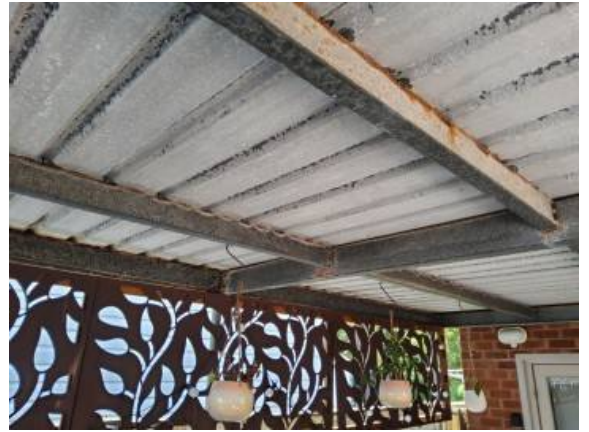
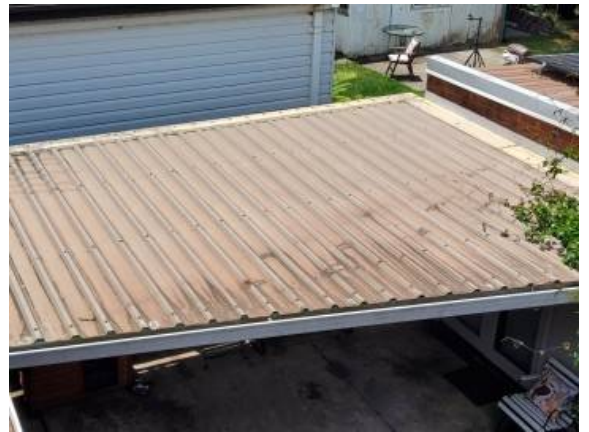
Rusting to the roof sheeting / screws require repair / replacement.

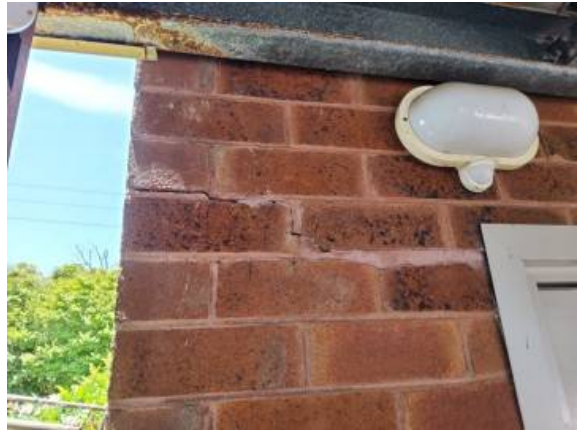
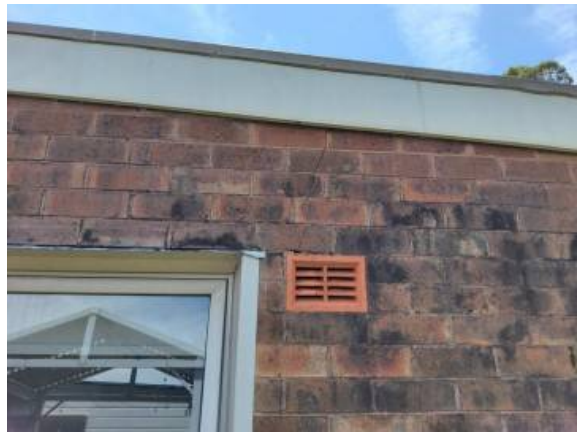
Minor brick cracking to some sections requires repair / filling.

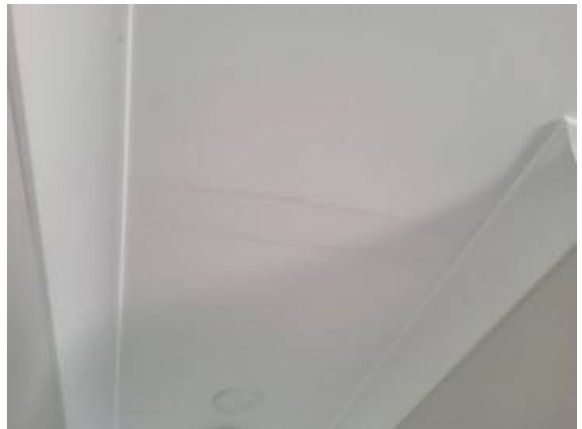
Signs of water staining to the hallway roof ceiling. Have a licenced roofing contractor engaged to further inspect and provide a full scope of works to rectify.

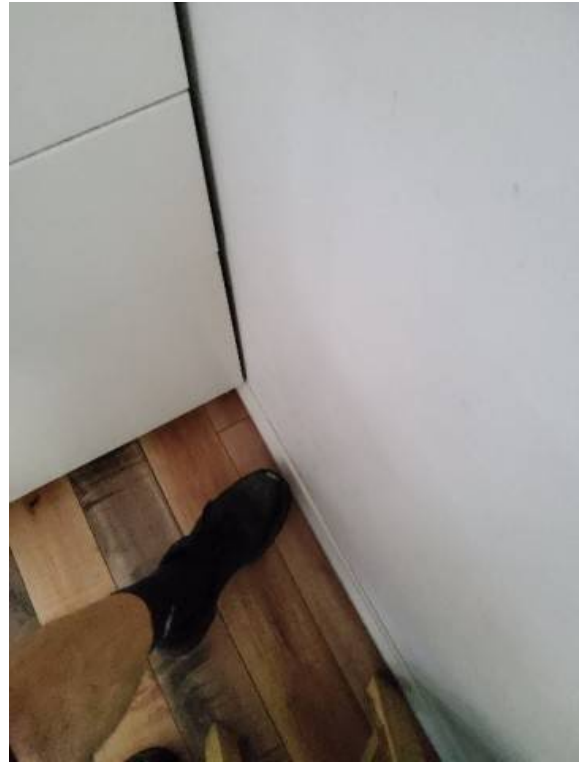
Loose skirtings require refitting.

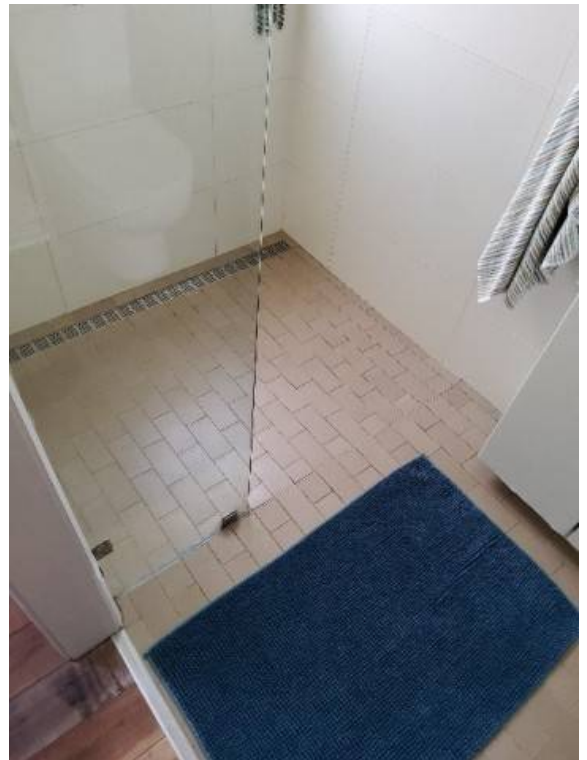
The main bathroom shower is an open design without the use of a screen / hob. Ponding / pooling can occur with this type of design, and is highly dependant upon the fall created from the tile bedding. If the fall is inadequate you will require to have a screen / door / hob fitted to divert water to the shower drain.

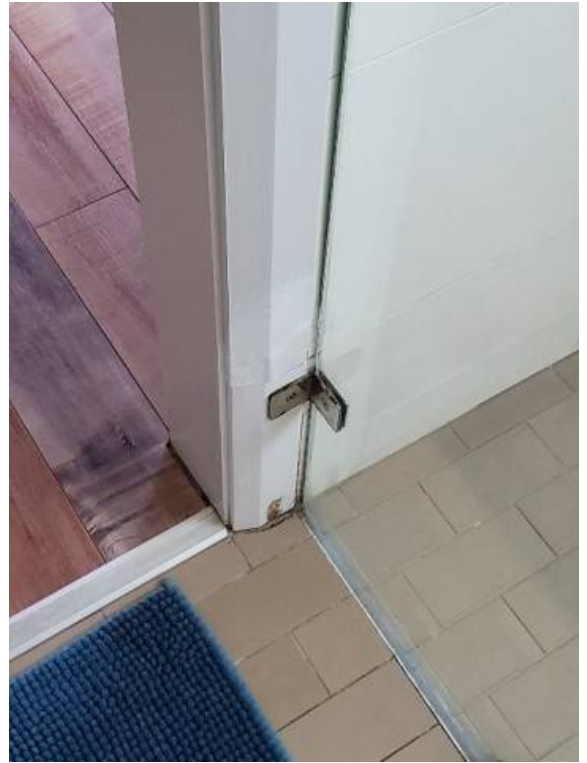
Water staining / damage to the door architrave adjacent to the shower screen indicates a past or current leak to the shower screen requires repair / resealing to the shower screen junctions.

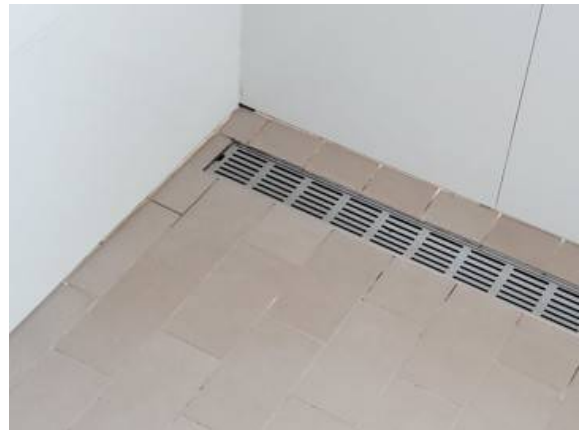
Shower screen floor / wall junctions require filling / sealing with a flexible sealant.

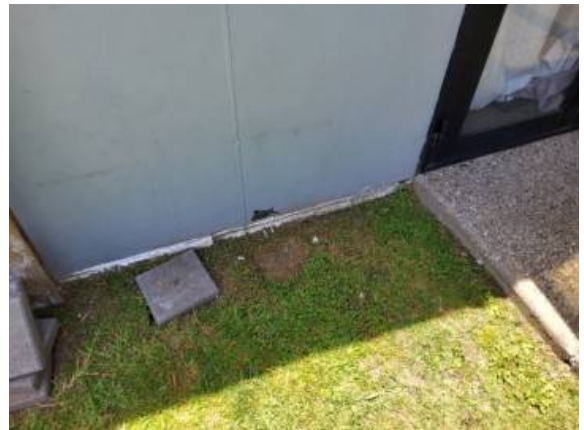
Damaged external cladding requires repair. The external cladding most likely contains ACM. This is a safety hazard and requires handling with appropriate levels of caution.

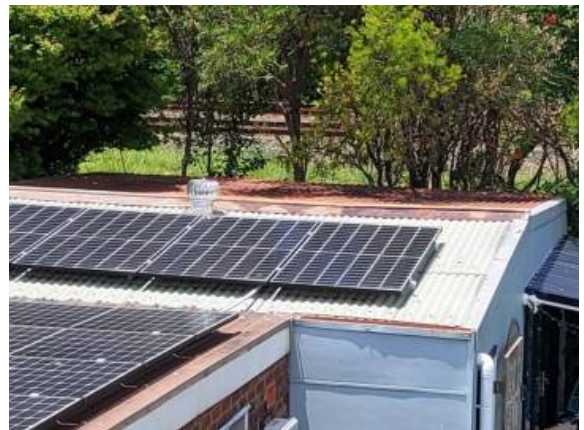
Extensive rust to the roof sheeting and flashings requires repair or replacement.

Note: The exposed roof framing timber shows of past termite damage and requires repair. Refer to the pest report.

An exposed roof framing timber was seen to be affected by termite attack. Under test conditions it was revealed that the termite workings were inactive, ie the absence of live termites at the time of inspection. Visible damage appeared to be localised. A further more invasive inspection is recommended. Also, competent advice e.g from a licenced building contractor should be obtained to determine the extent of any structural damage and as to the need or otherwise for rectification or repair work. The above recommendations should be implemented by the client as a matter of urgency. For further advice consult the person who carried out this inspection.

The visible damage to the timbers appears to be extensive. Further damage will almost certainly exist in concealed areas. Please refer to the definitions section of this report - Section 1.2 - Timber Damage.

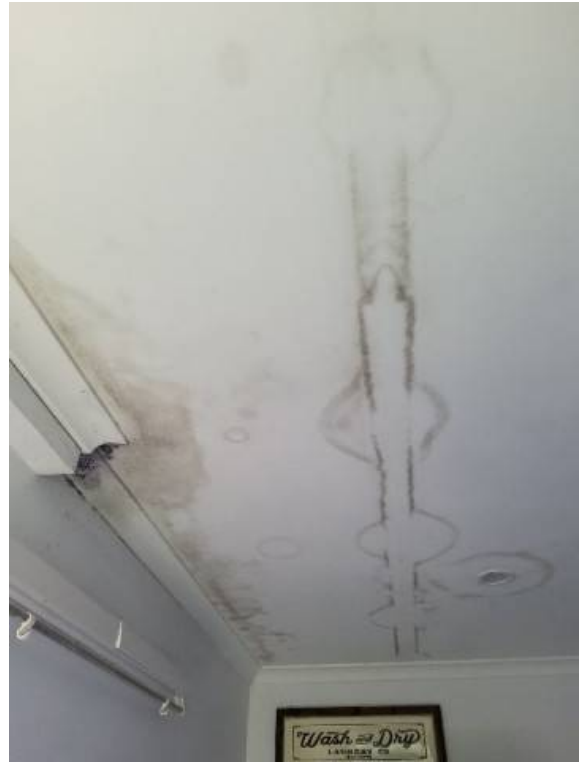
Extensive water staining / leaking to the roof linings. The roof sheeting and flashings require repair / resealing.

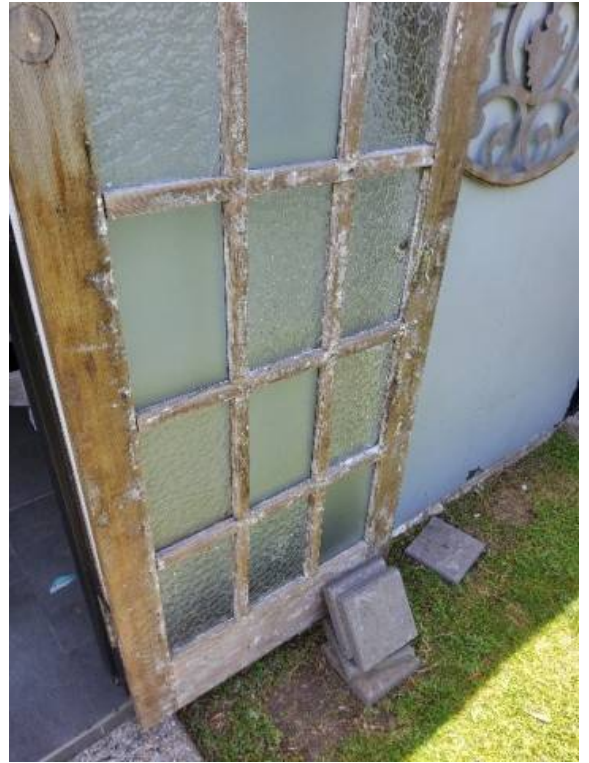
The laundry door shows of weather damage and requires repair and repainting.

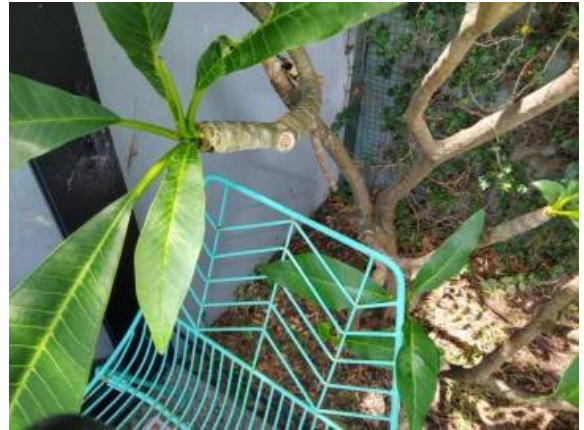
- We strongly recommend the slab edge be exposed as soil and vegetation can and may conceal termite entry.

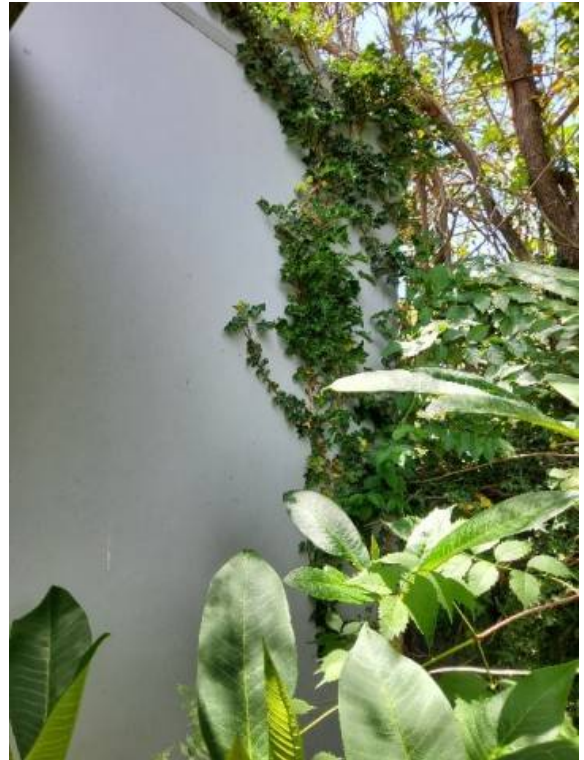
- Remove garden beds and vegetation close to or abutting the external walls of the structure. These can attract / allow concealed termite entry and should be removed.
