# **BUILDING AND TIMBER PEST INSPECTION REPORT**

McGrath Wollongong.

34 Immarna Avenue, West Wollongong.

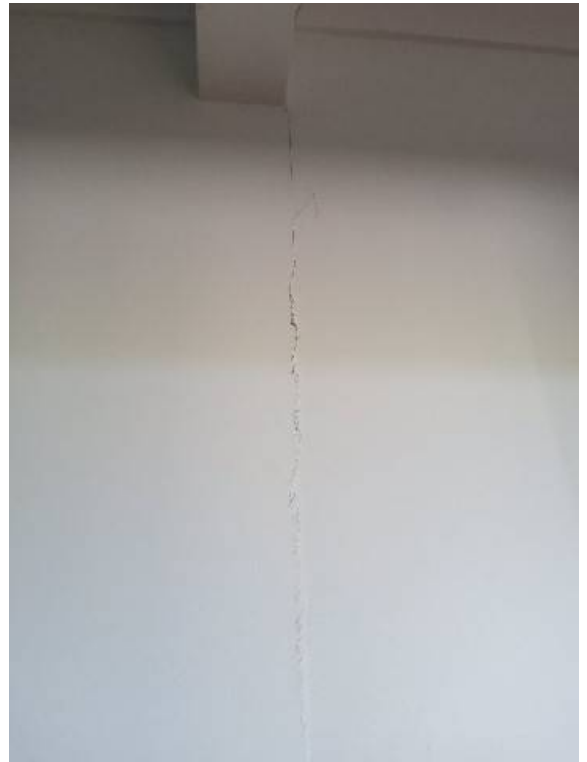
Cracks to some wall sheeting. These cracks can be filled / sealed / painted.

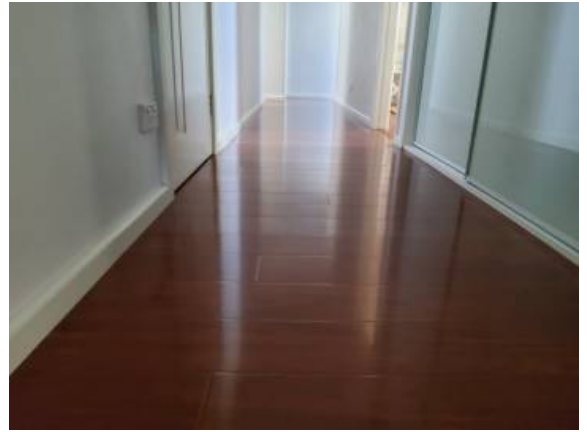
Some flooring shows signs of undulations / out of level. This is a visual inspection only, no technical / calibrated instruments have been used. The undulations / out of level areas are consistent with the age and construction type, no visual indicators are present to suggest any structural impairment is present at the time of inspection.

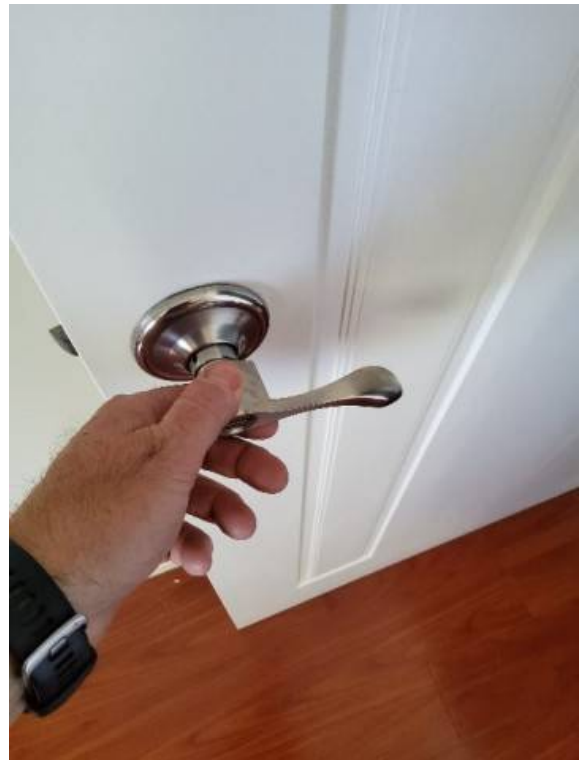
Some door hardware requires repair / re-fixing.

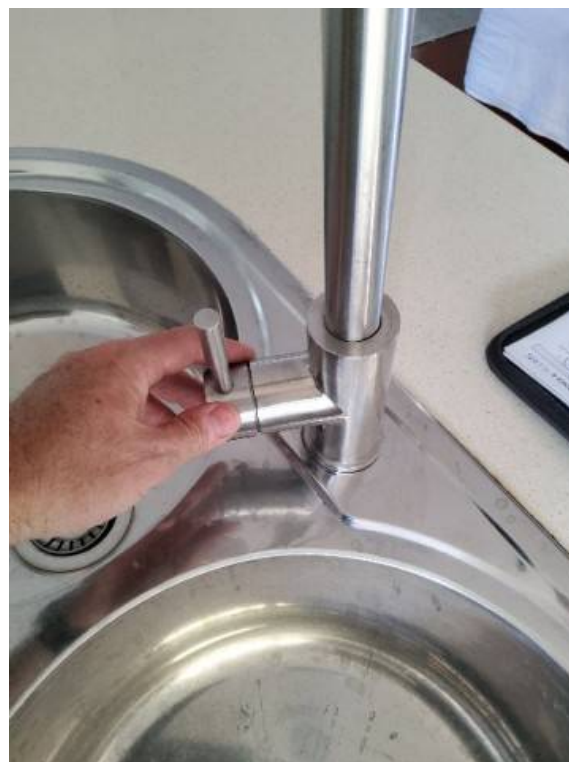
Mixer tap requires new washers / reseating.

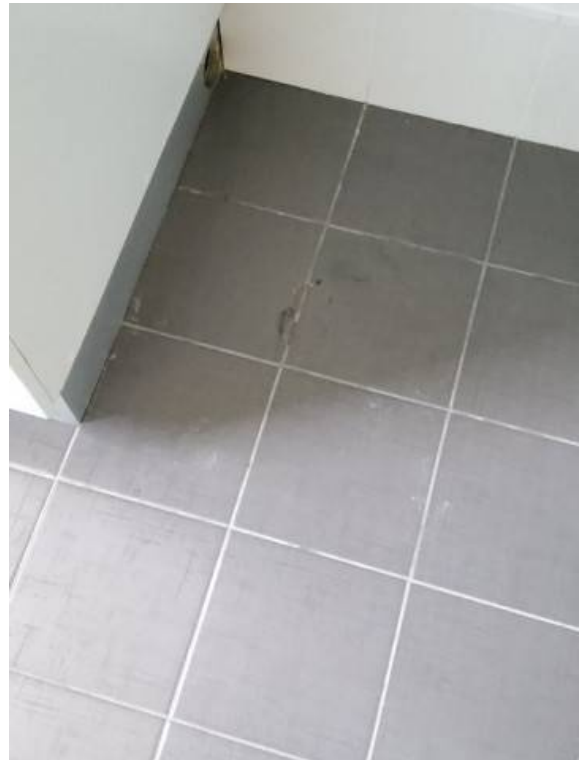
Chipped laundry floor tiles require replacement.

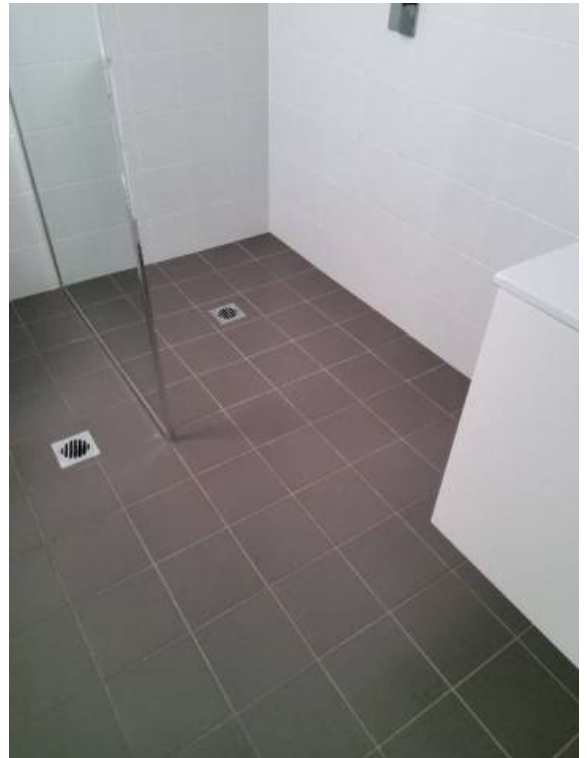
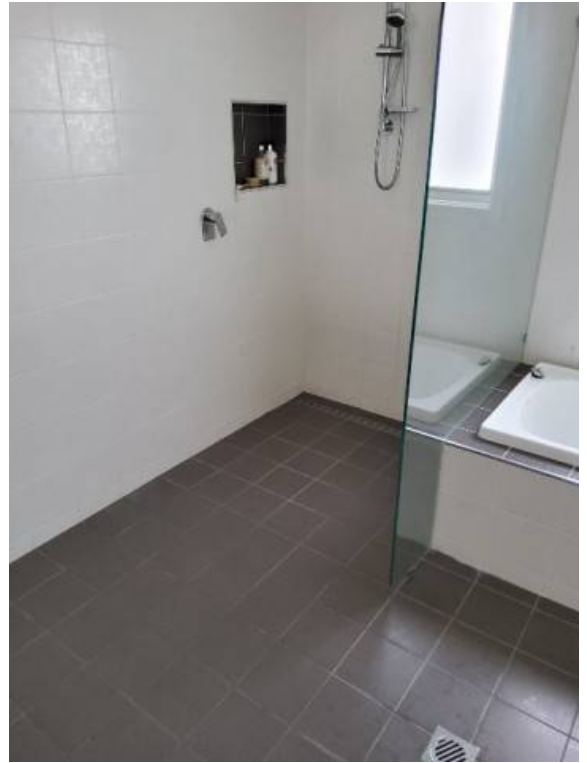
The main bathroom shower is an open design without the use of a screen / hob. Ponding / pooling can occur with this type of design, and is highly dependant upon the fall created from the tile bedding. If the fall is inadequate you will require to have a screen / door / hob fitted to divert water to the shower drain.

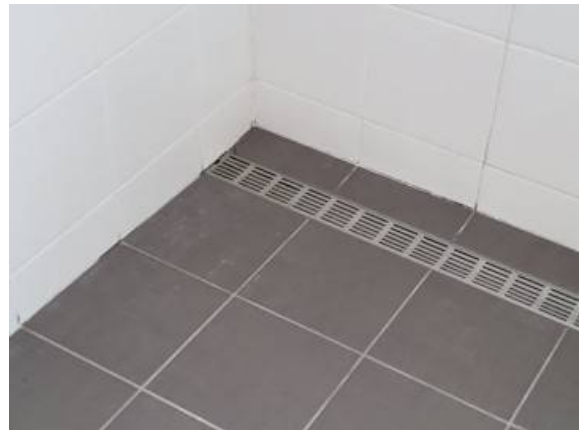
Junctions of shower floor and wall tiles require resealing with silicone.

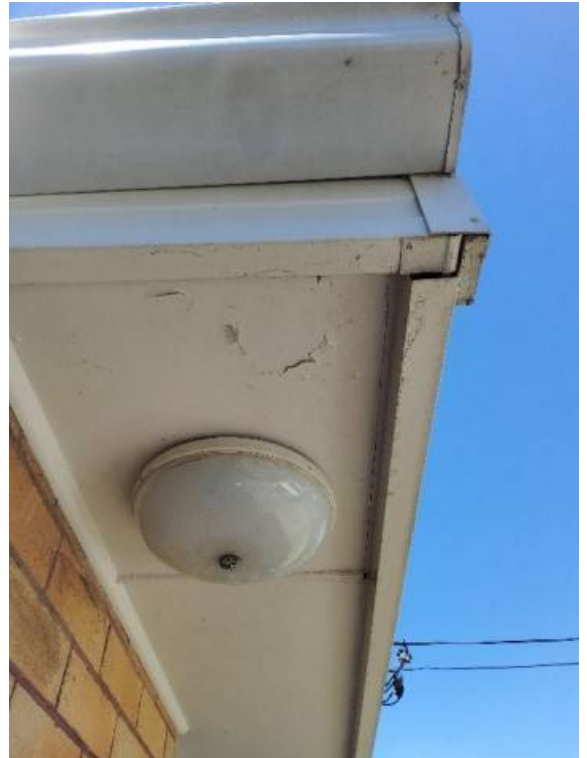
Some external surfaces require repainting.

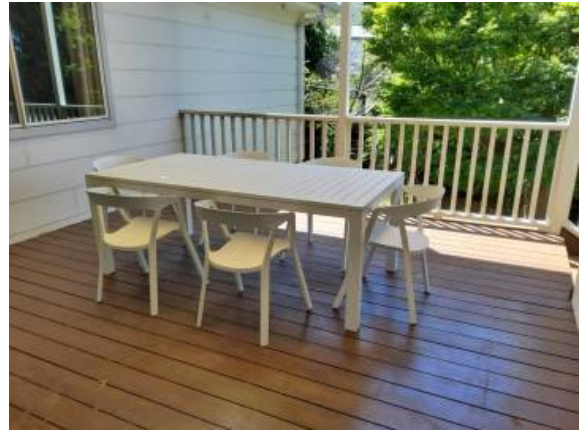
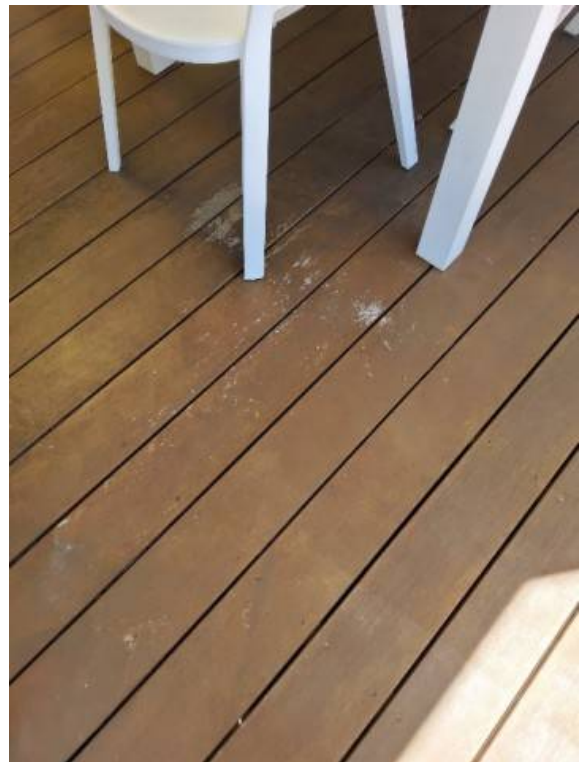
The timber decking boards require resealing / coating to maintain the integrity of the timbers.

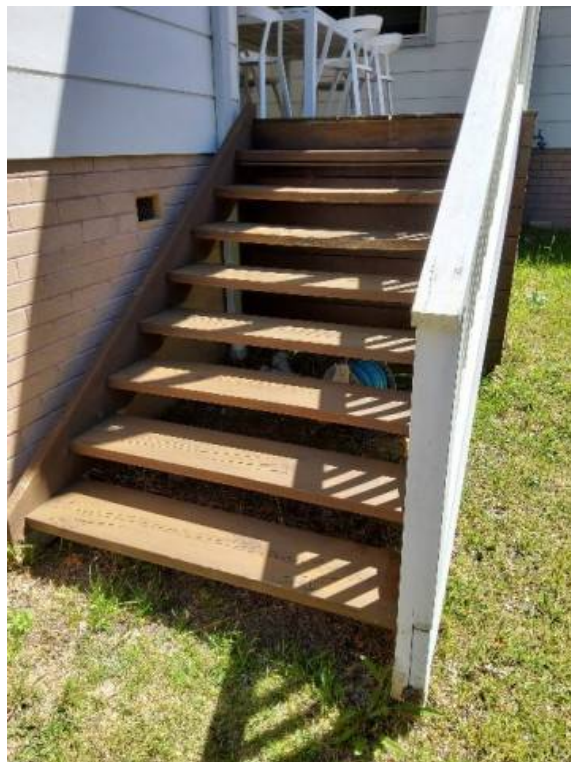
Loose stair treads require refixing.

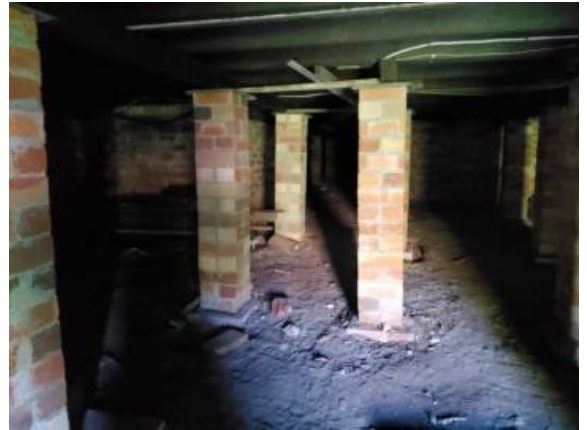
Some piers show signs of subsidence / movement. The movement is consistent with the age and construction type.

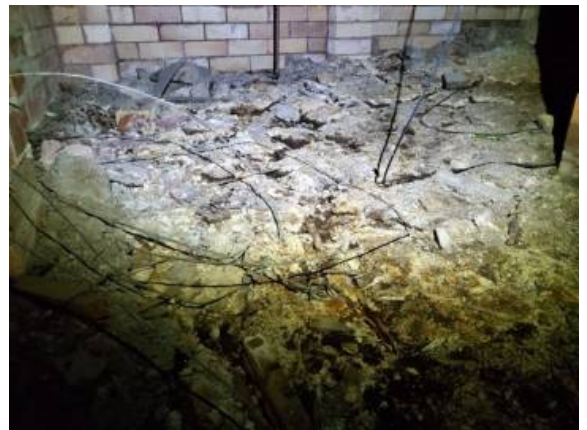
There are subfloor rooms below the external ground level, these rooms maybe subject to dampness and water penetration. It is common to have damp problems and water entry into these types of rooms, especially during periods of heavy rainfall. Due to the age and the style of construction it is unlikely that there is adequate waterproofing to these perimeter walls. Please note that water penetration may not be evident upon initial inspection.

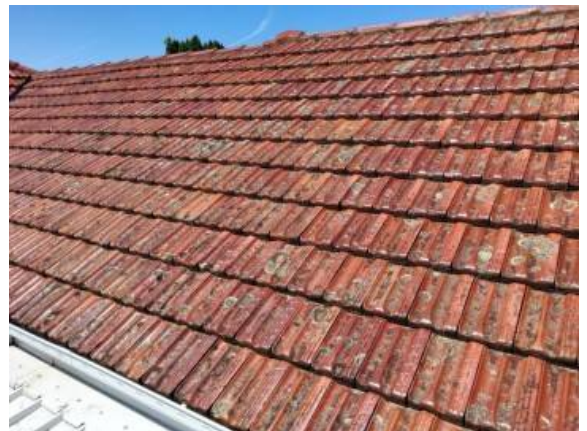
Roof tiles require pressure cleaning to remove excessive build up of mould / dirt. Lichen is a build up of mould / algae.

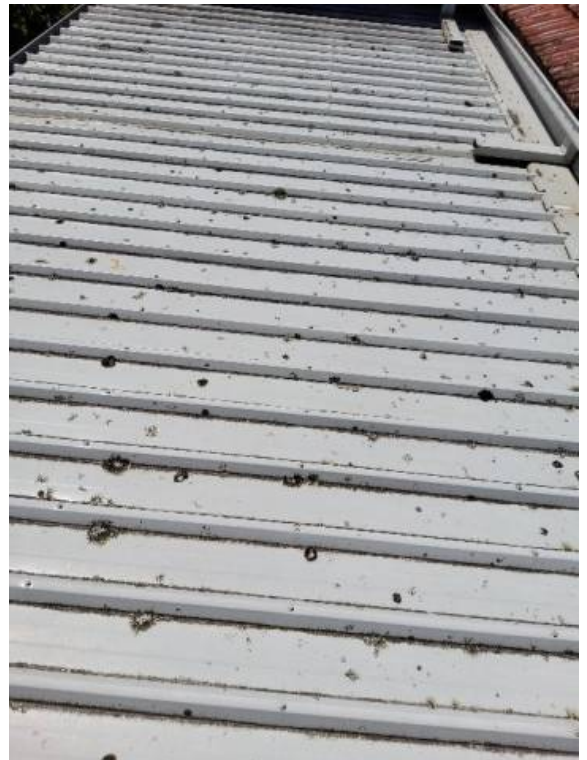
The roof sheeting requires pressure cleaning to remove excessive build up of mould / dirt. Lichen is a build up of mould / algae.

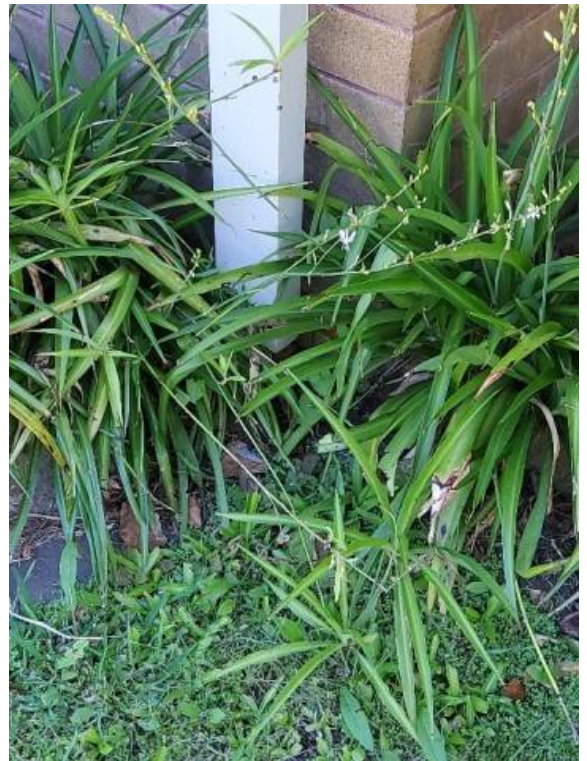
Extend downpipes to discharge storm water runoff away from the perimeter and underfloor space.

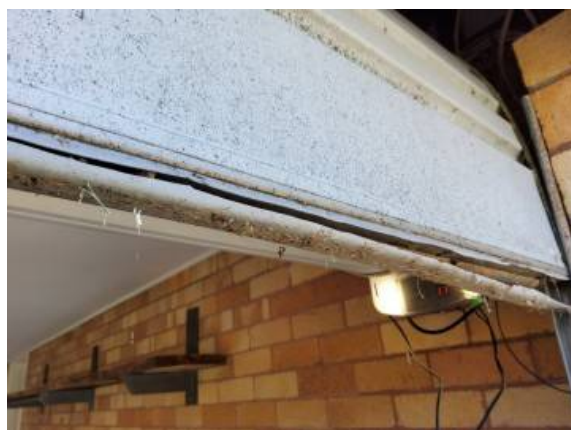
The roller door rubber seal is missing and requires fitting.

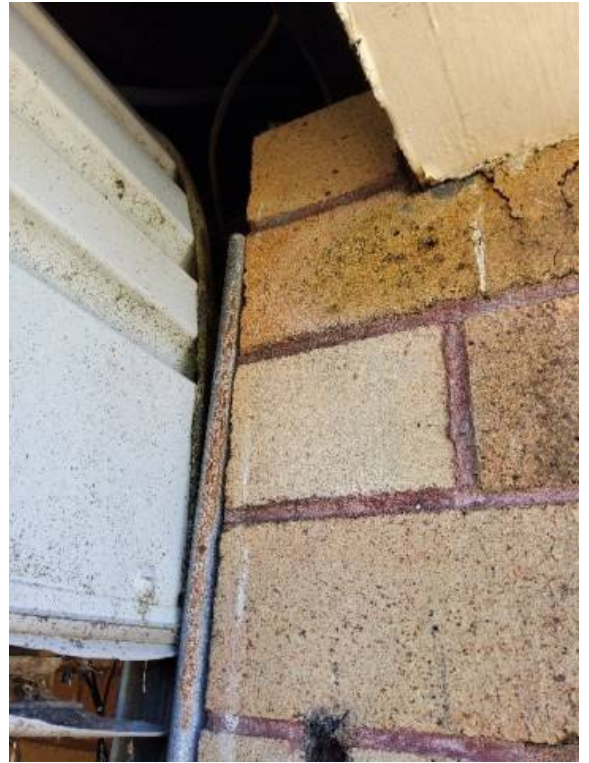
Roller door tracks show signs of rust and requires resealing / coating with kill rust or better.

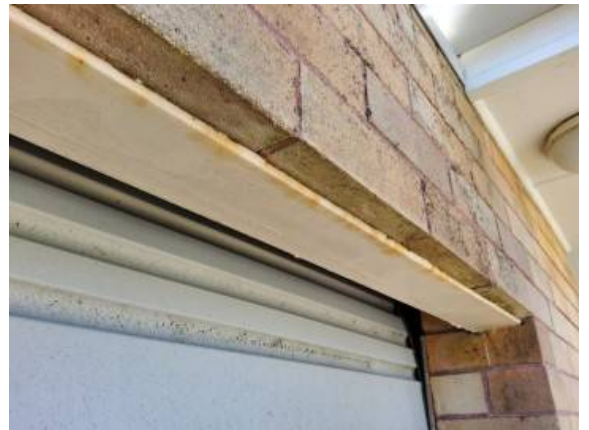
Rust spotting to the garage lintel requires kill rust coating.

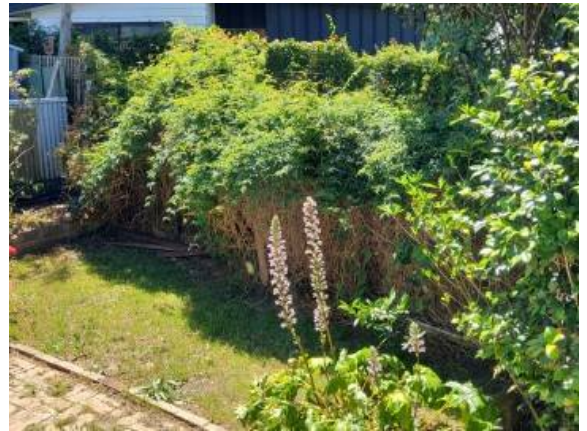
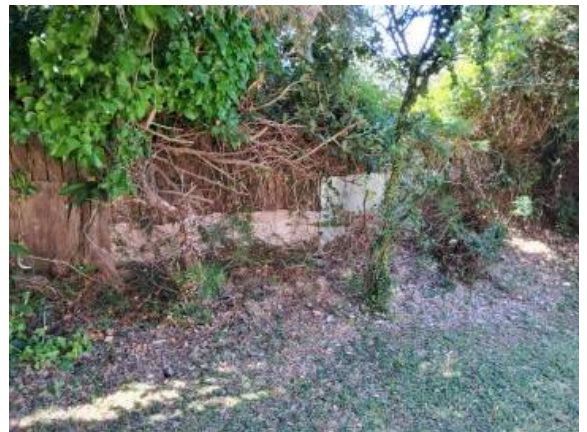
Dilapidated fencing to some areas require replacement.

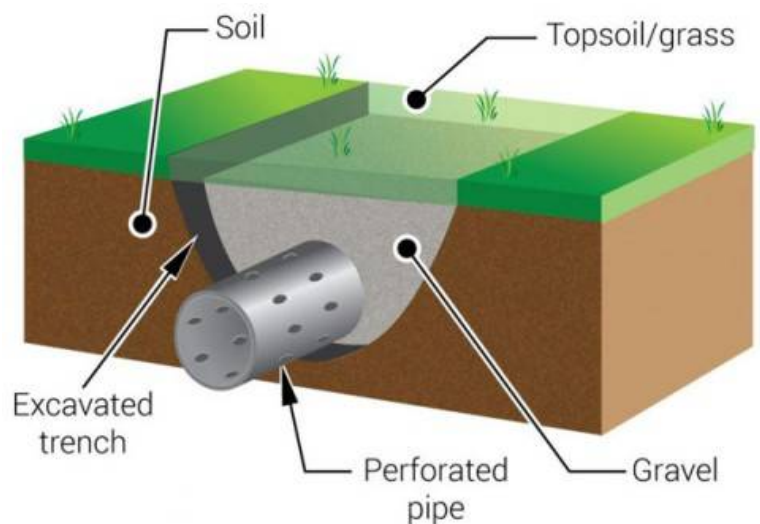
There are some low areas that should be monitored during wet weather, and if ponding occurs action should be taken to prevent ponding. This may require top dressing of the turf to eliminate low areas or installation of yard drain/s to this area (connect to existing stormwater) Refer to attached image for standard agg line detail.

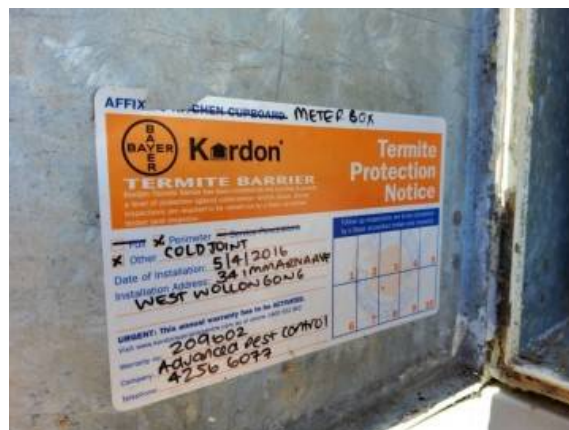
A termite treatment sticker in the meter box indicates that the a building Jon has been protected from termite activity by Kordon Barriers. These barriers were installed in 2016.
