STANDARD PROPERTY INSPECTION REPORT

Report number: 727

Property address: 8 Cashmere Street, Redbank Plains Qld 4301

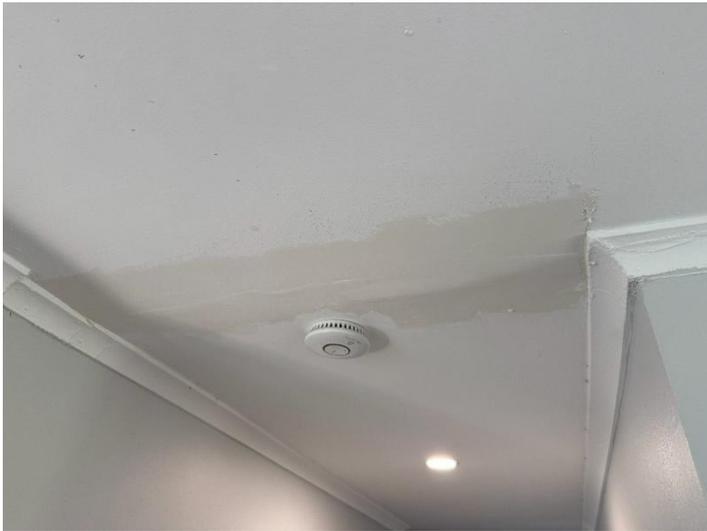
General wear and tear is noted, plus cracks to most of the upper ceilings - repairs recommended recommend seek further advice from a licenced and practicing plasterer

Undulations were noted to the ceiling lining. Common in a house of this age. Consult a qualified plasterer for further assessment and repairs as required. Note:

There are marks and imperfections to the interior ceilings at various locations. These can be repaired normally

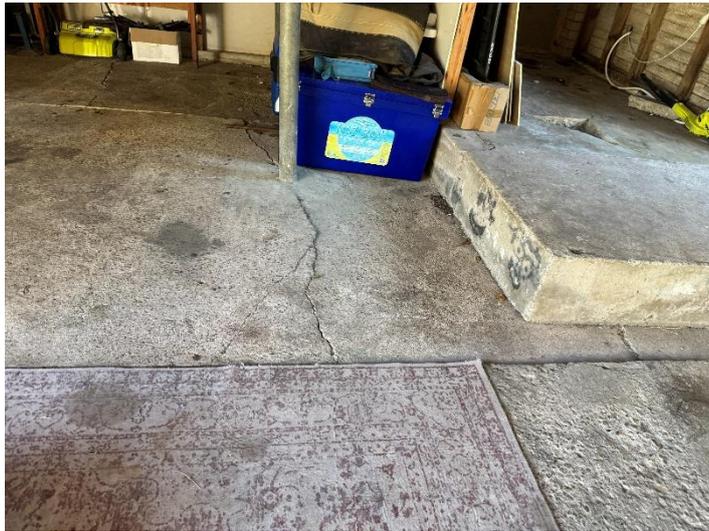
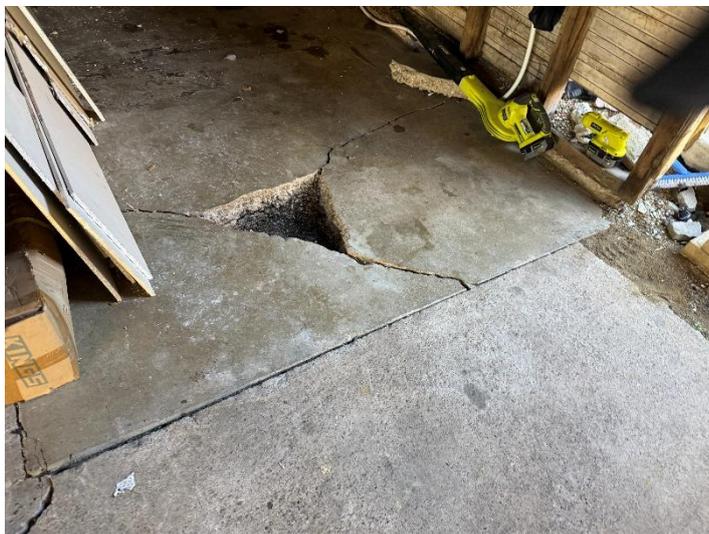
Significant cracking and subsidence to the lower concrete floors - recommend seek further advice from a licenced and practicing structural engineer before purchase

The floors to the upper level are out of level, approx 0-30mm across individual rooms - recommend seek further advice from a licenced and practicing Structural engineer

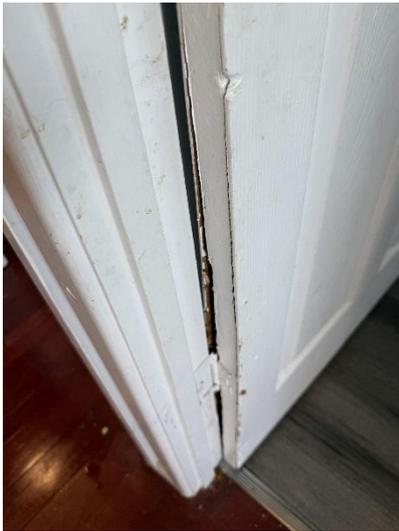
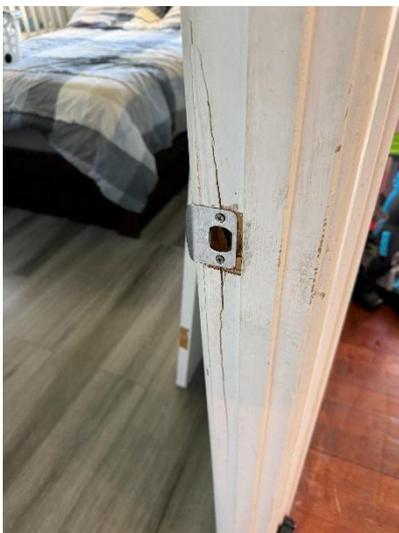
The internal door to the front right bedroom requires replacement and the timber door frame is damaged

A door is missing to one of the front bedrooms

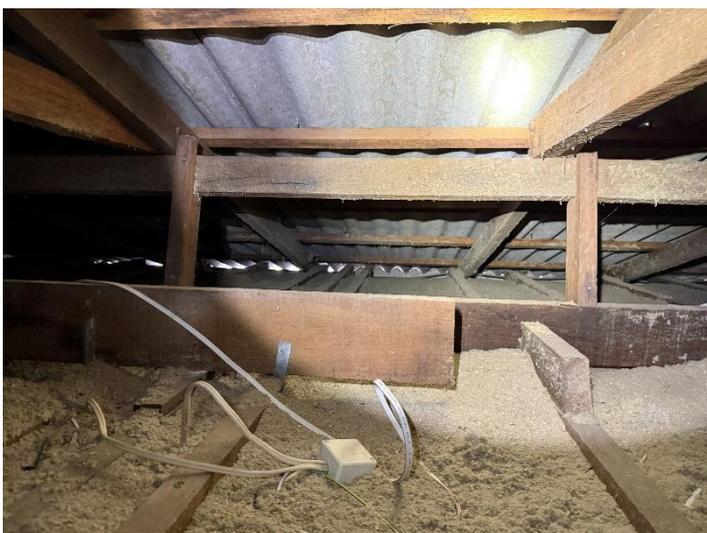
Insulation is present in the roof cavity. This restricted inspection to some roofing timbers. Removal of insulation is not within the scope of a standard visual inspection report.

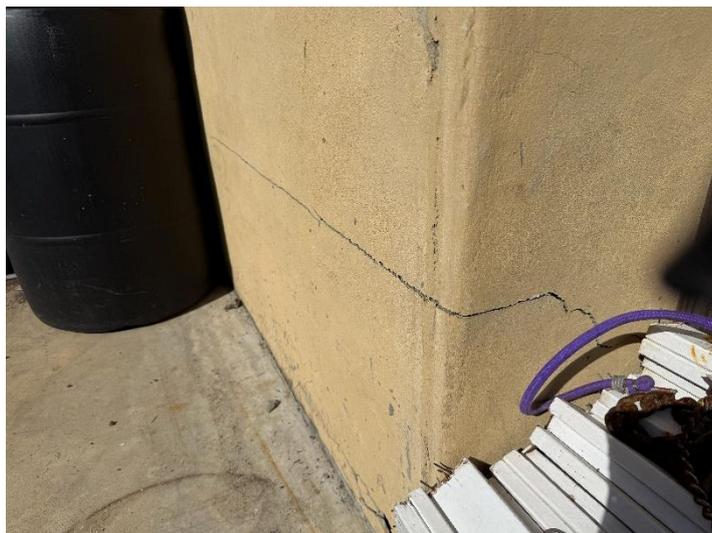
Left side

Cracks to the brick base, more so the left side and rear - cracks approx 0-5mm and 2.0m long, horizontal, sheer and stepped, plus the front brick wall is leaning over approx 40mm - recommend seek further advice from a licenced and practicing Structural engineer before purchase

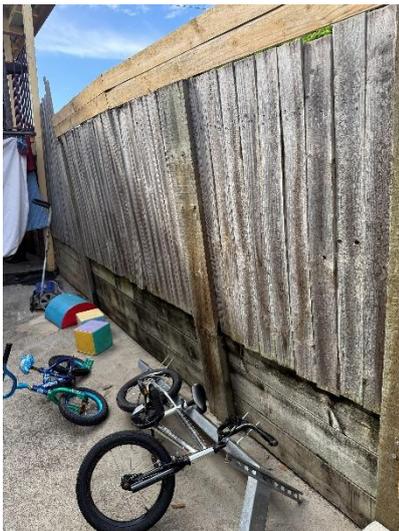
The rear timber retaining wall, is poorly constructed and leaning over - repairs required
