Pre-Purchase Building and Pest Inspection Report (PPBPIR)

16/15 Smith Road, Woodridge, QLD 4114

Monday, 29 July 2024

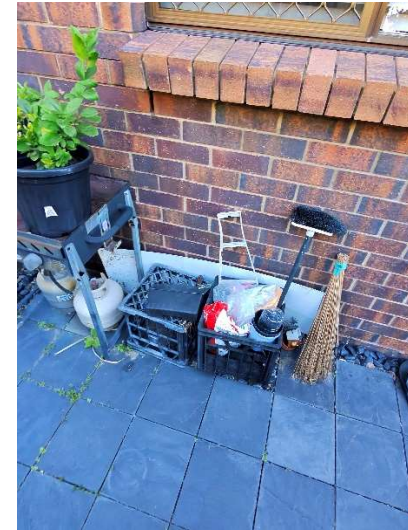
Some of the weep holes sit too close to ground level, leaving these areas vulnerable to water entry and termite attack. Weep holes should ideally have 75 millimetres of ground clearance to help prevent decay and potential termite entry. Consideration should be given to an annual inspection or treatment in accord with "Australian Standard 3660" be carried out to reduce the risk of further attack.

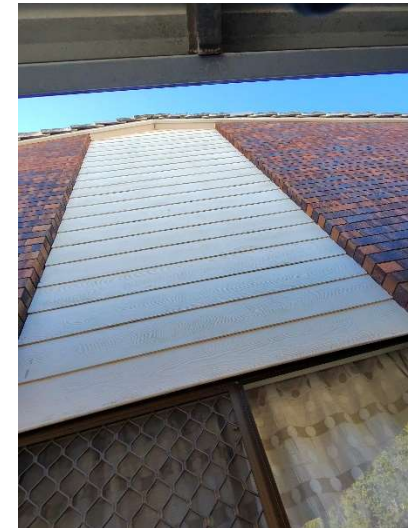
Wood rot detected

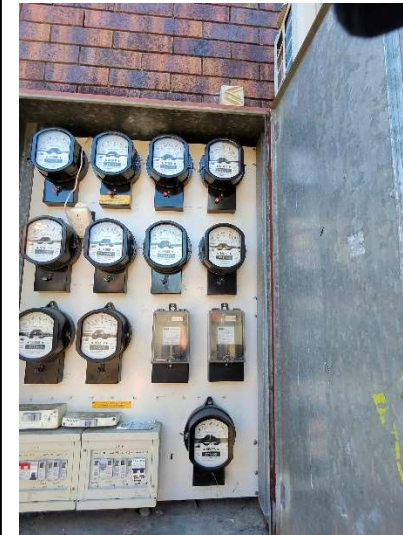
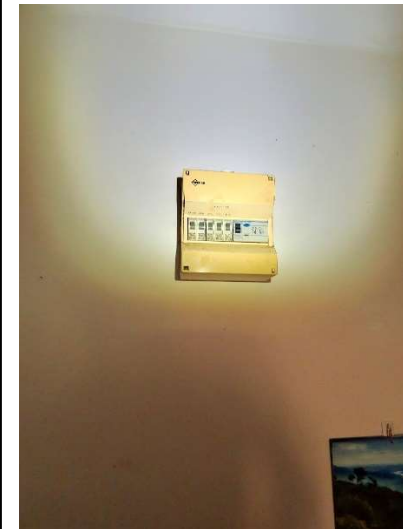
- It is suggested that consideration be given to connection of the pool pump equipment to off-peak power.
- Recommend Electrical inspection- Wires not in conduit
- Recommend Electrical inspection- Electrical earthing issues
- The smoke alarms appeared to be inadequate and do not appear to comply with the current legislation.

The air conditioning services appeared to be operational at the time of the inspection. However the louver was not working. Service recommended. Operationally tested by means of thermal screen observation (cold in summer and warm in winter).

We recommend connecting the air conditioning services discharge to the storm water system, this area is highly conducive to termites. Repairs recommended.

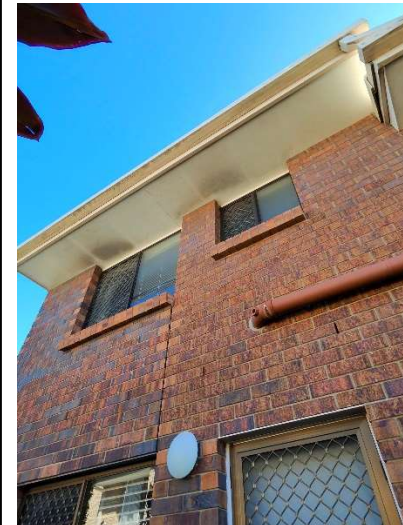
Dirt or mould was detected on the eaves this type of fungus does not structurally damage could but can cause health issues.
