PRE-PURCHASE STANDARD PROPERTY & TIMBER PEST REPORT

Inspection date: 24 October, 2024

Property address: 8 Kidd Street, Robertson Qld 4109

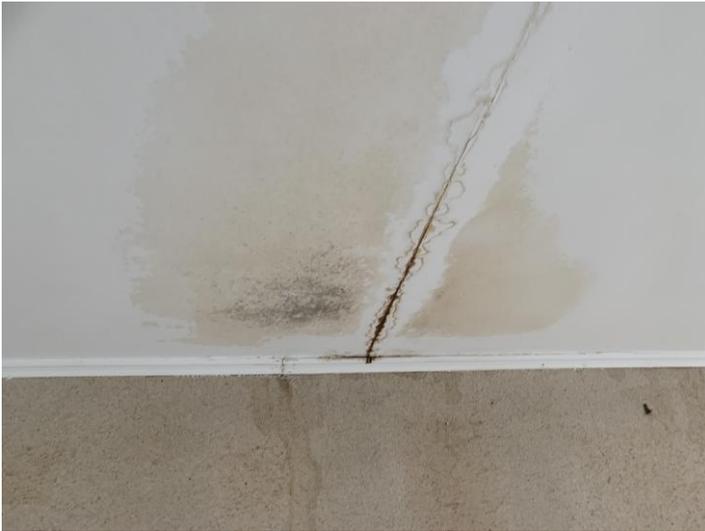
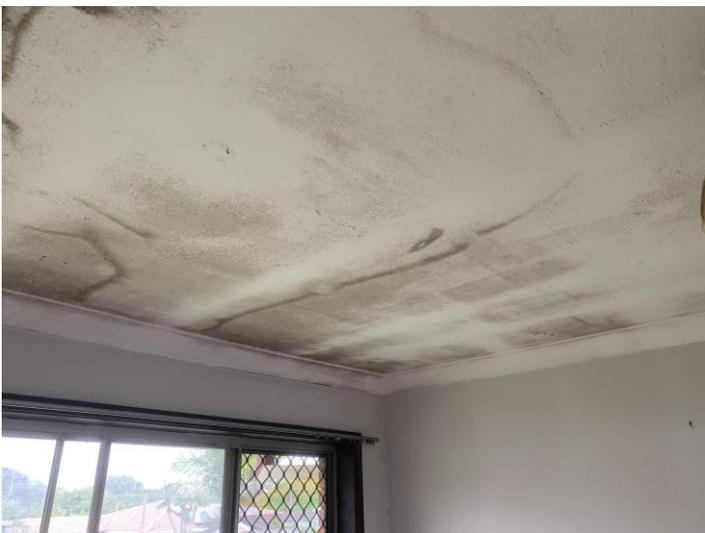
cracks to several ceilings, damage to most ceilings due to roof leaks

repairs required

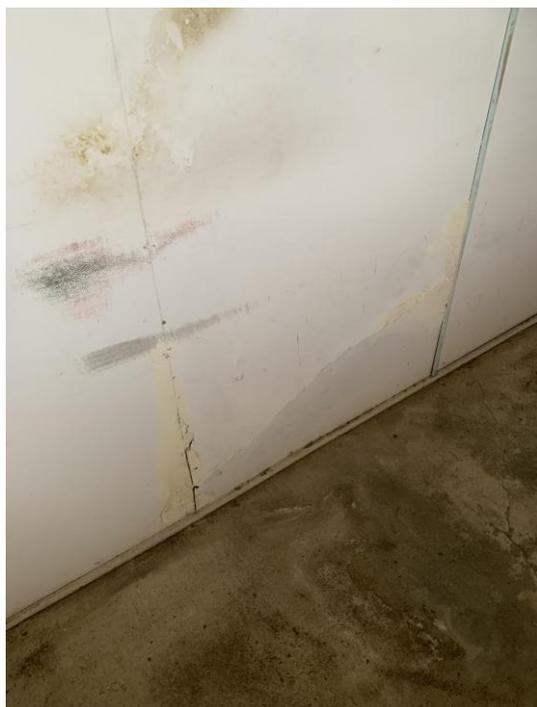
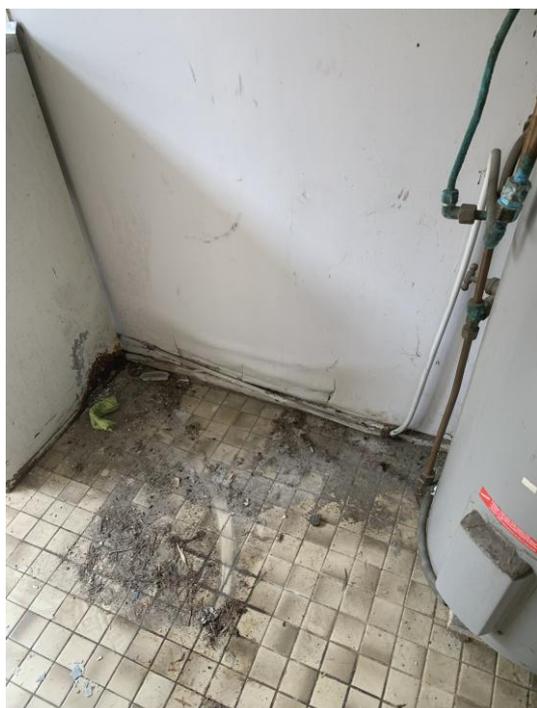
D3 Internal Walls

Significant fungal decay to the laundry / dining room wall - appears to be due to a leaking washing machine - further investigations - repairs required

Cracks to the wall of the front living room and damage to the wall sheeting in the garage - repairs required recommend seek further advice from a licenced and practicing plasterer

Fungal decay was found to the laundry wall and the fascia boards

A high moisture reading was found to the laundry wall - further invasive investigations are recommended

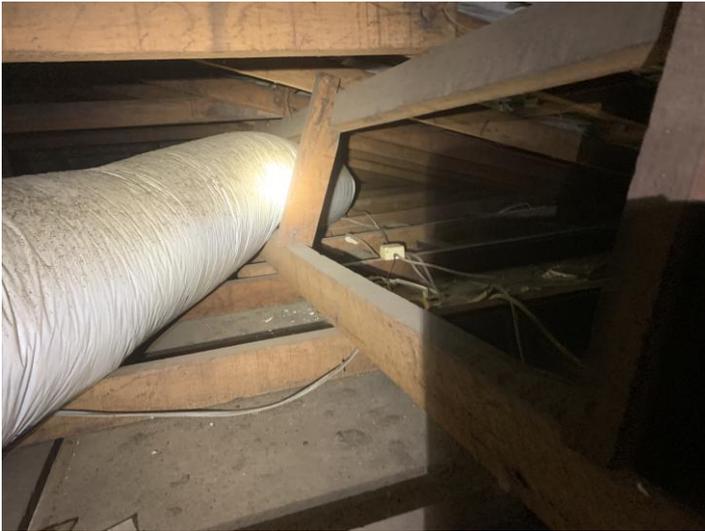
No Sarking is present to roof cavity. It should be noted that tiled roofs without sarking may leak in heavy wind driven rain. Sarking installation is not a building requirement.

The installation of an additional access point is recommended to the front of the dwelling, enable a full inspection

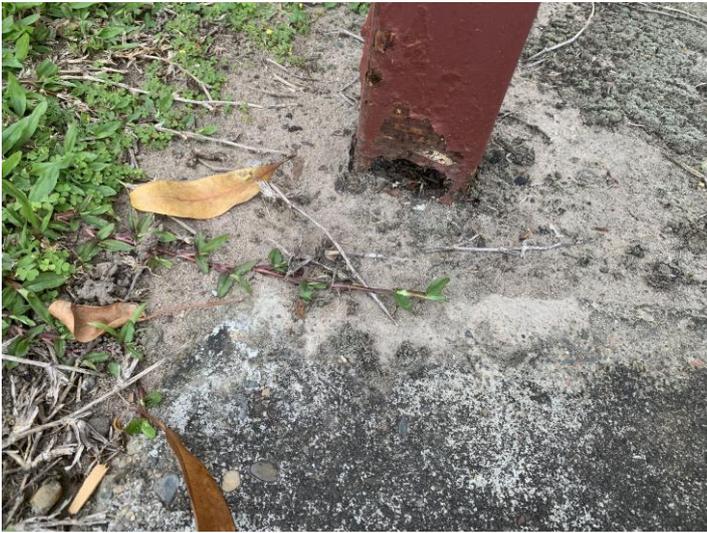
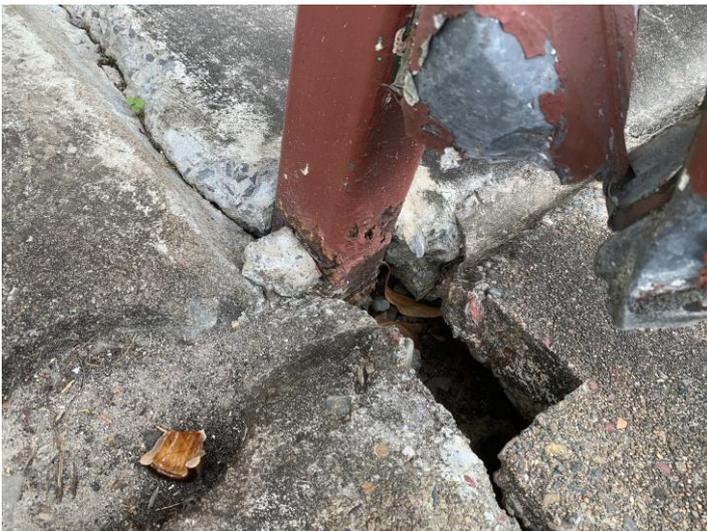
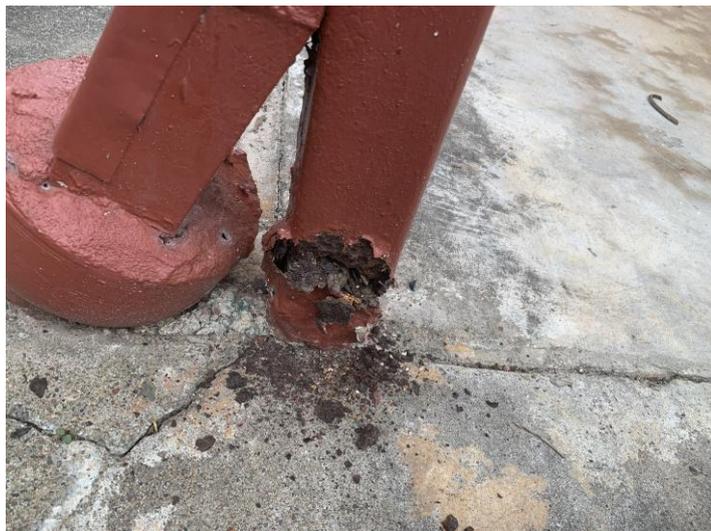
Significant corrosion to the seven metal supporting piers, that support the front veranda- replacement requires as large holes to most

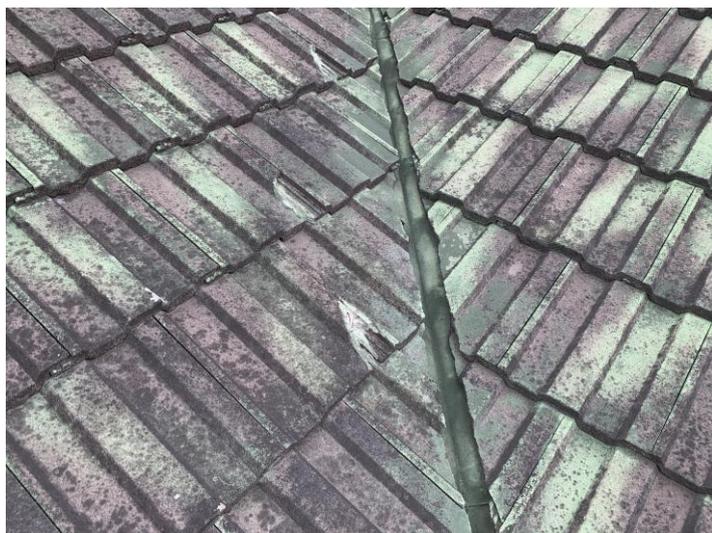
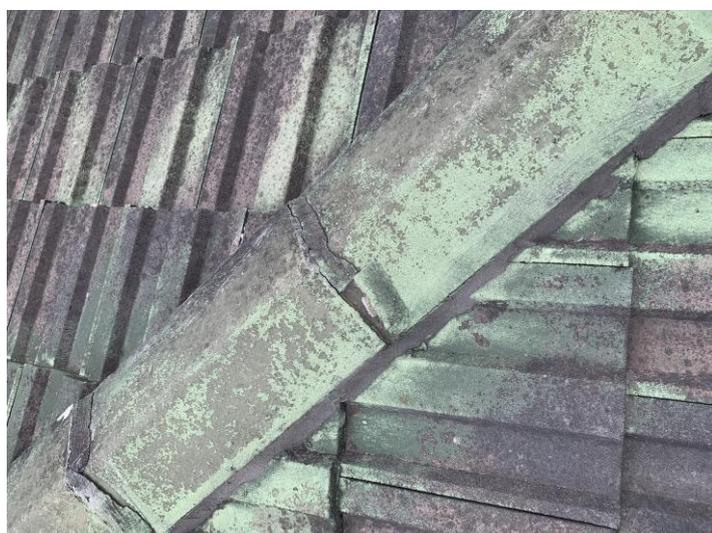
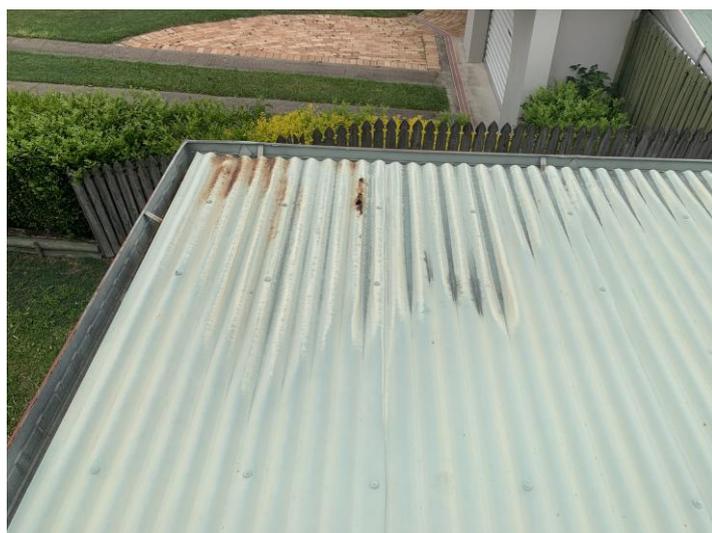
There are cracks in the bedding mortar. This is not unusual for a tiled roof, and is often caused by normal movements in the roof frame. It is recommended that maintenance work is carried out on the roof so that the loose tiles can be re-bedded using flexible bedding compound to help prevent re-cracking.

Several roof tiles have broken corners - refer to a roof restoration company

Significant corrosion to the garage roof - the wrong type of roof sheeting has been used - replacement required
