PRE-PURCHASE STANDARD PROPERTY & TIMBER PEST REPORT

Report number: 127 - Report Prepared For Vendor.

Inspection date: 22 January, 2025

Property address: 17 Mitchell Street, Redbank Plains Qld 4301

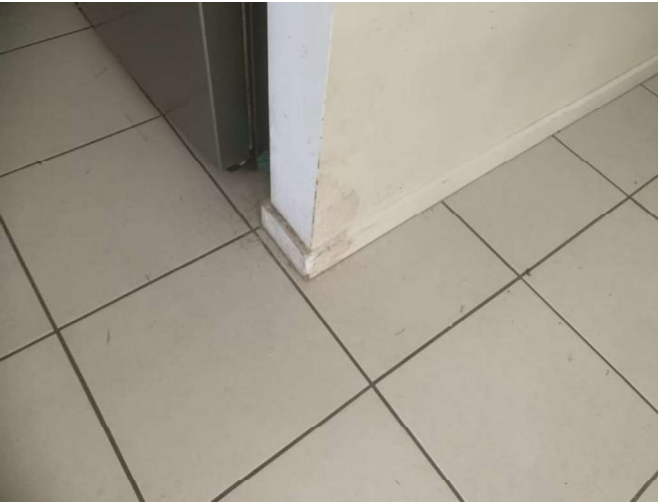
paint and minor plaster defects to all walls

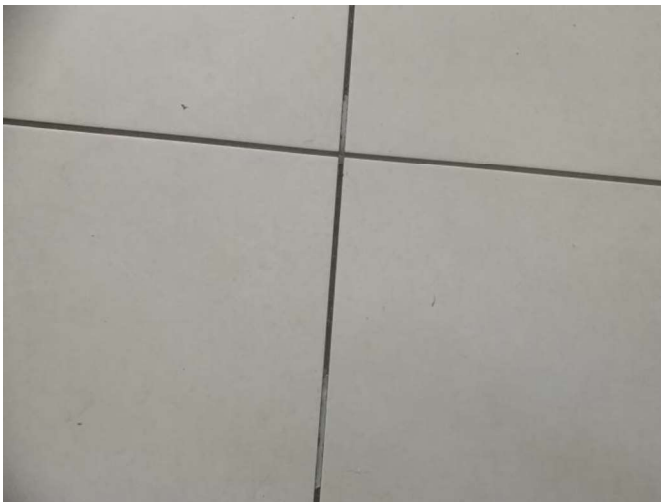
D4 Floors

The sealant to the expansion joint, of the tiled floor, in the living room, requires replacement, as missing to areas

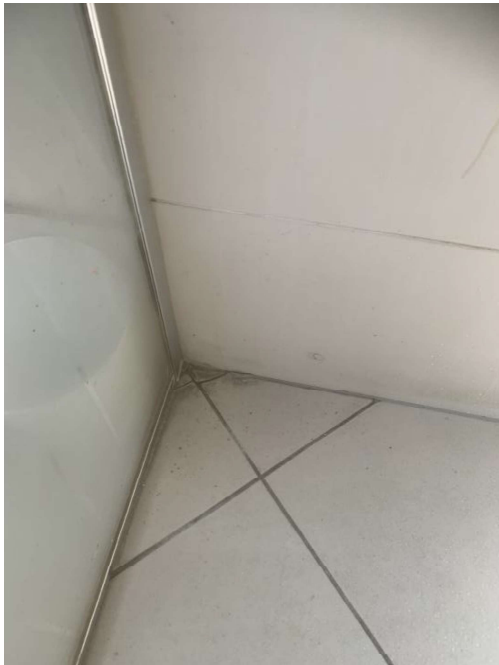
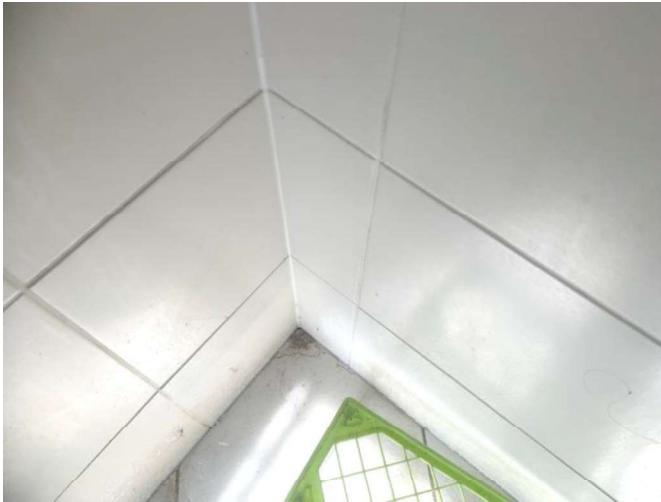
A few broken small tiles to the base of the ensuite shower, and a hole to the other corner - repairs required recommend seek further advice from a licenced and practicing tiler

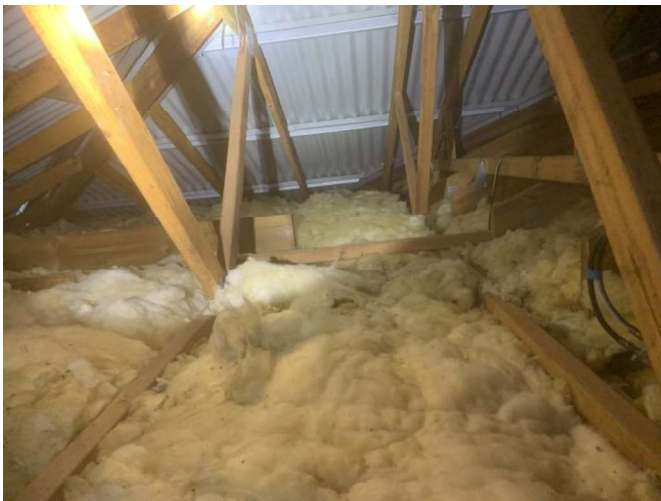
Insulation is present in the roof cavity. This restricted inspection to some roofing timbers. Removal of insulation is not within the scope of a standard visual inspection report.

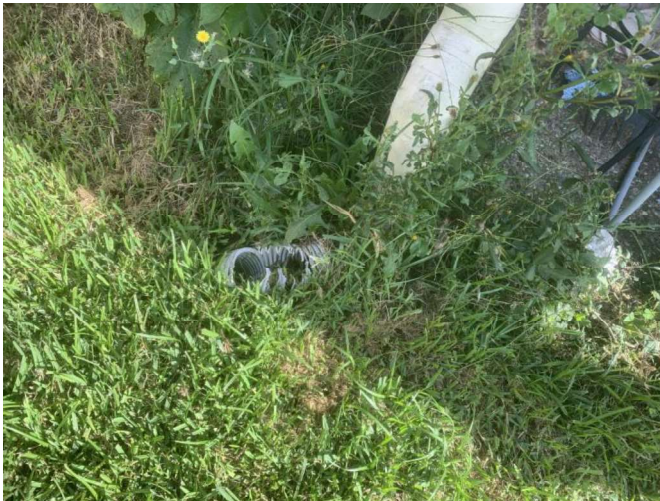
The plastic connection from the downpipe to the stormwater pipe has perished - repairs required

Recommend a roof plumber assess the gutters and downpipes to make sure they are functional and adequate for the situation

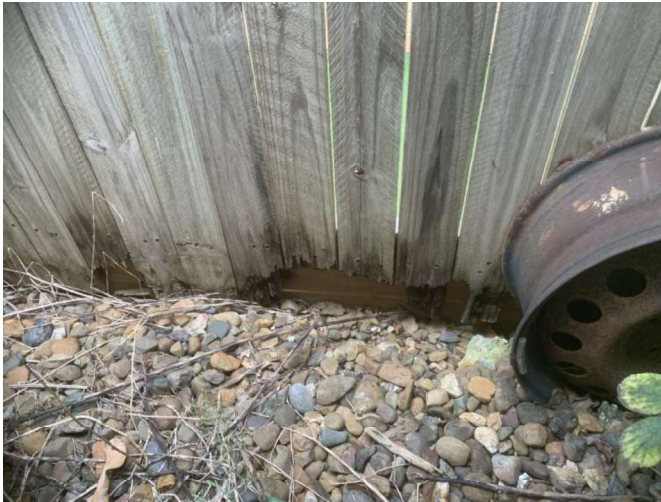
Fungal decay was found to the bottom of the right side timber fence - repairs recommended

Fungal decay was found to the bottom of the right side timber fence

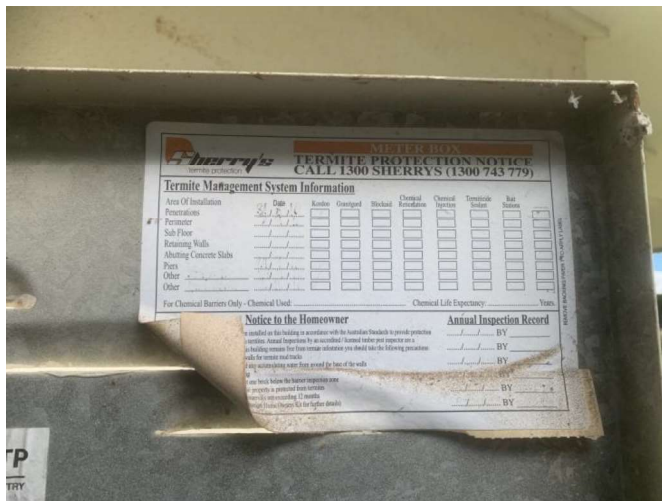
At construction in 2010 a Kordon Termite management system was installed

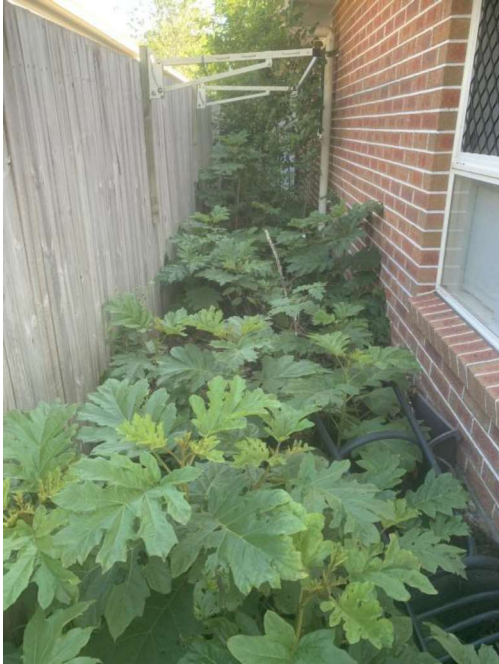
The garden to the right side is over grown - remedial work required
