# Inspection Report

## Coastal Building Inspections

**205 Dandaraga Road, MIRRABOOKA, NSW, 2264**

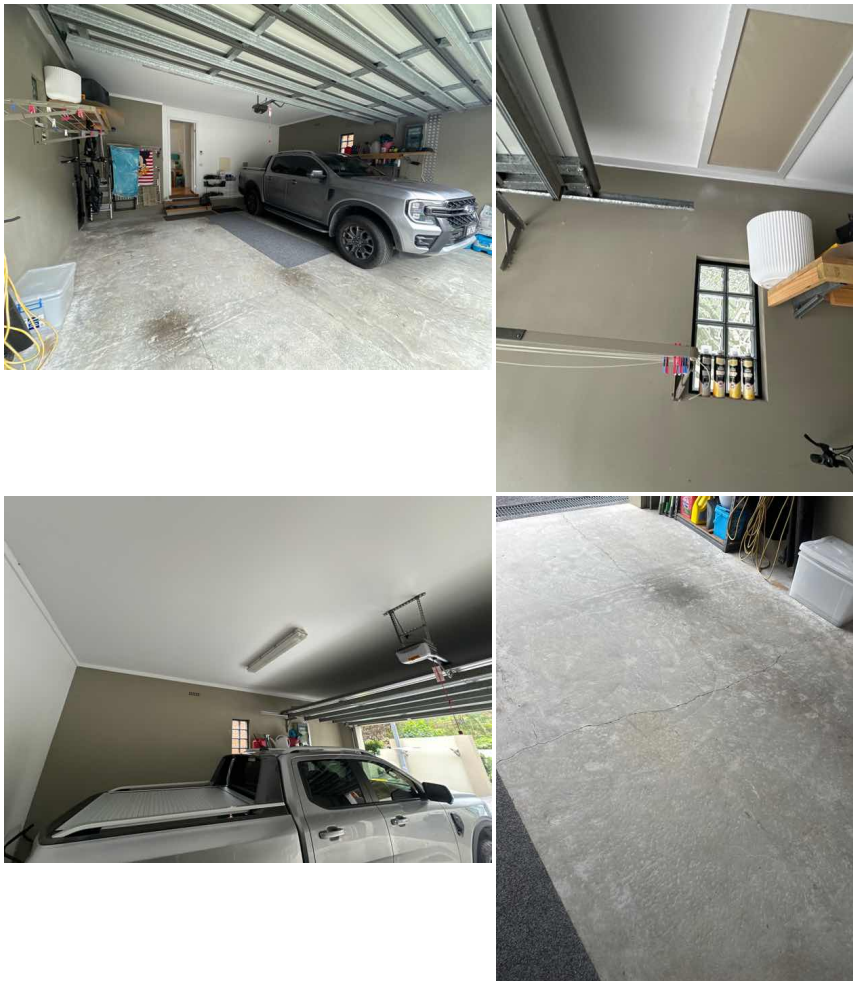
Minor hairline slab cracks - Note. Whilst these cracks appeared to be minor at the time of inspection, we strongly recommend you monitor these cracks and if worsening occurs contact a qualified concreter for further advice.

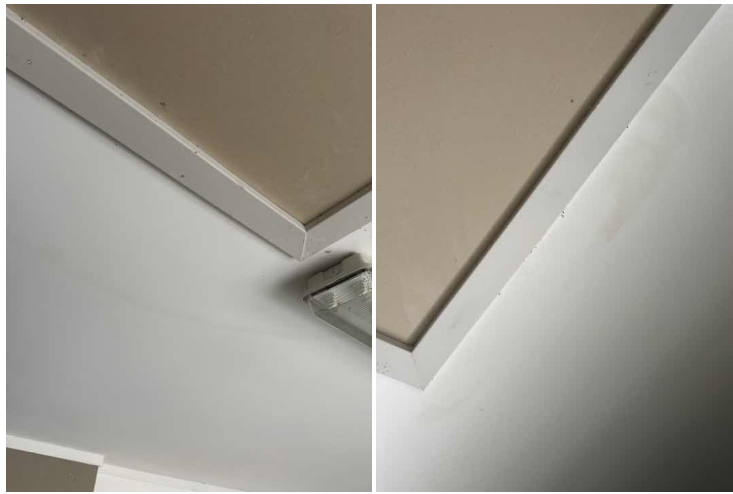
Ceiling stains - No moisture readings obtained from same. Recommendations: These may have been repaired, however, you will need to monitor after a prolonged period of rainfall - If leaking persists, a qualified plumber should be engaged for advice and recommendations.

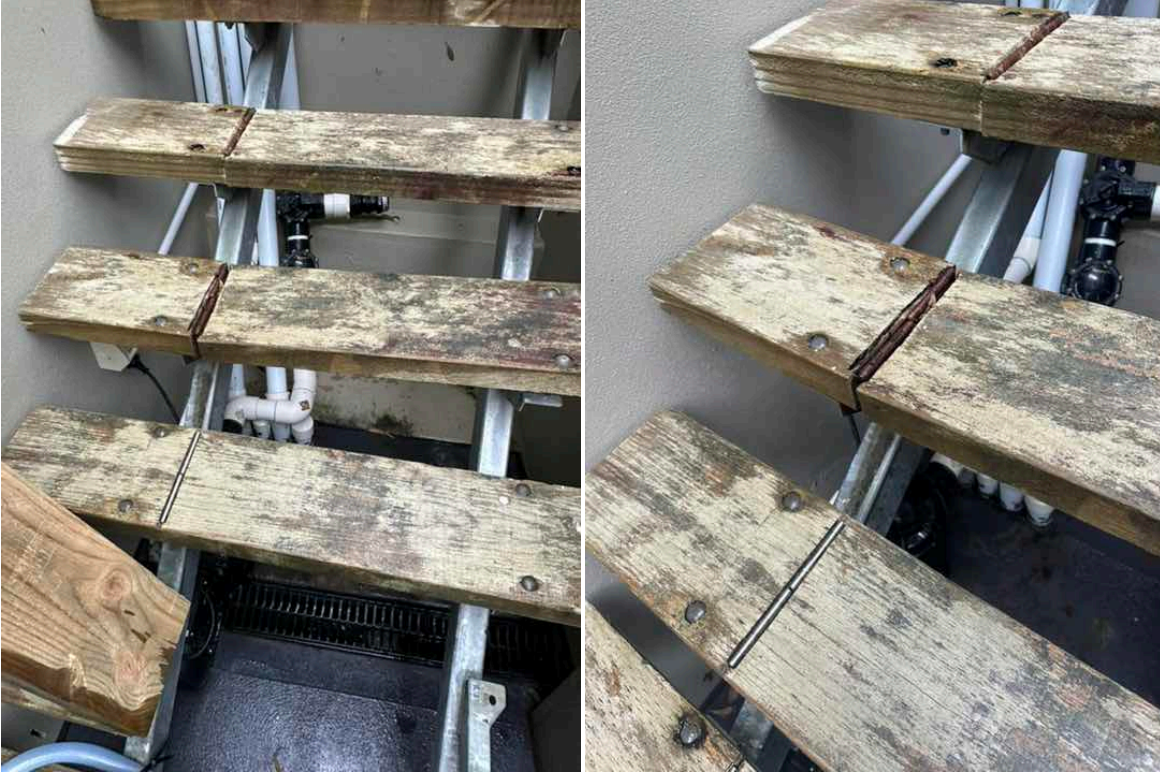
Timber fungal decay in sections of stair treads. This is a safety hazard and repair is required. Recommendations: A qualified carpenter should be engaged for advice and recommendations.

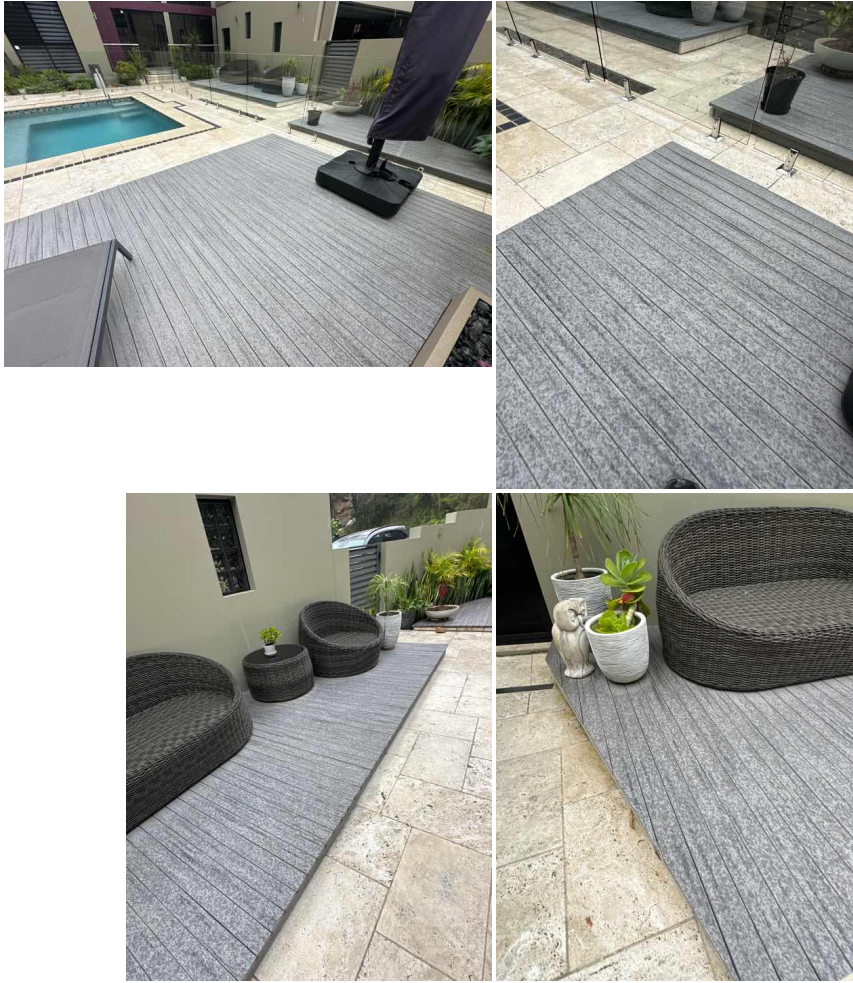
Moisture damage was observed on deck boards - Recommendations: Evaluation and repairs by a qualified decking contractor.

Decking board surfaces are weathered - Recommendations: We recommend cleaning and maintenance as needed.

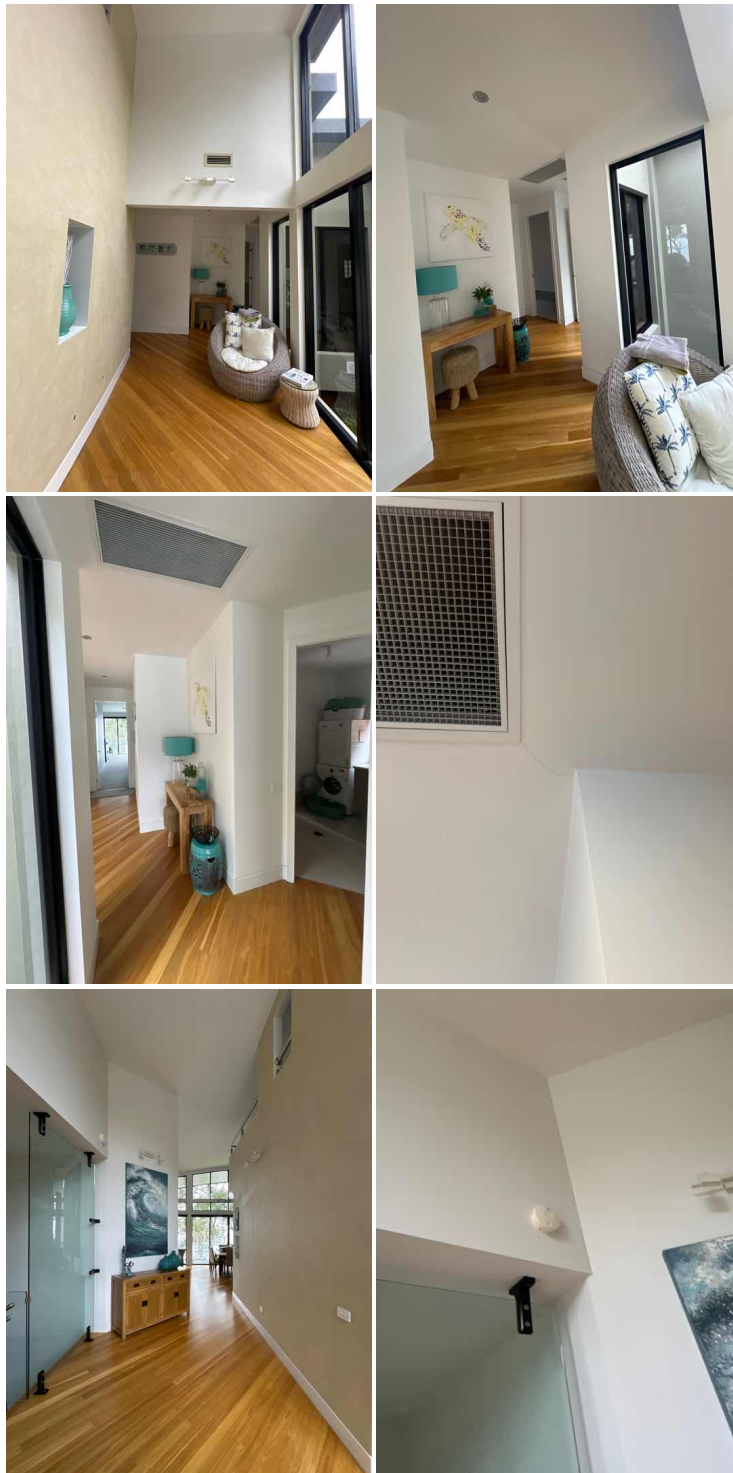
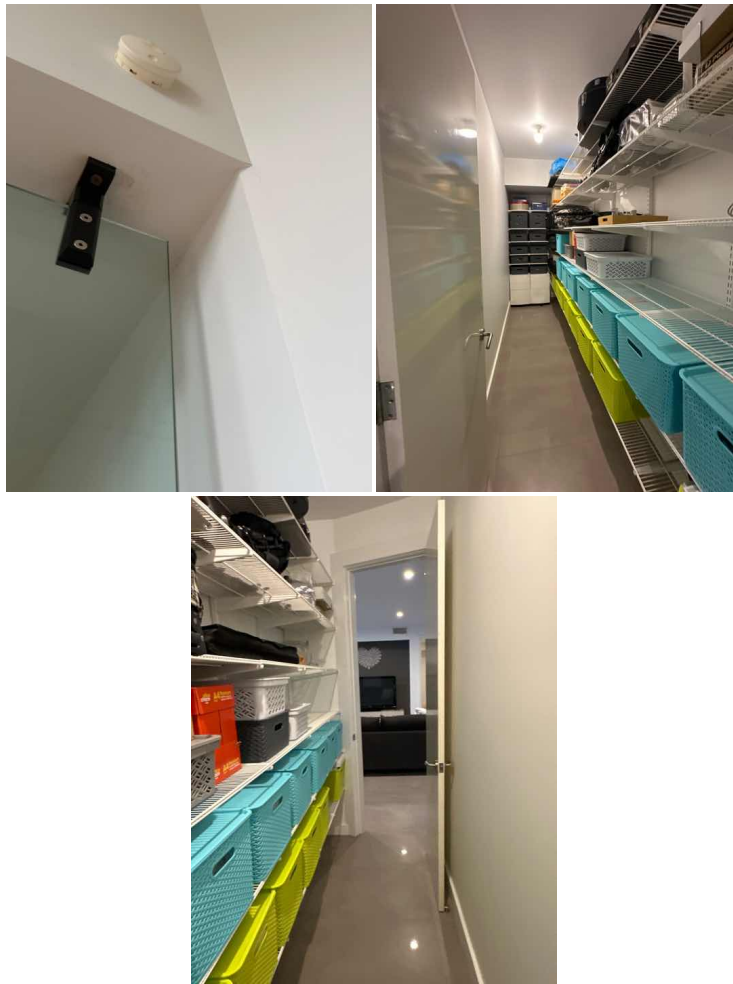
Settlement Cracks Noted. These are typical and generally patch and paint will suffice

General age wear and tear noted to the walls. Recommendations: Patch/paint as required

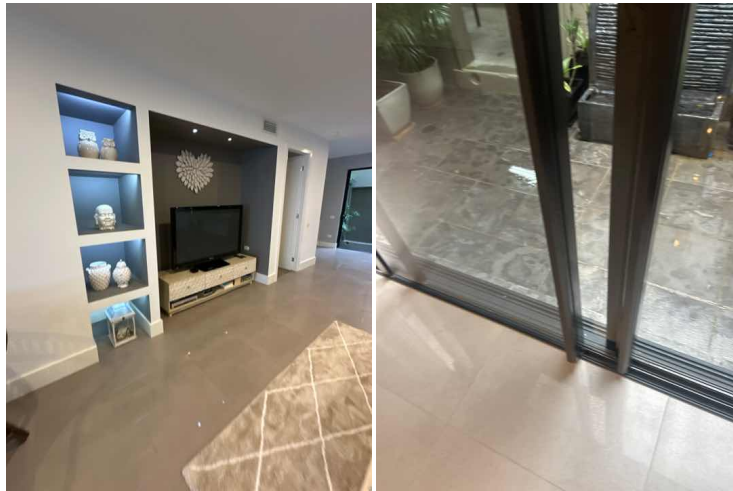
Repairs/Replace rollers for smoother operation.

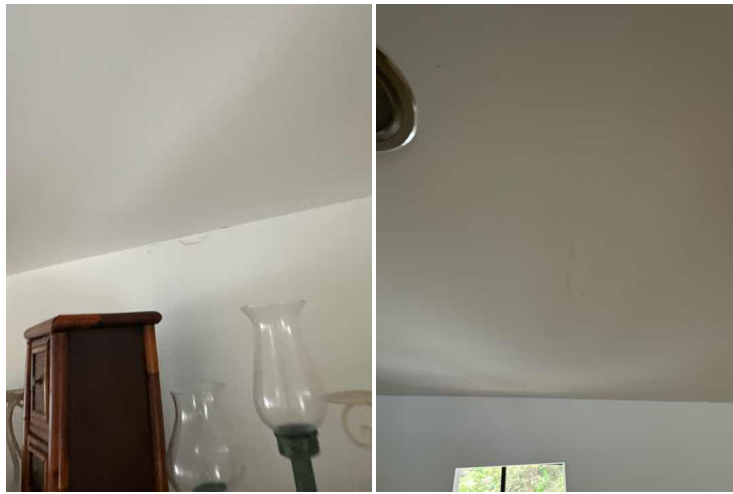
Ceiling stains - No moisture readings obtained. Recommendations: These may have been repaired, however, you will need to monitor after a prolonged period of rainfall - If leaking persists, a qualified plumber should be engaged for advice and recommendations. Patch/paint required

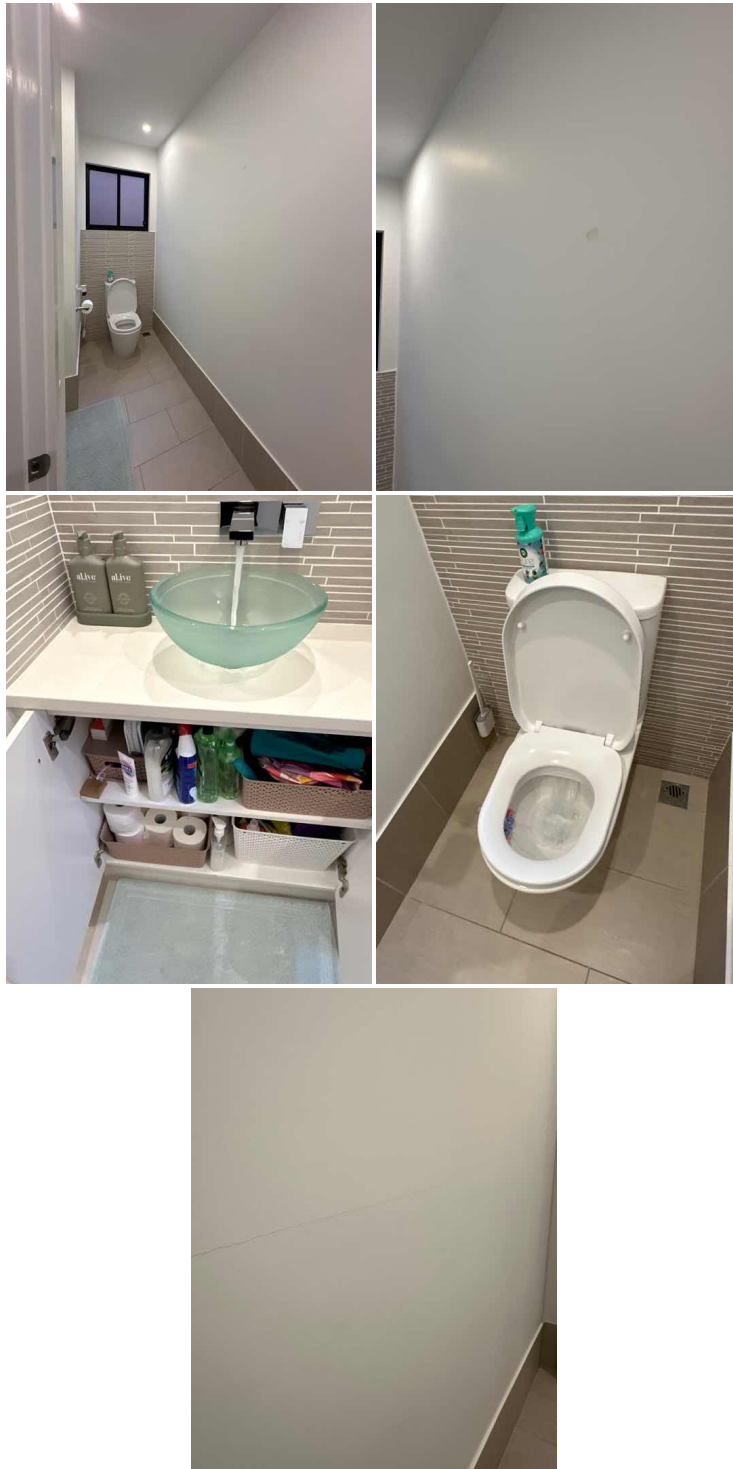
Settlement Cracks Noted. These are typical and generally patch and paint will suffice

General age wear and tear noted to the walls. Recommendations: Patch/paint as required
