Building and Timber Pest Inspection Report

Inspection Date: Wed, 14 Aug 2024

Property Address: 33A Beecroft Rd, Beecroft NSW 2119,
Australia

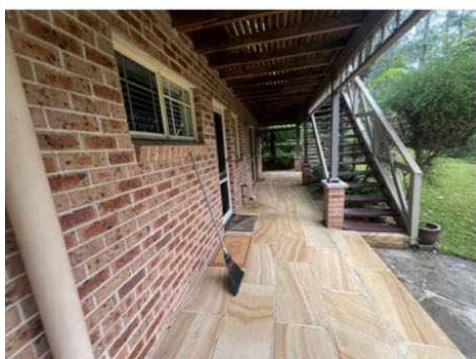
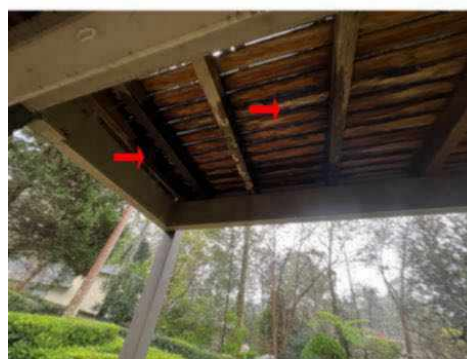
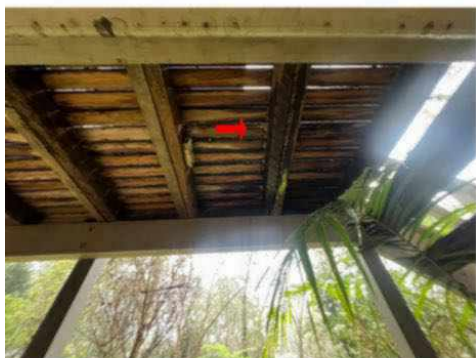
Building: Main Building
Location: Balcony
Finding: Wood Rot - Balcony
Information: The balcony timbers show signs of fungal decay (wood rot) in several sections. This wood rot is suspected to have developed over a prolonged period of time due to frequent weather exposure, which is expected in a property of this age and condition

Timber members and timber junctions are sealed and protected by paint and other sealants. When these sealants deteriorate over time, they allow water penetration to the fixing points and butting timbers, causing wood rot. If left unmanaged, the wood rot is likely to develop further, possibly necessitating repair or replacement works or a safety hazard in the long-term future.

To maintain the condition of the timber structure, any severely affected timbers should be replaced as soon as possible with pre-treated replacements. A licensed building contractor should be consulted to determine what would be required for repair and replaced of the affected timbers.

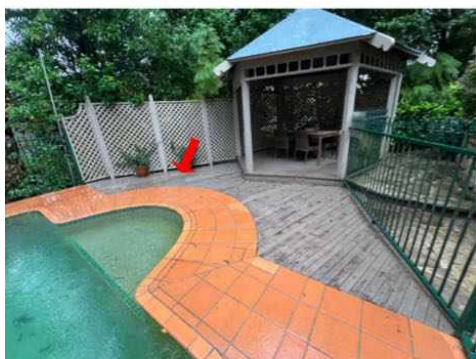
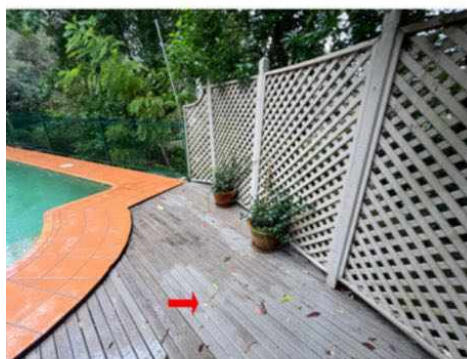
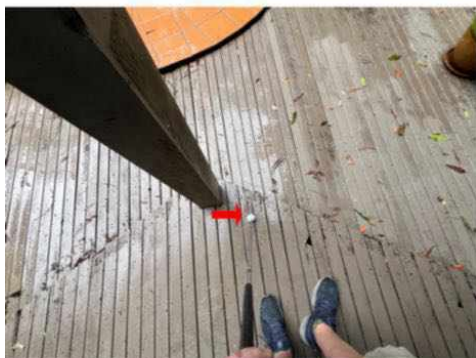
Finding 3.02

Finding: Wood Rot - Deck

Information: The timbers show signs of fungal decay (wood rot) in several sections. This wood rot is suspected to have developed over a prolonged period of time due to frequent weather exposure, which is expected in a property of this age and condition.

Timber members and timber junctions are sealed and protected by paint and other sealants. When these sealants deteriorate over time, they allow water penetration to the fixing points and butting timbers, causing wood rot. If left unmanaged, the wood rot is likely to develop further, possibly necessitating repair or replacement works or a safety hazard in the long-term future.

To maintain the condition of the timber structure, any severely affected timbers should be replaced as soon as possible with pre-treated replacements. A licensed building contractor should be consulted to determine what would be required for repair and replacement of the affected timbers.

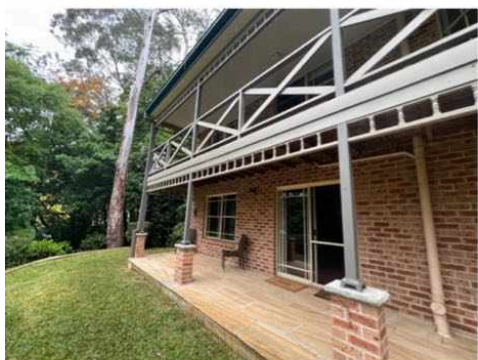
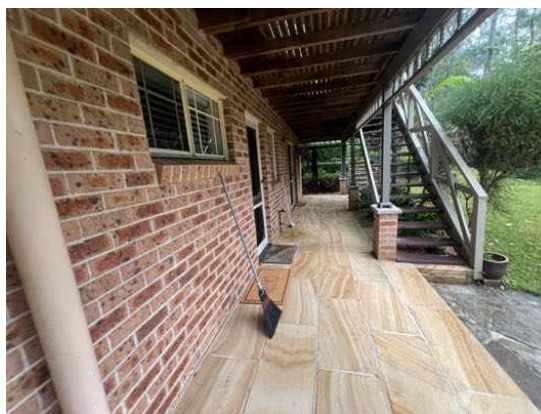
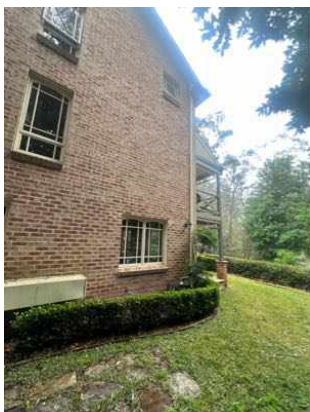
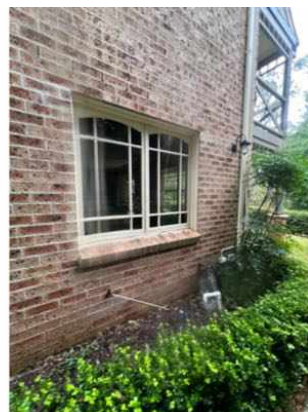
| Information: | An inspection zone of at least 75mm in relation to the exposed slab edge, between the bottom brick and the perimeter pavement, is required. This inspection zone should be maintained in order to force termites into the open where they can be detected more readily during regular inspections. The slab edge should not be concealed by anything that may prevent inspection of the area, including render, landscaping, soil, turf, paving, concrete cladding or other structures. |

As in this case it is common that termite barriers have been installed during the construction process. Where paths, paved areas and gardens have concealed slab edge and cannot be properly inspected. Therefore it is recommended that termite inspections be carried out every 12 months as per their product warranty to aid protection of the property against termite infestation.

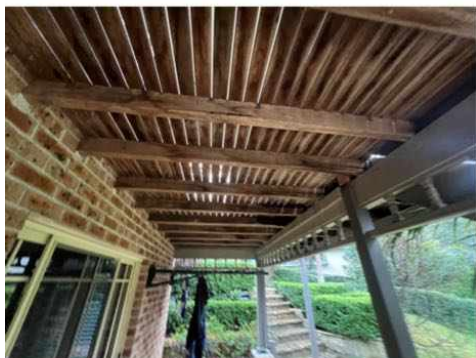
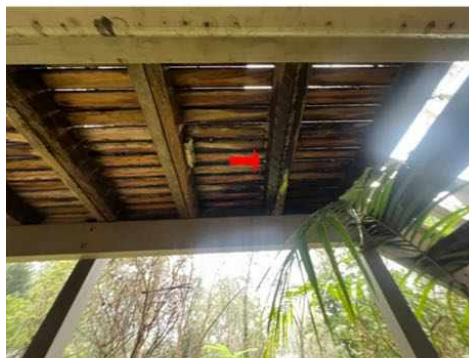
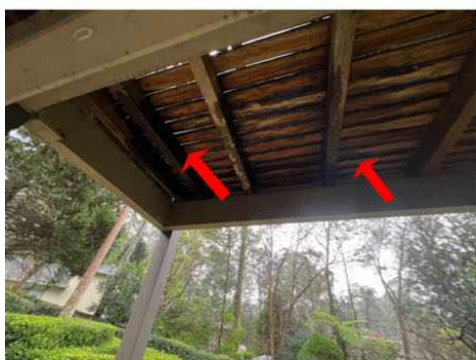
Finding 7.01

| Finding: | Wood Rot - Balcony |
| Information: | The balcony timbers show signs of fungal decay (wood rot) in several sections. This wood rot is suspected to have developed over a prolonged period of time due to frequent weather exposure, which is expected in a property of this age and condition |

Timber members and timber junctions are sealed and protected by paint and other sealants. When these sealants deteriorate over time, they allow water penetration to the fixing points and butting timbers, causing wood rot. If left unmanaged, the wood rot is likely to develop further, possibly necessitating repair or replacement works or a safety hazard in the long-term future.

To maintain the condition of the timber structure, any severely affected timbers should be replaced as soon as possible with pre-treated replacements. A licensed building contractor should be consulted to determine what would be required for repair and replaced of the affected timbers.

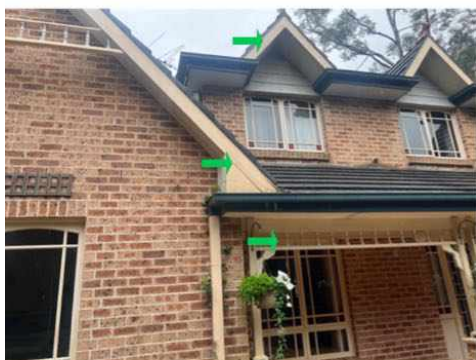
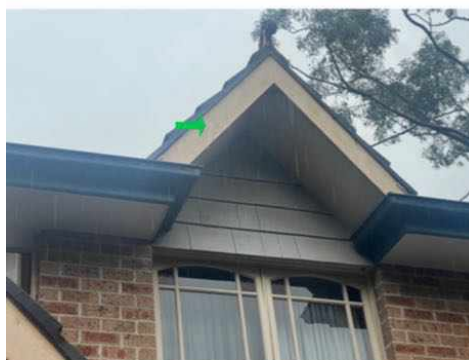
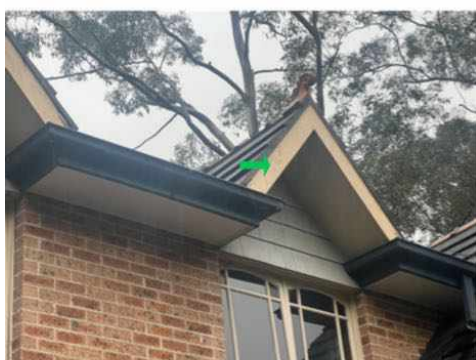
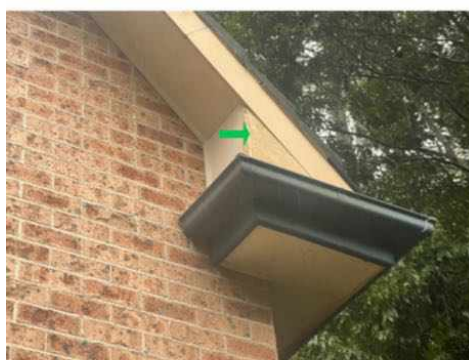
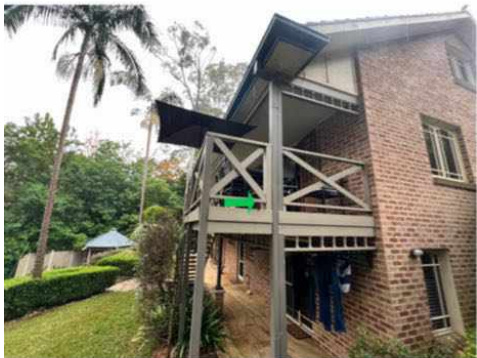
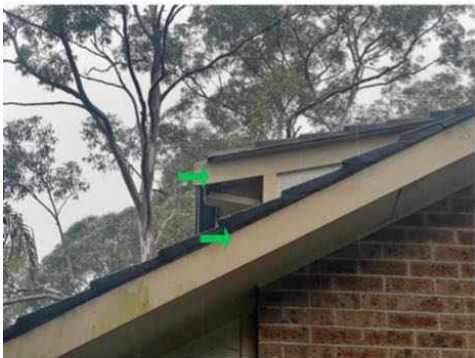
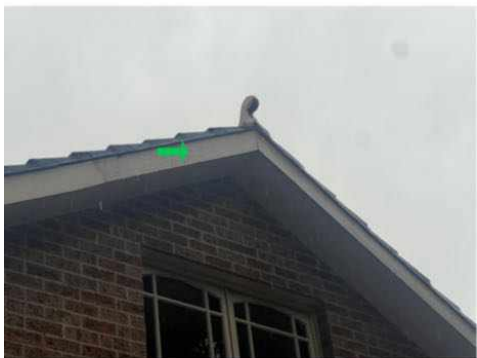
Building: Main Building
Location: All External Timbers
Finding: External Timber Maintenance - Exposed to weather
Information: External timbers that are frequently exposed to harsh weather conditions require adequate protection in order to maintain their condition. Where timbers have not been maintained, painted or treated adequately, general deterioration is likely to occur at an accelerated rate.

Regular maintenance is required Applying adequate treatment, paint coating of these timbers is required which prolongs the life expectancy of the building elements reducing the need to replace rotting and weathered timbers.

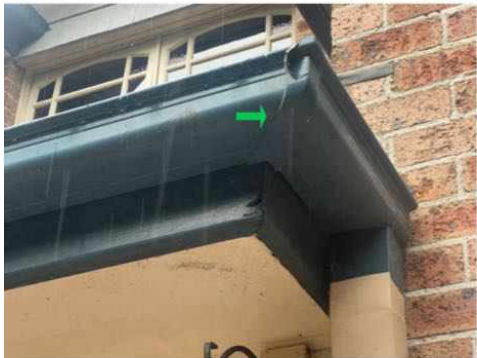
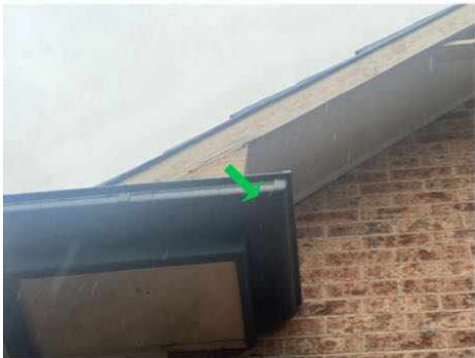
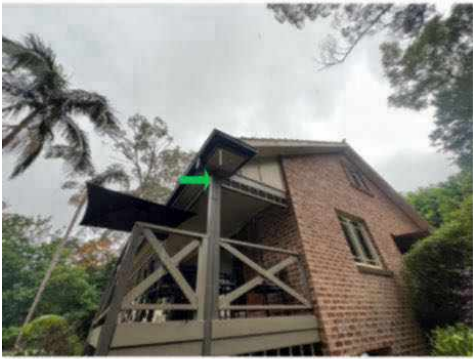
Building: Main Building
 Location: Balcony
 Finding: Gutter & Downpipe - Maintenance
 Information: There are areas where the downpipes and gutters are not sealed and the silt builds up in the joint and creates corrosion. Where the guttering or downpipes show signs of leaking the area may result in premature corrosion.

Guttering and downpipes should be cleaned regularly not just the leaves, all debris including silt should be removed.

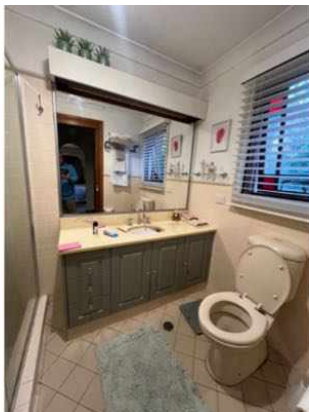
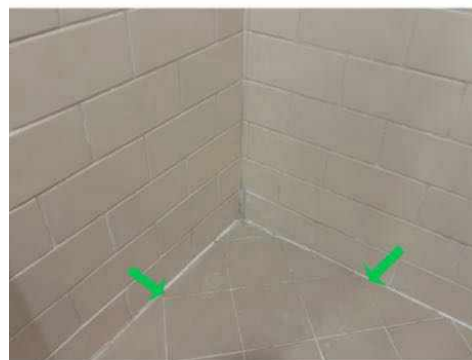
Building: Main Building
 Location: Ensuite
 Finding: Silicone Junction Sealant - Maintenance
 Information: The sealant at the junctions at the time of the inspection were in good working order.

Ongoing maintaining a silicone seal the tile junctions are required to stop moisture and or mould growth behind the silicone sealant. When this occurs replacement of the silicone is required.

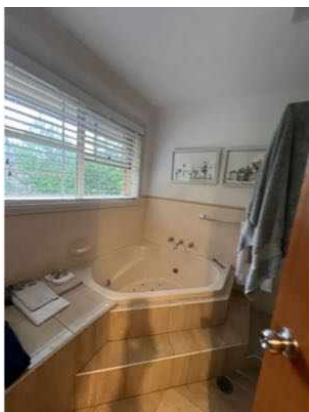
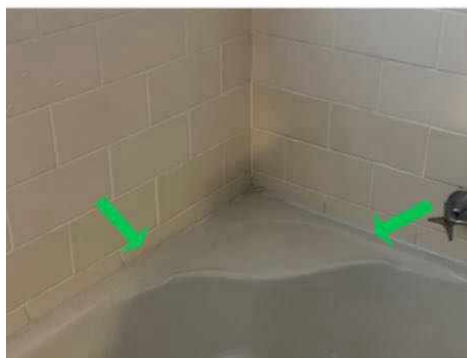
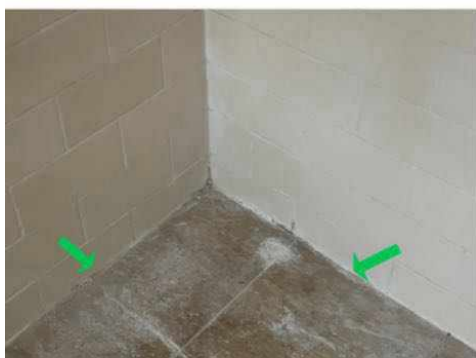
Building: Main Building
 Location: Bathroom
 Finding: Silicone Junction Sealant - Maintenance
 Information: The sealant at the junctions at the time of the inspection were in good working order.

Ongoing maintaining a silicone seal the tile junctions are required to stop moisture and or mould growth behind the silicone sealant. When this occurs replacement of the silicone is required.

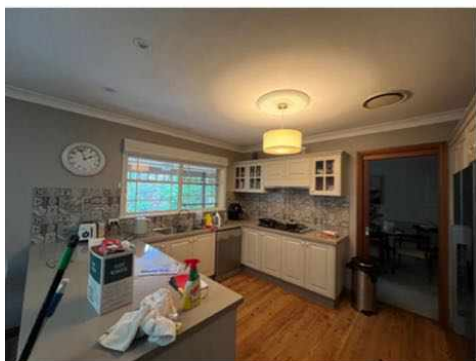
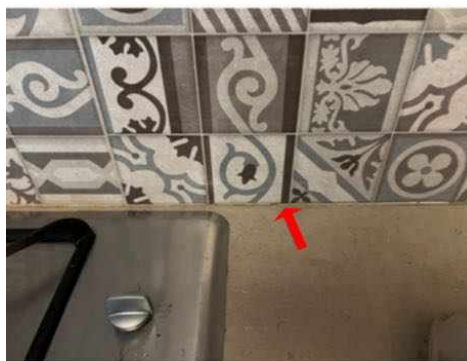
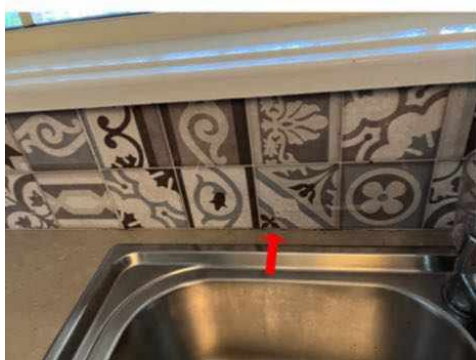
| Information: | The sealant at the junctions has started to deteriorate therefore it is advised to replace the silicone. |

Where these sealants are not installed to standards required by the BCA / NCC and the AS 3958.1 or in accordance with manufacturer's instructions they are considered defective.

Monitoring of a silicone seal is required to identify for any breaks or deterioration that will allow mould spores to lodge forming mould therefore it's recommended that silicone seals are replaced when deterioration, lifting or breaks has been identified.

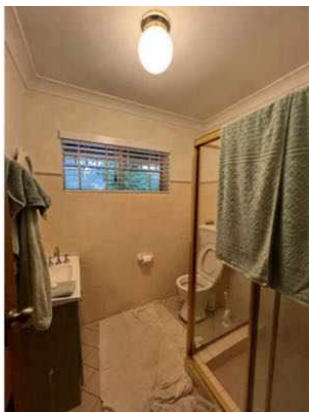
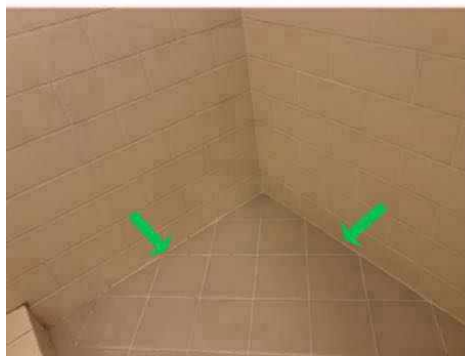
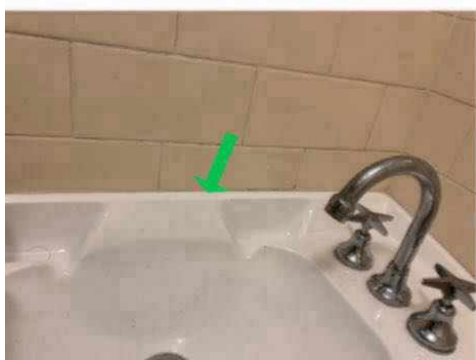
Where these sealants are not installed to standards required by the BCA / NCC and the AS 3958.1 or in accordance with manufacturer's instructions they are considered defective.

Ongoing maintaining a silicone seal the tile junctions are required to stop moisture and or mould growth behind the silicone sealant. When this occurs replacement of the silicone is required.

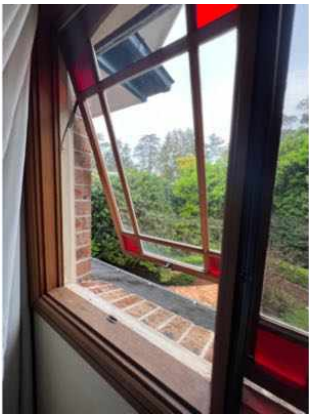
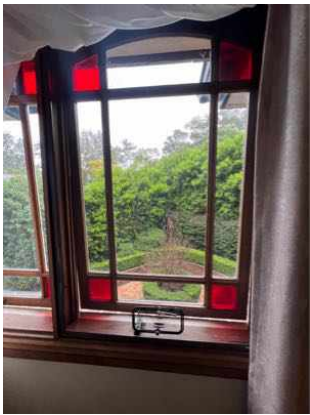
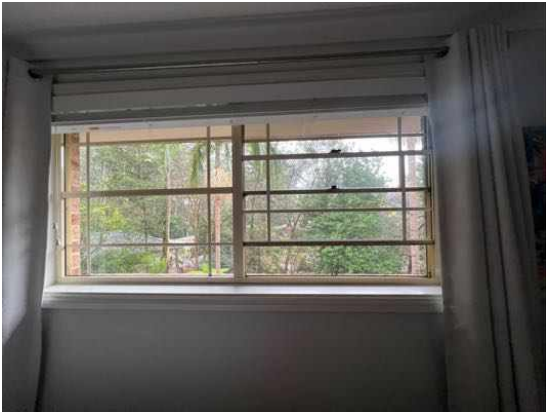
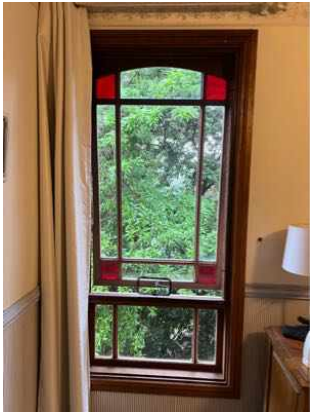
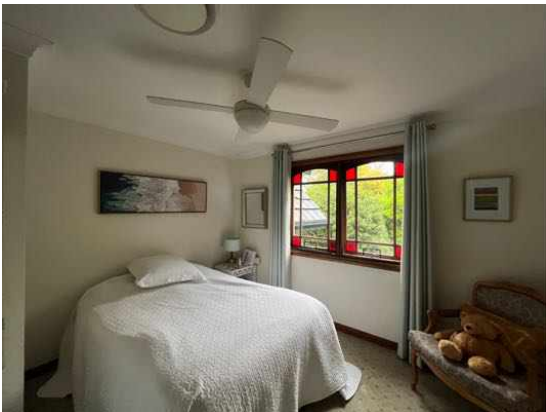
| Finding: | Window - Fall hazard |
| Information: | The windows within these locations are able to be fully opened which allows for potential fall hazard which at the time of construction would have complied with the Building Code of Australia and the Australian Standards. |

Australian Standards introduced AS 5203:2016 Protection of openable windows? falls prevention therefore windows allowing falls from windows 2m above the surface beneath are only to operate at a maximum of 125mm.

A licensed carpenter may be engaged to fit locks to prevent the windows being opened to 125mm maximum.
