# BUILDING AND TIMBER PEST INSPECTION - VR

Complies with Australian Standard AS 4349.1-2007 & AS 4349.3-2010  
Inspection of Buildings Part 1 & Part 3: Pre-Purchase  
Inspections of Residential Buildings - Appendix C

Jul 27, 2026

4 Gavin Pl  
Kings Langley, NSW 2147, Australia

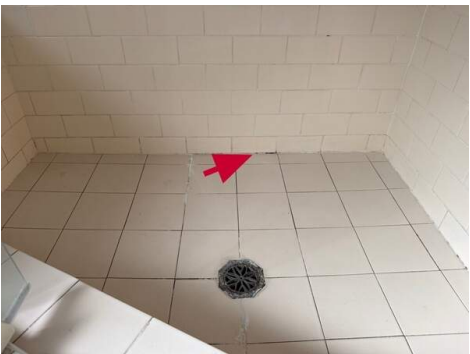
Photo Ref #1

### 7.3.1 Sealant Recommended - Tiled Junctions

Within the shower recess, movement at tiled junctions such as shell recesses and wall-to-floor or wall-to-wall connections may cause cracks in grout and sealant over time. These junctions are especially vulnerable due to structural shifts and temperature changes.

Building: Main Building  
Area: Interior  
Location: Bathroom 1  
Defect Significance: Minor Defect  
Defect Type: A (Damage)

To maintain water tightness, it is important to use a high-quality, flexible, mould-resistant sealant at all tiled junctions. Regular inspections should be carried out, with repairs or reapplication performed promptly to prevent water ingress and damage.

Engaging a qualified tiling or waterproofing specialist is advised to ensure correct sealing at these movement-prone junctions. Routine maintenance will help prolong the life of the shower recess and avoid secondary issues such as mould or water damage.

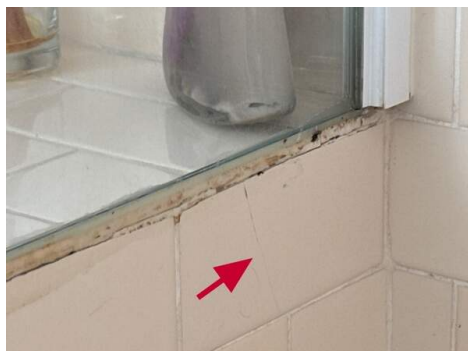
Photo Ref #2

### 7.3.2 Cracked or damaged tiles evident - Fine

Fine cracking was evident to the tiling in this area at the time of inspection.

While the cracking appears to be minor, this area may be frequently exposed to water, allowing potential for water penetration into adjoining sections of walls or flooring.

If left unmanaged, water penetration to these areas may lead to subsequent water damage, which is likely necessitate repair work to affected building elements.

A tiling contractor should be appointed to ensure that no further water damage occurs. The re-application of silicone and grouting throughout remaining tile work is also advised, to further protect the area against water penetration.

Where water penetration has led to water damage, appointment of a relevant tradesperson may be required to repair damaged building elements.

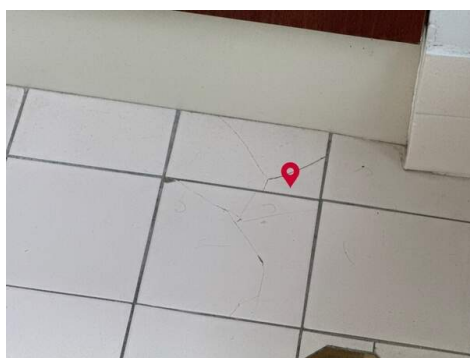
Photo Ref #3

### 7.3.3 Cracked floor tiles evident - Fine

Cracking in the floor tiles was evident in this area at the time of inspection.

Expansion and contractions in the floor foundations may have caused movement and resulted in the cracking to tiles in this area.

Cracked tiles throughout the household may detract from the overall appearance of the affected areas.

While not considered a matter of urgency, replacement of cracked floor tiles is advised as a solution. A tiling contractor or general handyperson may be appointed to perform these works at client discretion.

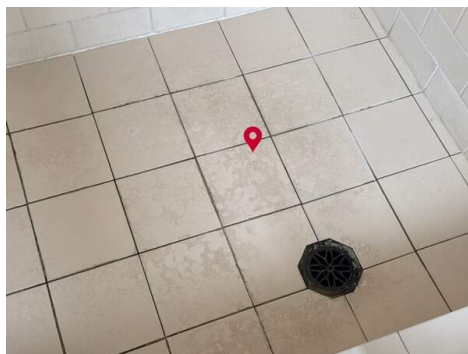
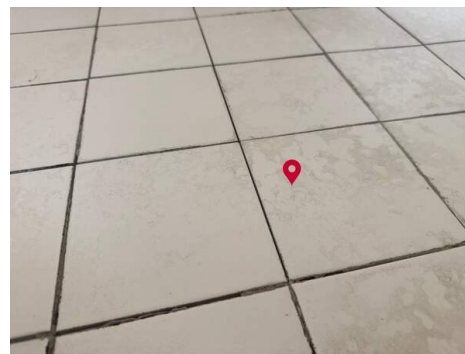
### 7.3.4 Surface - Discoloured

Discolouration was evident to the surface of this building element at the time of inspection. This degree of surface damage is consistent with general deterioration, which is generally expected of a property of this age and condition.

Discolouration usually occurs when the surface has been stained by foreign substances or water. Despite surface discolouration in this area, it is unlikely that this defect indicates any major underlying defects. Discoloured surfaces are unlikely to cause secondary damage to associated building elements and do not require repair or replacement. However, the client may wish to seek quotations for the cost of refurbishment and/or replacement of any affected building elements. A general handyman or painting contractor may be appointed to restore the condition of discoloured surfaces.

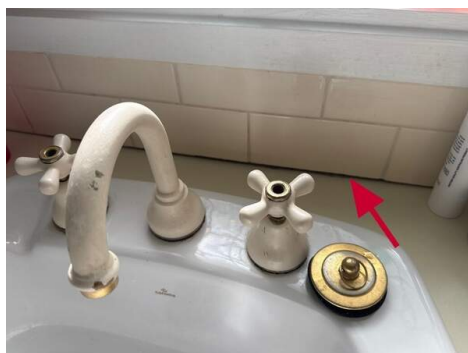
Photo Ref #6

### 7.3.5 Sealant - Recommended

Different materials and floor areas move at different rates, generally causing cracking to grout or sealant at this point.

Flexible and mould resistant materials should be applied to affected areas to prevent any secondary issue. Regular maintenance and replacement of damaged or missing or sealant and grout is highly recommended to the wet areas, as this is a regular wear and tear defect.

Sealant and grouting in areas that come into regular contact with water should be maintained for the long term care of your property. A sealant specialist or tiling contractor is recommended to be appointed to complete these works at the earliest convenience.

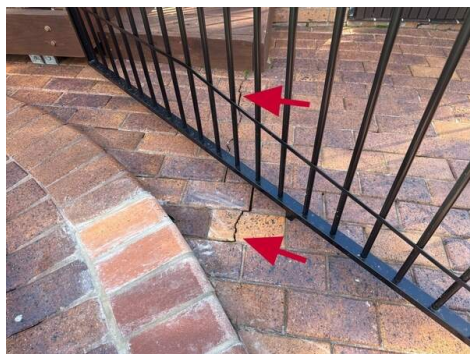
Photo Ref #8

### 7.3.7 Cracking - External Concrete or Paving Damage - Distinct

There is evidence that the cracking observed is consistent with the general age and expected deterioration of the area. Environmental factors causing expansion and contraction of the slab may also contribute.

This level of cracking could additionally result from poor initial installation, such as inadequate compaction of the sub-surface or insufficient reinforcement, which may lead to further defects over time.

It is recommended to contact a building inspector if the cracks widen, lengthen, or increase in number to ensure ongoing assessment and appropriate management.

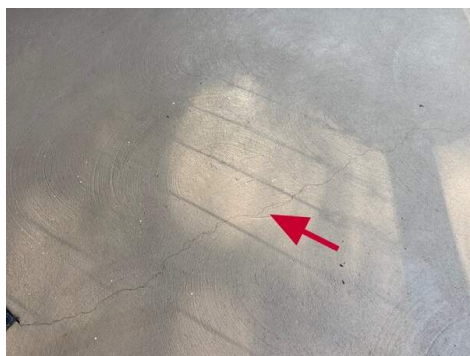
Photo Ref #9

## 7.3.8 Cracking - External Concrete Category 1 - Fine (Less Than 2mm)

Fine cracks were identified in external concrete areas as shown. Although fine cracks are quite noticeable, they are often only considered to be an appearance defect, and usually do not indicate any structural damage. To be considered a Category 1 or fine crack, the crack is found to be <2mm in width.

Generally the cause of a hairline crack in existing concrete such as driveways and pathways is indicative of the expansion and contraction of the concrete. Such causes are generally due to environmental factors, such as moisture levels, weather conditions, root systems of nearby trees or the soil types on which they are laid. Fine cracks may also be due to poor original installation of the concrete. Factors such as poor compaction of the sub surface and/or inadequate reinforcing of the slab may create cracking and other secondary defects.

Monitoring of all cracking should be conducted frequently. Always contact a building inspector should cracks widen, lengthen, or become more numerous.

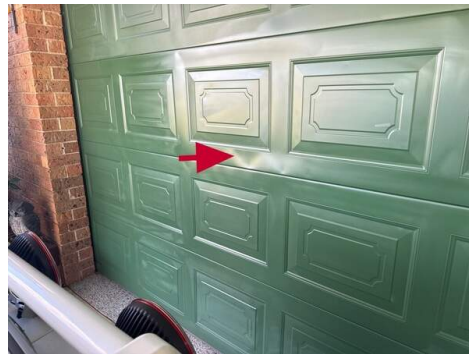
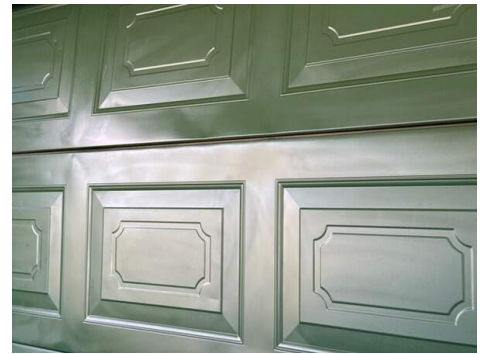
### 7.3.9 Garage Door - Minor Impact Damage

The garage roller door has a number of marks and dents likely to have resulted from impact damage at sometime.

A qualified roller door installer or supplier should be engaged to check out the operation and overall condition of the doors to determine if repair is an option otherwise replacement may need to be considered.

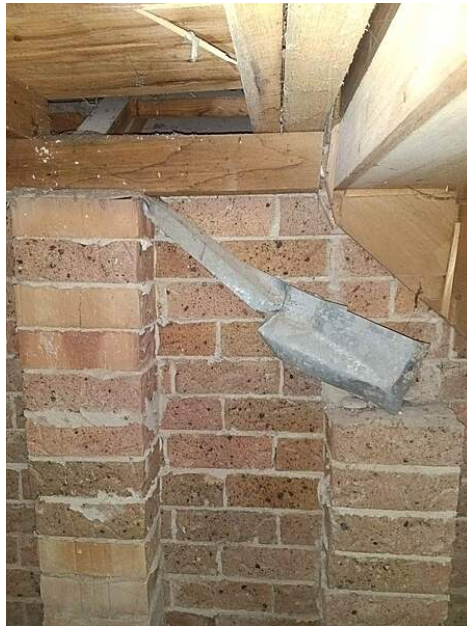
Photo Ref #12

### 7.6.1 Ant Caps - Damaged

It was observed in the subfloor area that ant caps have not been installed on piers or other building elements as shown in the photo. It is important to note that ant caps were installed in other areas of the subfloor.

In the absence of ant caps, regular monitoring of these areas is recommended to identify any signs of termite or timber pest activity. We advise increasing the frequency of professional pest inspections.

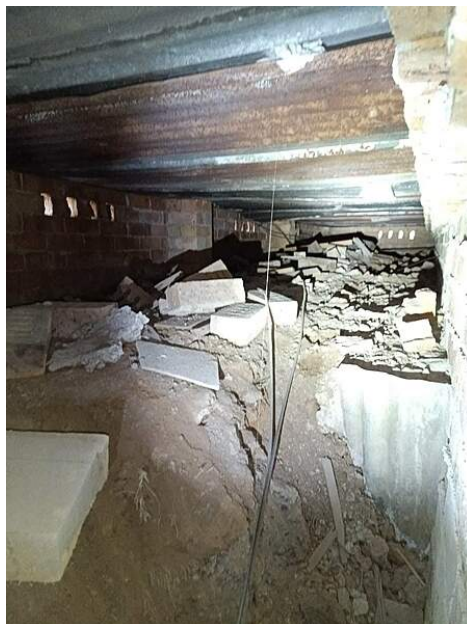
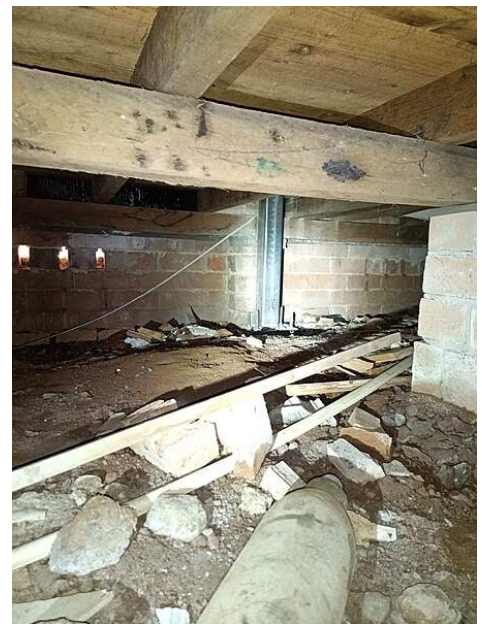
There is evidence that timber elements in direct contact with the ground or exposed to moisture can create an environment conducive to termite activity. This applies to structural components, fencing, or stored timber, all of which can attract termites.

Excessive moisture can cause the timber to decay and develop wood rot, further increasing the risk. Untreated or non-durable timber in contact with external ground areas provides an entry point for subterranean termites, which can lead to damage.

To minimise the risk of termite infestation, any timber in direct contact with the ground or exposed to moisture should be removed or treated as soon as possible. Preventative measures help protect the property from potential termite-related damage.

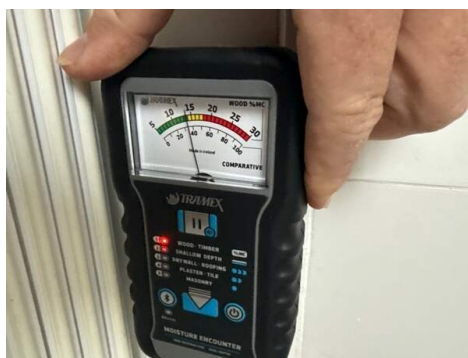
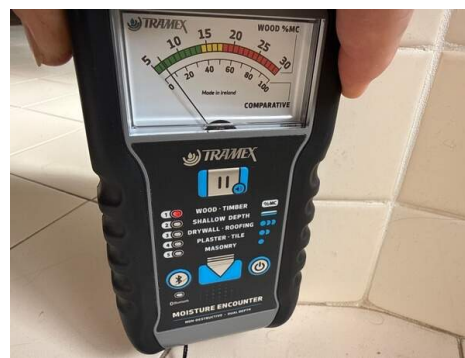
### 7.7.1 Moisture Meter Reading: Low or Zero

Upon inspecting the wall and door frames as shown, there was no evidence or only low levels of moisture detected.

Recommended action: No immediate action required; monitor as needed.

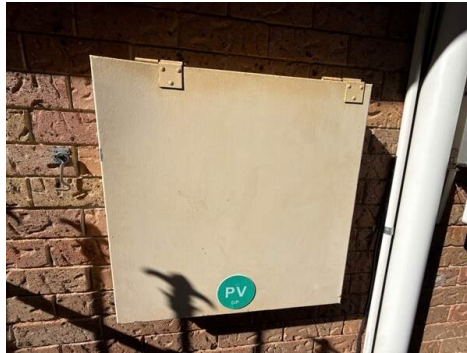
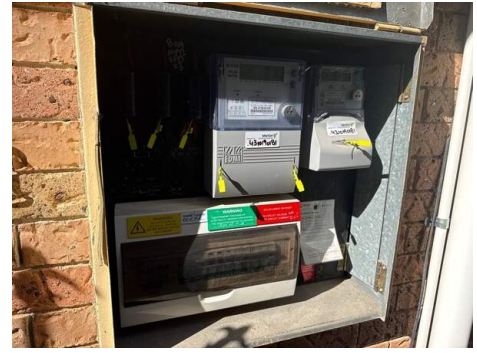
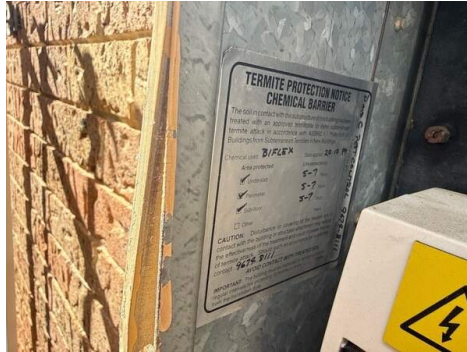
### 7.7.2 Evidence of a Termite Barrier or Management System (TMS) was Identified - Biflex

If a Termite Management System has been identified, it is advisable to review the type of barrier, installation date, warranty conditions, and any documentation provided by the builder or previous owner. Contact the installing company to confirm whether the system is still under warranty.

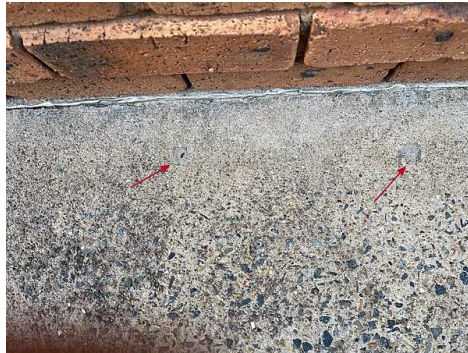
Photo Ref #20

### 7.7.3 Evidence of a Chemical Treated Zone or Barrier was Identified

It is strongly recommended to conduct annual inspections of the barrier and surrounding areas, as factors such as deterioration can reduce its effectiveness over time.

The client should obtain detailed information about the type of barrier, date of installation, warranty conditions, and any documentation from the builder or previous owner. Contact the installing company to verify whether the system is still under warranty.

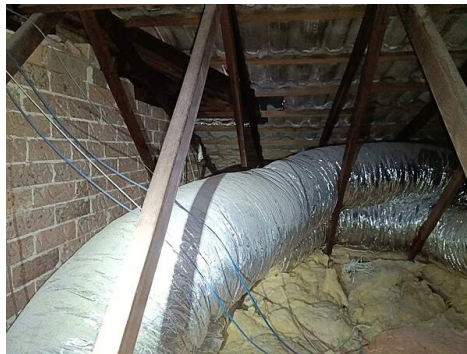
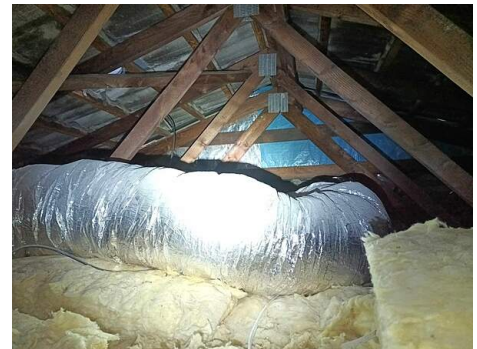
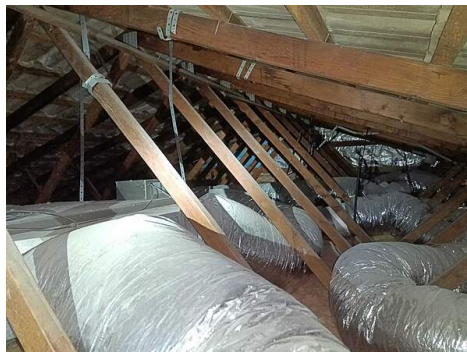
| Comments: | AC Ductwork, Bulk Insulation and Low Clearance |
